FOURTH & CENTRAL PROJECT

Street Tree Report

June 2021

Prepared by:
Environmental Science Associates
80 South Lake Avenue, Suite 570
Pasadena, California 91101
Ryan Gilmore
ISA Certified Arborist WE-9009BM

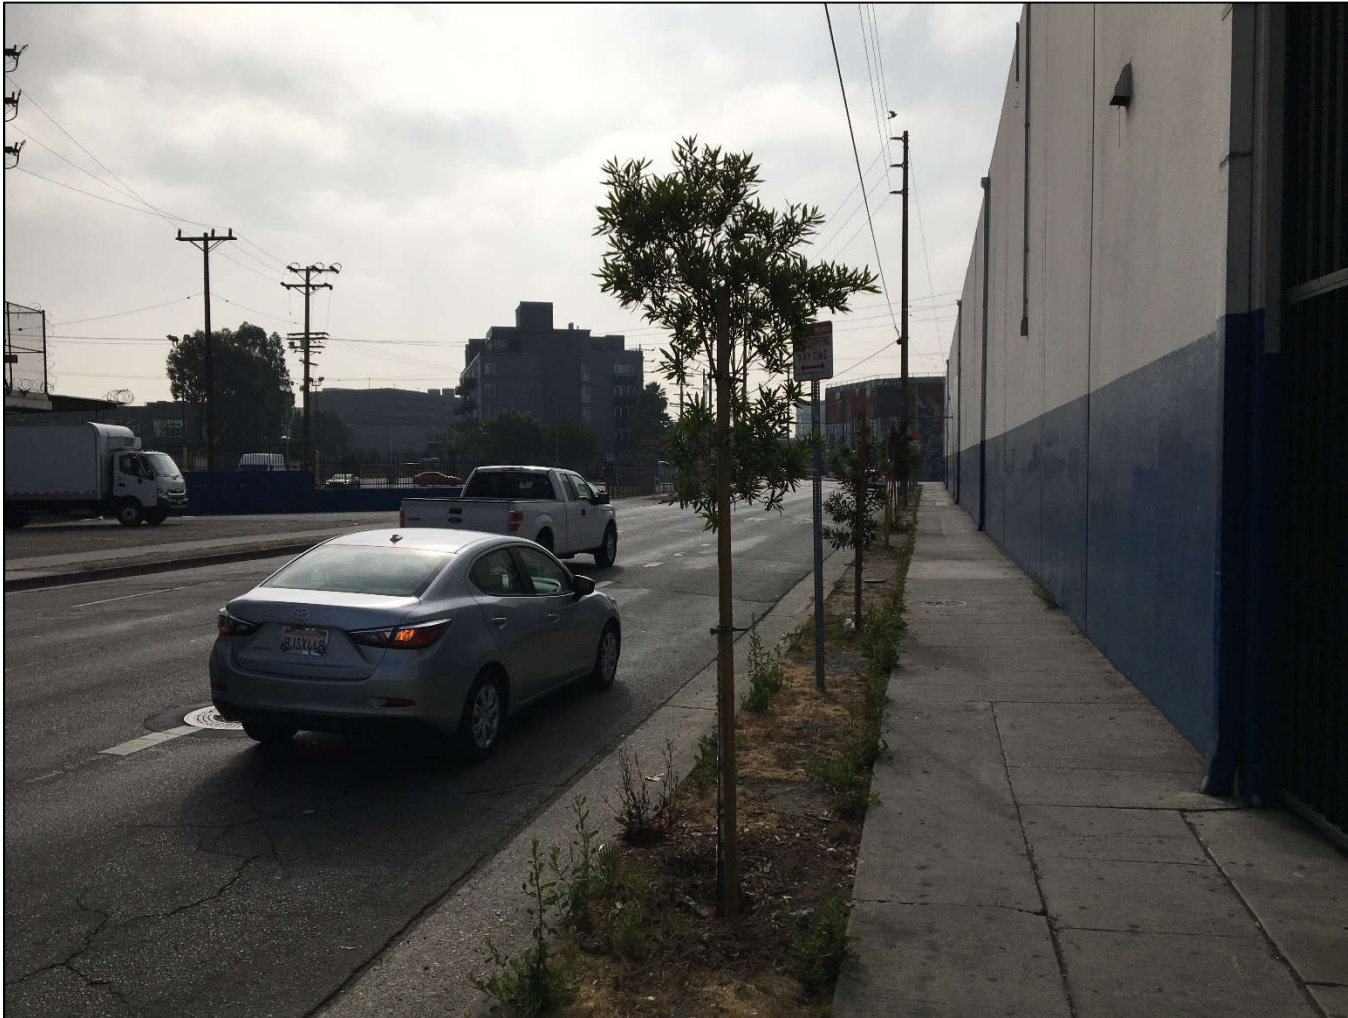
Photo 1 (East). Tree Number 1. Removal required to accommodate construction.

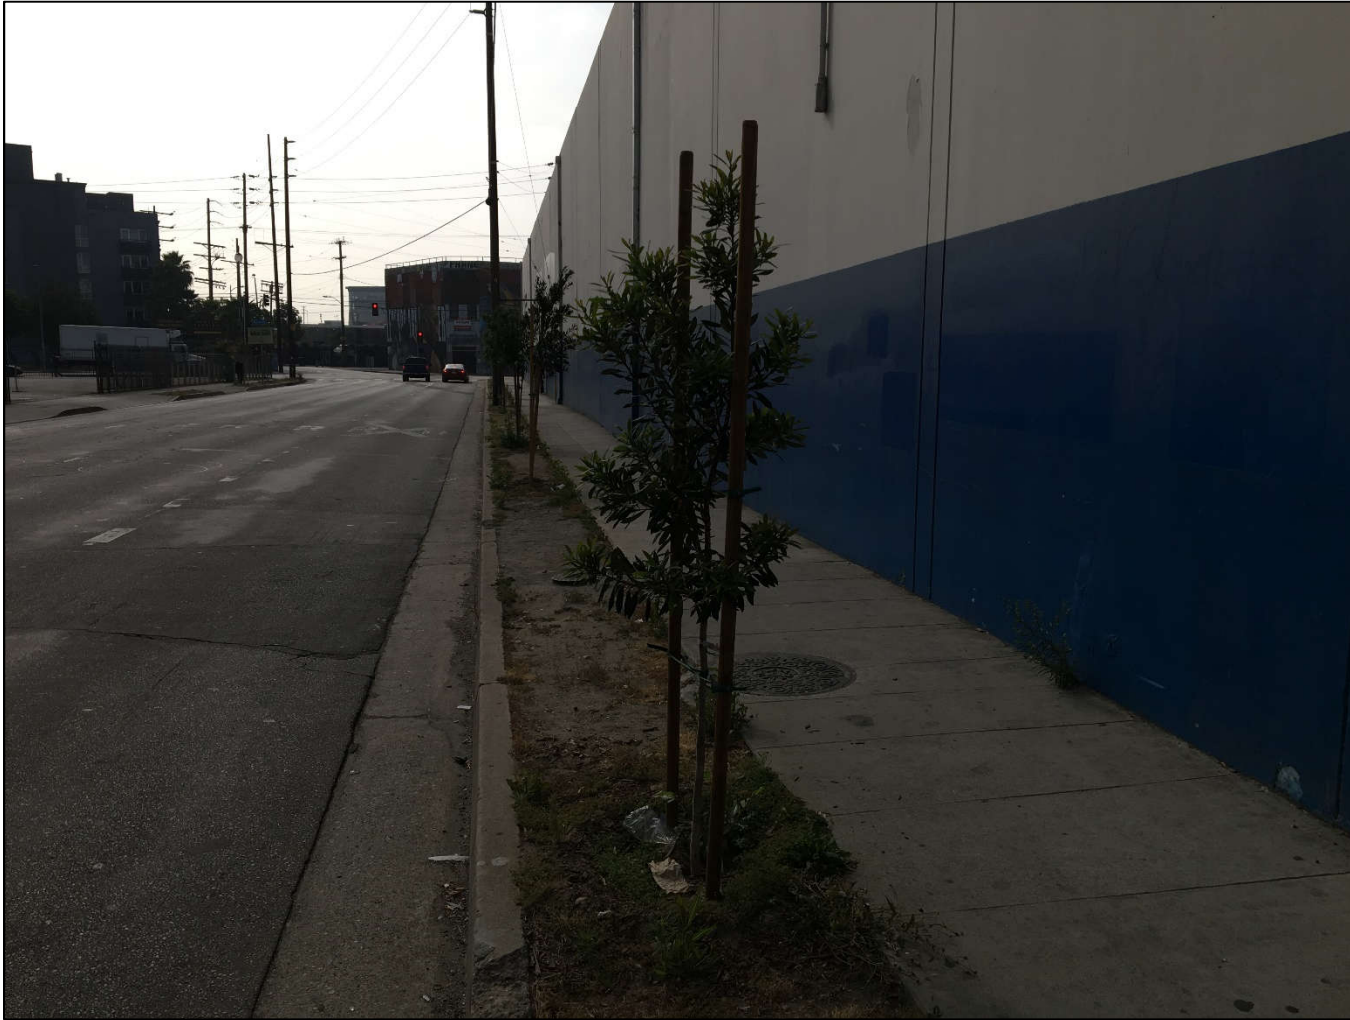
Photo 2 (East). Tree Number 2. Removal required to accommodate construction.

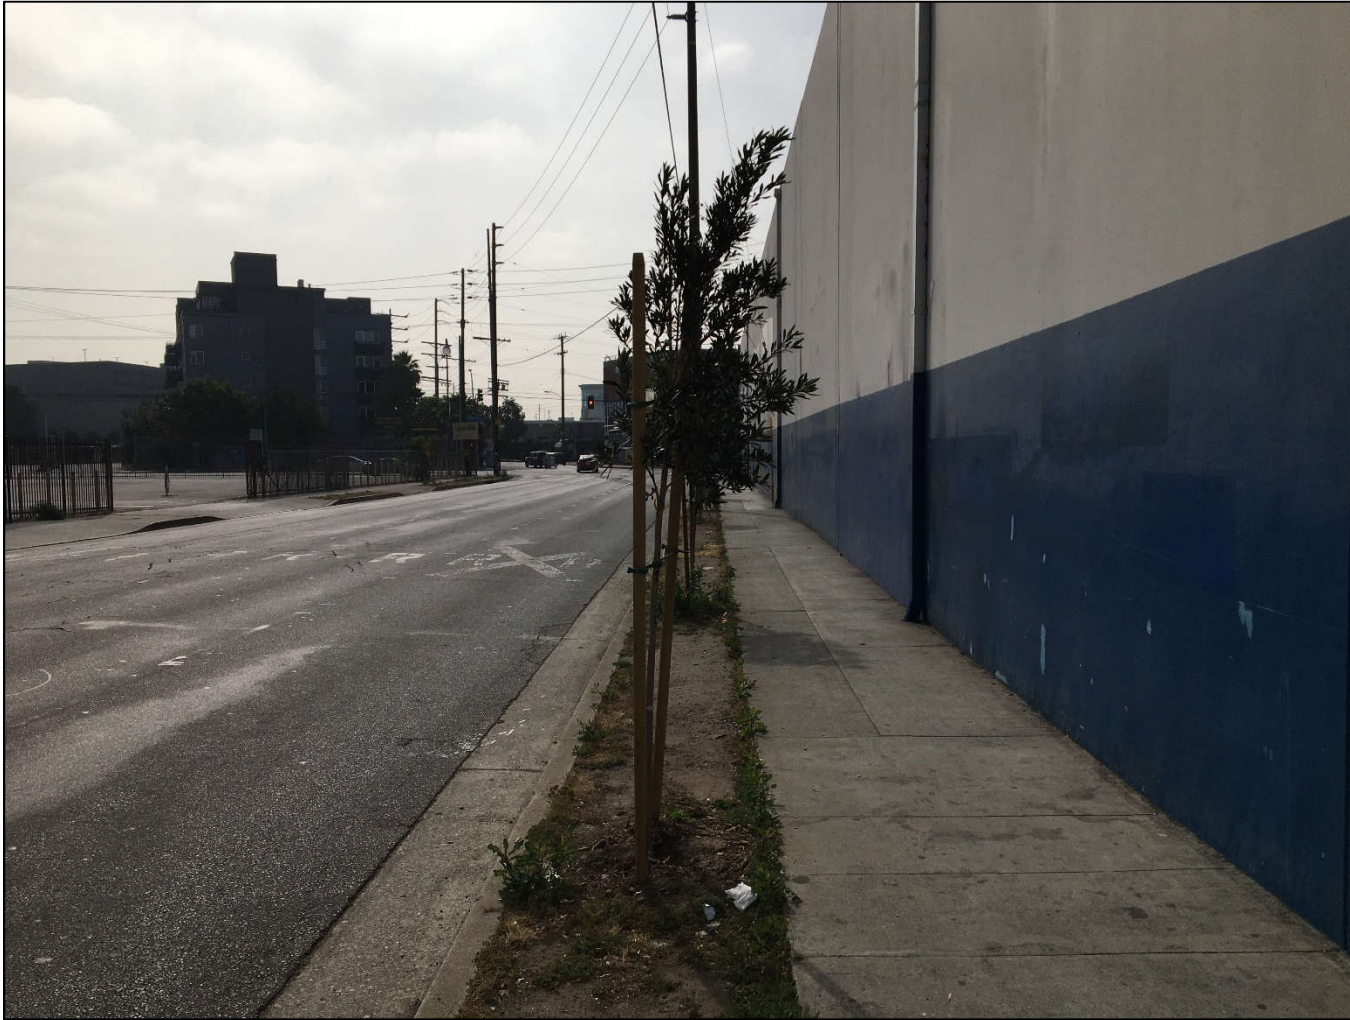
Photo 3 (East). Tree Number 3. Removal required to accommodate construction.

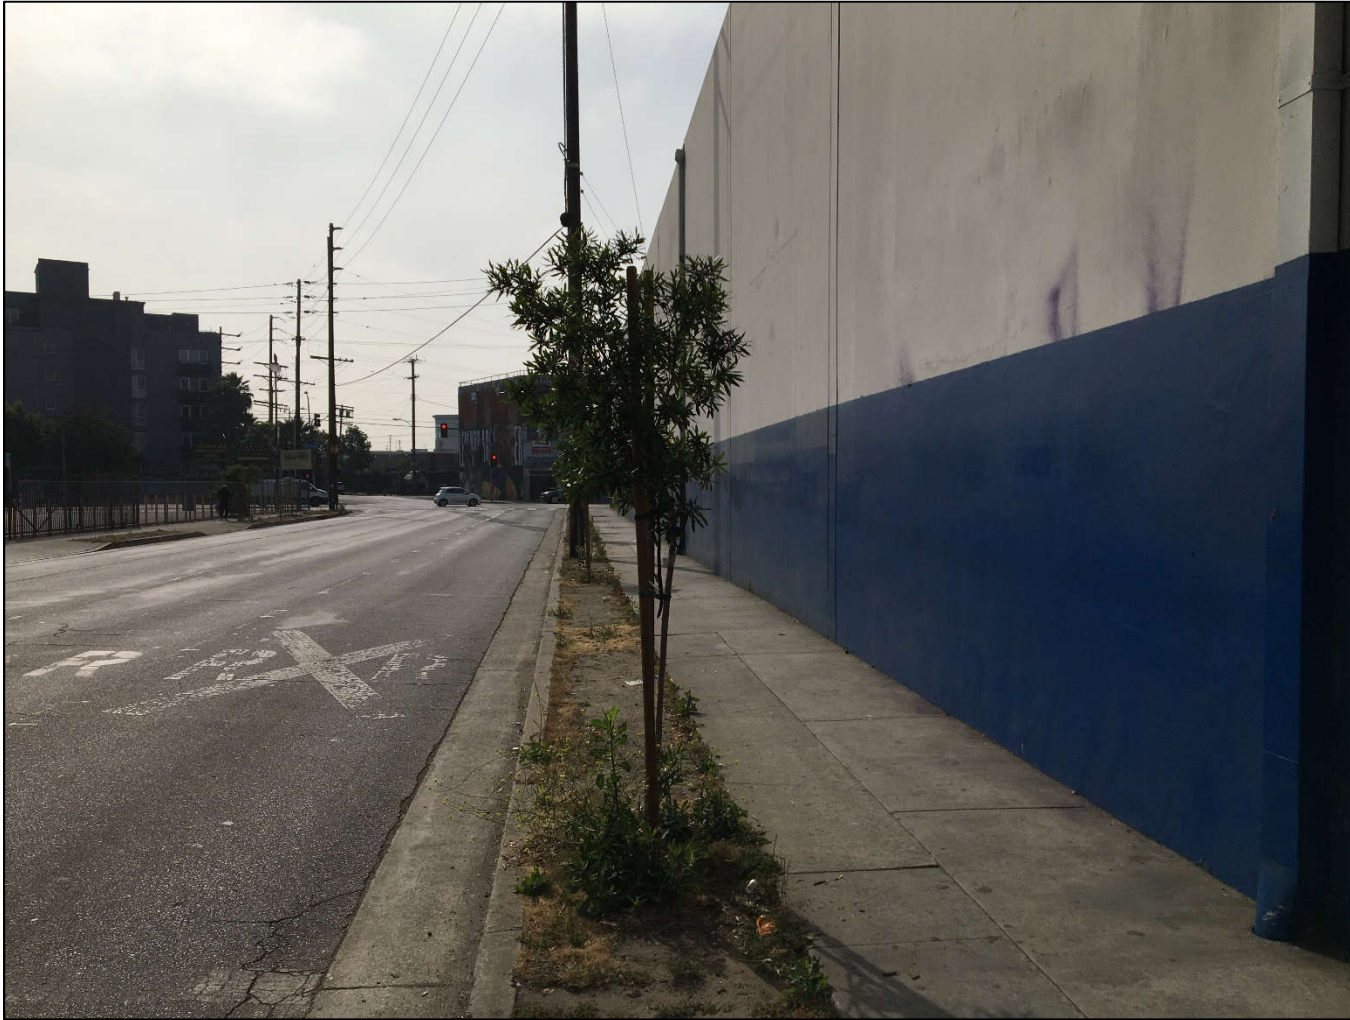
Photo 4 (East). Tree Number 4. Removal required to accommodate construction.

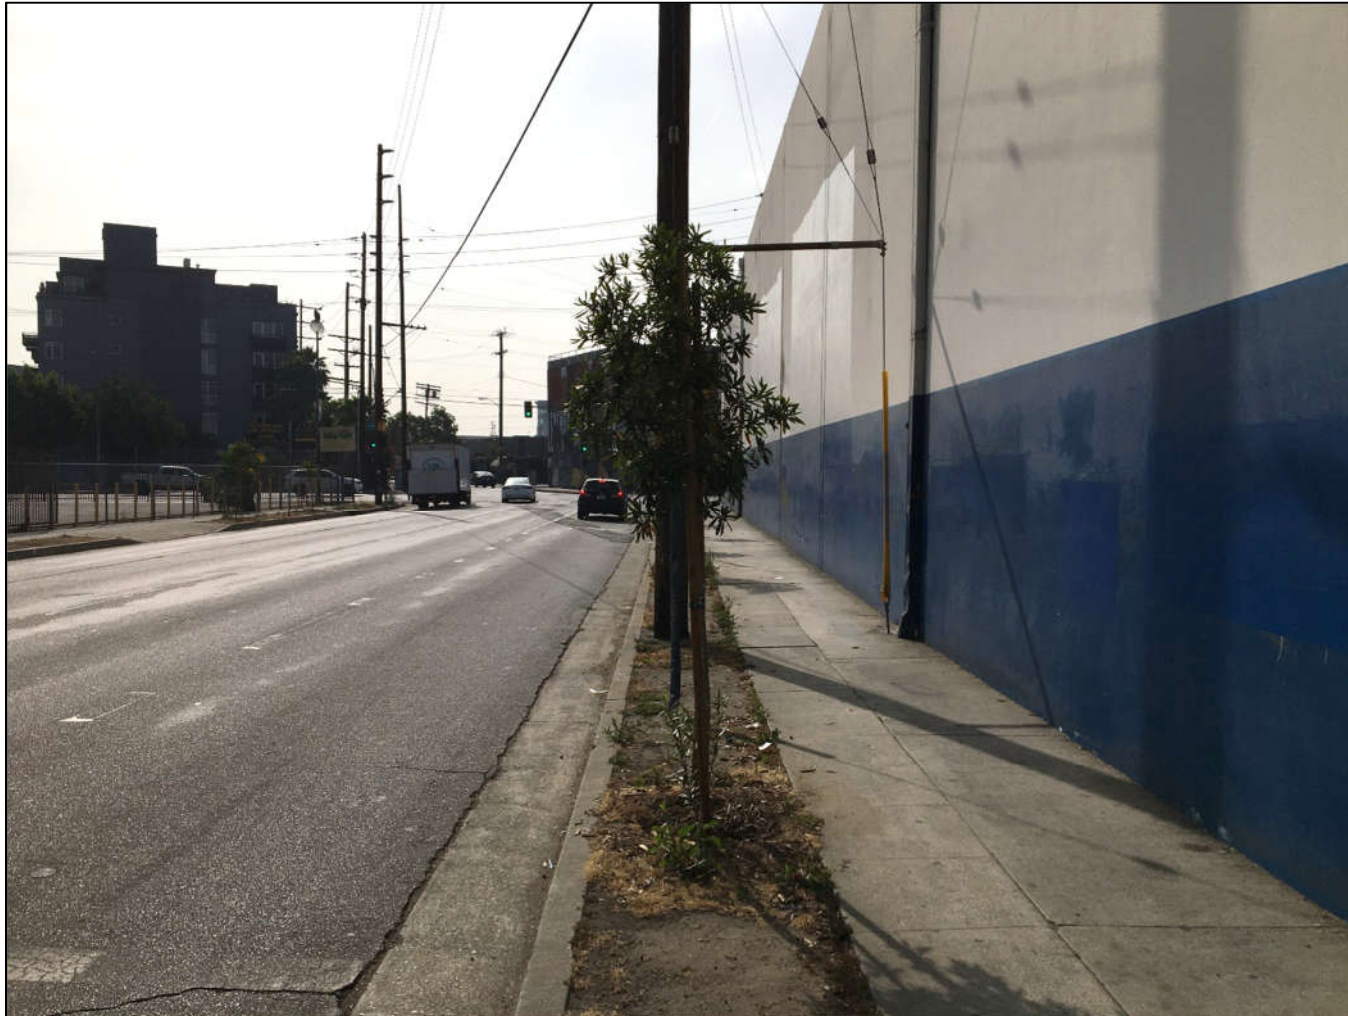
Photo 5 (East). Tree Number 5. Removal required to accommodate construction.

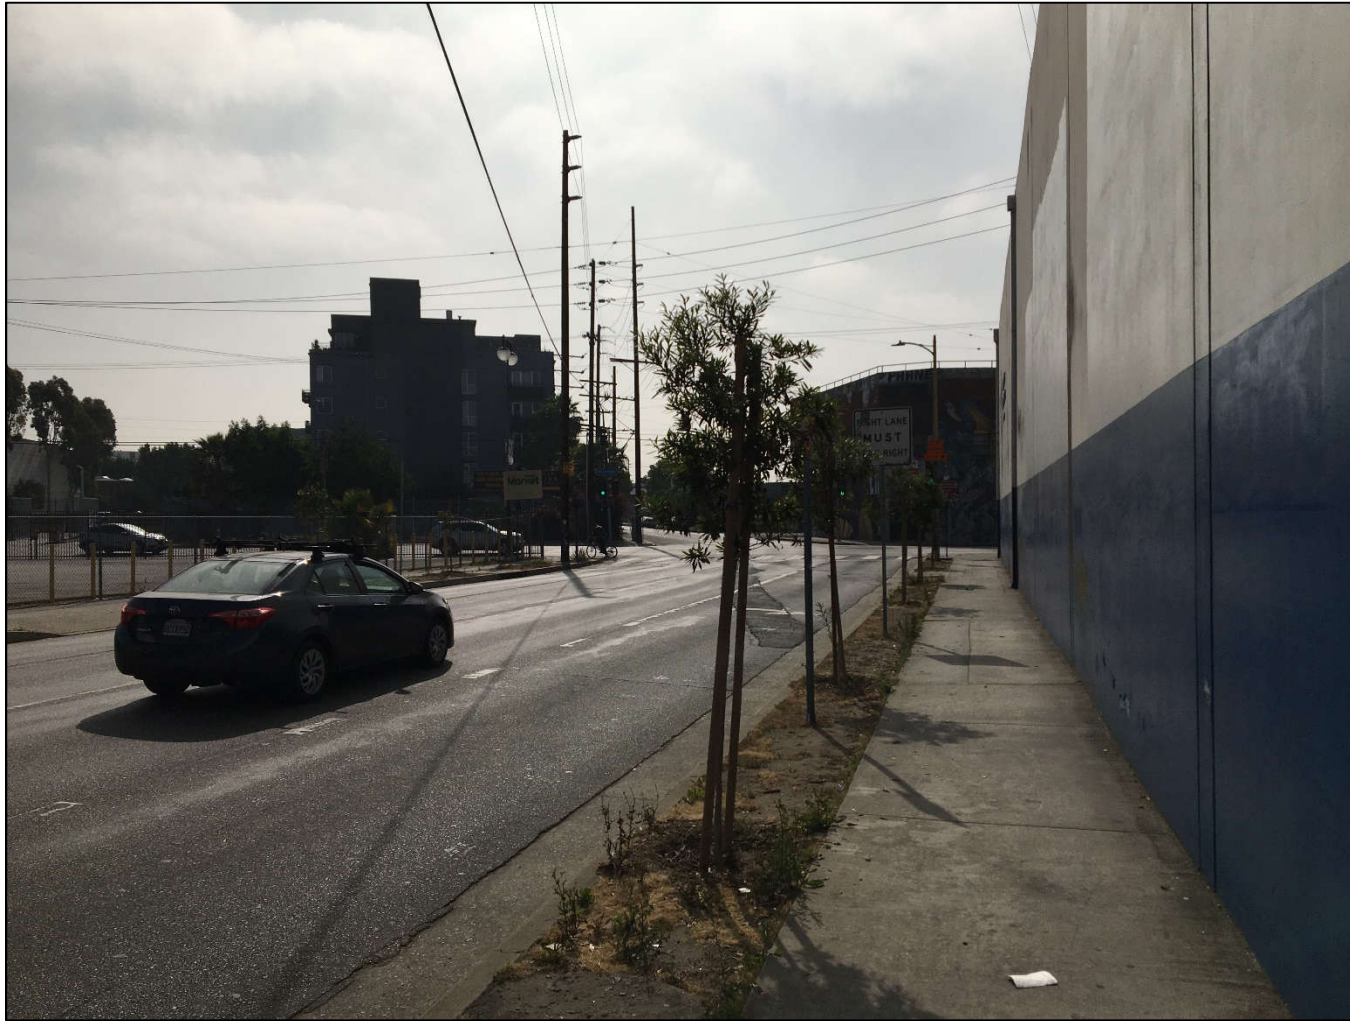
Photo 6 (East). Tree Number 6. Removal required to accommodate construction.

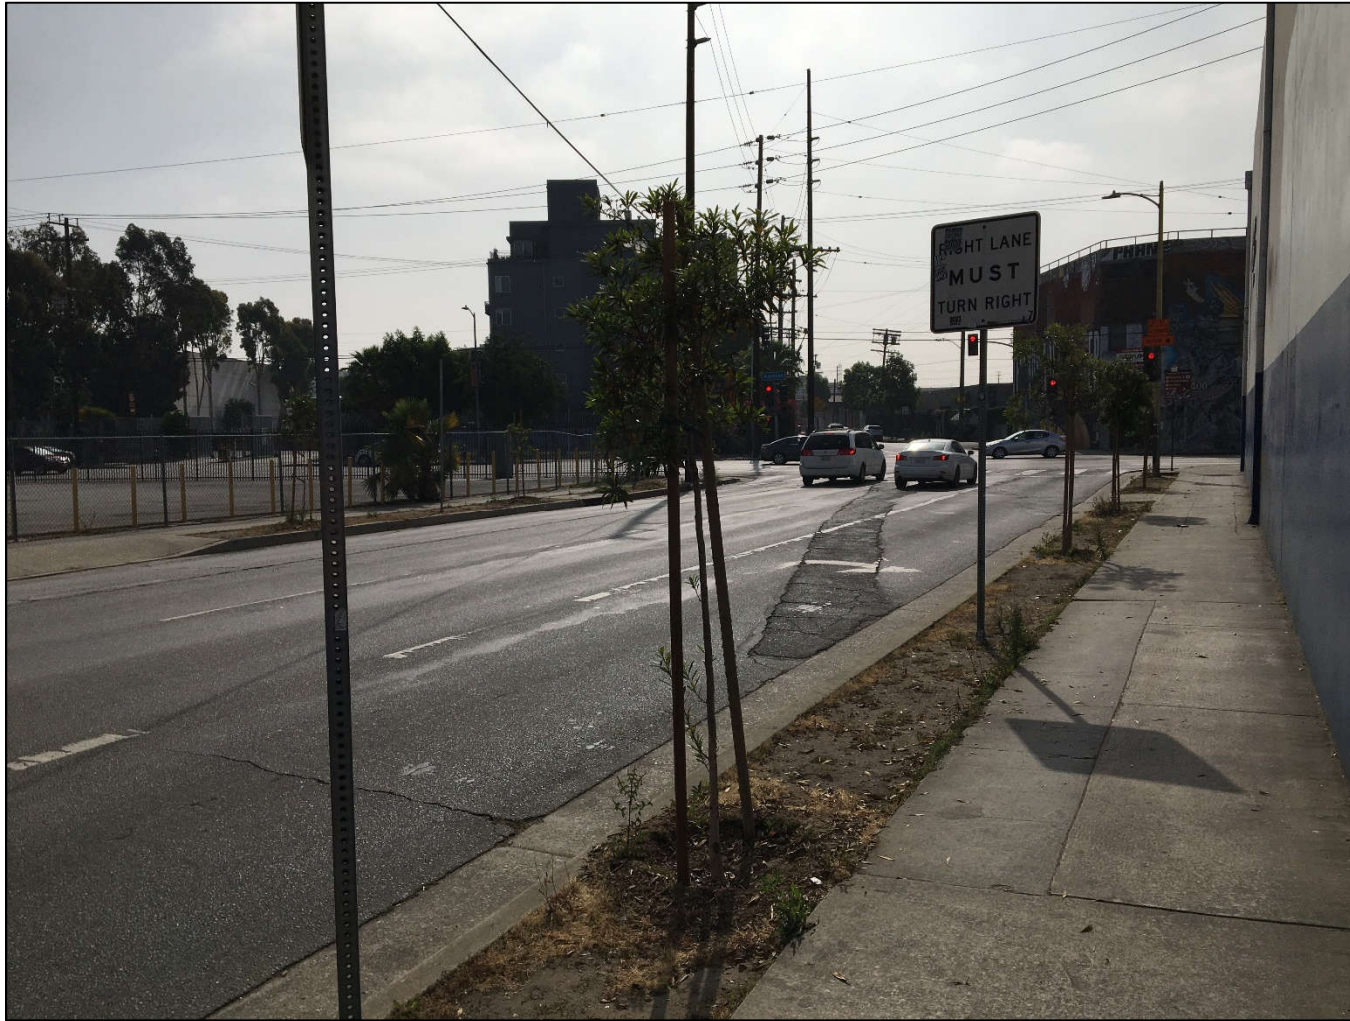
Photo 7 (East). Tree Number 7. Removal required to accommodate construction.

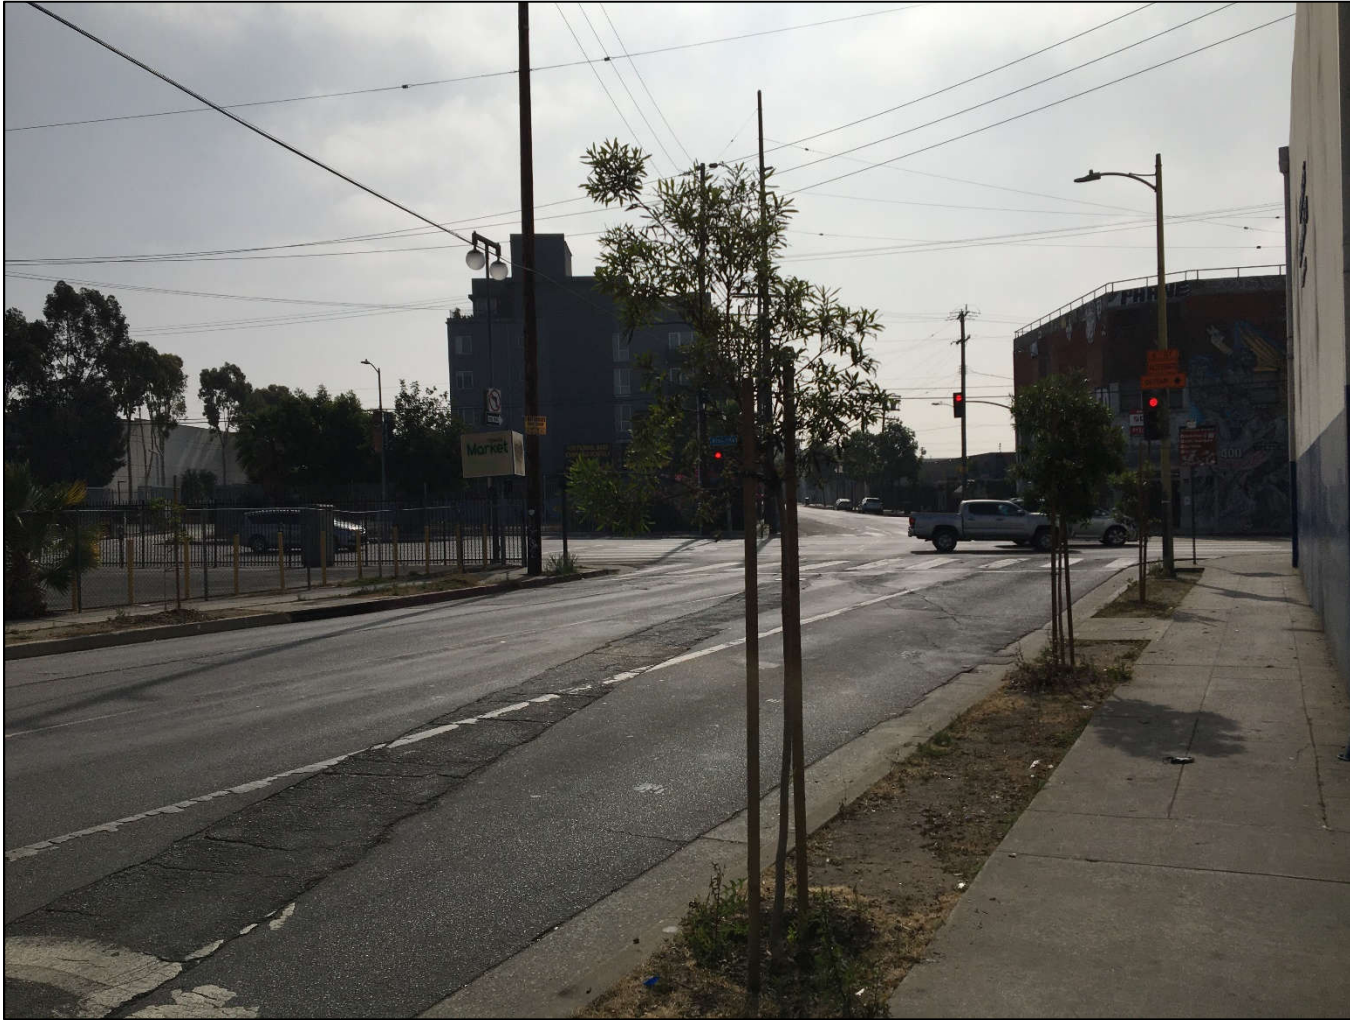
Photo 8 (East). Tree Number 8. Removal required to accommodate construction.

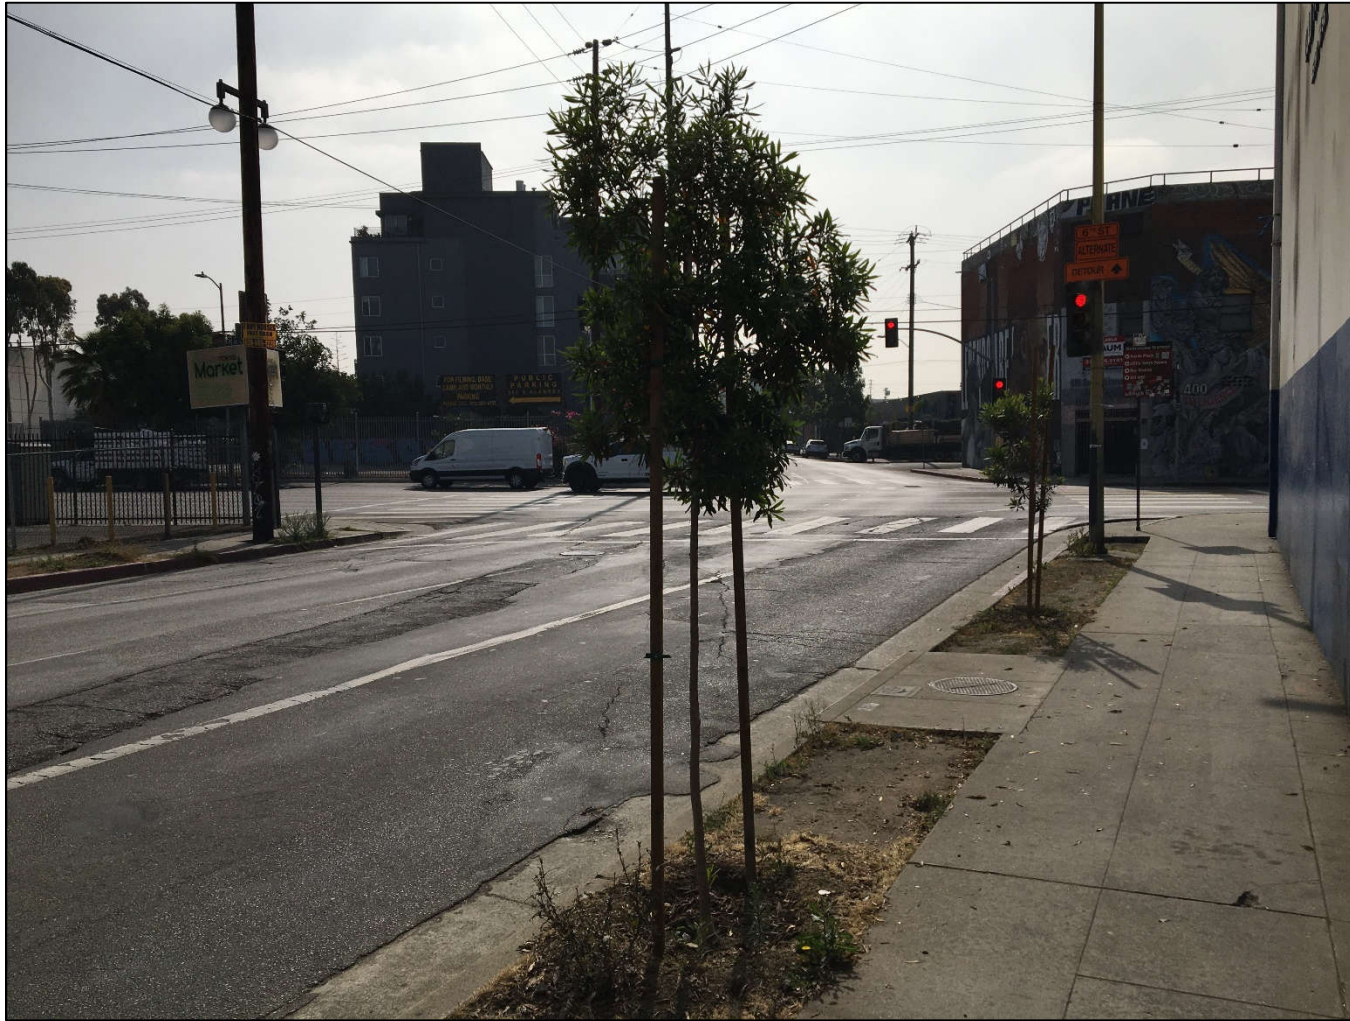
Photo 9 (East). Tree Number 9. Removal required to accommodate construction.

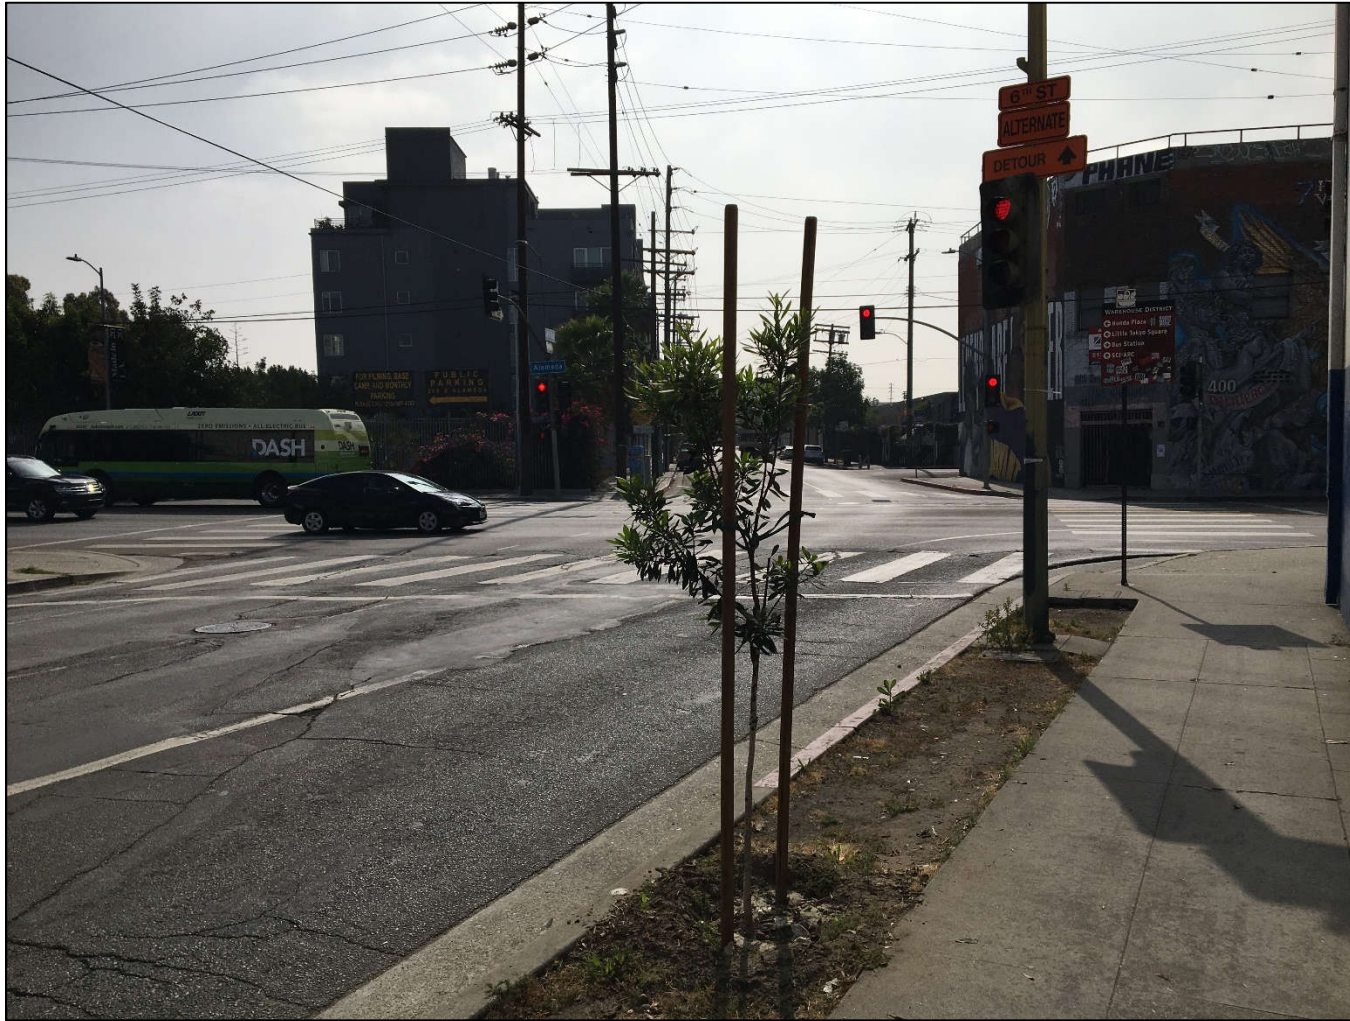
Photo 10 (East). Tree Number 10. Removal required to accommodate construction.

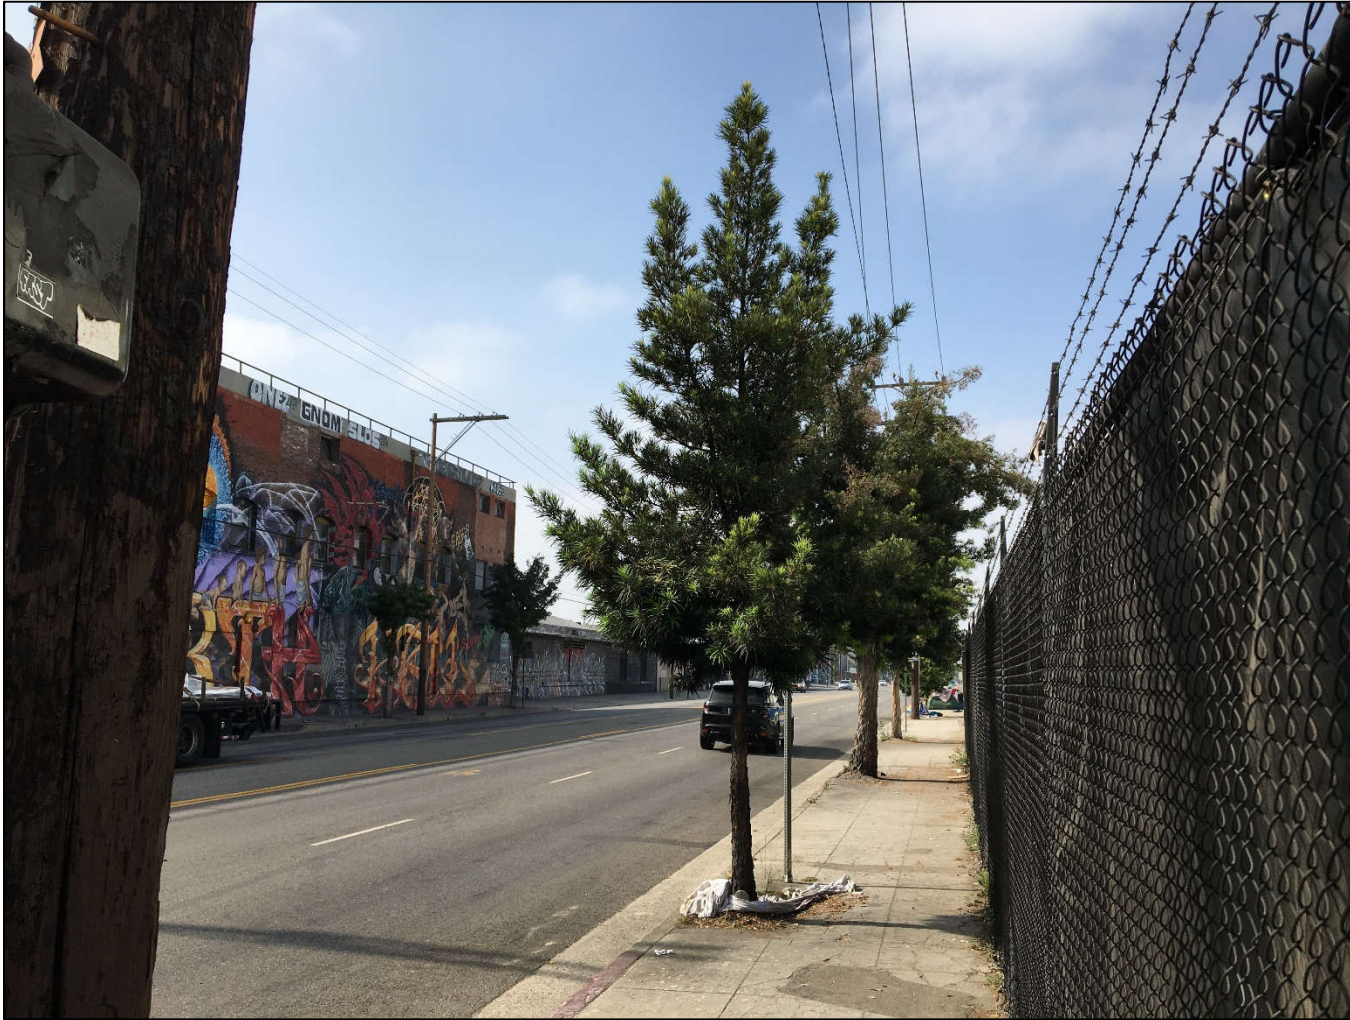
Photo 11 (South). Tree Number 11. Removal required to accommodate construction.

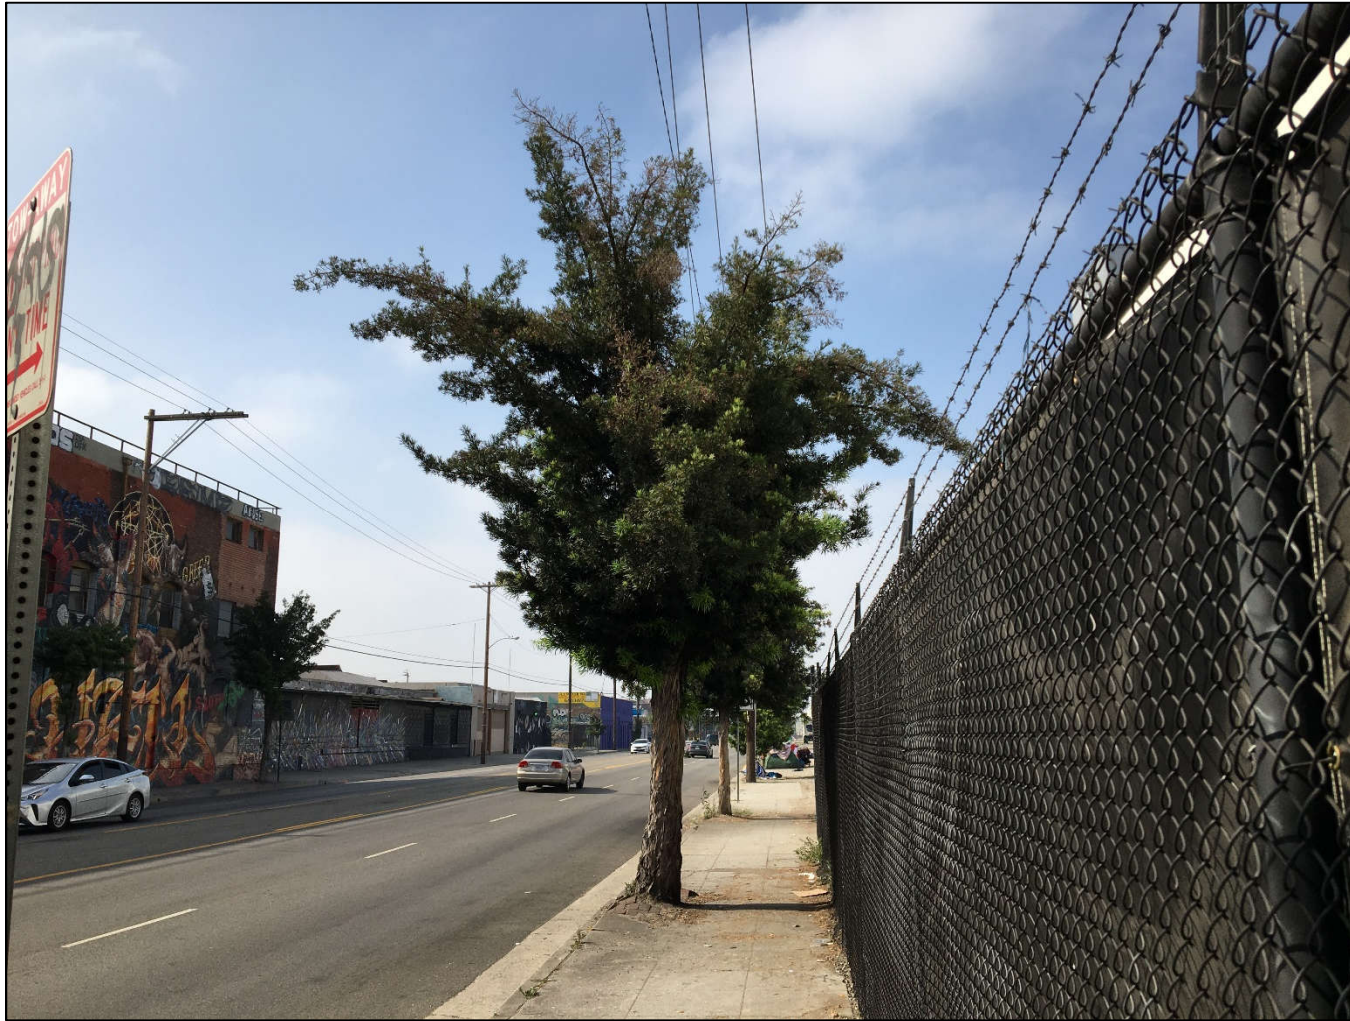
Photo 12 (South). Tree Number 12. Removal required to accommodate construction.

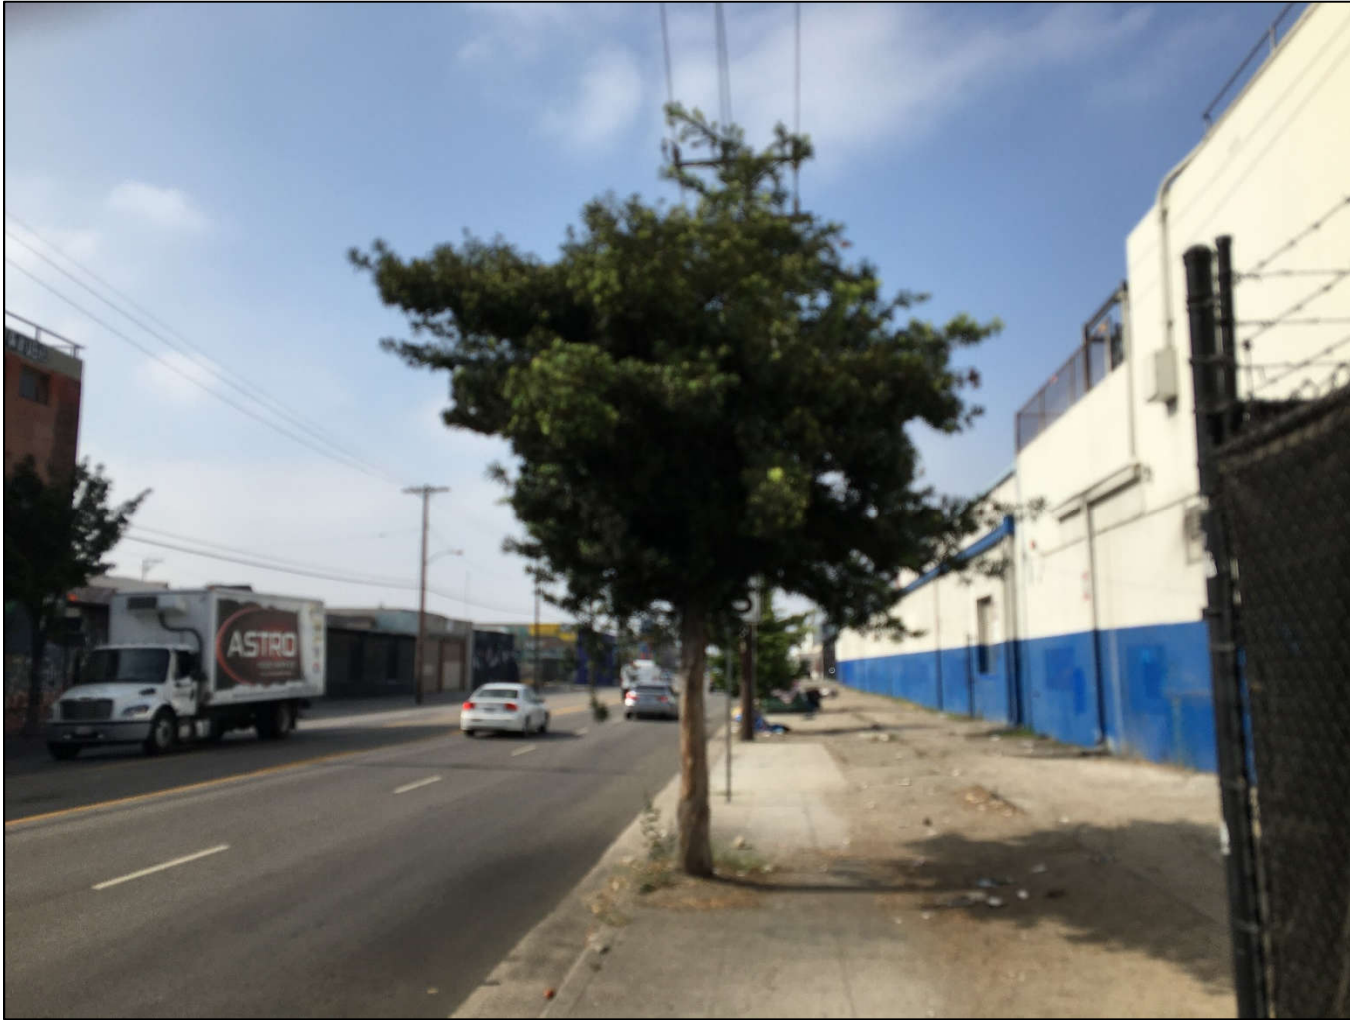
Photo 13 (South). Tree Number 13. Removal required to accommodate construction.

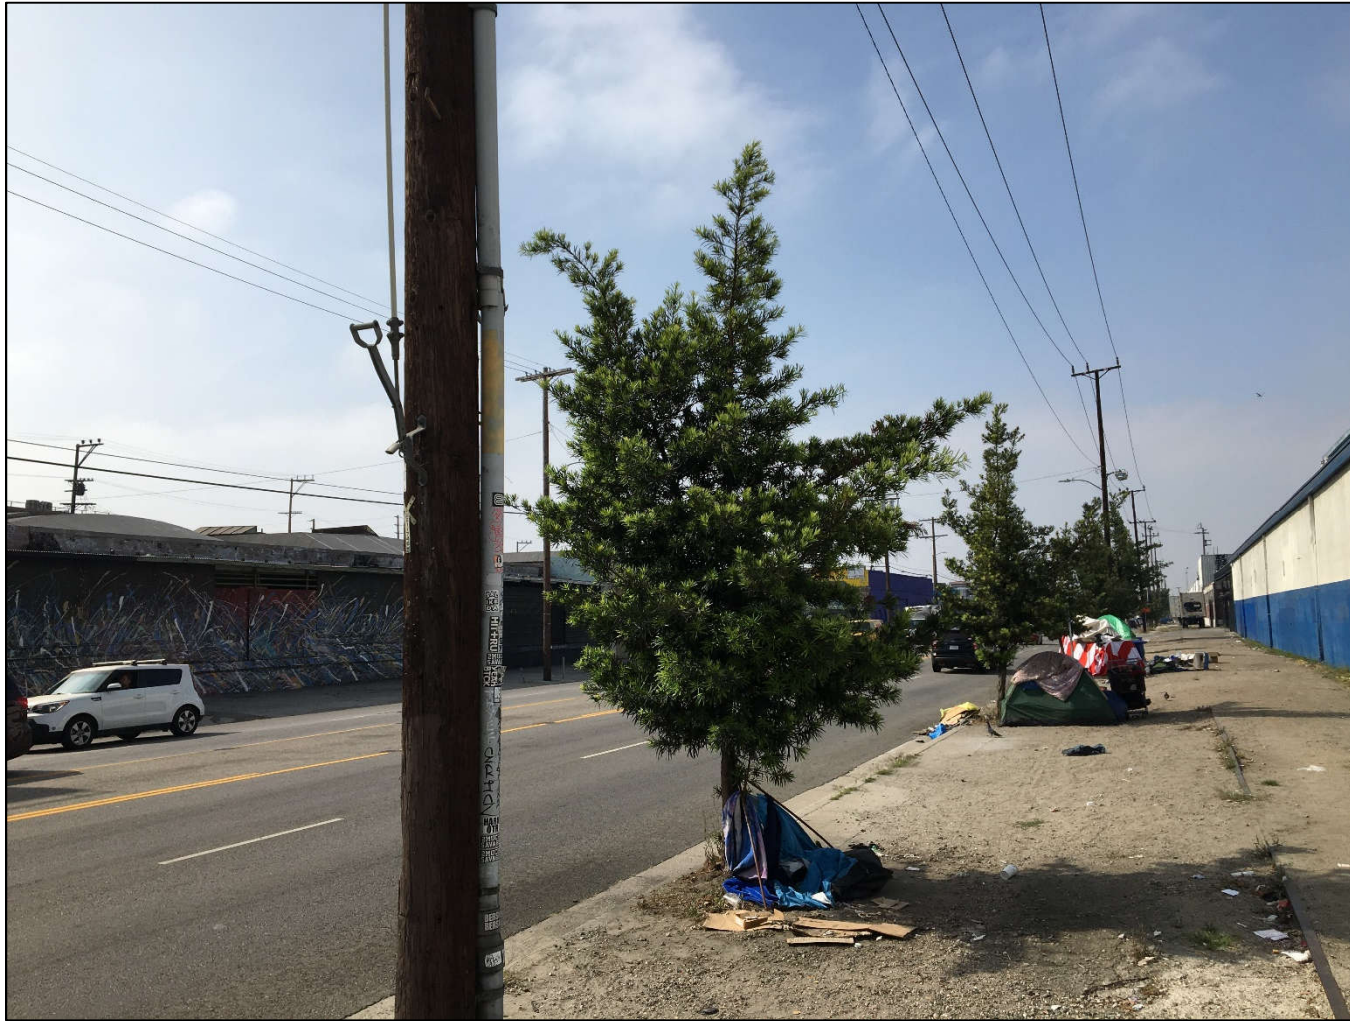
Photo 14 (South). Tree Number 14. Removal required to accommodate construction.

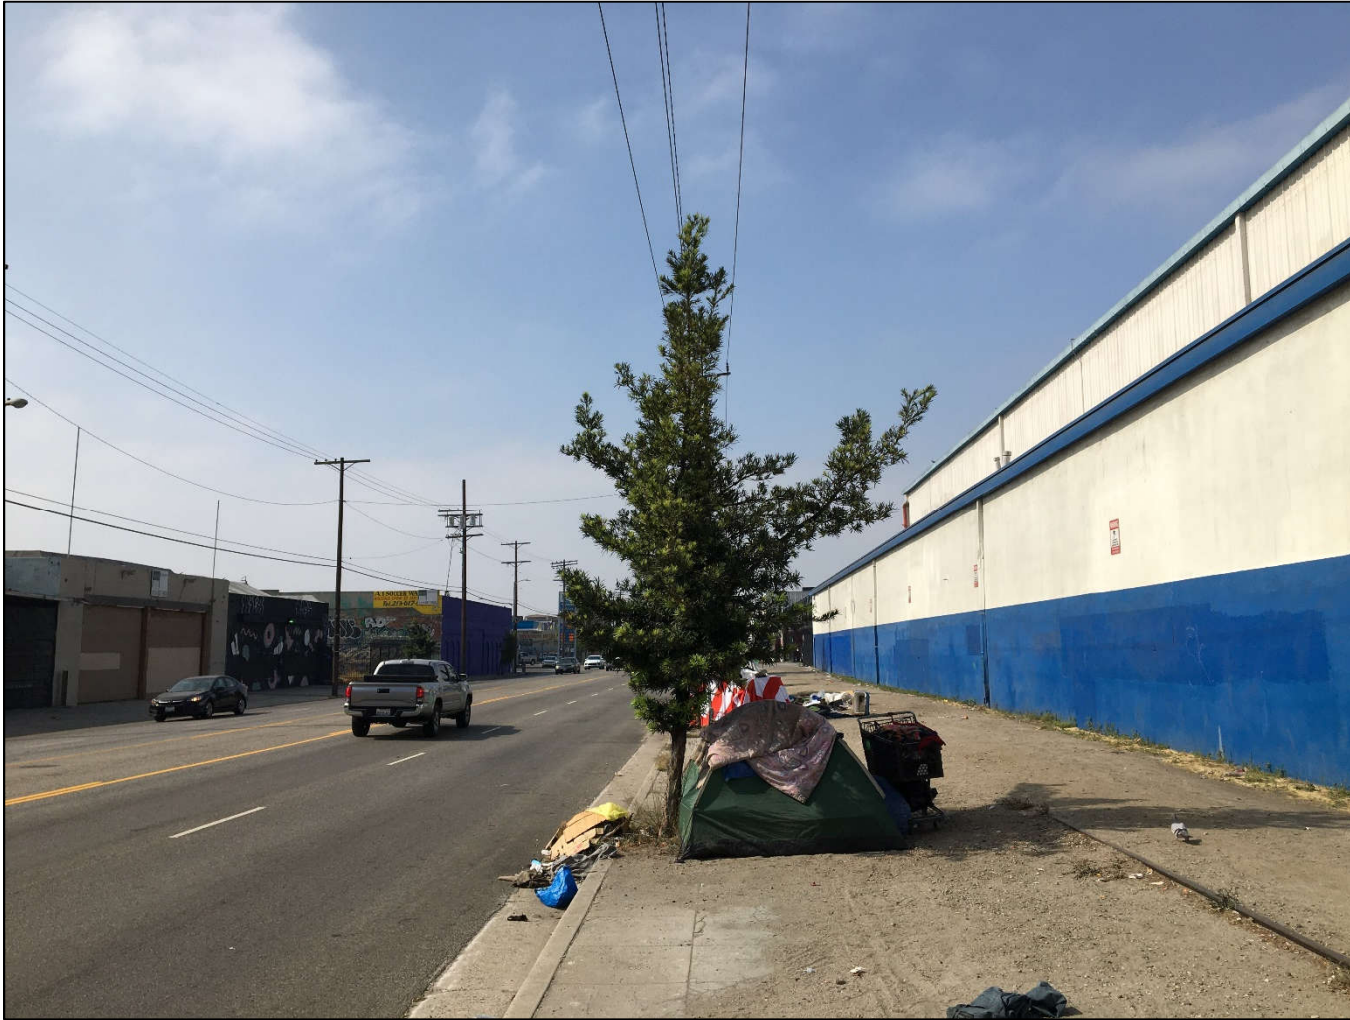
Photo 15 (South). Tree Number 15. Removal required to accommodate construction.

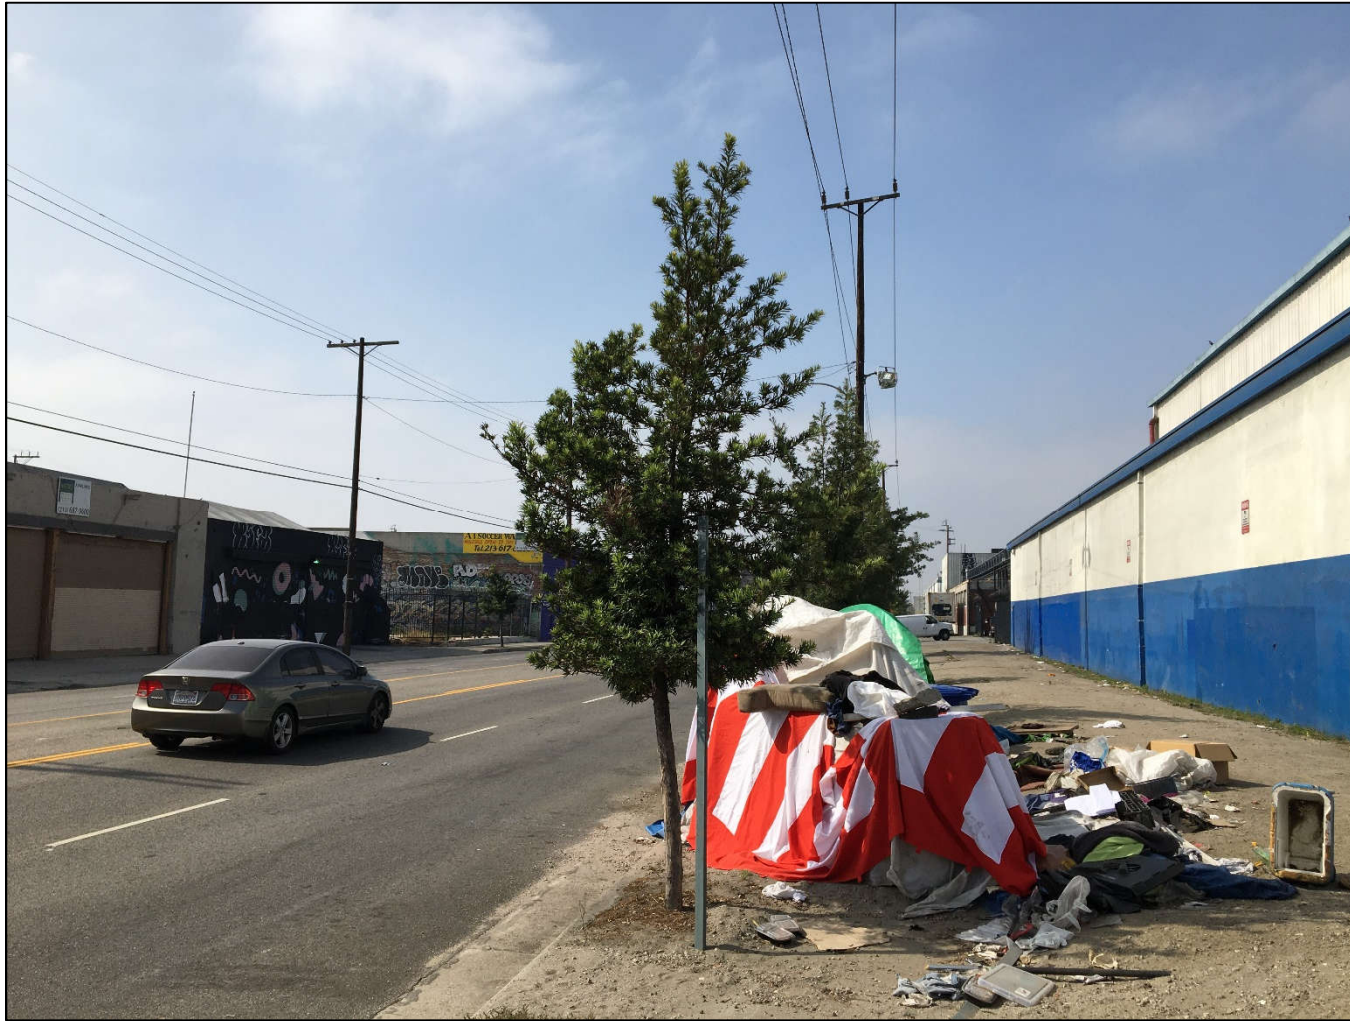
Photo 16 (South). Tree Number 16. Removal required to accommodate construction.
