FOURTH & CENTRAL PROJECT

Street Tree Report

June 2021

Prepared by:
Environmental Science Associates
80 South Lake Avenue, Suite 570
Pasadena, California 91101
Ryan Gilmore
ISA Certified Arborist WE-9009BM

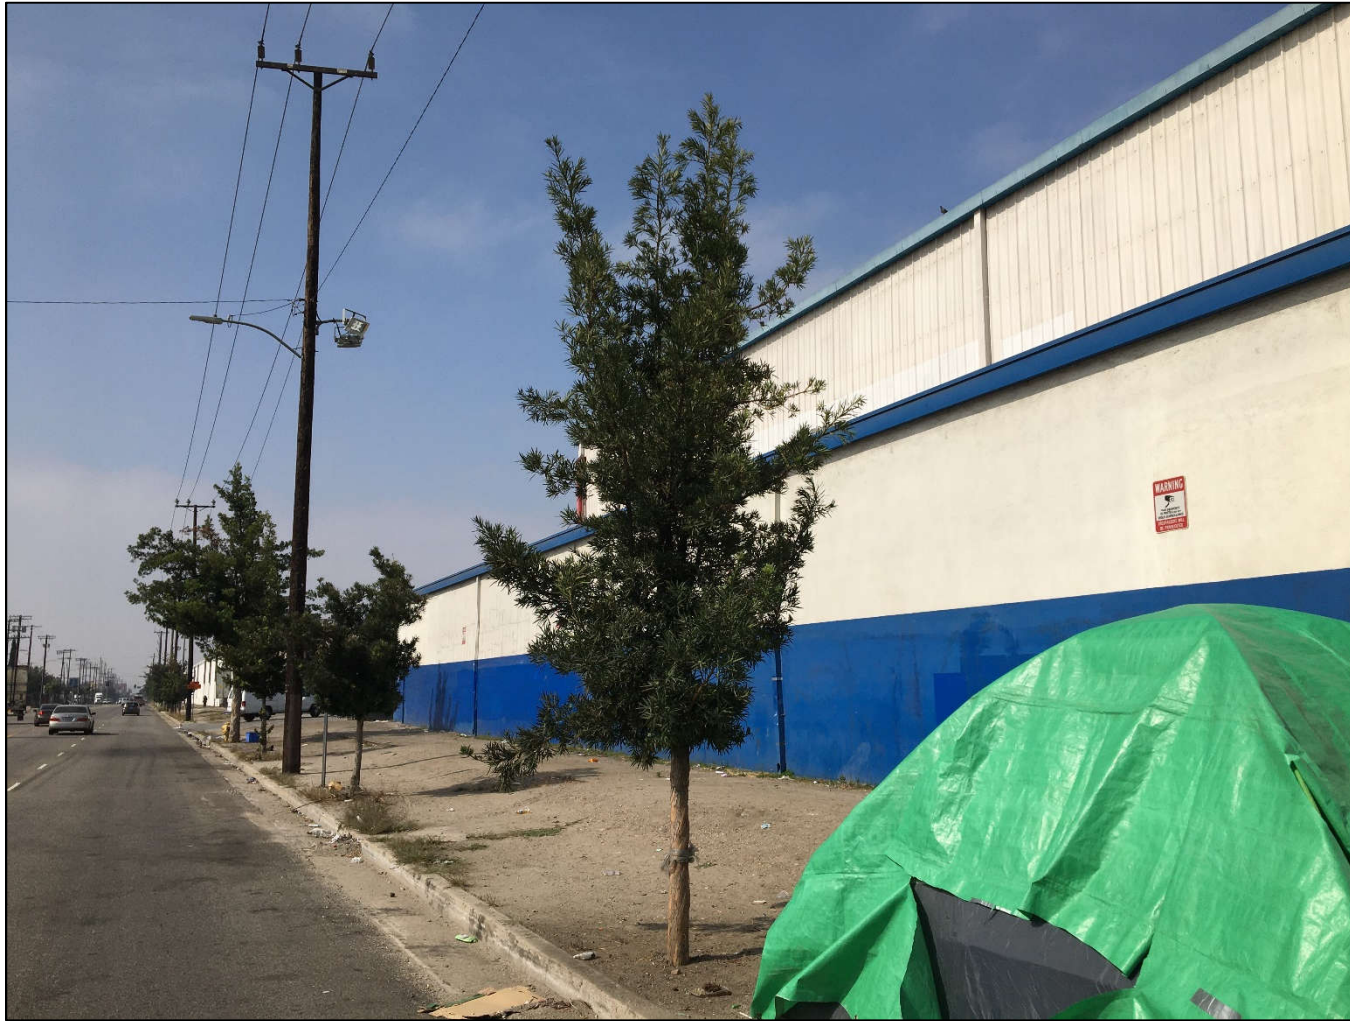
Photo 17 (South). Tree Number 17. Removal required to accommodate construction.

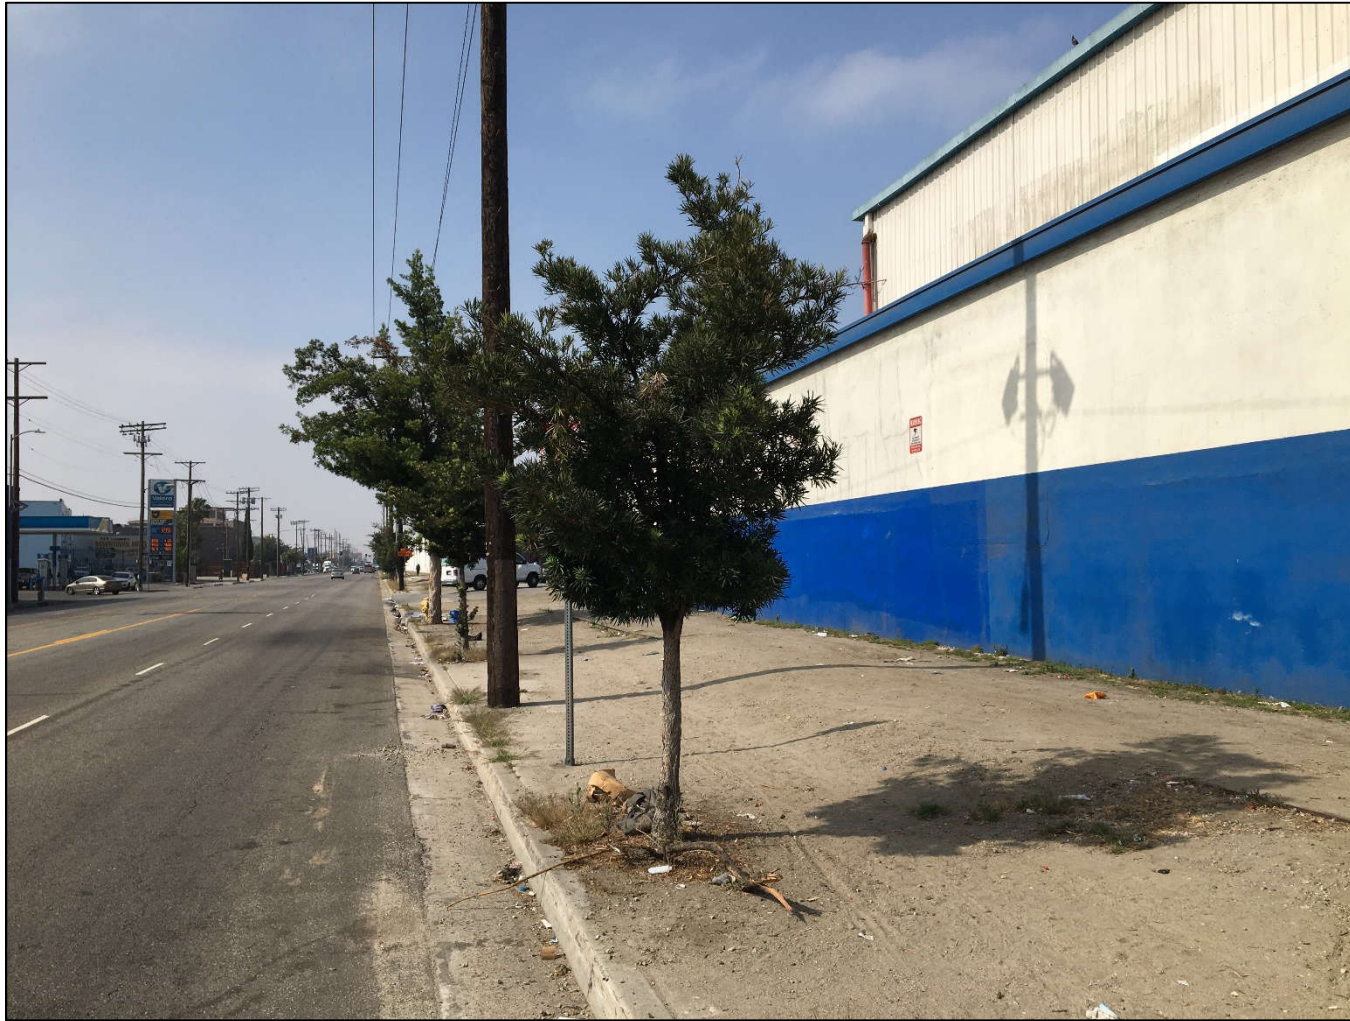
Photo 18 (South). Tree Number 18. Removal required to accommodate construction.

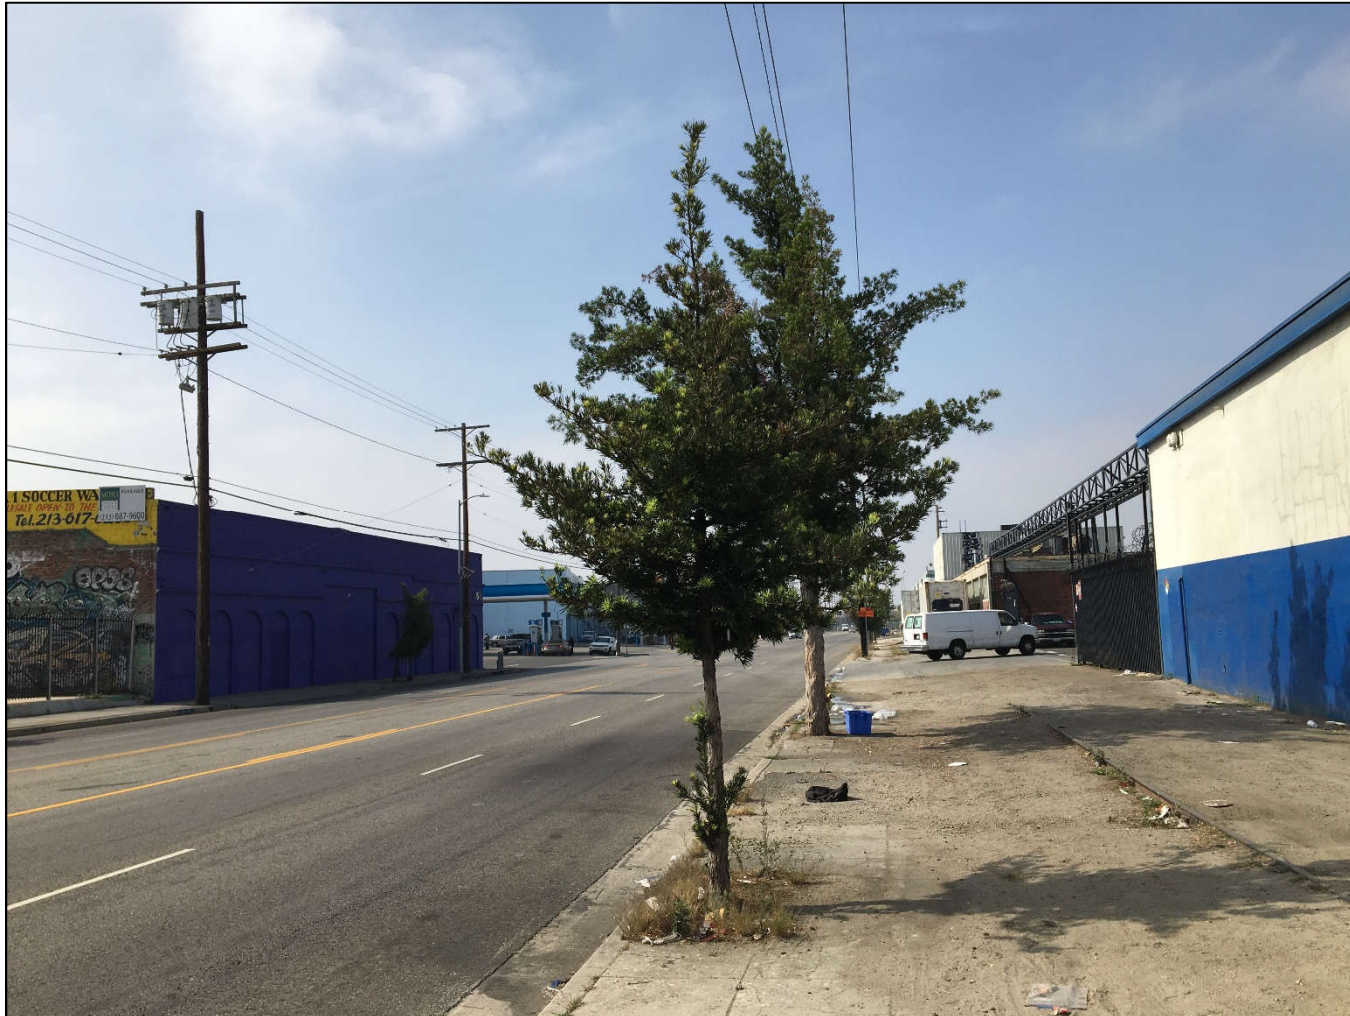
Photo 19 (South). Tree Number 19. Removal required to accommodate construction.

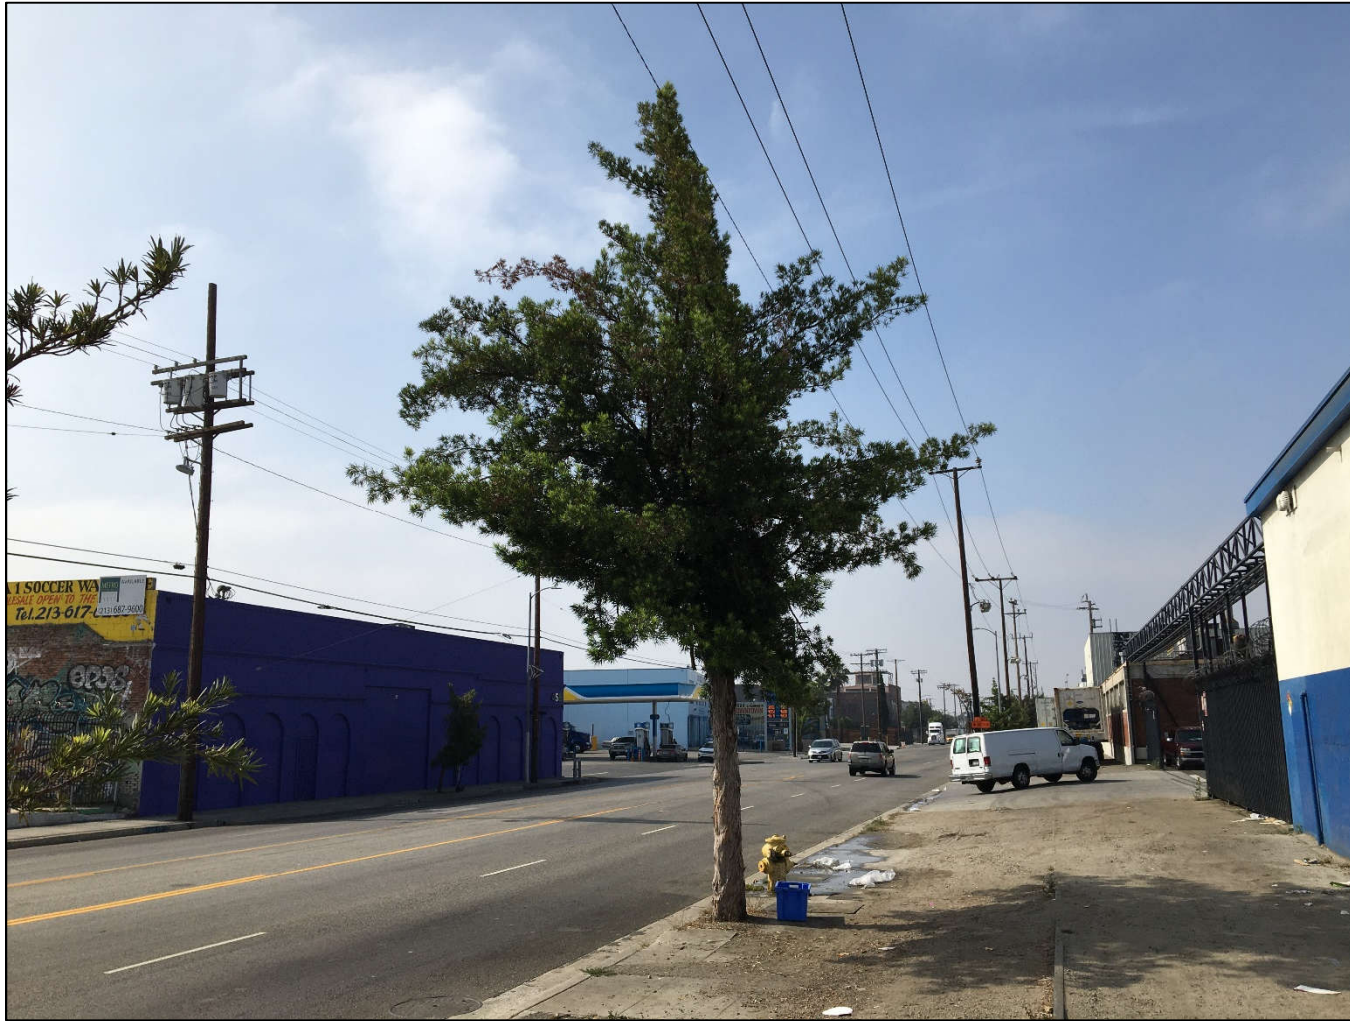
Photo 20 (South). Tree Number 20. Removal required to accommodate construction.
