Arborist Report

Certified Arborist's Tree Inventory & Pre-Construction Report –

Data: February 13, 2021
Report: February 26, 2021

Site:
Zach
720 Central Avenue
Mountain View, CA 94043

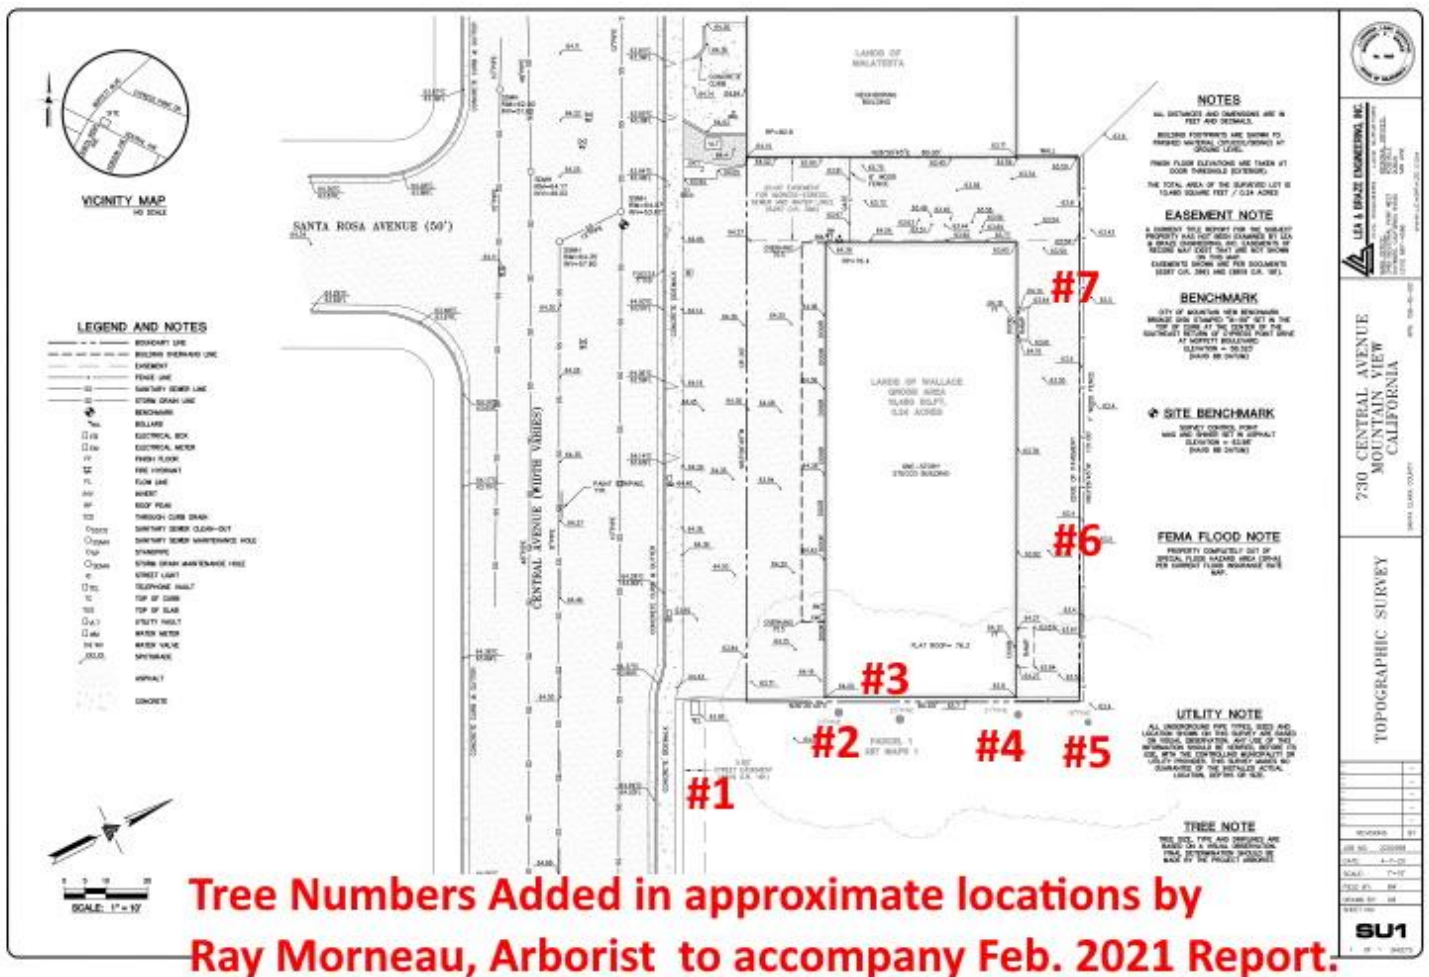
3.1 Tree Locations Map using the “Topographic Survey” (SU1) ...

Seven (7) trees are associated with this property, either as site trees (2), those just off-site as overhanging neighbors' trees (4), or municipal street trees (1).

The two onsite privets are really mere shrubs which may have had tree-potential but were repeatedly severely pruned to be multi-stemmed shrubs with no prospects of ever becoming useful trees. These are not "Heritage Trees" and must be removed.

The maple street tree just beyond the property line can remain unscathed, if The City does not require utility work in its root zone.

The neighboring property's four Canary Island pines have been subjects of substandard pruning practices over the most recent 20 years ... also some foliage branch breakage due to over-thinning and no proper management of endweights as they have accumulated. But, as they are at least 17-feet from the new building, per sheet A0.3, they can be expected to endure with no noticeable change – if the root zones between these pines and the new foundation can remain largely unimpacted.

- C. Meanwhile, it should be sufficient to:
 - C-1: install tree protective fencing (TPF) at the property line – probably just relying on the typical contractor's chain link site fence.
 - C-2: install root zone protection – like a 6-inch thick layer of arborist chipper chips, supplemented by plywood sheets or steel trench plates (depending on type of traffic).
 - C-3: provide supplemental water to root zones and notify tree owners that it is advisable for them to provide ongoing supplemental water for their trees. Also, notify them that their trees would shed fewer branches if properly pruned.
