SUMMARY

I was contacted by Nuvis Landscape Architecture to provide a Tree Protection Assessment for the Sunset Complex Reservoir project. The existing reservoir tanks will be removed and replaced with new tanks. The parking area on the west side will also be lowered, a retaining wall installed, and the entire parking area will be repaved. Around the edge of the complex are trees, many of which are Protected Species. The trees need to be evaluated and Tree Protection Recommendations provided. Nuvis has requested an independent Arboricultural opinion on the trees near or within the Work Limits. The Scope of this written Report will include:

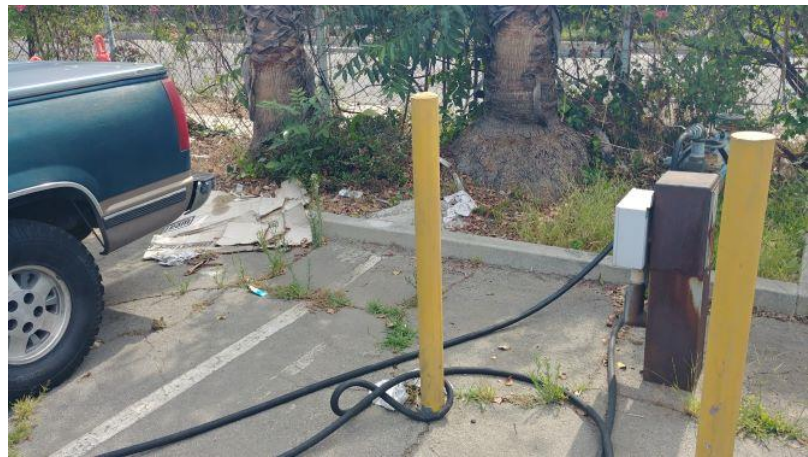
2, 3. The two Fan Palms (WR1-2). They should not be in conflict with repaving activities.

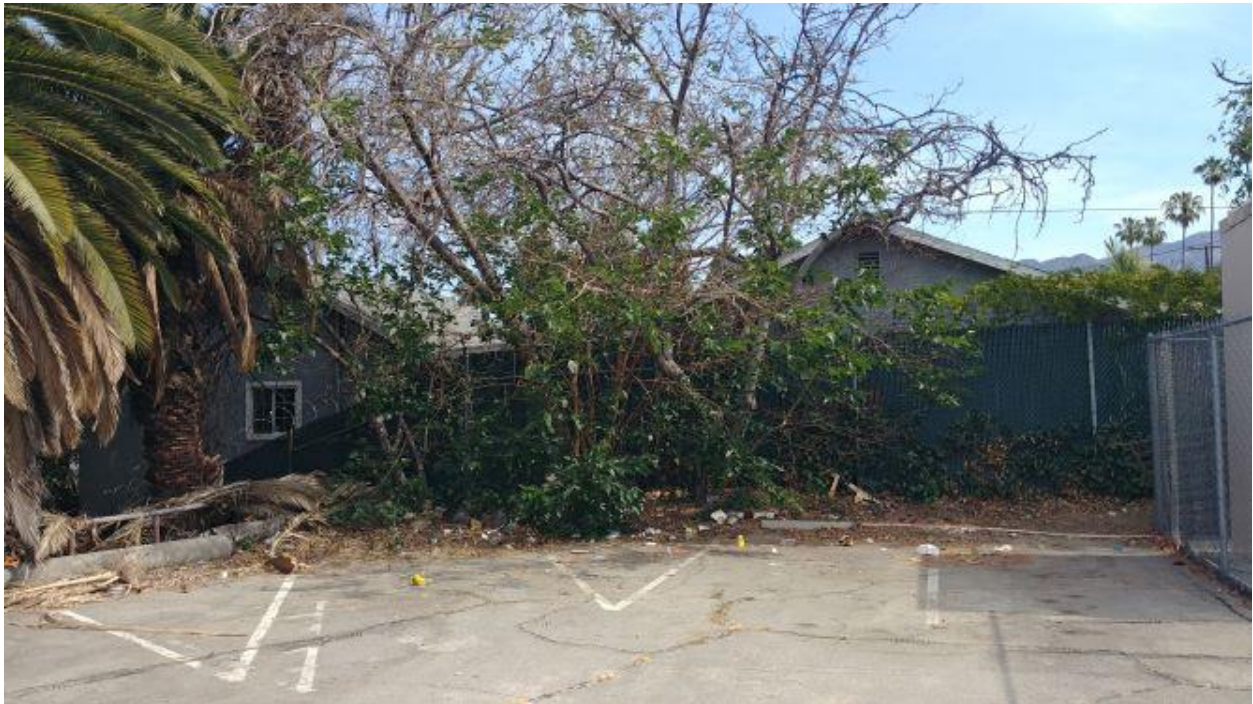
7. M1 in the Norwest corner. Is in Poor condition. Likely will need clearance pruning for paving.

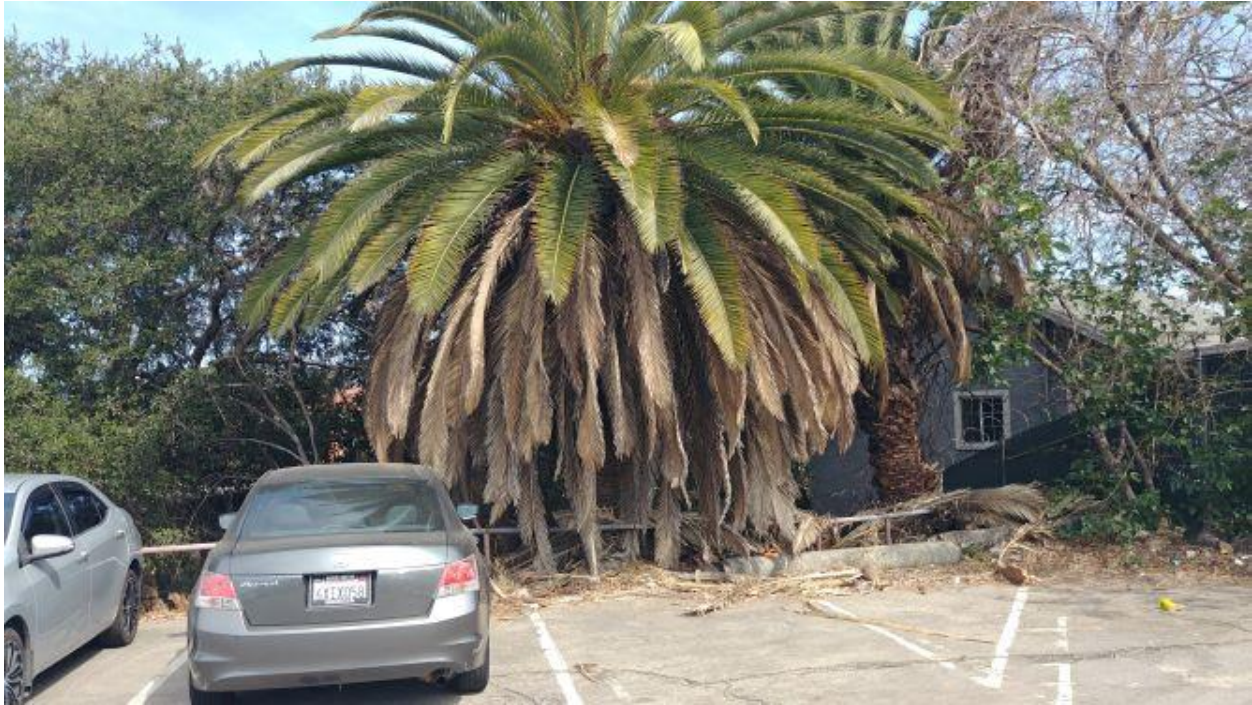
8. CP1 will likely need clearance pruning for paving operations.

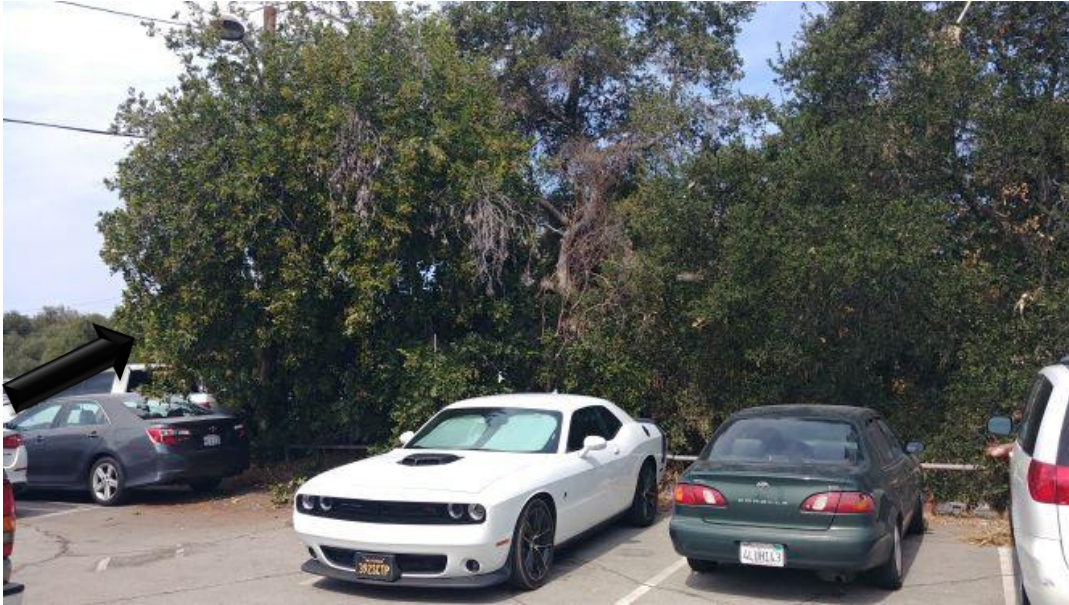
10. Trees at corner of north parking. CW1 (arrow) will likely need clearance pruning.

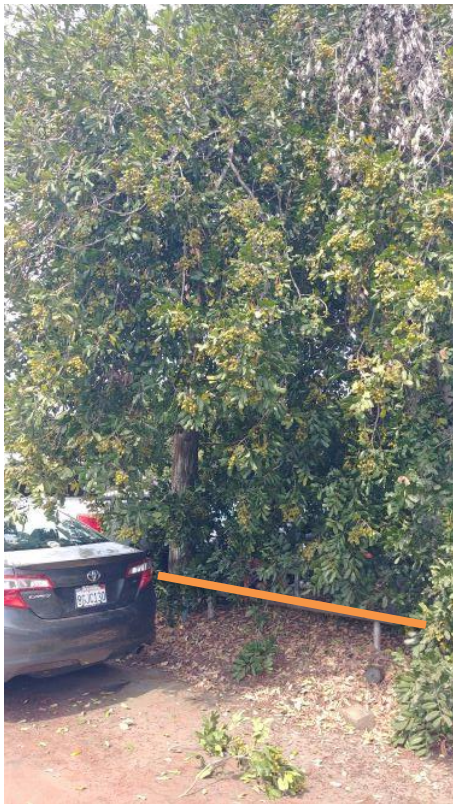
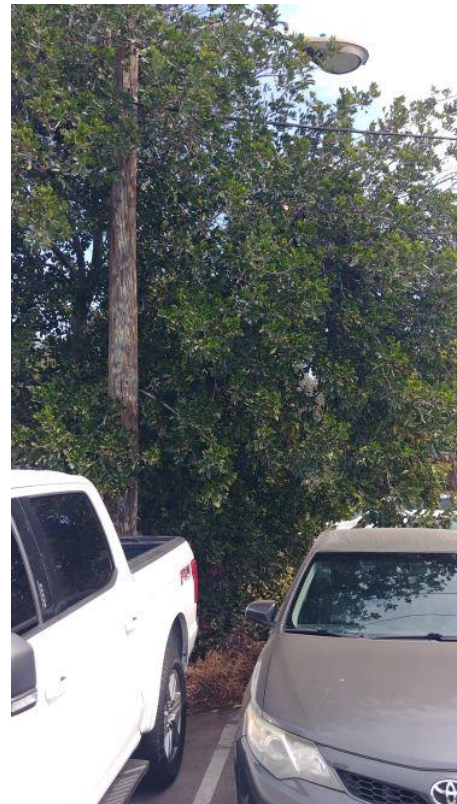
11, 12. Looking southwest and north at the branches to be clearance pruned. Orange line marks the location of the work limits which is approx. where the metal rail fence is located.

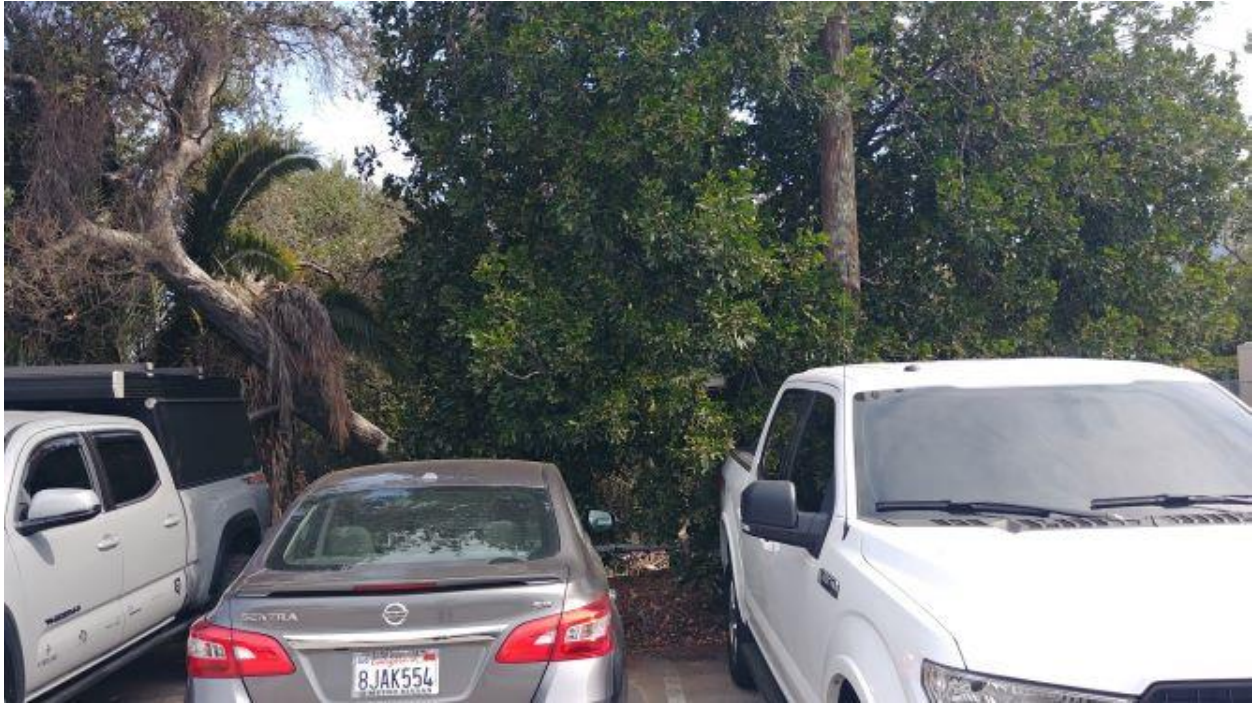
13. Looking north at CW1 and the branches to be clearance pruned.

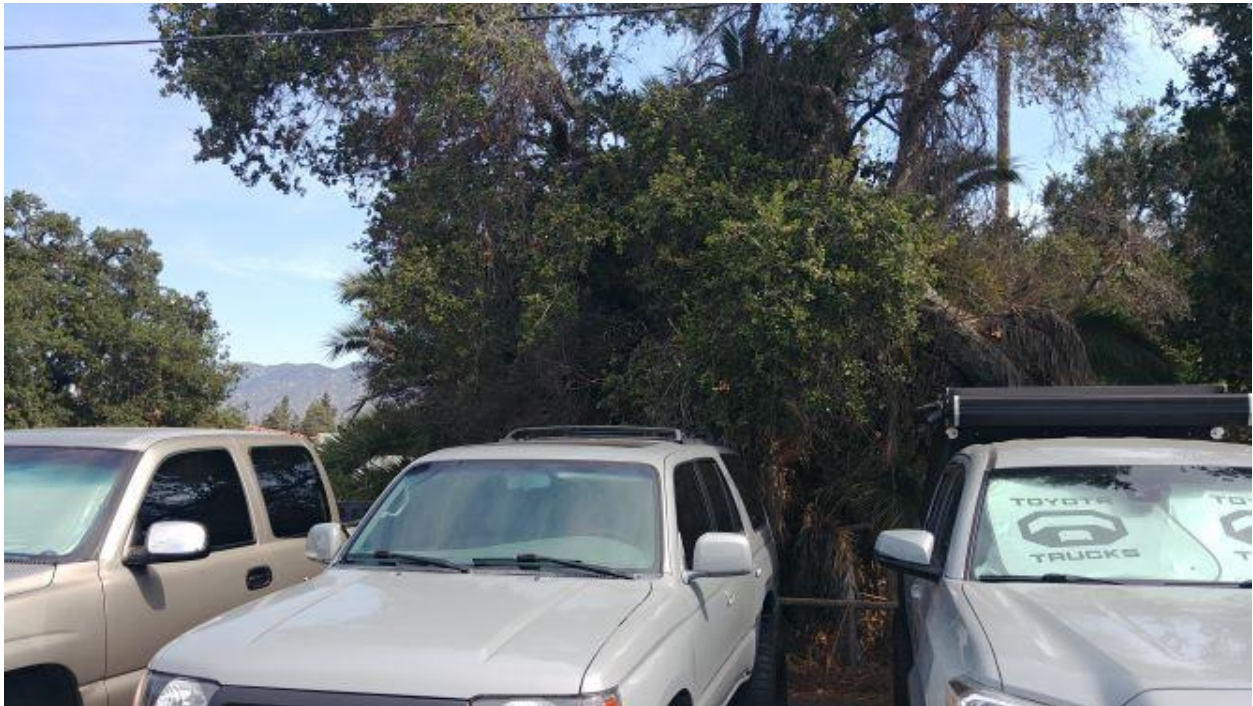
14. Looking north at #1.

Turning the corner to the west there are several branches from an Oak (#1) extending into the WL. One 3-4 in. branch and additional small stems may be pruned back to an appropriate location. No retaining wall is scheduled to be installed in this area, and no grade lowering.

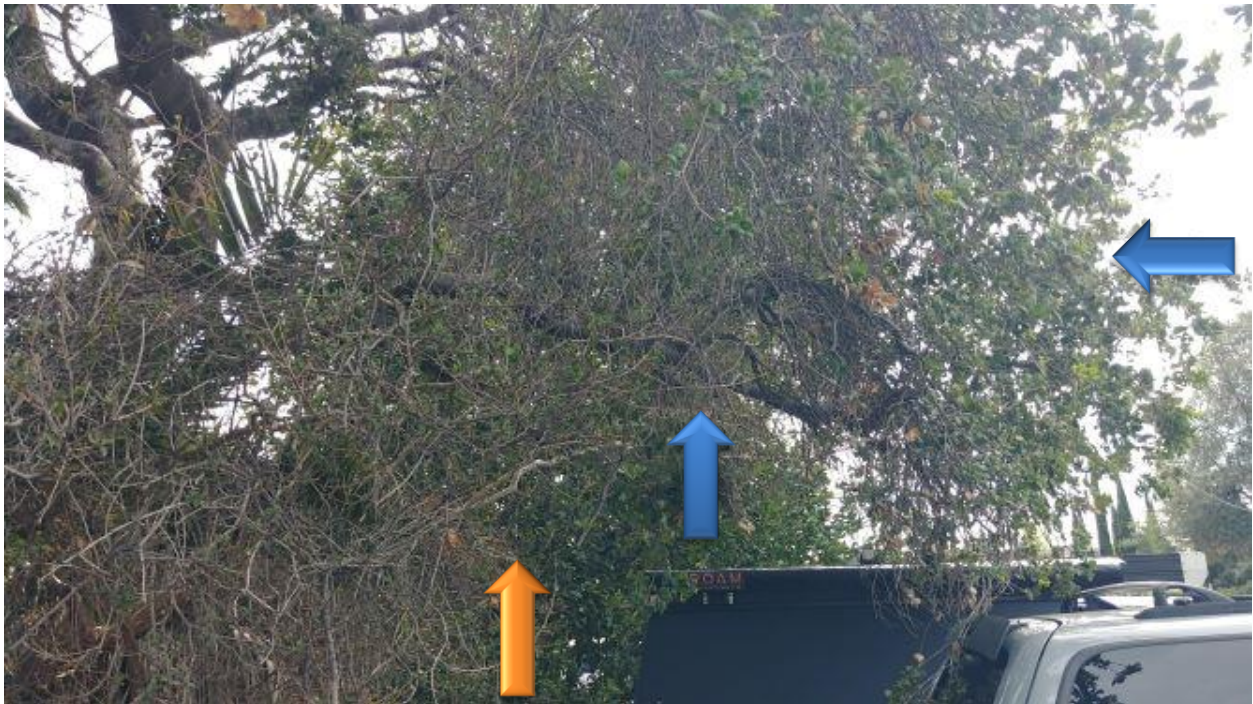
15. Looking east at the overhanging branches (blue arrows) to be raised and pruned back. Orange arrow marks the approx. location of the work limits.

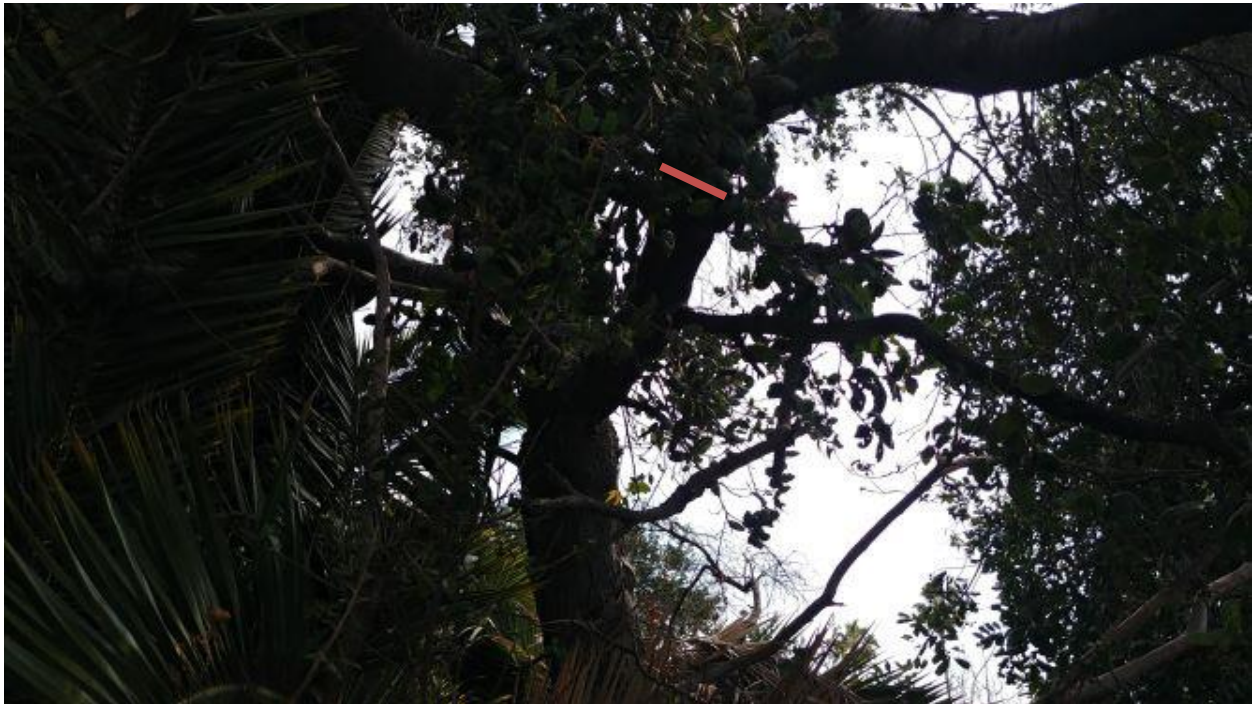
16. If necessary, branch may be pruned back to a location with a lateral branch (red line).

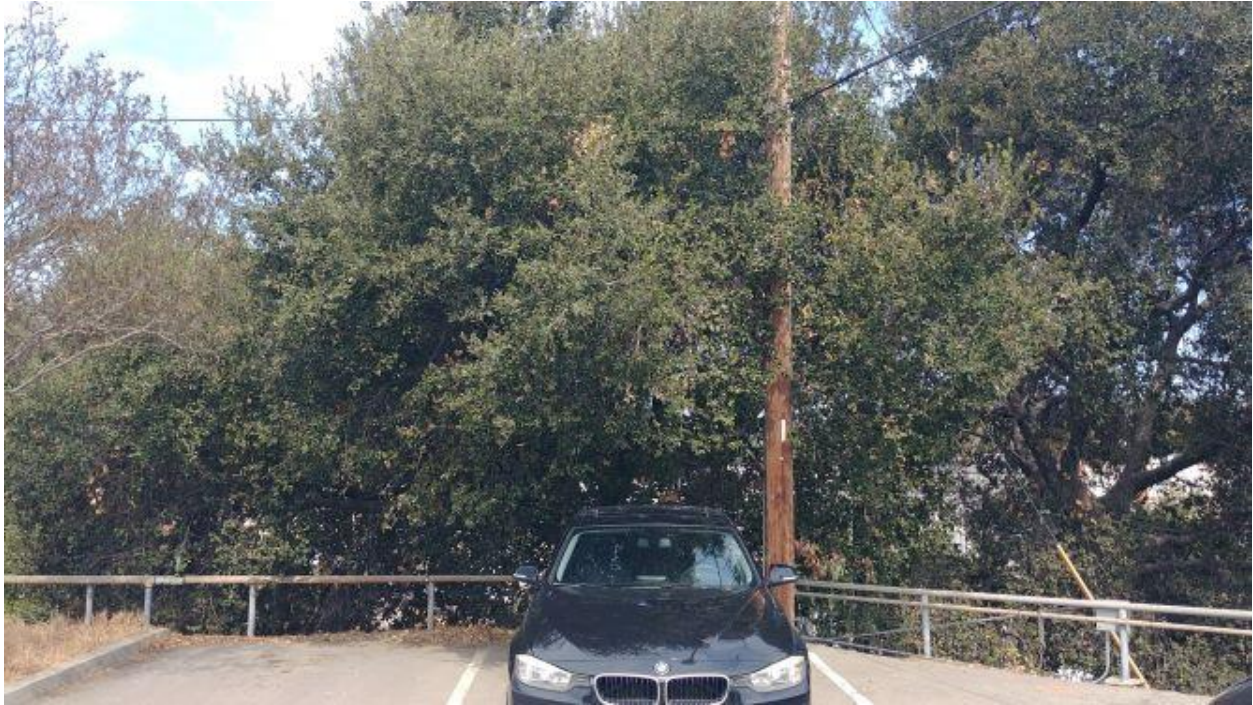
17. #2 in northwest corner of west parking area.

At the northwest corner are 1-2 in. Oak branches (#2) that may be raised. Roots should not be affected. This is near where the retaining wall will be installed per Plan pg. C-010,⁵ and approx. where the grade reduction will begin. In the west median is a Crape Myrtle (CM1) that is dead and may be removed. The center median to the east has a multi-stem Crape Myrtle (CM2) that could be retained. Per the Paving Plan C-007 this median is redesigned. Retention of the tree is recommended.

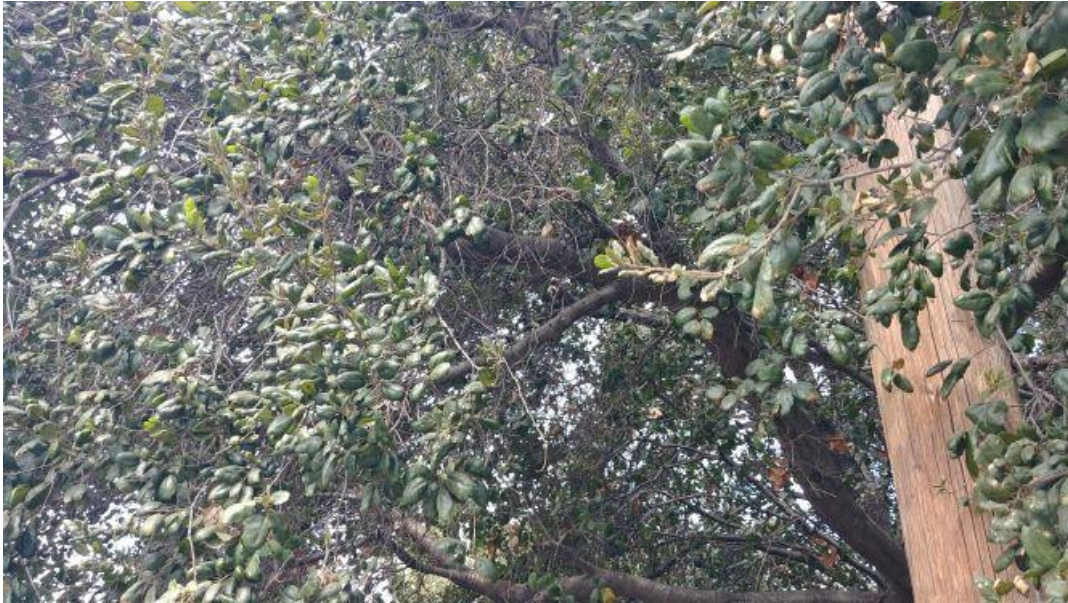
19. Looking up at the branches of #2.

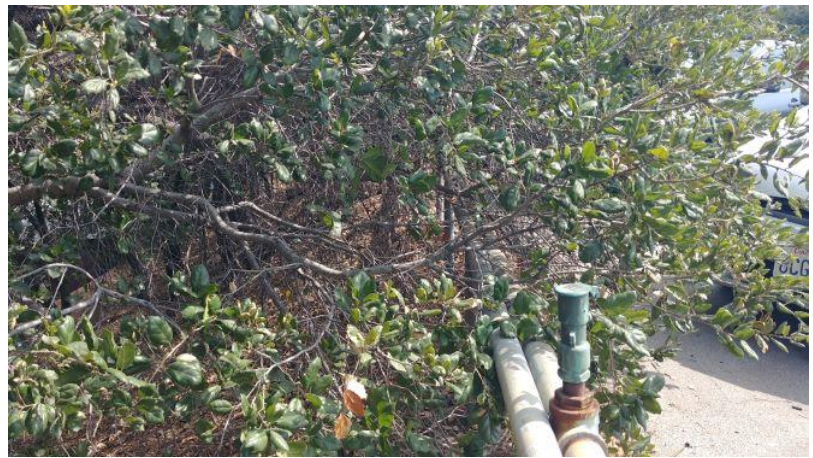
Further south are two Oaks (#3-4) that have 1-2 in. branches that may be pruned back to the WL. They are more than 10 ft. from the work limits so their roots should not be affected. South of here is a Crape Myrtle (CM3) that is dead and can be removed. By the parking lot fence are 3 Oaks (#5-7) that will need 1-2” stems raised and pruned back. Trees #5 and #6 are 8.5 ft. from the WL. Roots will potentially be encountered.

24, 25. The tips of small branches from #4.

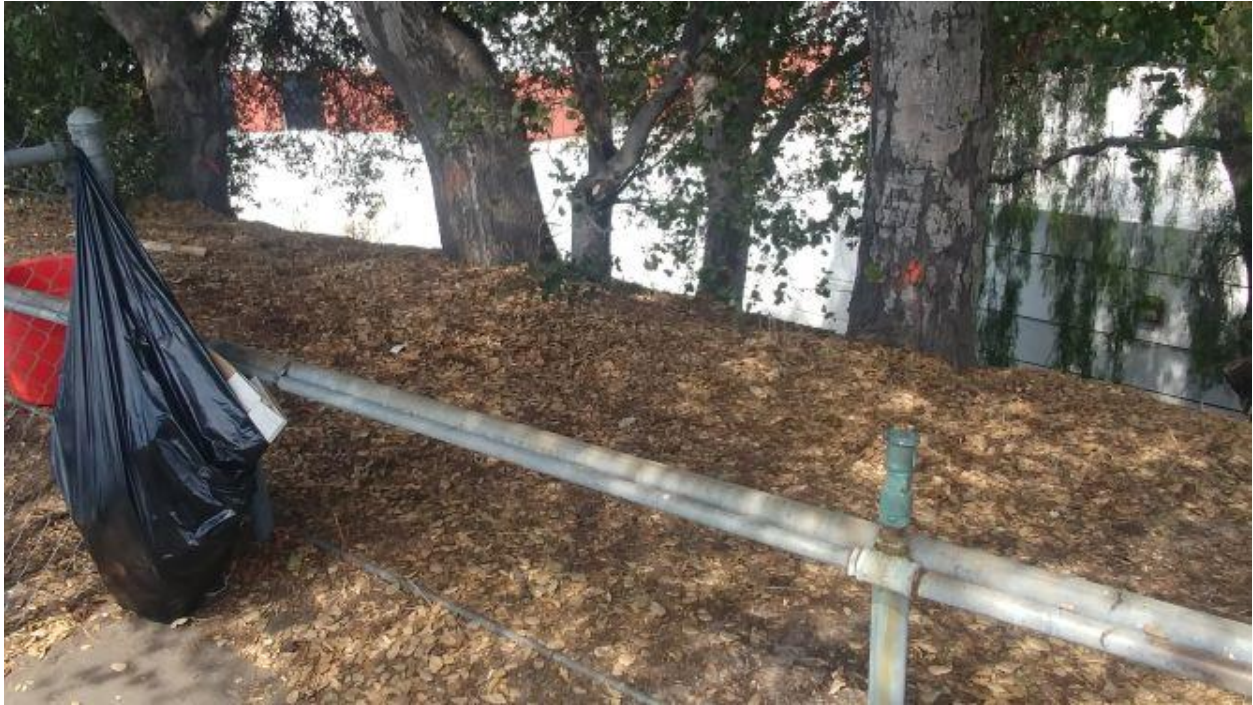
28. Trunks of trees #5-7 (R-L). #5-6 are 8.5 ft. back of the work limits, #7 is 10+ ft.

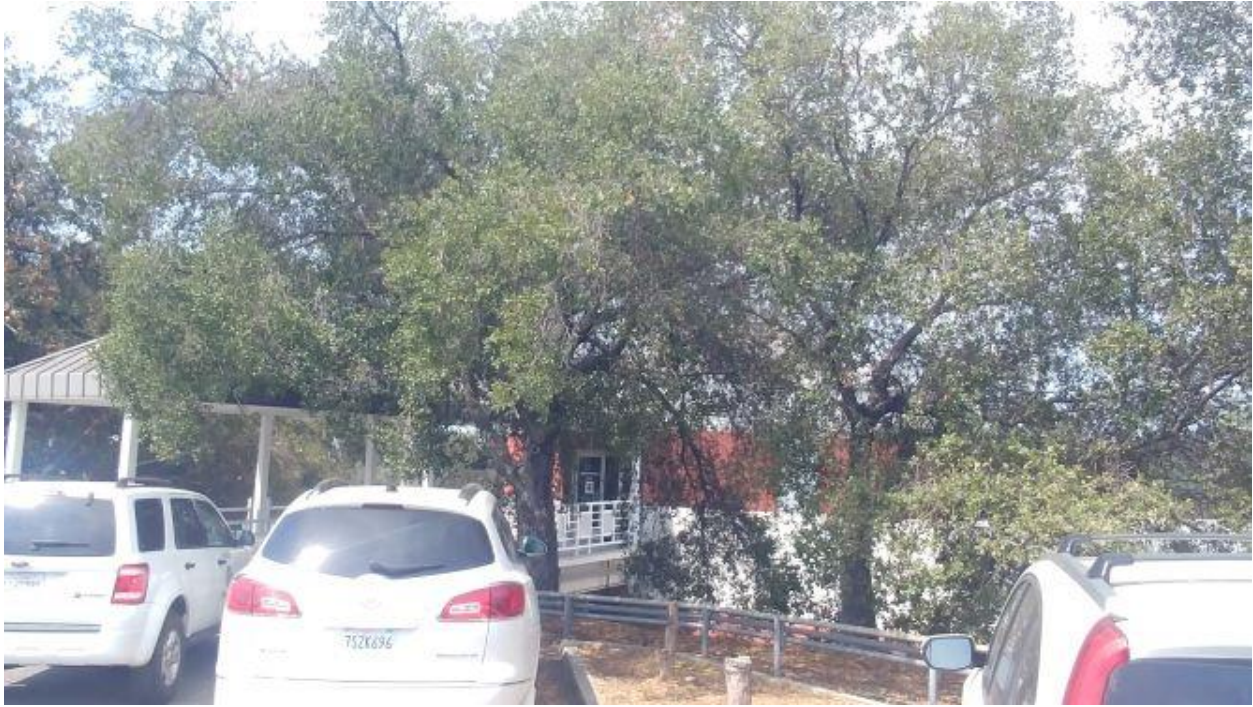
34. Trees # 8-9.

North of the bridge walkway are two Oaks (#8-9) with 1-2” branches raised. The Oaks are 6 ft. and 3 ft. back of WL. Roots will likely be encountered.

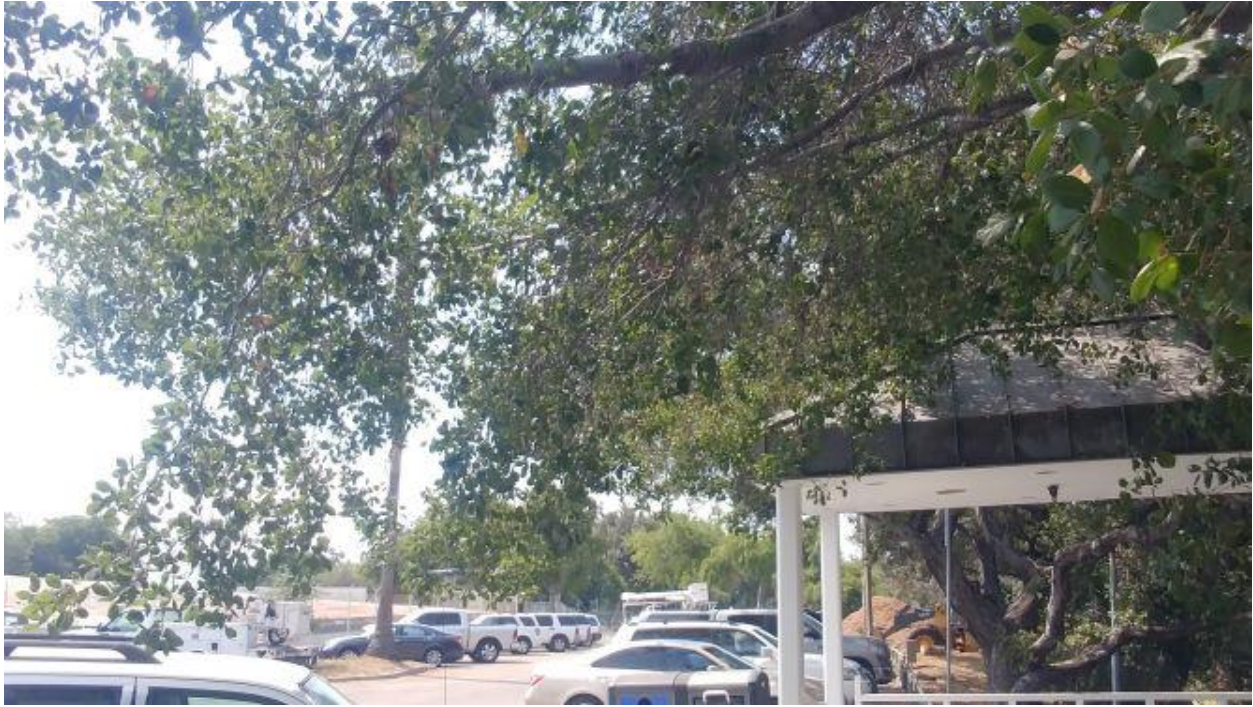
37. Potential branches to be pruned.

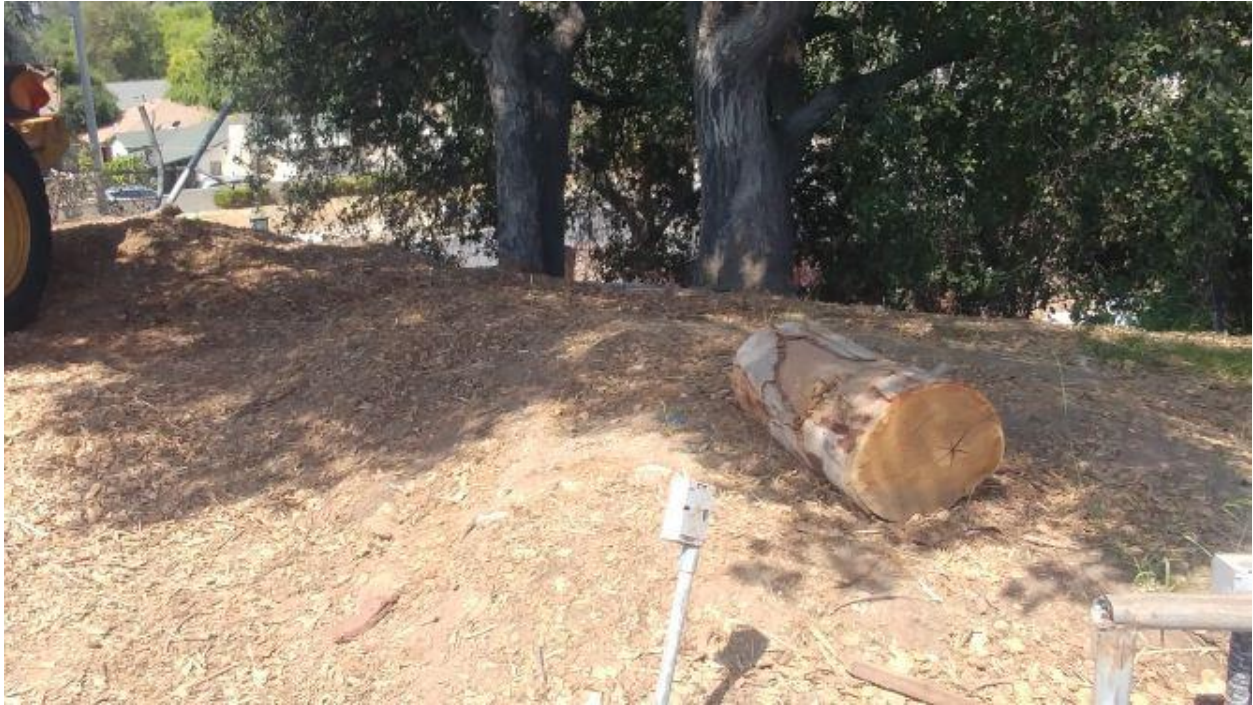
Further south are 3 Oaks (#13-15, tags #1617-1619) that sit 21 ft. back of the WL. There should be no conflicts. The retaining wall installation ends south of this location.

47. Trees 13-15. The closest is 21 ft. behind the WL.

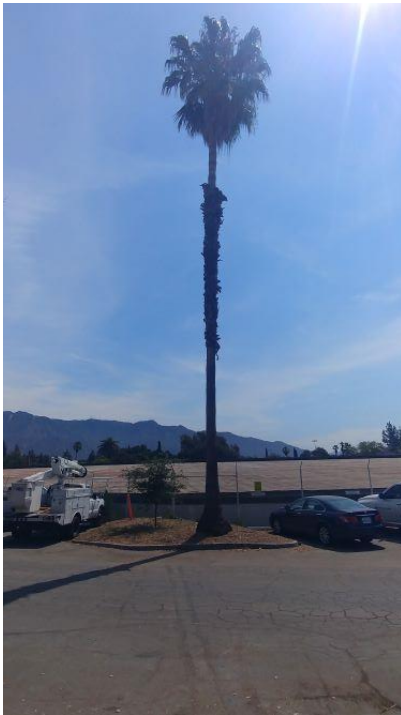
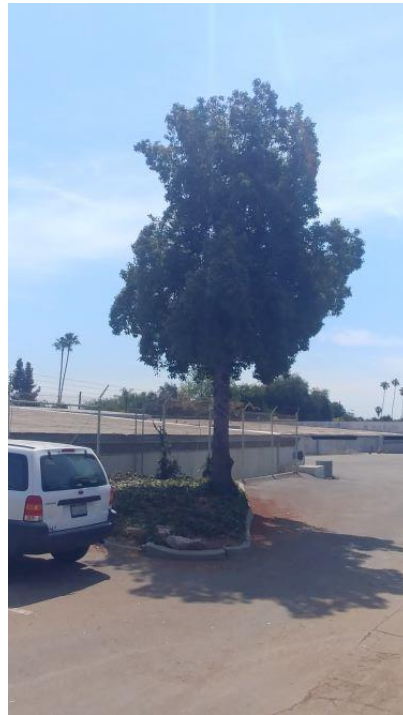
Across the parking area is a median with a large Fan Palm and a small Oak (<2 in. DSH). These will be removed per the Paving and Grading Plan sheets (C-008, 011).

48, 49. Fan Palm, small Oak and Brachychiton to be removed per plans.

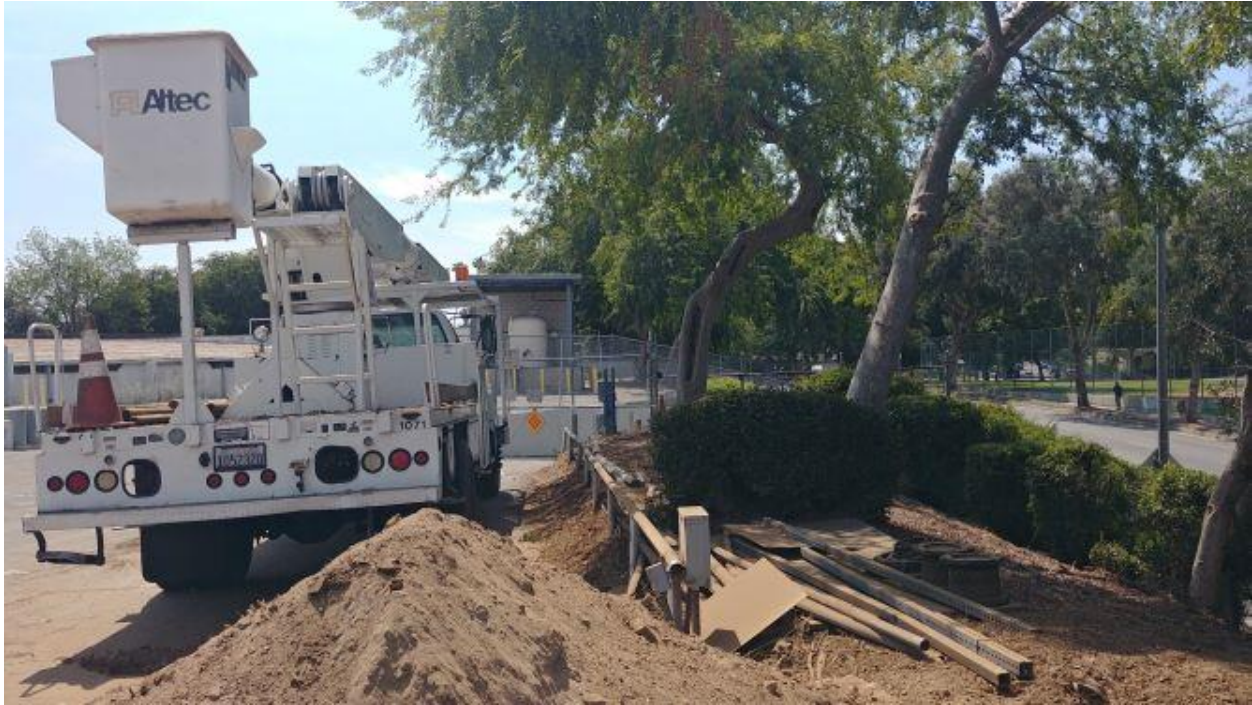
On a mound facing Mountain St are 3 Chinese Elm (#16-18). #16 is 10+ ft. back of WL. #17 has a significant lean towards Mountain St and is 6 ft. back of WL. #18 is 4 ft. back of WL,

has a significant vertical cavity, and has an off-center crown on the south side towards Mountain St. Additionally, per the Grading and the Yard Piping Plan sheets (C-011, -016) there will be new pipeline installed where these trees are located. Trees #17 and #18 should be removed due to holding and support roots likely being removed. There will be no Tree Protection procedures that will adequately protect their roots.

50. Trees #16-18 (R-L). Note lean on #17 and decay cavity on #18.

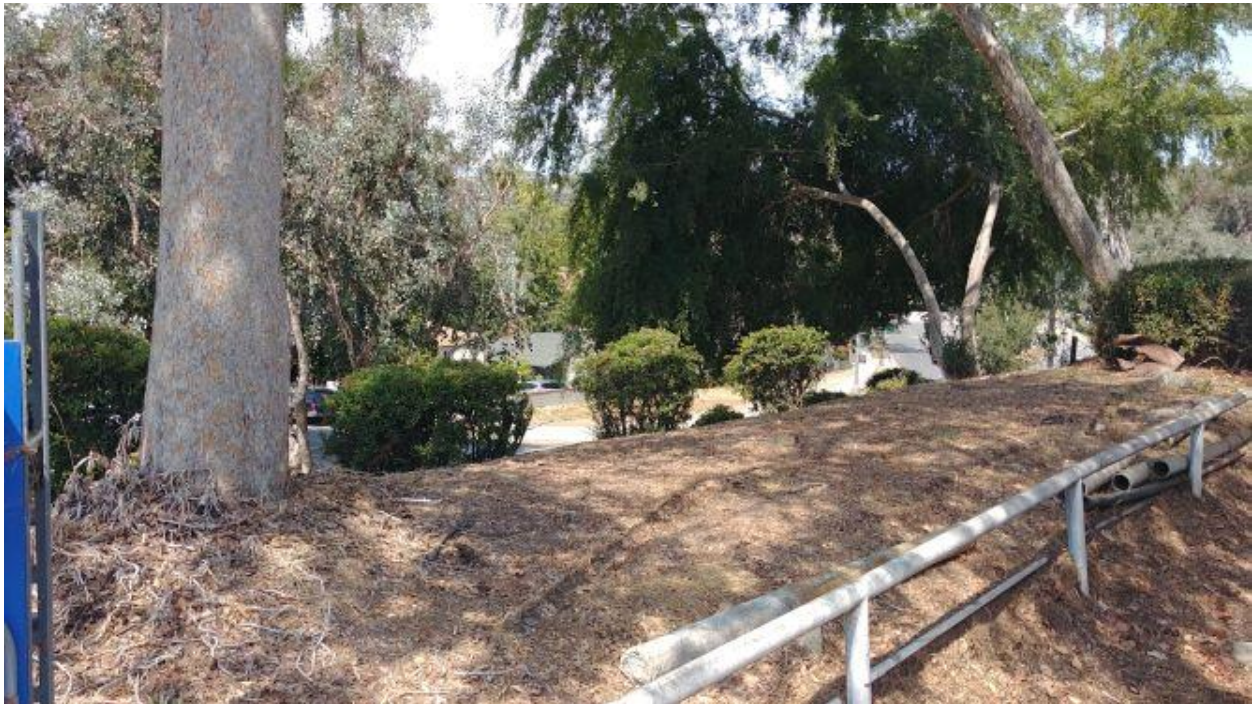
51. Trees 16-18. Note significant lean on #17.

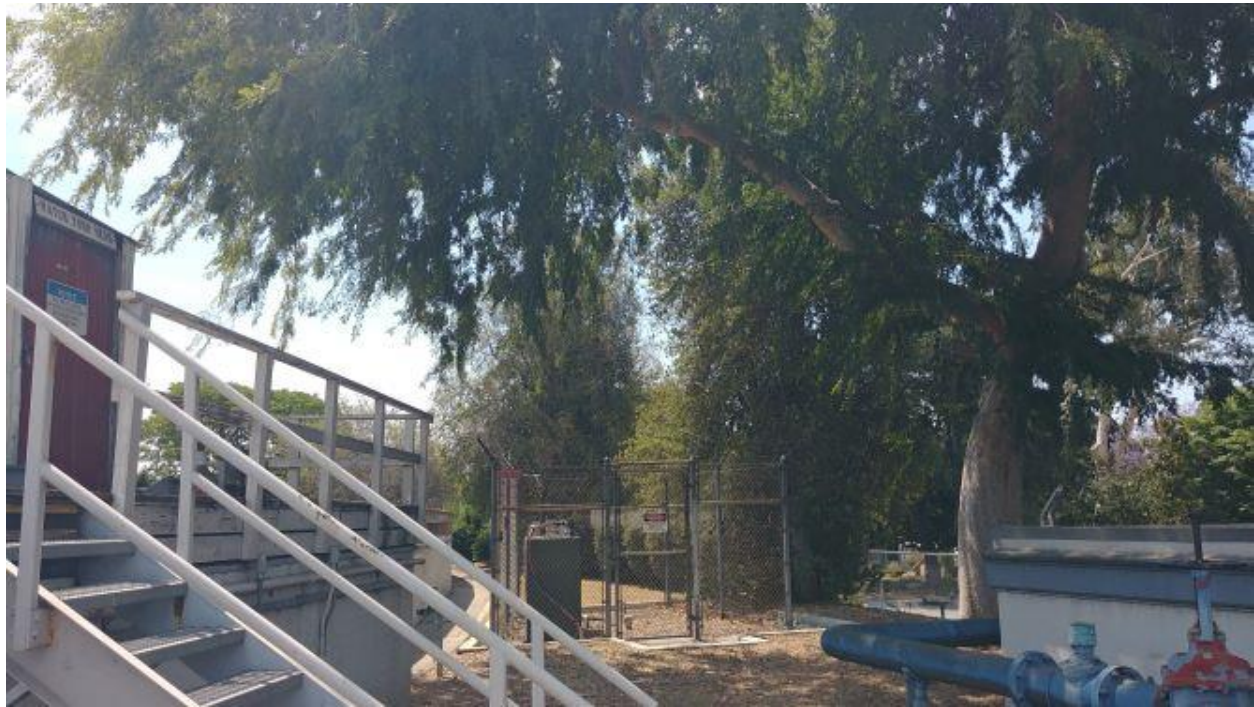
South of the Pump House is a Chinese Elm (#21, tag #1606). It is 20 ft. back of WL. Potential for some minor limb pruning.

59. Tree # 21. Possibly minor crown raising.

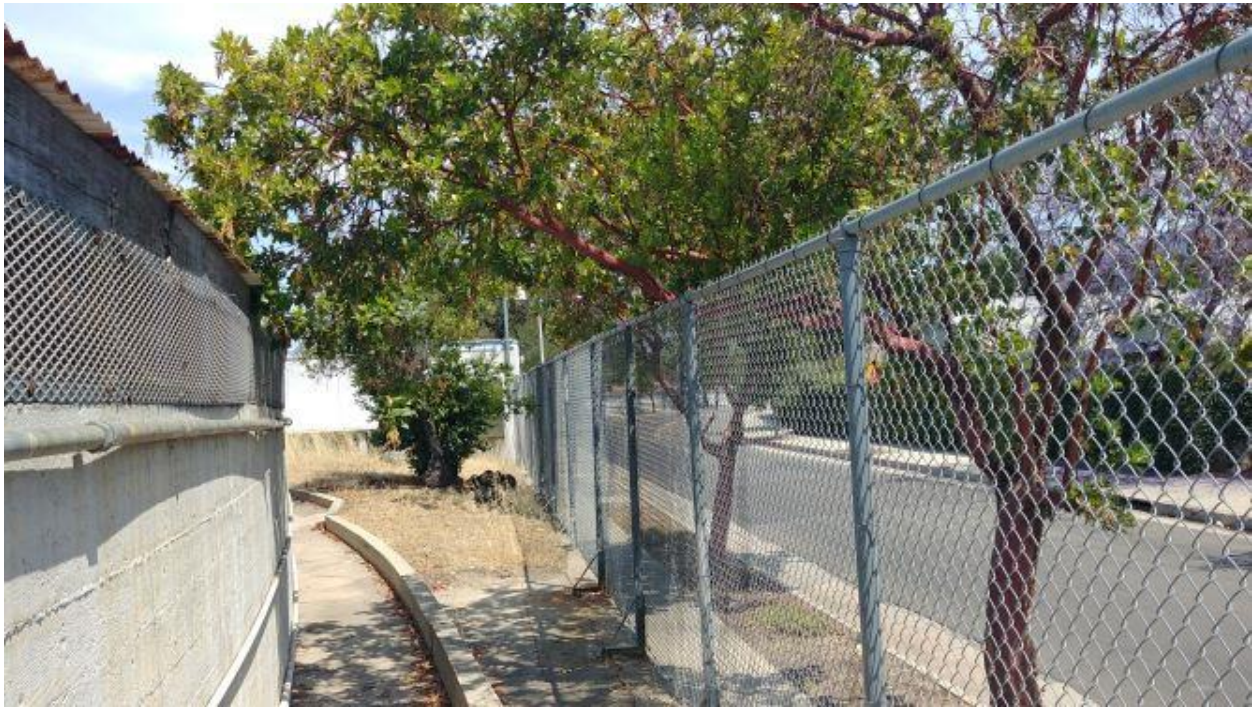
71. Tree #26 (Street Tree Madrone).

The second street tree north of it is a Pacific Madrone (#26). A long 4-inch branch extends into the work area. This branch may be removed at the parent branch.

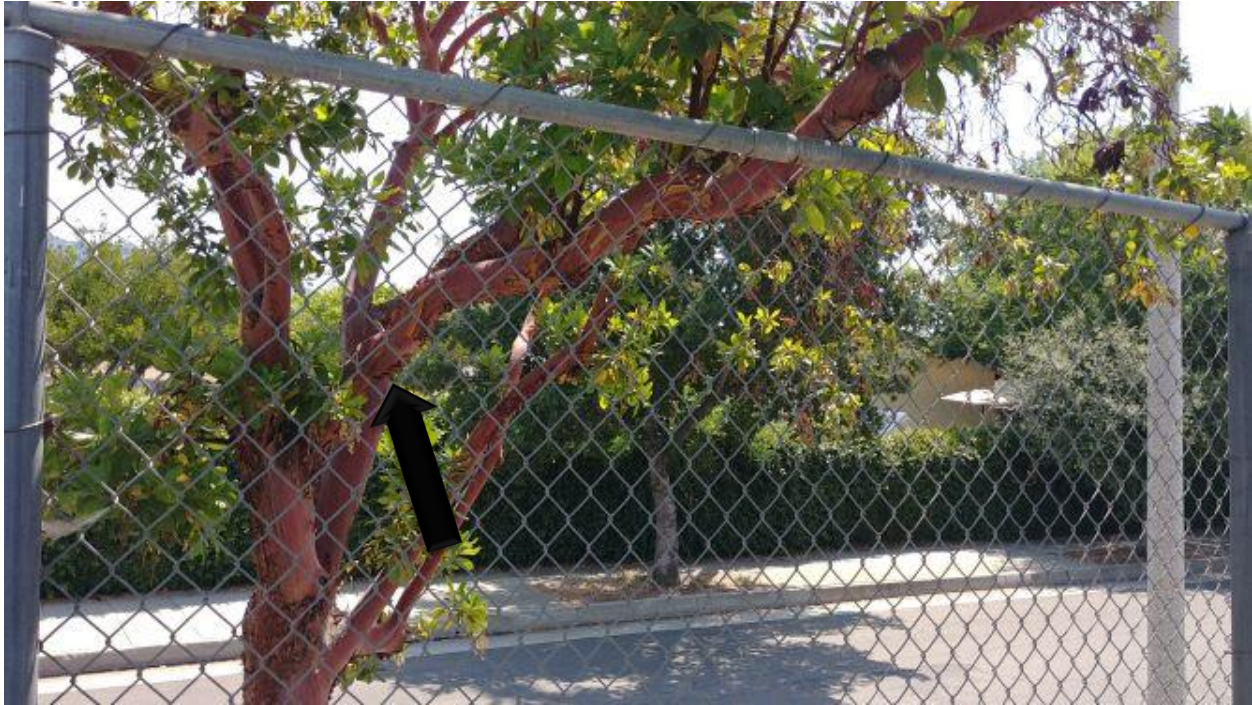
72. 4-inch branch may be pruned at parent stem (arrow).

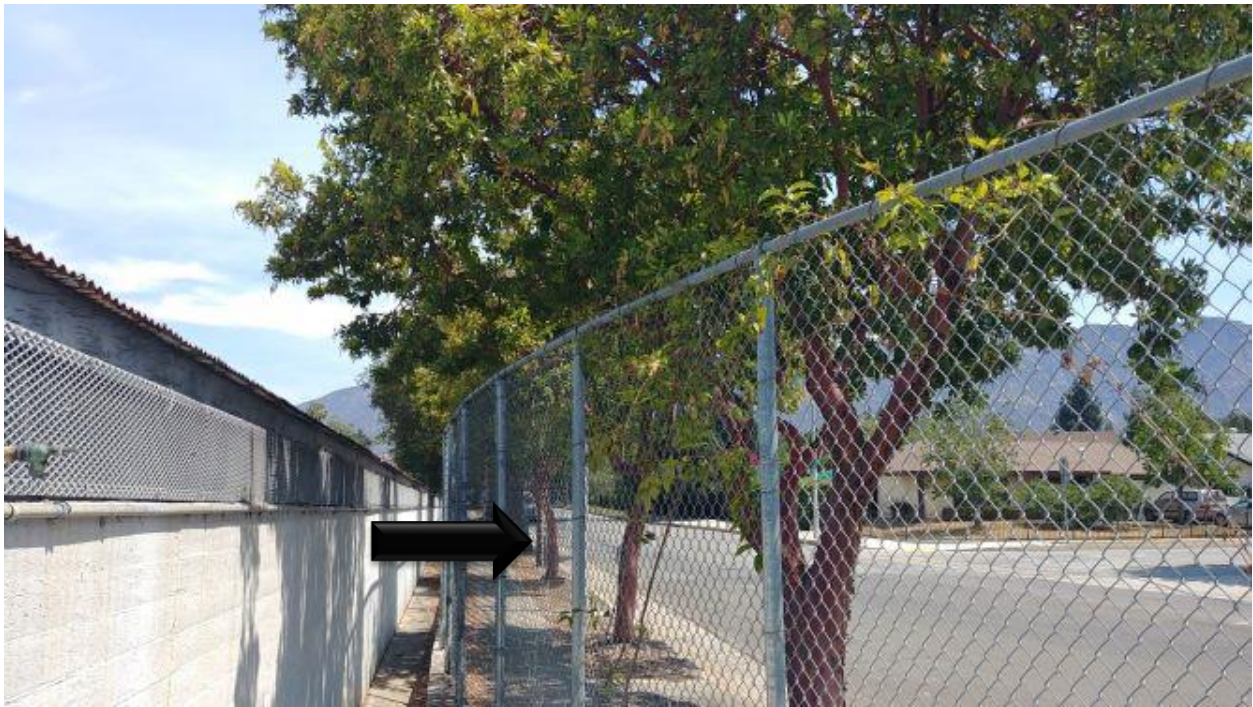
76. Tree #29. The second tree to the north (arrow) is scheduled to be removed for a driveway installation.

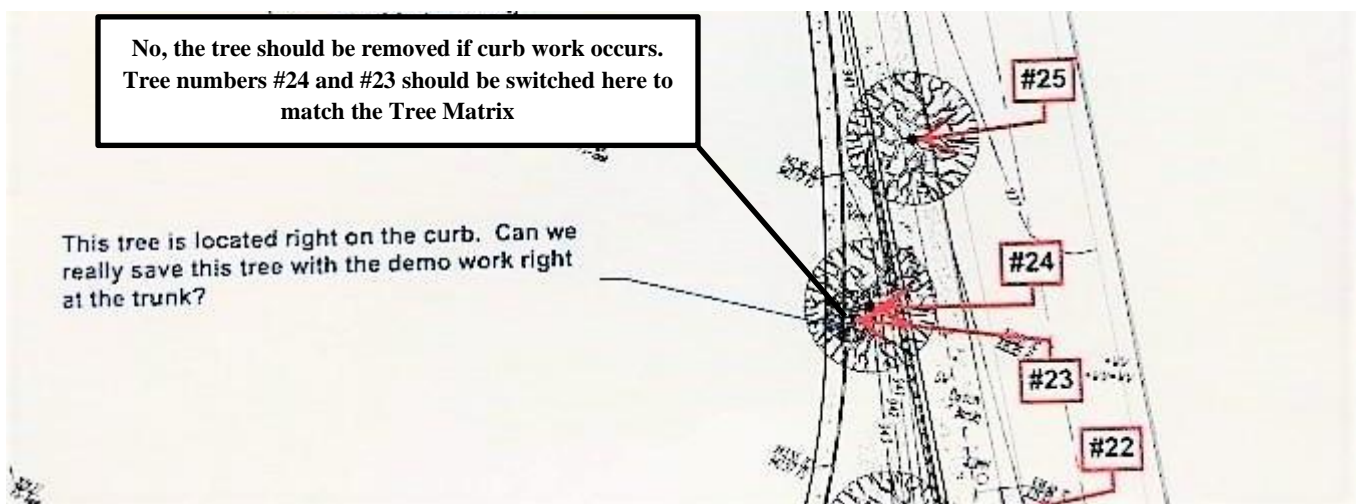
8. Comment on #24 impacted by demo work, and correct numbering (shown as #23 - Sheet C-006).

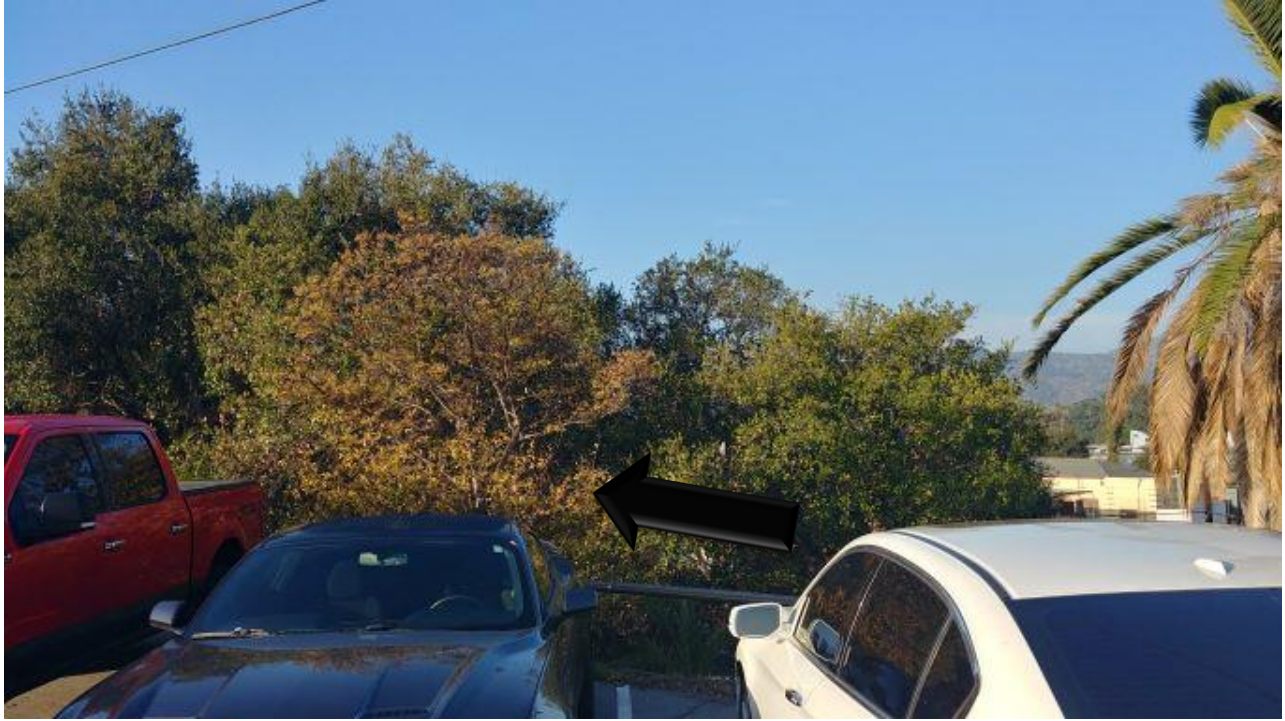
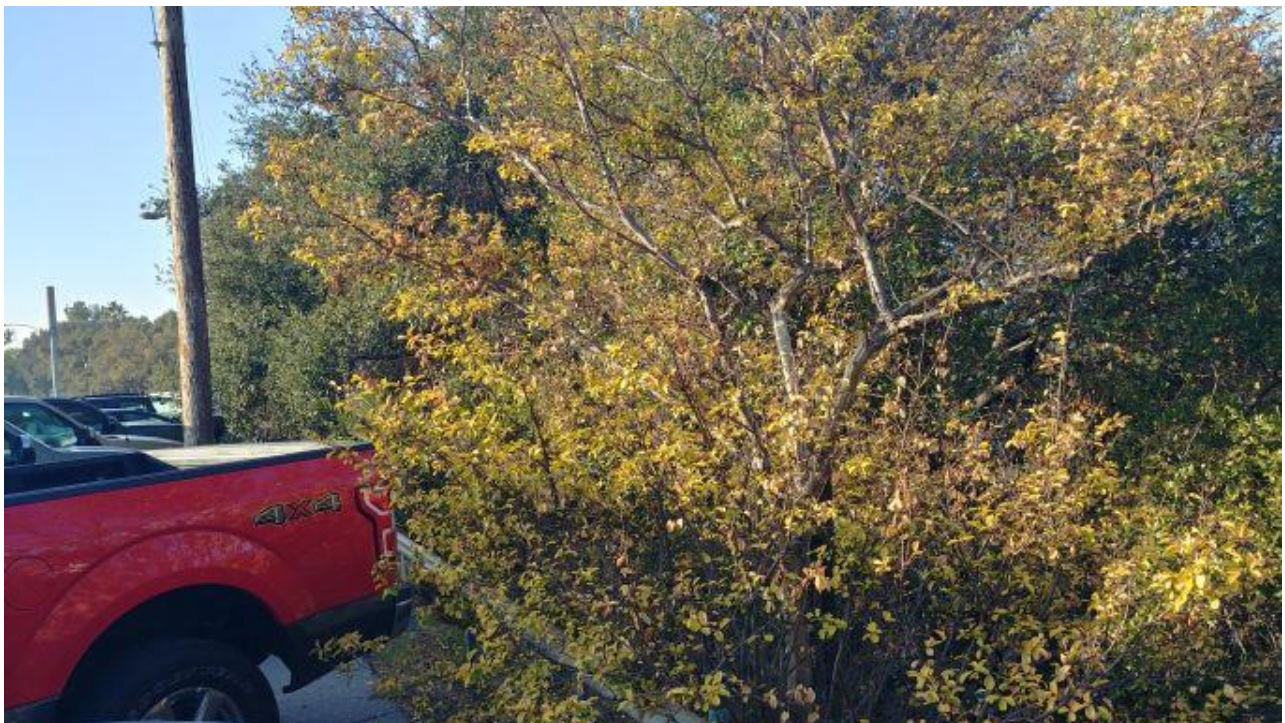
(a, b). Correct photos of #CM3. Tree is in conflict with new construction.

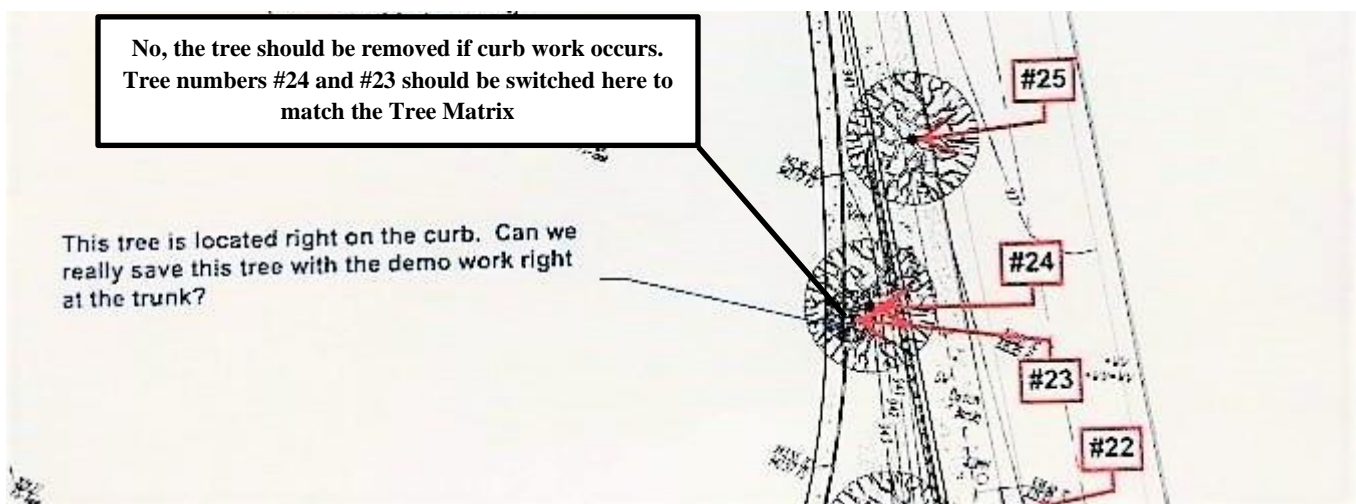
8. Comment on #24 impacted by demo work, and correct numbering (shown as #23 - Sheet C-006).
