**Consulting Arborist's Report**

# **Tree Inventory & Evaluation**

**For: 5001 Wilshire Boulevard**

Date: **February 11, 2021**

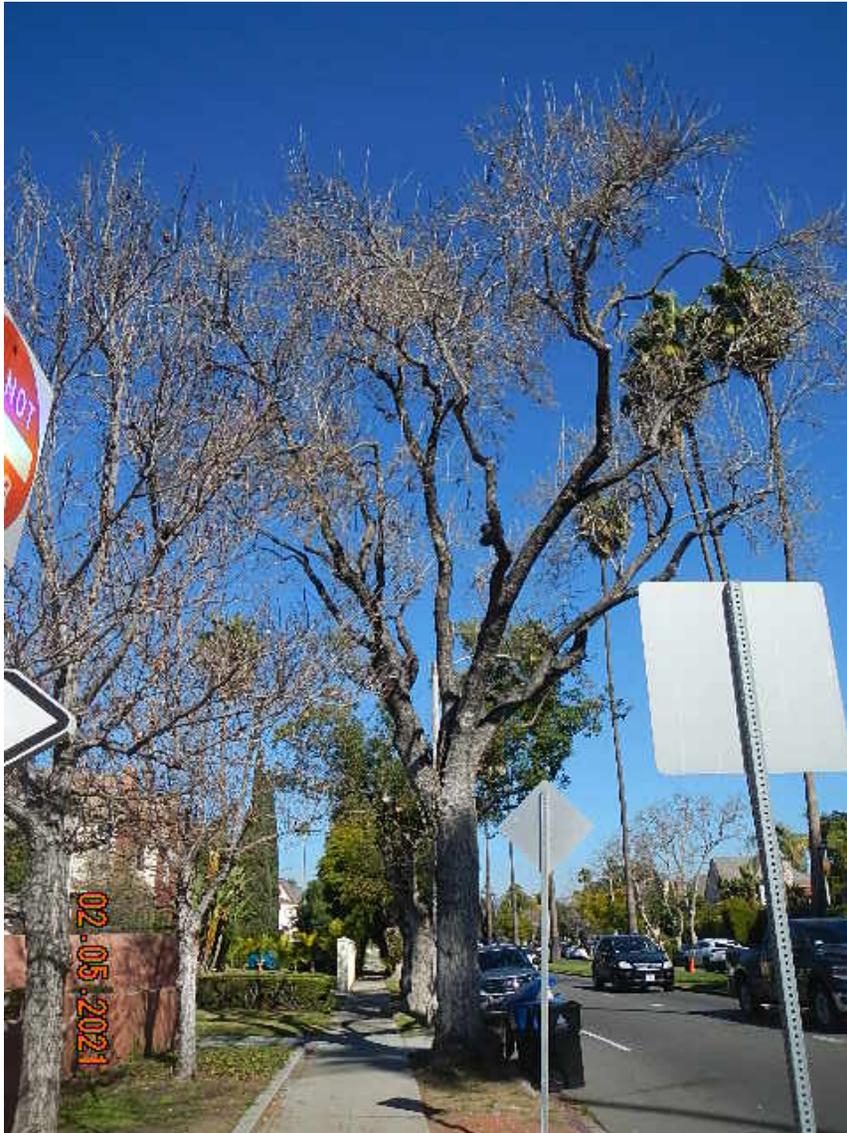
There is only one street tree, and it is on Highland. There are no adjoining street trees on the other surrounding streets. The existing street tree is in a poor state of health and structure. The street tree in this report is a large Arizona ash. The main limb structure is codominant with included bark. It has been headed back and lion-tailed. The bark on the trunk below the limbs is popping off, which is considered a serious warning of possibly imminent limb or trunk failure.

The numbering of the trees begins with the #1 Arizona ash street tree and moves westward across the north edge of the site. There is only one street tree, and it is on Highland. It is in a 4.5' wide parkway. Street trees on the rest of the block are of different genera. Camphors and jacarandas are more common street trees on this section of Highland. Arizona ash is not a common street tree in southern California, and it is not listed in Street Trees Recommended for Southern California. The species and most of the genus is known for large shallow roots. This specimen has the typical large and shallow roots and is starting to lift the sidewalk. Its structure is poor, due to being codominant, with severe included bark, and then being headed and lion-tailed.

#1 Arizona ash on Highland has been lion-tailed and headed.

All site trees will be removed. Only the street tree will remain, and the City should require that it be removed and replaced as well. For these reasons no clearance recommendations are offered. It is the recommendation of this consultant that the street tree be removed. It has now outgrown the space provided, and it may pose a high level of risk.

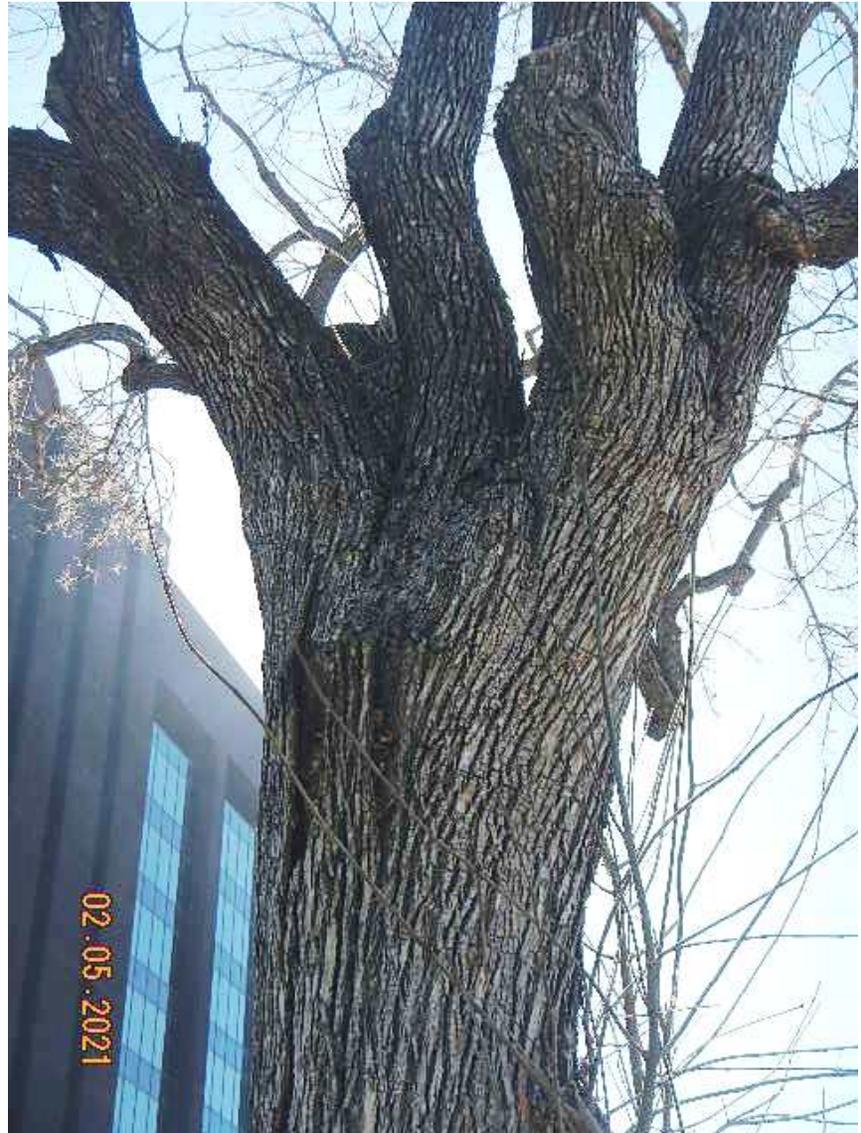
#1 Ash, note included bark and loose bark below – a warning sign

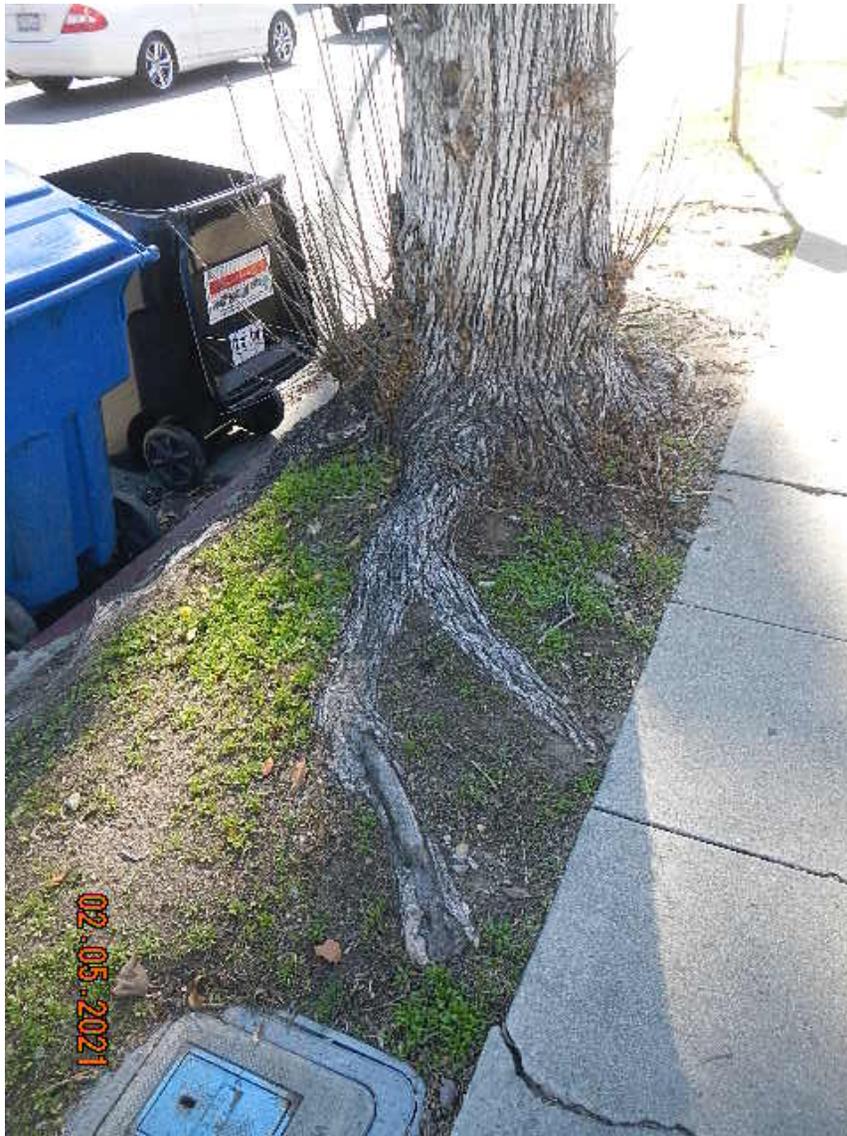
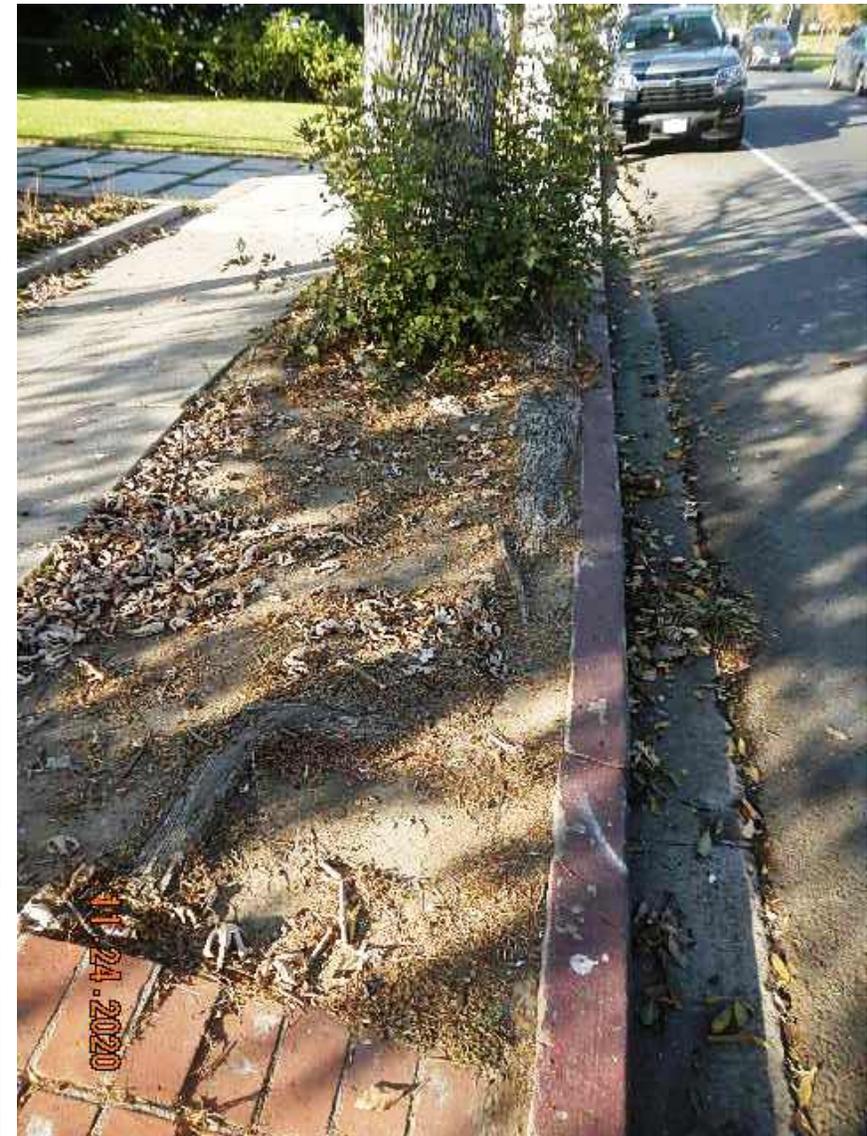
For this section of Highland, removal and replacement of most of the existing trees would be necessary soon. The parkway is narrow and the trees are big. In addition, the trees are of several mixed genera. The one particular tree adjoining this site is a poorly structured and shallow rooted Arizona ash. It is hard to believe Arizona ash was ever on the approved list of street trees, and certainly it would not be suggested for such narrow parkways. It is amazing to me that it lasted this long.

#1 Ash – note surface roots on the north side and damaged sidewalk. #1 Ash – note surface roots on south side

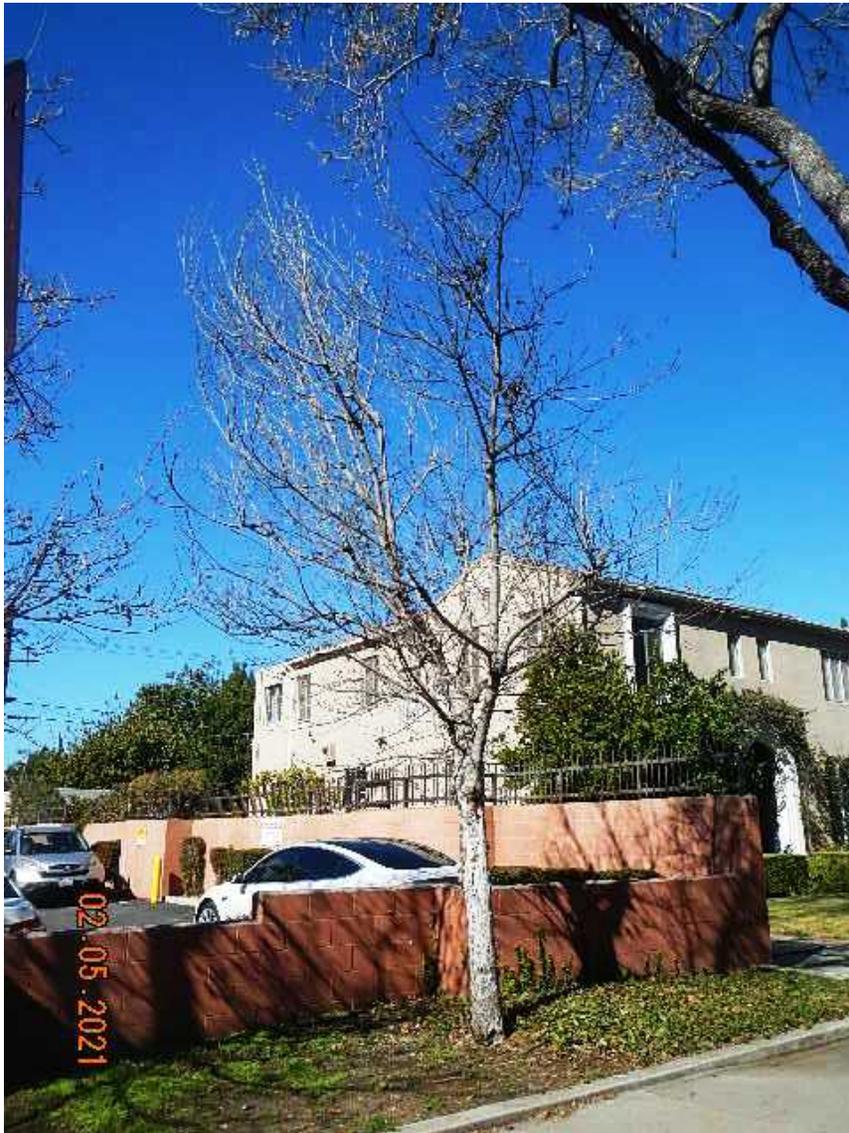
There are two silver maples (#2 &3) on the other side of the sidewalk, in a relatively small planter. The more northern tree is suppressed under the Arizona ash. Two old flush cuts are bleeding and there are many epicormic shoots, probably from over-pruning. The second maple is in front of the other in the same planter. This planter has far too little root space for even one silver maple. The second one is slightly larger, probably due to not being suppressed and having less competition with the ash tree. Silver maple is not even considered a good species in more northern climates. They are fast growing and would not survive long in this planter, even if the project was not built.

#2 Silver maple – note codominant leaders and overhead ash

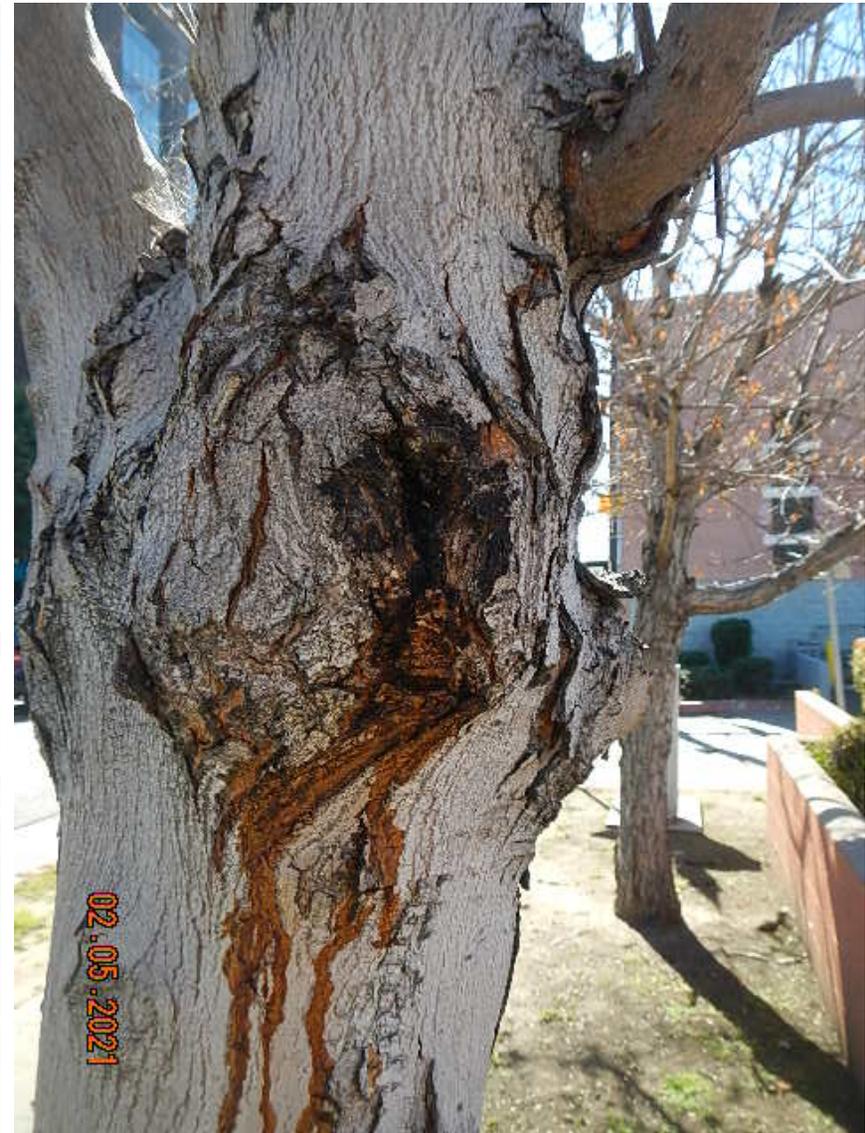
#2 Maple, note bleeding old flush cuts.

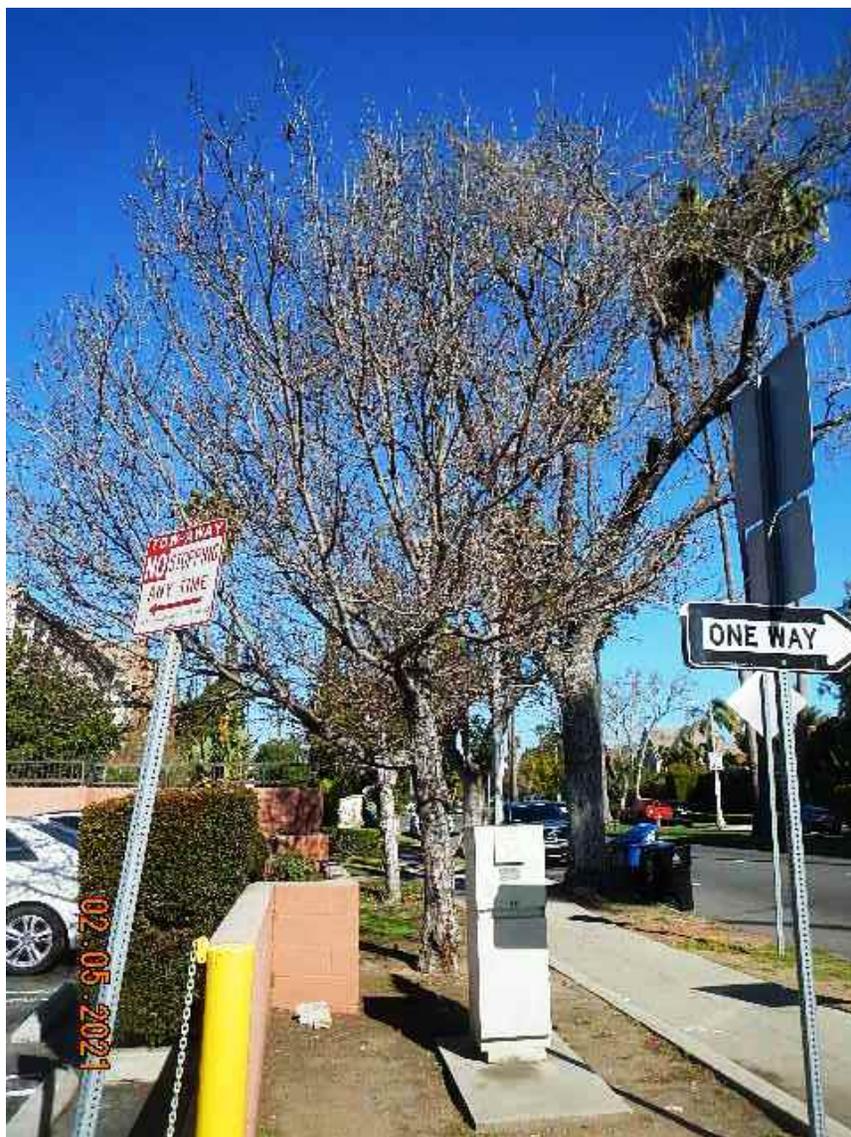
#3 Silver maple – note narrow planter and crowded limbs.

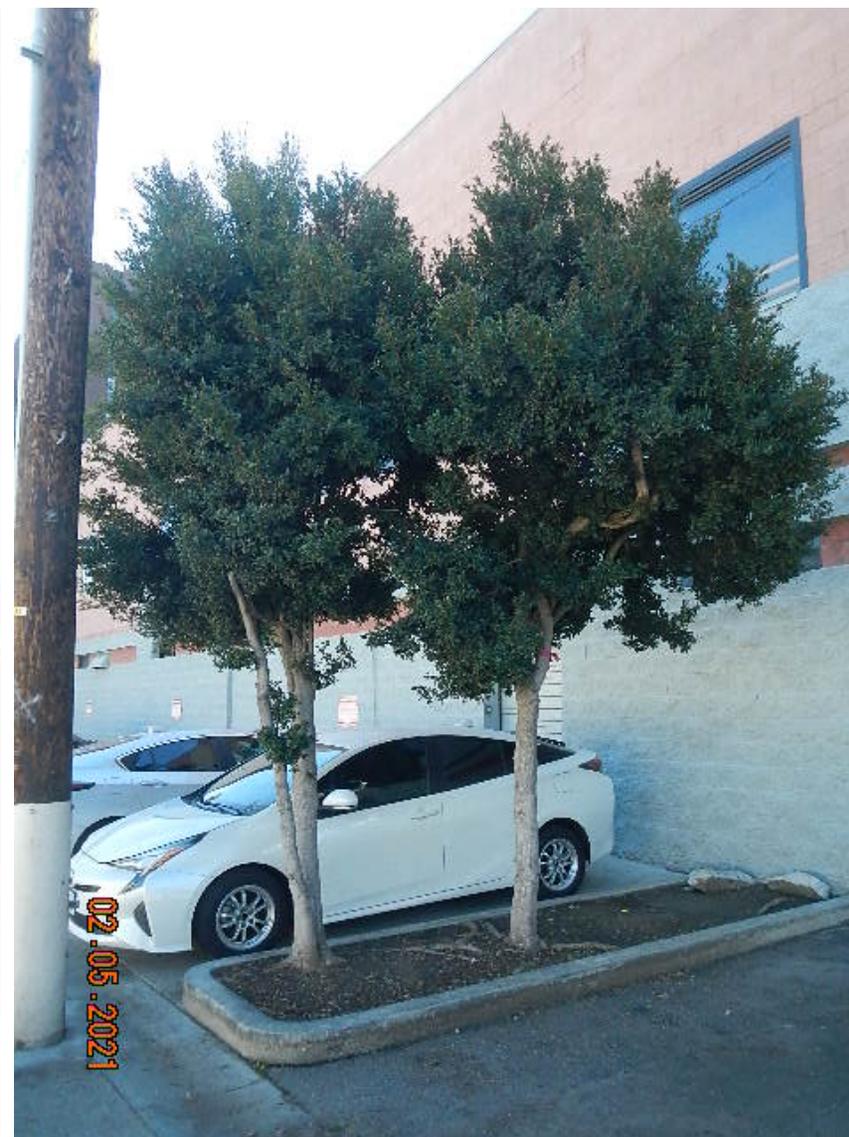
Trees #4 &5 are commonly grown as shrubs or hedges. Compact brush cherry could be a decent small tree, but both are in the same small finger island in the back parking area. Neither was trained to be a tree, but in their small size, it doesn't matter that much, but they would never have an adequate life span with two in such a small root space.

#4 & 5 Compact brush cherries and shallow crowded roots.
