Arborist Report

**905 N. Capitol Ave.
San Jose, CA 95113**

Prepared by:
HortScience | Bartlett Consulting
325 Ray Street
Pleasanton, CA 94566

September 16, 2021

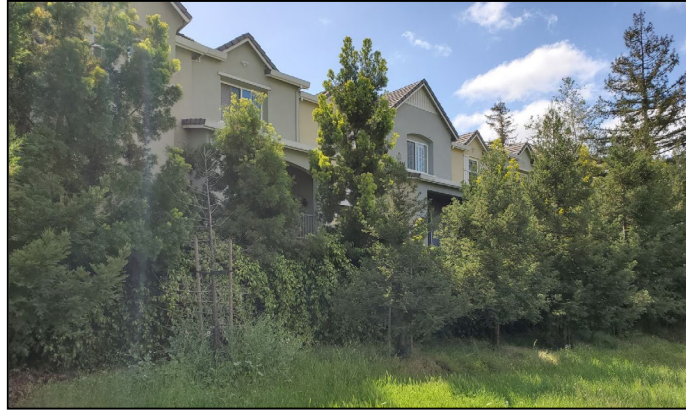
Coast redwood was the most common species, with 14 trees. Twelve (12) were in fair condition, while tree #107 was in good condition and tree #108 was dead. Tree #83 was located in the center of the southern parcel and displayed signs of drought stress. The other 13 trees were located west of Kestral Way. Trees #107 – 117 formed a row screening the adjacent property (Photo 1). Trees #119 and 120 were off-site with crowns that overhung the property line by approximately 8' – 10'. Many of the on-site trees were staked with rubber ties. Trees #107 – 117 were young to semi-mature in development, with trunk diameters ranging from 3" to 11". Trees #83, 119, and 120 were more established, with diameters ranging from 17" – 19".

Photo 1 (above): Coast redwoods #107 (left) through #112 are in the foreground screening the adjacent property.

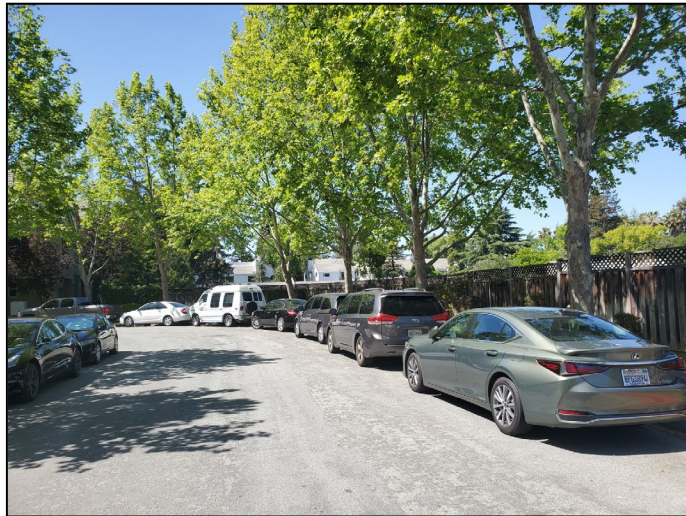
The second most common species was London plane with 12 trees. Trees #84, 125 – 128, and 135 – 138 were in good condition located within planting strips along Kestral Way. Trees #84, 137, and 138 were adjacent to the south parcel and trees #125 – 128, 135, and 136 were adjacent to the southern edge of the north parcel (Photo 2). Trees #131 – 133 were in fair condition located along N. Capitol Ave in 4' by 4' sidewalk cutouts. They had small diameter branches overhanging the site by less than 10'.

Photo 2 (below): London planes #125 – 128, 135, and 136 are planted on the N. side of Kestral Way

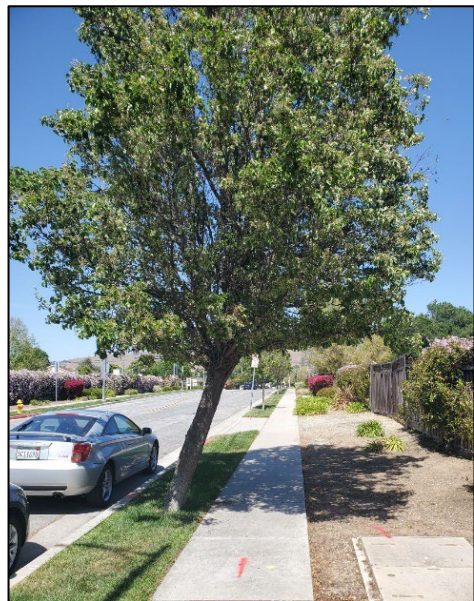
Seven Callery pears were street trees planted in 4'-wide planting strips along Penitencia Creek Rd. Three trees were in poor condition and four were fair. Pears were young in development, with trunks ranging in diameter from 3" to 10". Trees had poor structure with crowded, narrow attachments. Tree #139 had a significant lean over the sidewalk (Photo 3). Powdery mildew was present on several trees.

Photo 3 (right): Callery pear #139 had a lean over the sidewalk.

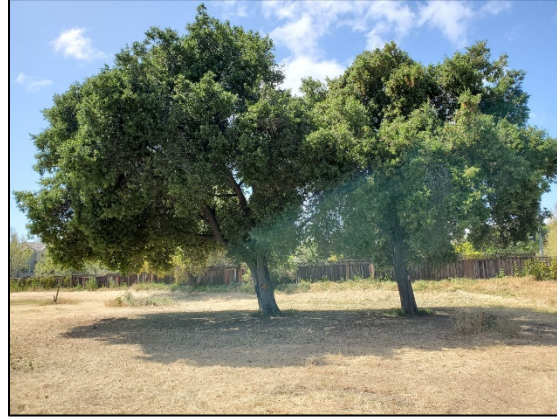
Four coast live oaks were assessed. Trees #79 and 80 were located on the south parcel and were in good condition with dense canopies and good form (Photo 3). They were mature in development with trunk diameters of 27" and 36", respectively. Trees #104 and 105 were in fair condition and were located on the north parcel between the residence and the open field. Tree #105 had a single 5" trunk while #104 had multiple trunks ranging from 2" to 6" in diameter.

Photo 3 (above): Coast live oaks #80 (left) and 79 (right) were in good condition with dense crowns.

| Tree No. | Species | Trunk Diameter (in.) | Protected Tree? | Condition 1=poor 5=excellent | Suitability for Preservation | Comments |
|---|---|---|---|---|---|--|
| 80 | Coast live oak | 36 | Yes | 4 | Moderate | Codominant attachments arise from 5'; dense green canopy; good rounded form; mechanical damage on trunk with good response growth. |
