Kielty Arborist Services LLC

Site: Block 21 Project, San Mateo CA

As requested on Wednesday, February 6th 2021, and again on Wednesday, September 22nd, 2021, I visited the above site to inspect and comment on the trees. A large development project is proposed on this block and will require the removal of all of the surveyed trees. A LU evaluation sheet and tree replanting form can be found within this report. The most current site plans have been reviewed for writing this report. No neighboring heritage trees will have construction performed within a radius equal to ten times the diameter of the tree trunk.

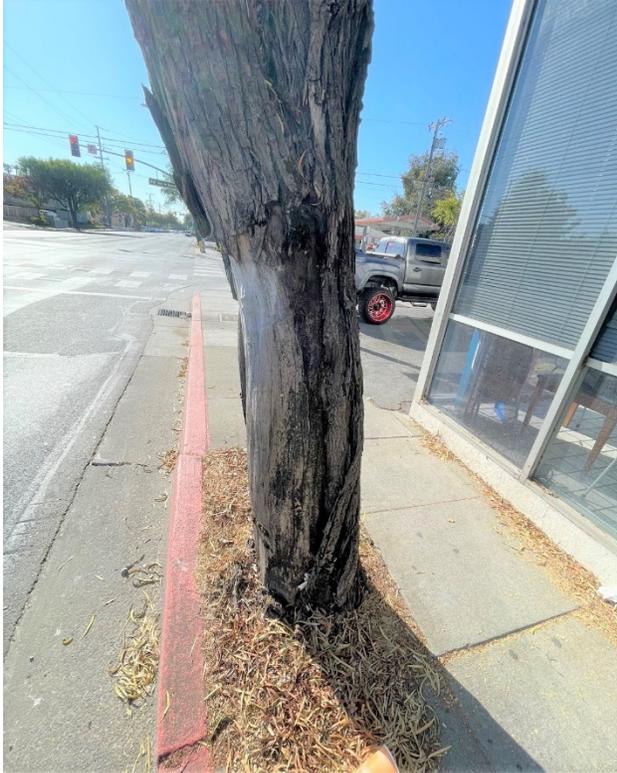
Trees #1-11, and #13-16 are street trees consisting of Australian willow trees and hackberry trees. The Australian willows (#1-7) are all mature and in fair to poor condition. Codominant unions with included bark (common for species) were observed on many of the Australian willow trees. Some of the Australian willows have been hit by vehicles in the past or have been topped. This species is a poor selection for a street tree. Australian willow tree #1 is a hazard to vehicles and pedestrians as the tree has lost more than 50% of its cambium on the lower trunk. The excessive decay makes the tree a hazard. This tree should be removed as soon as possible.

Showing tree #1 with extensive decay

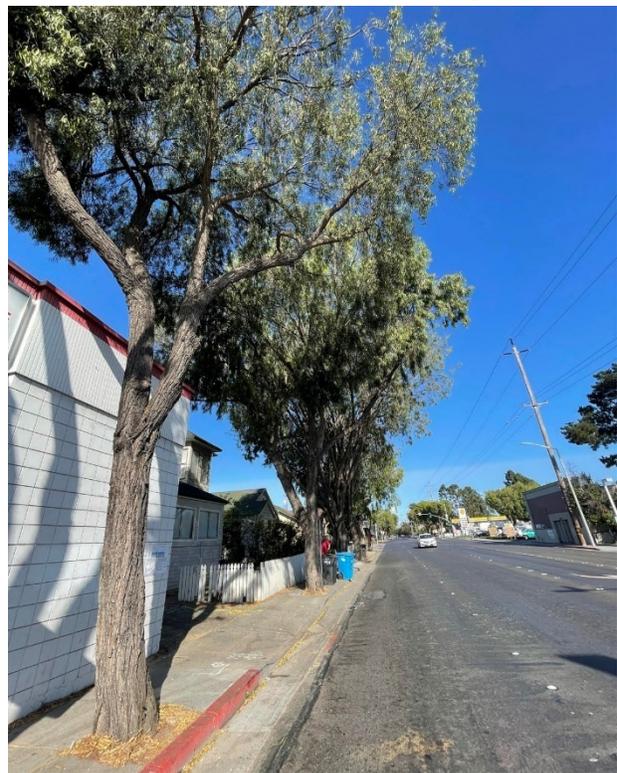
Showing row of Australian Willow trees

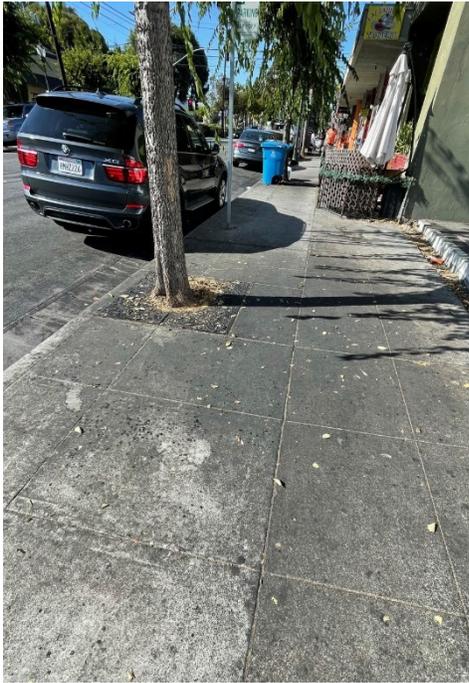
Hackberry street trees #8-11 & 13-16 are in fair to poor condition. Many of the trees have been topped in the past due to being located underneath high voltage utility lines. The trees are located within tree grates. The grates have not been expanded and are girdling the trees. Decay at the tree root crowns was also observed. The Hackberry trees all have aphids and are causing damage to the sidewalks as they drop “honeydew” all of the sidewalk making the sidewalk sticky and dirty. For this reason this species is a poor species selection for a sidewalk tree. Annual insecticide treatments are needed to control the insect problem.

Showing sticky honeydew on ground from aphids

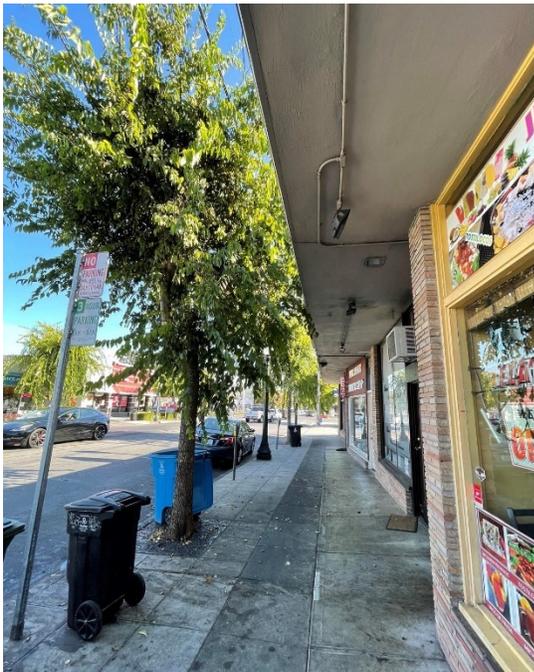
Showing Hackberry trees

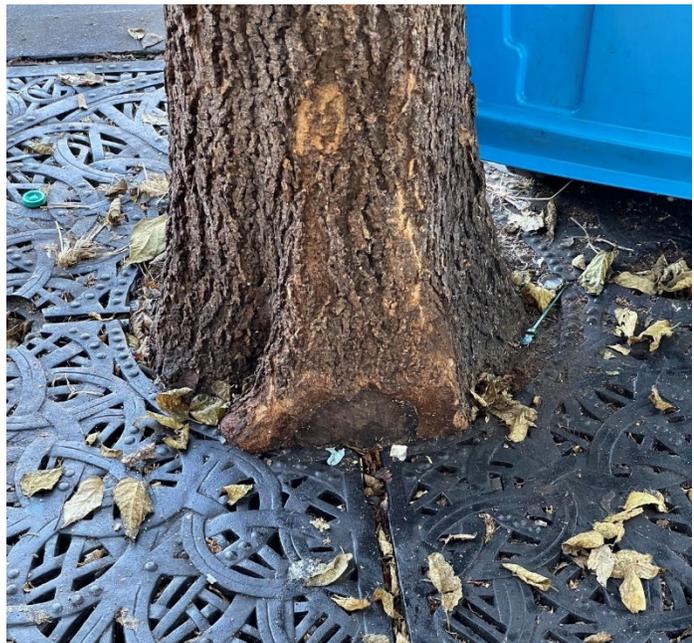
Showing tree grate girdling tree with decay observed

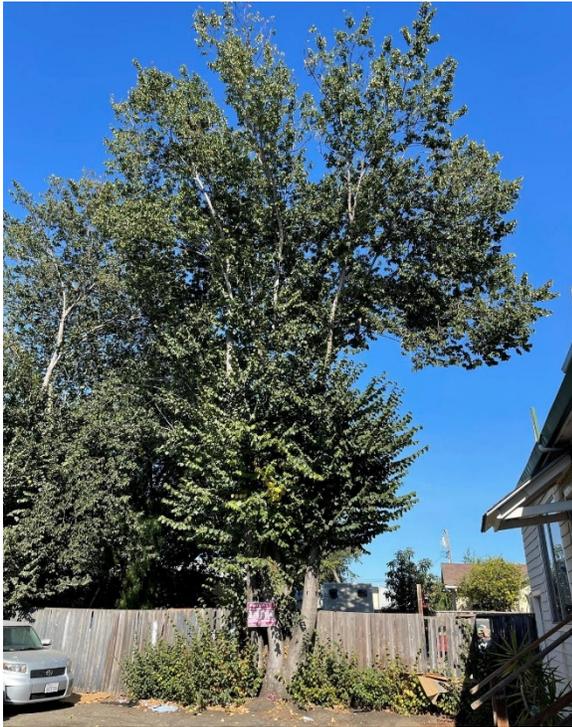
American elm tree #19 is in fair condition (lower end). The tree is codominant at 2 feet with 4 leaders creating included bark. The tree is on a property line and is surrounded by hardscapes and compacted soil. Included bark significantly raises risk of limb failure.

Showing elm tree #19

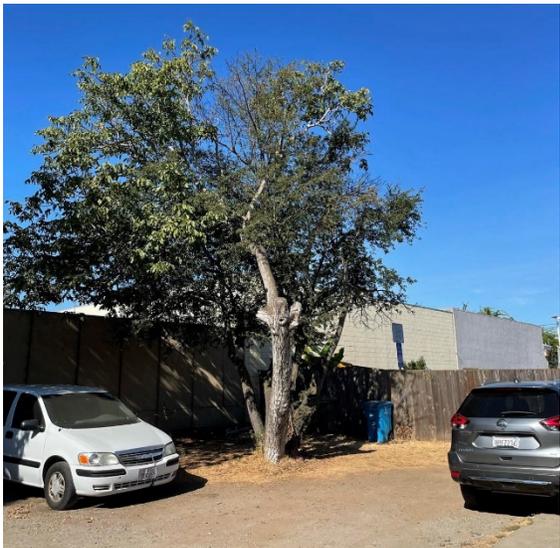
English walnut tree #24 is in poor condition. Large sections of the tree are dead. This tree is expected to decline regardless of management. English walnut tree #24 is adjacent to plum tree #25. The two trees share a root zone. Plum tree #25 is in decline.

Showing both trees

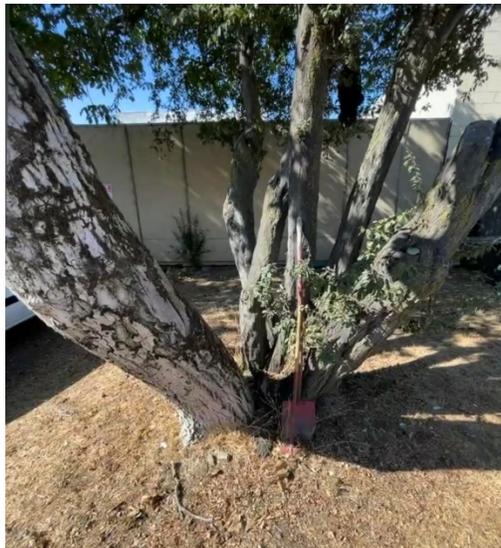
Showing both trees sharing root zone

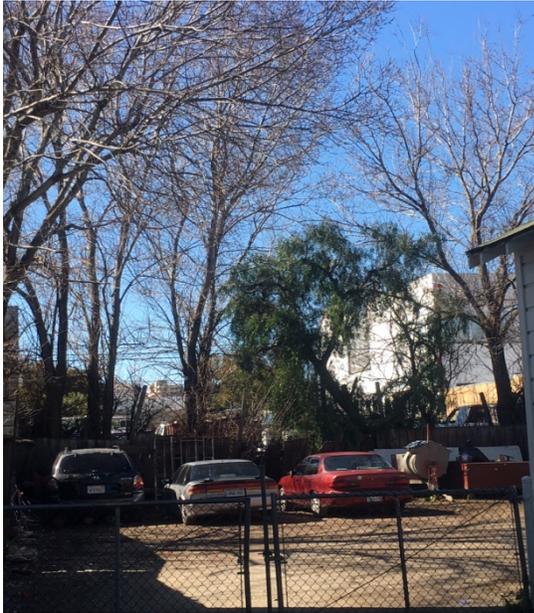
Australian cherry #26 is in fair condition. The tree is poorly located up against a small retaining wall. Removing the retaining wall may have high impacts on the tree's stability within the landscape. Tree removal before demolition is recommended. The tree's form is poor as the tree is codominant at grade.
