## SEISMIC RISK ASSESSMENT REPORT

### **Panorama Mall**

8401 Van Nuys Boulevard  
Los Angeles, California 91402

Report Date: July 23, 2015  
Partner Project Number: 15-140920.1

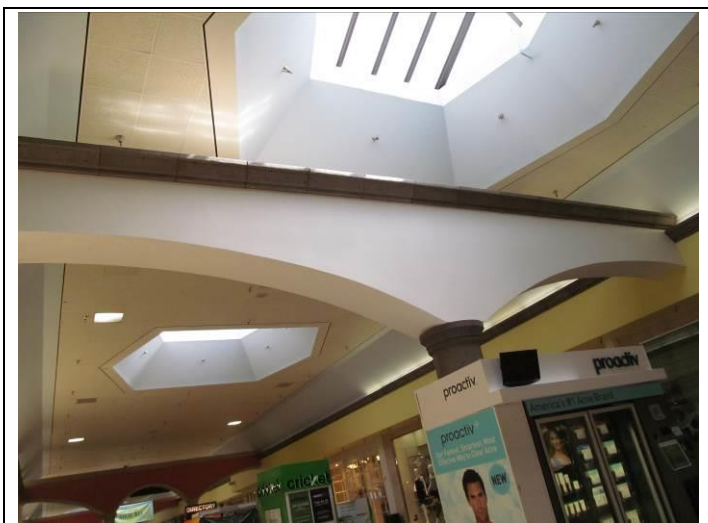
- The interface between the two building groups is expected to have stiffness inconsistencies that are likely to cause elevated levels of non-structural damage at building interfaces.

11. Linkage between the older building section and the newer wings A & B

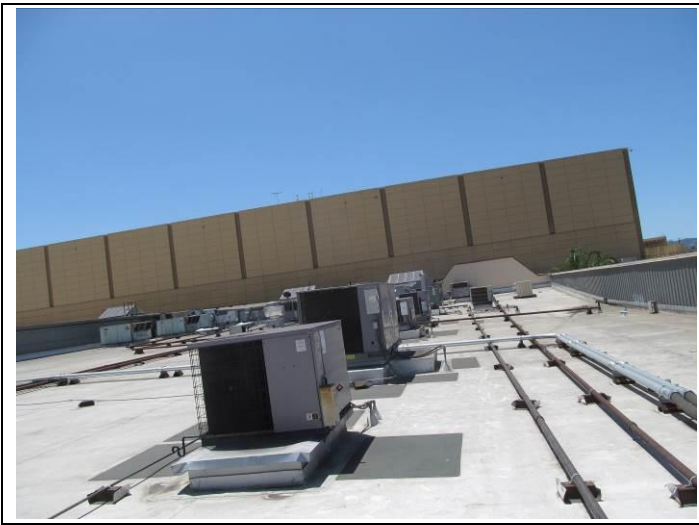
19. Roof deck over Building Sections A & B and gas lines

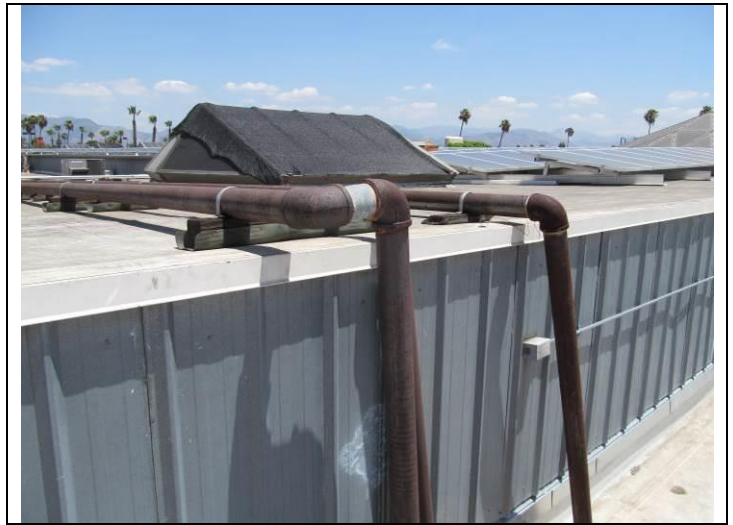
- Post-earthquake repair history and documentation of the repair history was not available.
- The gas feed lines on the roof deck are supported on wood riser blocks that do not penetrate the roof membrane. The lines are unbraced for more than 100-feet and could be prone to damage and rupture in strong ground shaking thereby increasing the potential for earthquake induced fire. Steps should be taken to establish improved anchorage and bracing of the gas feed lines.

20. Continuously unbraced gas feed lines

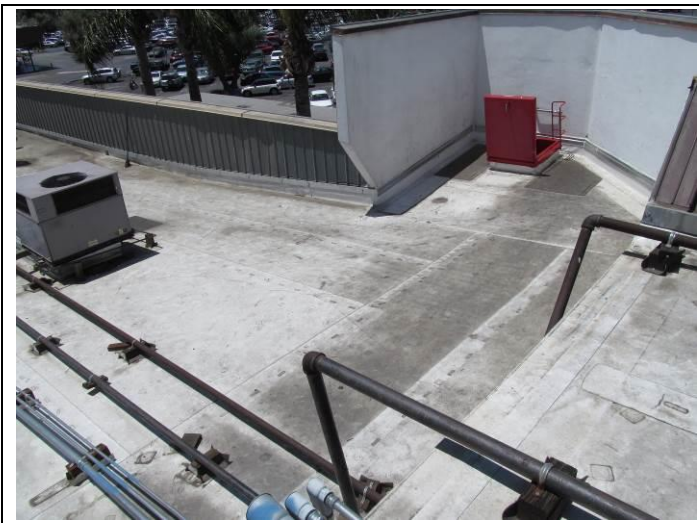
21. Continuously unbraced gas feed lines

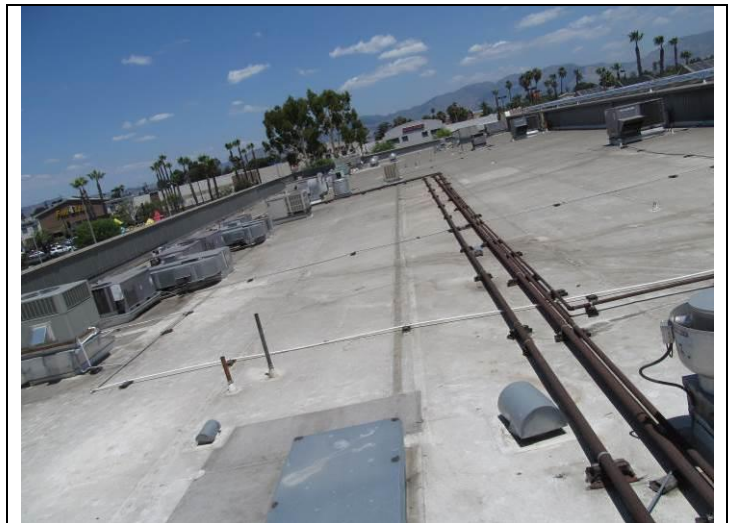
22. Continuously unbraced gas feed lines

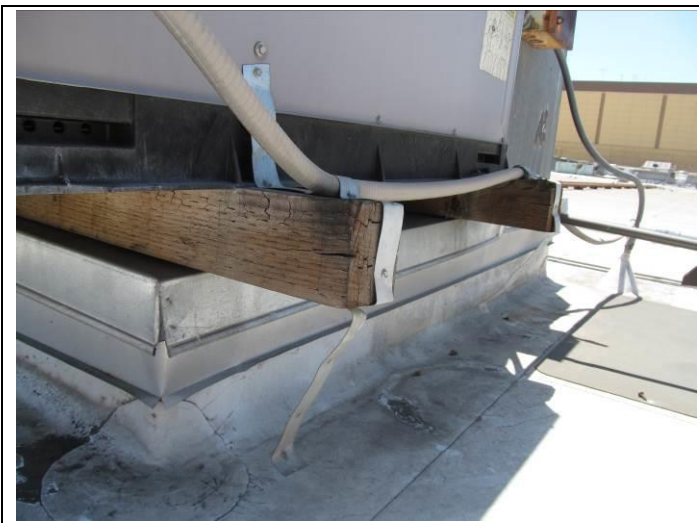
23. Equipment anchorage varies in quality

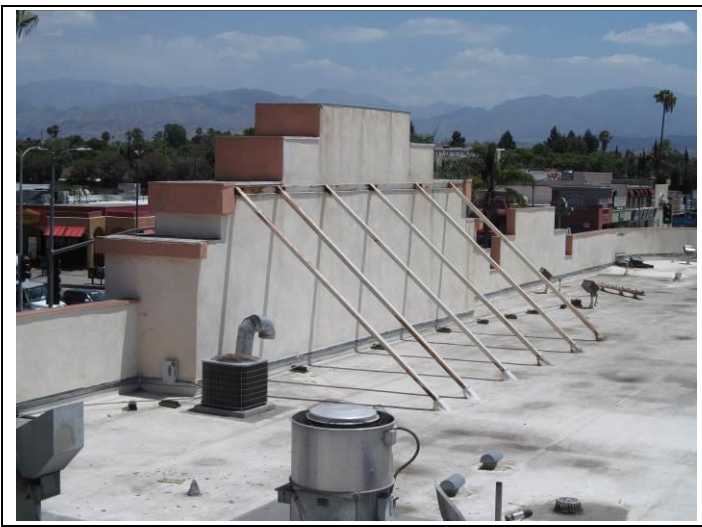
- One of the roof parapets was heavily braced while another similar parapet was not. This may be evidence of prior damage and a localized repair response but this could not be verified.

25. Braced parapet

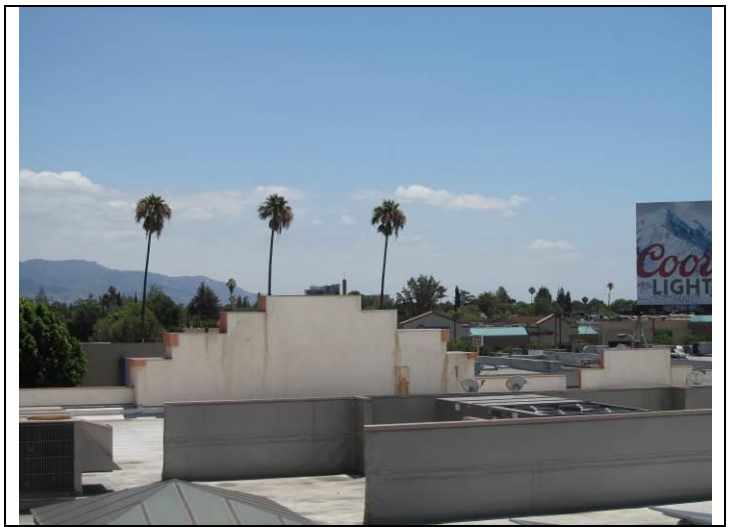
26. Unbraced parapet

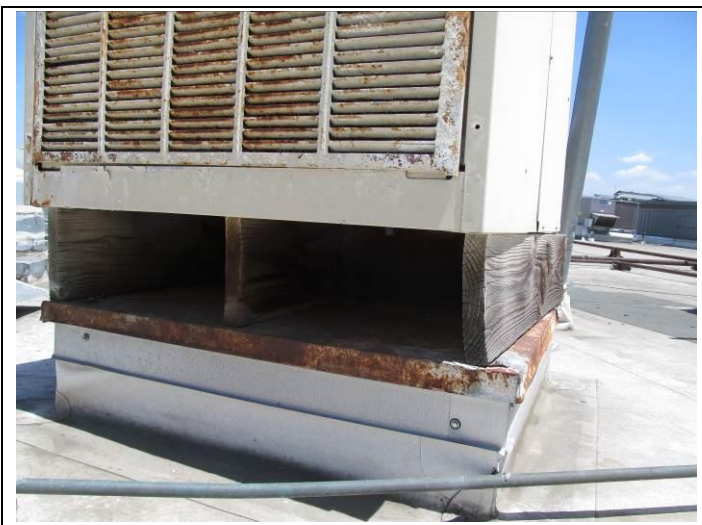
27. Equipment anchorage lacking

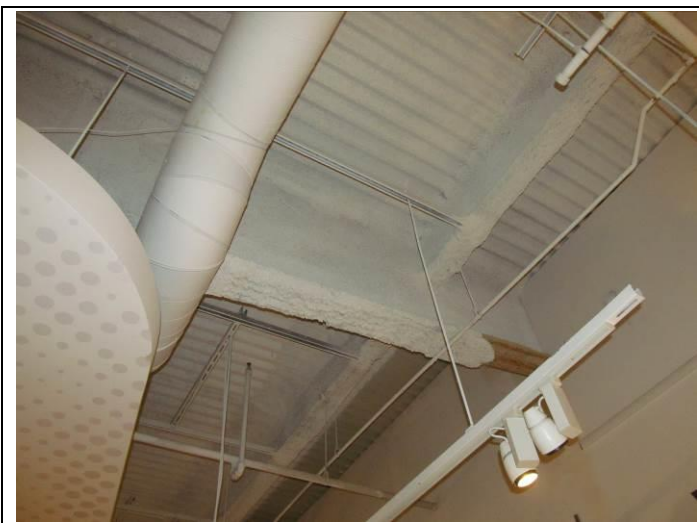
33. Exposed steel beam with fire safing scraped off of underside of flange

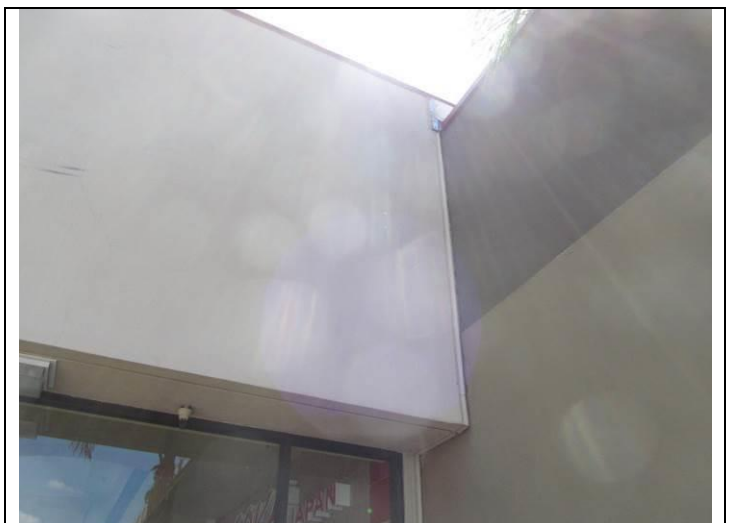
36. Building separation at transition to Walmart
