Civic Center Family Housing Project Initial Study

Preliminary Arborist Report

1601 Civic Center Drive
Santa Clara, CA

March 6, 2020

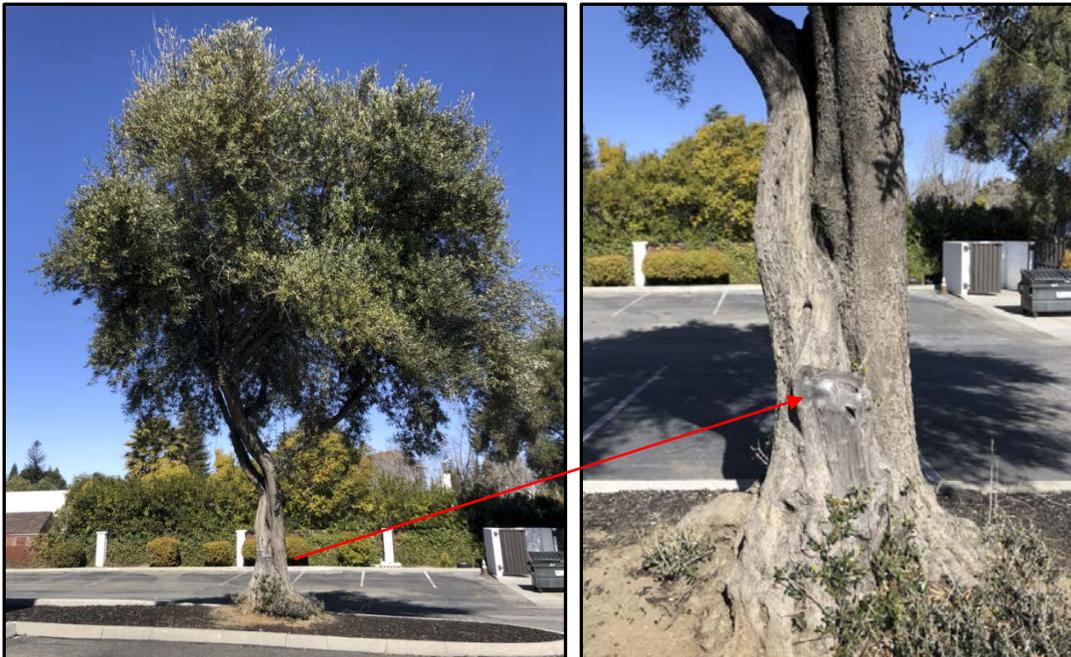
The most common species present was olive with 11 trees (58% of the population). The olives ranged from poor (2 trees) to fair (9 trees) condition. All had either multiple trunks arising from the base or were codominant, where a stem had been removed (Photo 1). Many of the olives had pruning wounds. Olives were semi-mature with trunk diameters ranging from 9 to 17 inches.

Photo 1 (left): Olive #143 was located in a narrow parking lot planter.
Photo 2 (right): A stem had been removed at 3 feet on the south.

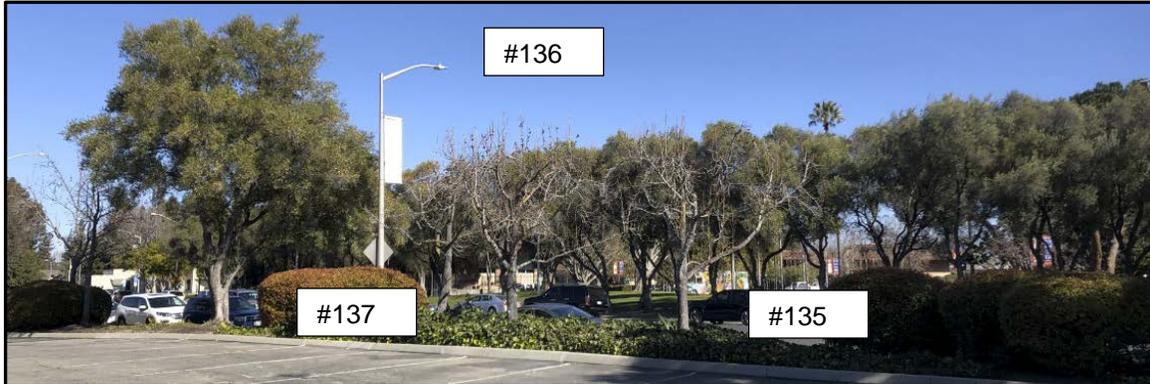
Five (5) sweetgums were growing near the street on the eastern property line. The sweetgums were in poor (4 trees) to fair (1 tree) condition. All but one (#140) of the sweetgums had been topped. The sweetgums were young with 7 to 8 inch trunk diameters.

Photo 3 (above): Five sweetgums were growing on along Lincoln.

- **Structural integrity**
Trees with significant amounts of wood decay and other structural defects that cannot be corrected are likely to fail. Such trees should not be preserved in areas where damage to people or property is likely. For example, sweetgums #135-139 had been topped. Growth arising from topping wounds is weakly attached and can be prone to breakage.
