# Oak Tree Survey Report

## Hope Gardens Redevelopment Project

**October 2019**

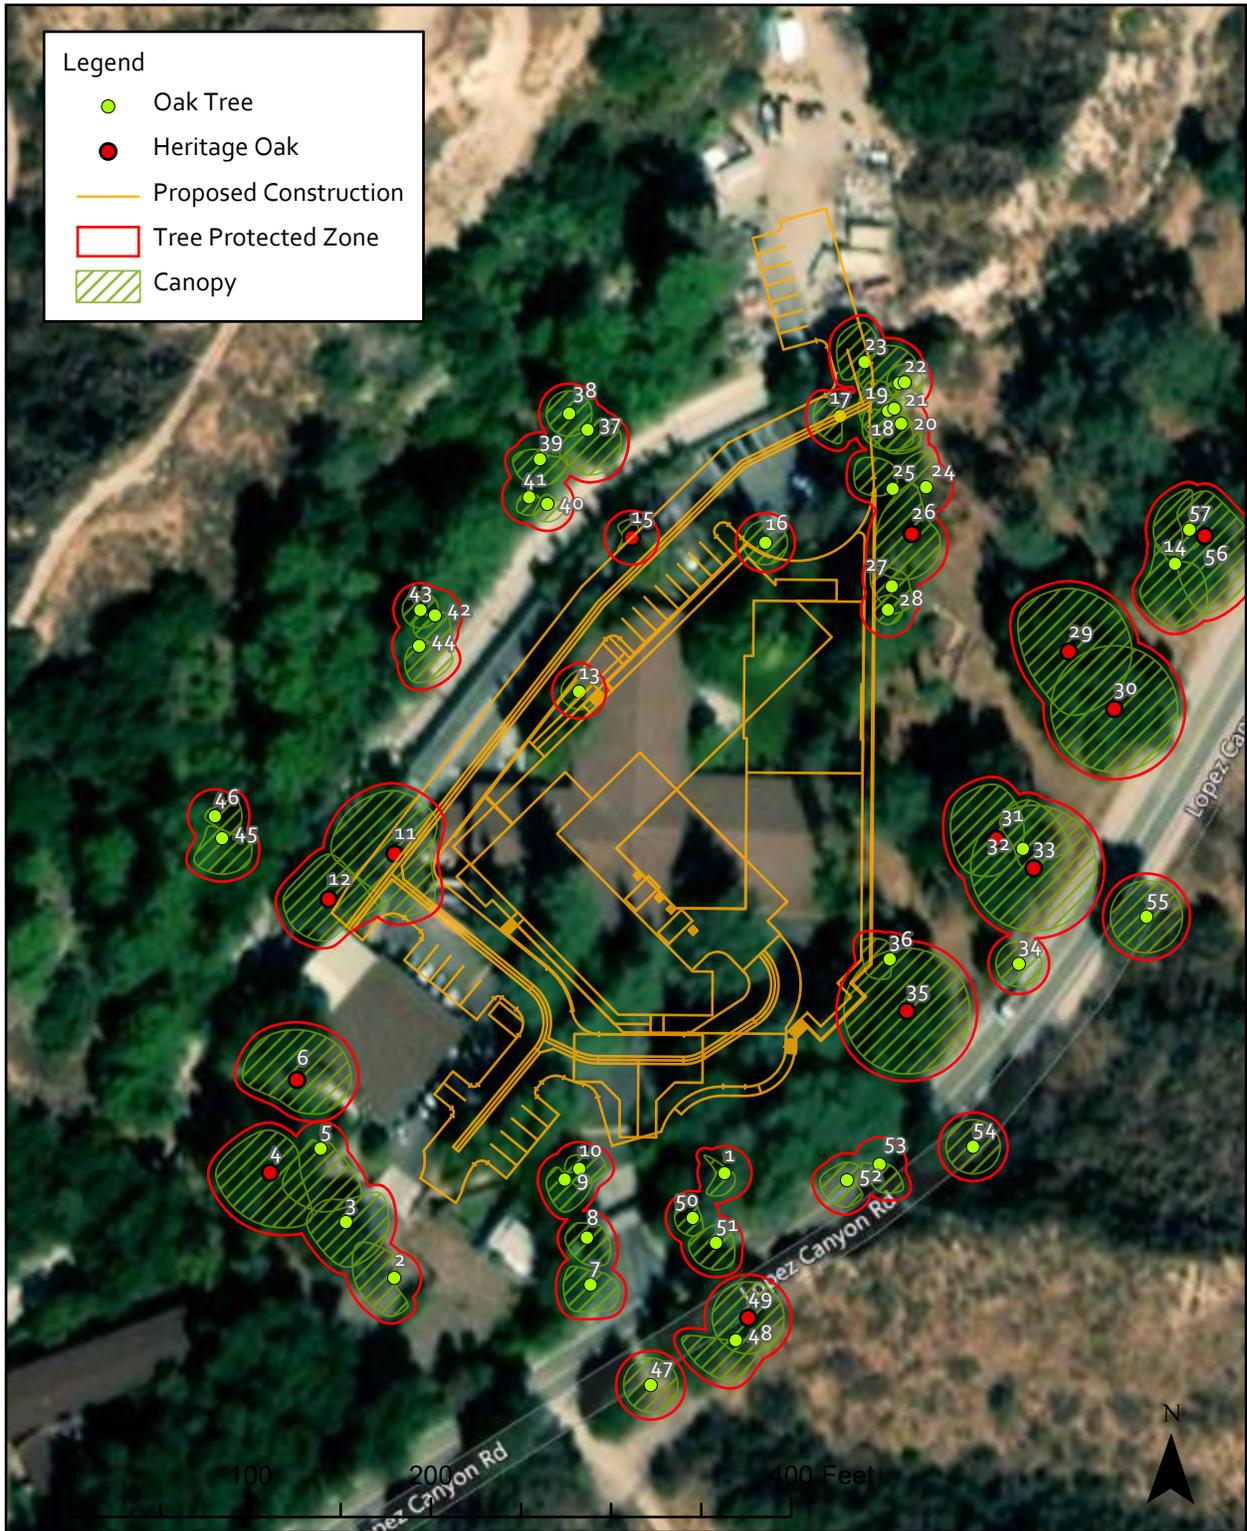
Figure 3. Oak Tree Survey

The proposed redevelopment of the Sequoia building would result in the removal of 6 oak trees (2 of which are heritage oaks), and encroachment into the TPZ of 10 oaks (3 of which are heritage oaks). These results are summarized below in Table 1 below and shown in Figure 3.

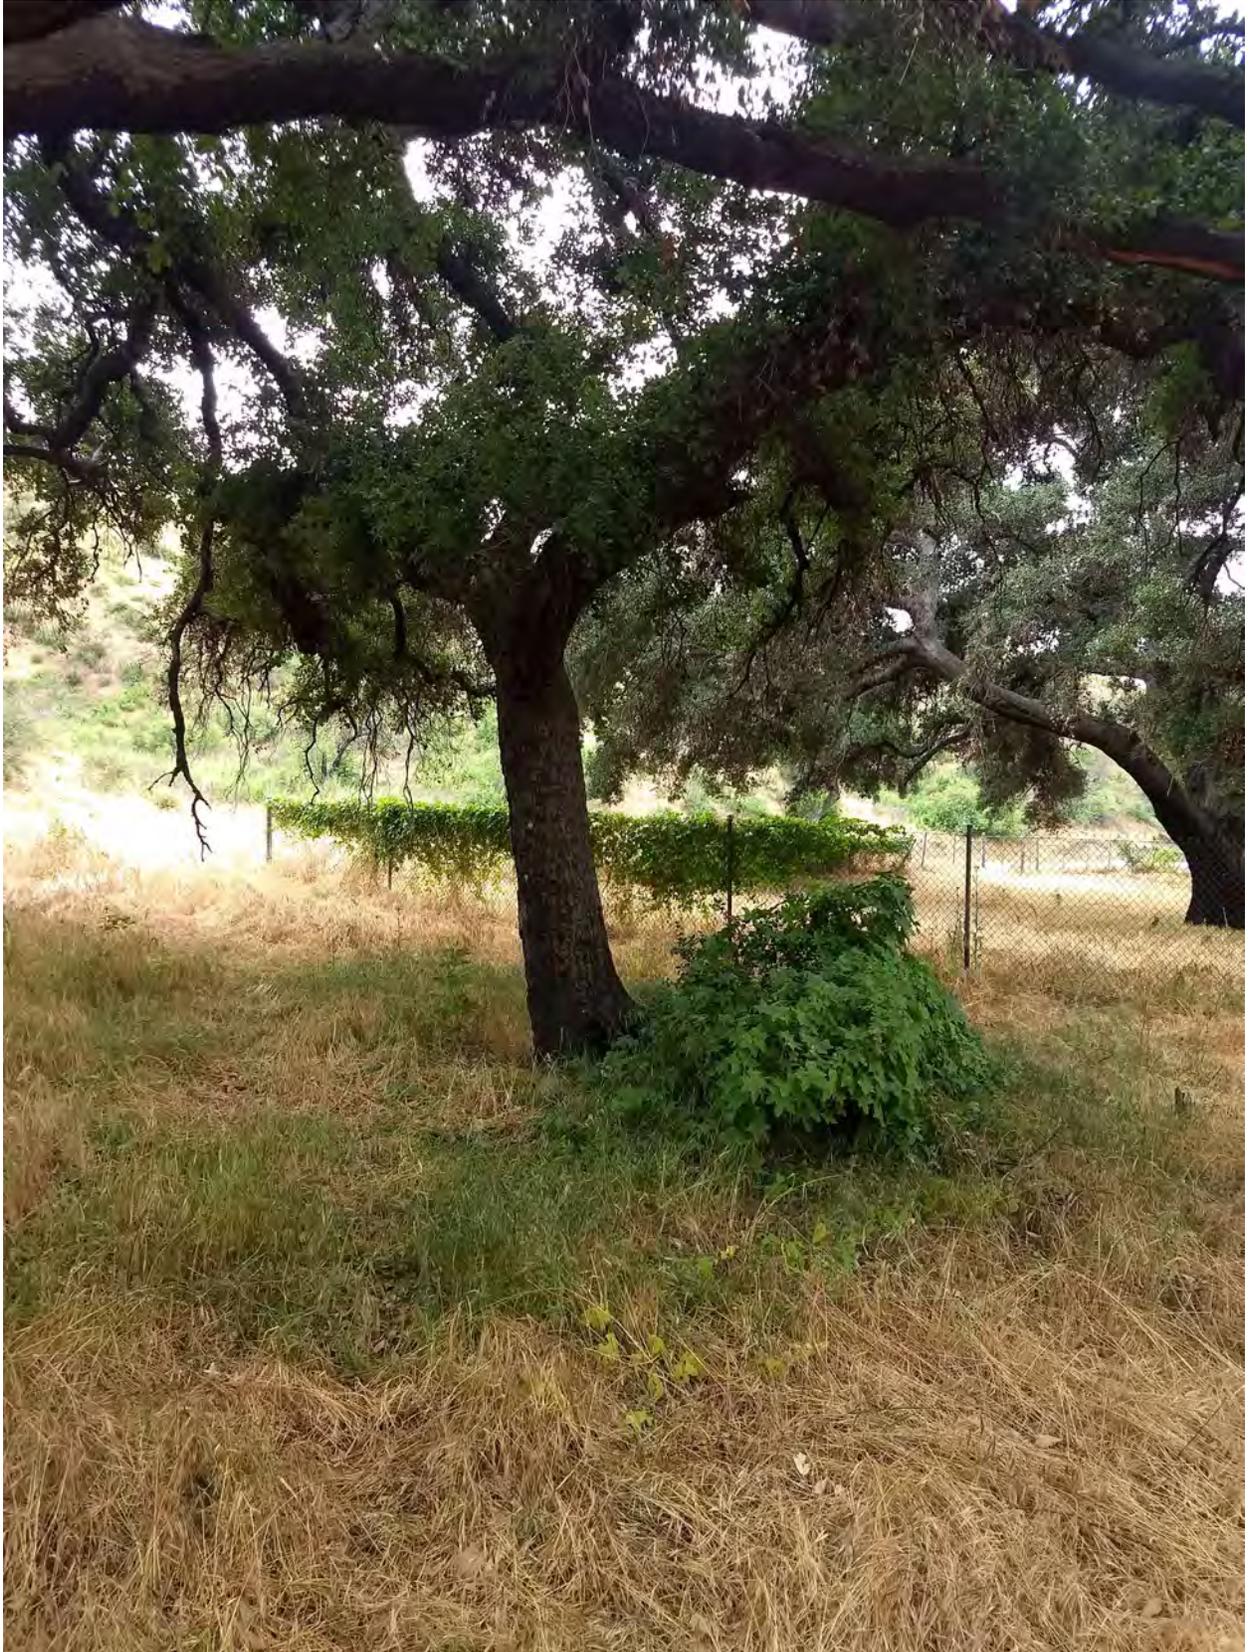
Oak #14

13	Can	25	15	12	10	10	10	10	10	10	10	5			B		5	
14	Can	15	19	0	1	10	30	35	25	12	15	3	UC, HB	HR		Bark, Dead, thinning	3	underneath the canopy of 2 other oaks
15	Coast	12	45	10	5	1	0	0	10	5	10	1	BB,UC,HB			NTG, Dead, thinning	1	topped, 2 huge trunks, 1 is dead, other has new growth but poor health, beneath power lines, heritage oak
16	Can	18	14	12	12	12	12	12	12	12	12	5					5	near parking lot

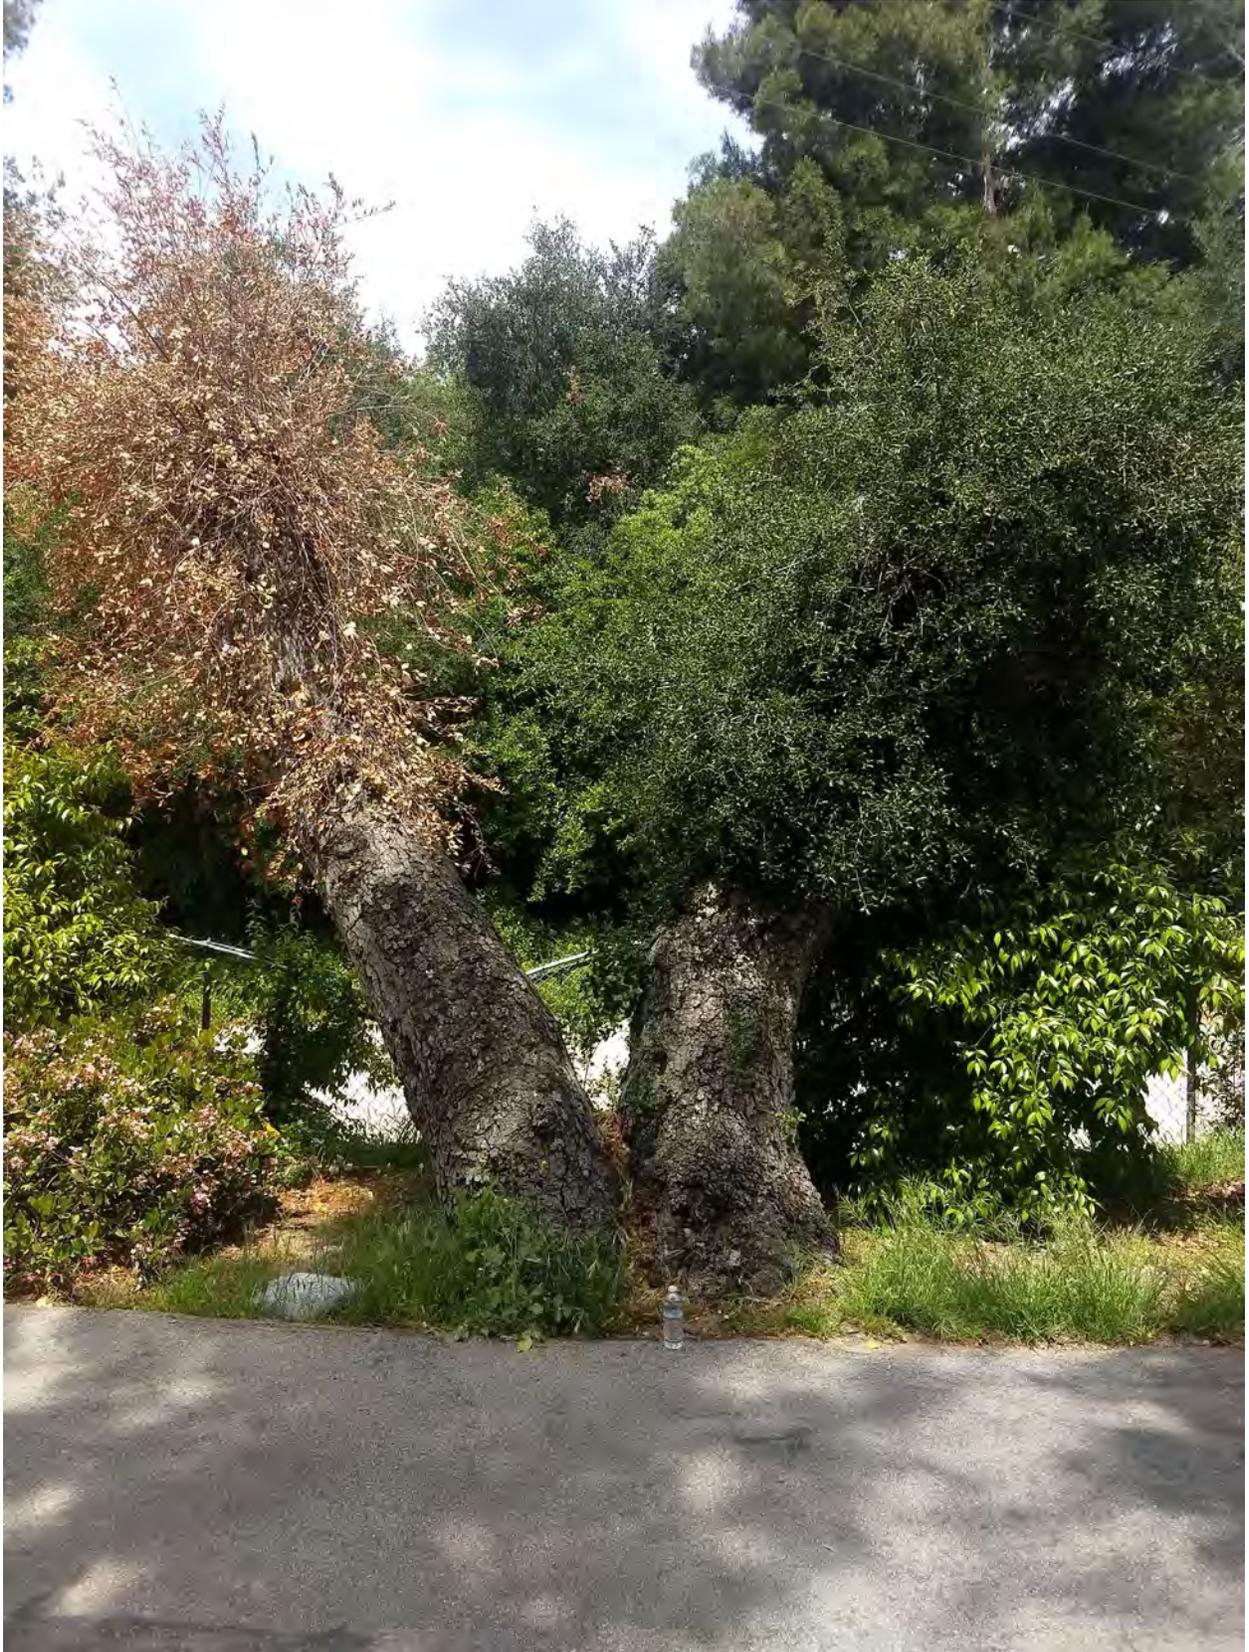
# Oak #15

Of the oaks that will be removed 5 of them are in good health (3, 4, or 5 health rating) and #15 is dead/dying (health rating of 1) and should be removed to avoid any future conflicts.

Continued consistent care and maintenance of oak trees on the Hope Gardens would be prudent and is the main recommendation from South Environmental. The high health and symmetry scores indicate that the current management is effective and no new management activities are required to maintain healthy trees. Oak #15 is also recommended for removal due to the poor health from being topped and the trees position beneath utility lines. Oak #26 on National Forest Land is not likely to survive, and the hollow trunk indicates that it is likely to lose more large limbs soon. Fencing exists to keep people from going near the tree from the Hope Gardens facility. To maintain the current low risk situation, South Environmental recommends the barrier remain in place.

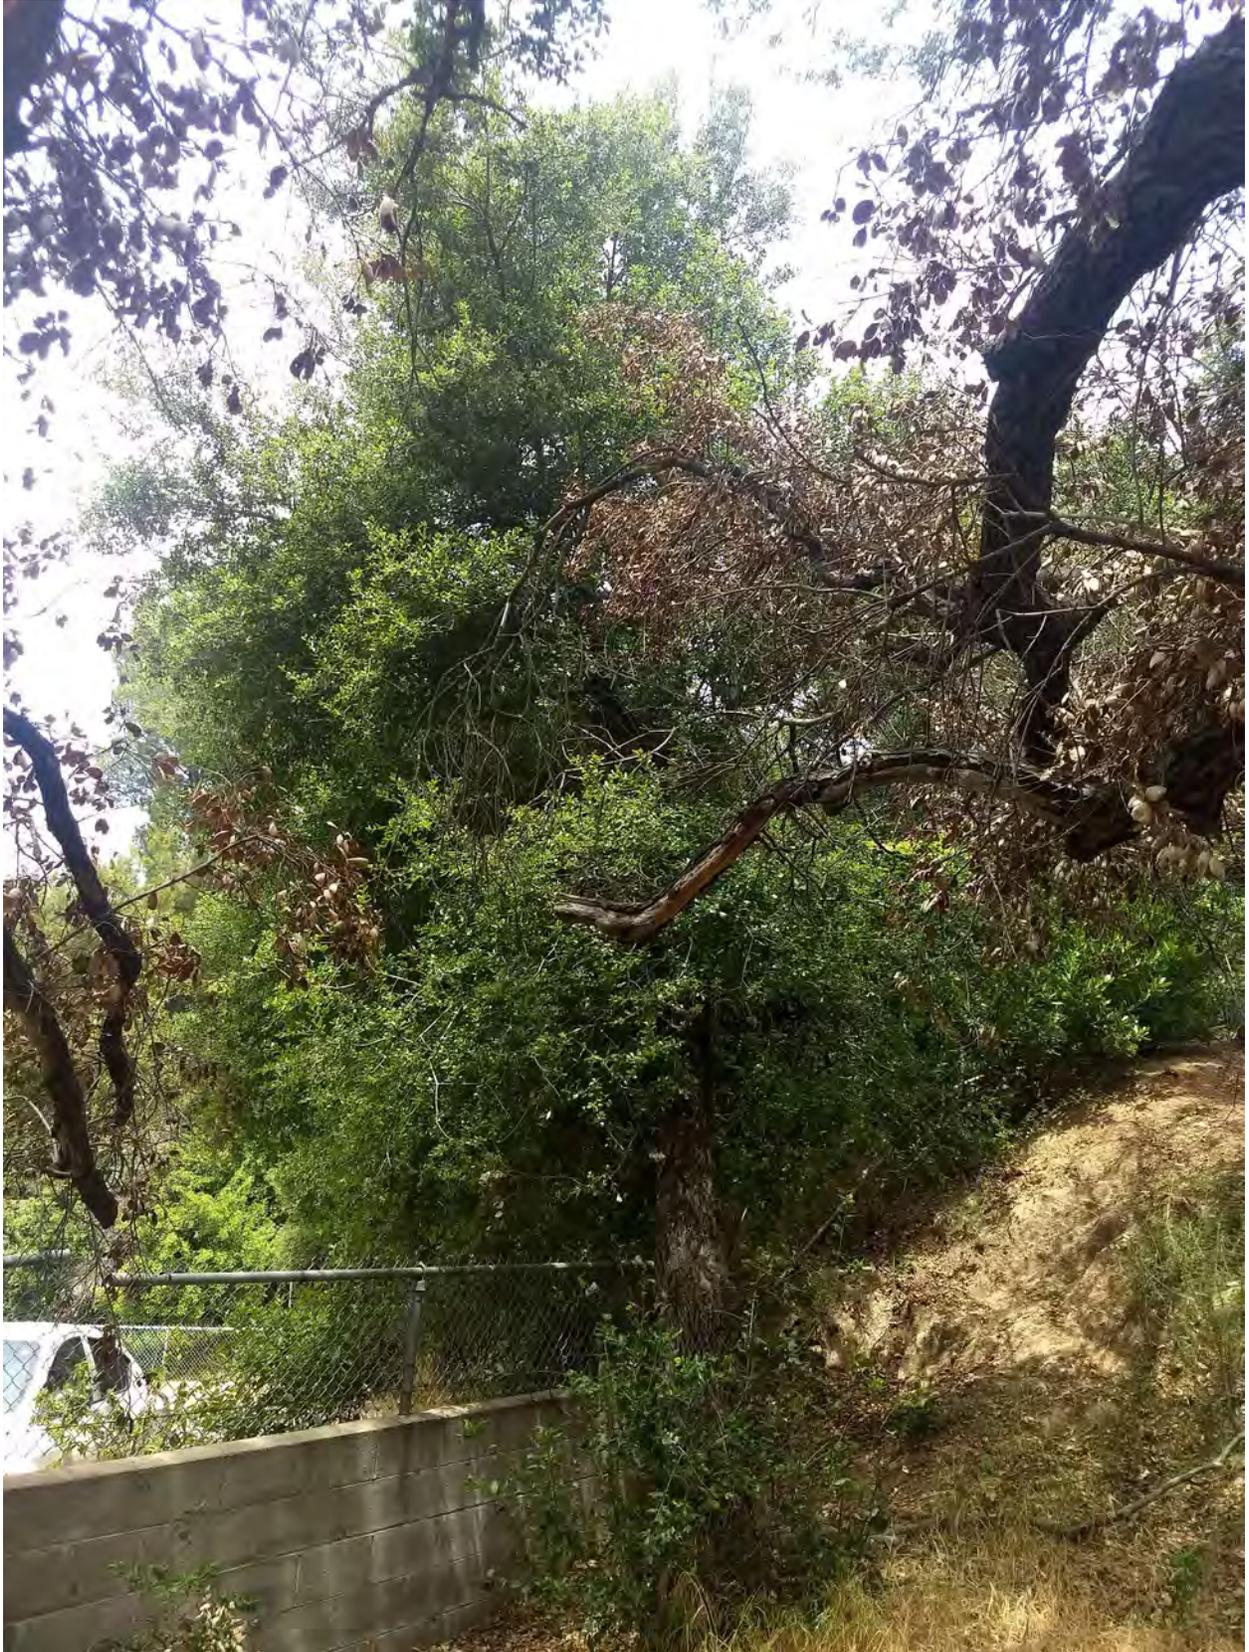
# Oak #25

It is unlikely that encroachment will result in the loss/death of any oaks, and all the encroached oaks would remain in place during and following construction. Typically, encroachment of 30% or greater into the trees TPZ would result in the death or significant decline of the tree. Oak #25 has an encroachment of 34.5% and the others are below 30%. However, oak #25 is suppressed by surrounding oaks and has a significant lean of the trunk onto the project site resulting in a TPZ that is within the proposed construction area. The area of encroachment into #25 TPZ is currently a parking lot, and the proposed construction would not result in additional encroachment because the area will remain as a parking lot or other developed area. Therefore, it is unlikely that encroachment into the TPZ of oak #25 would result in significant decline.

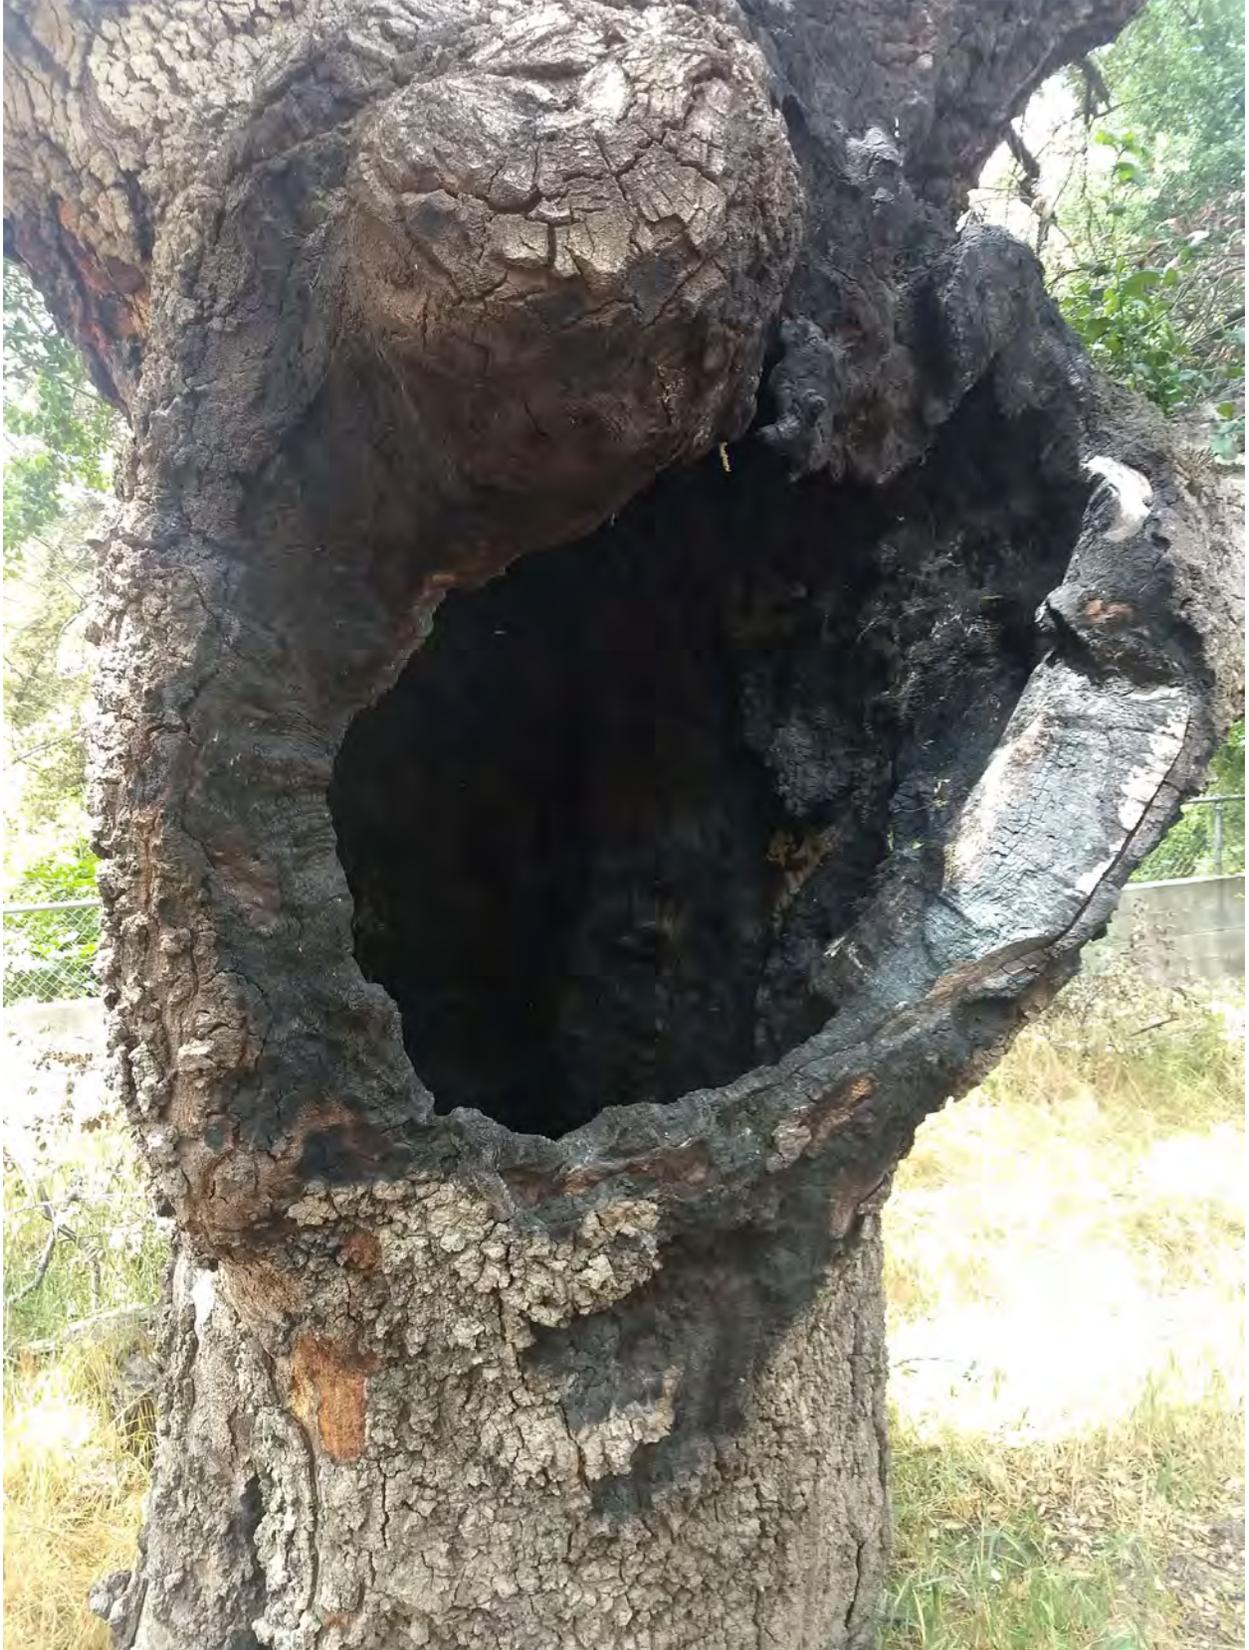
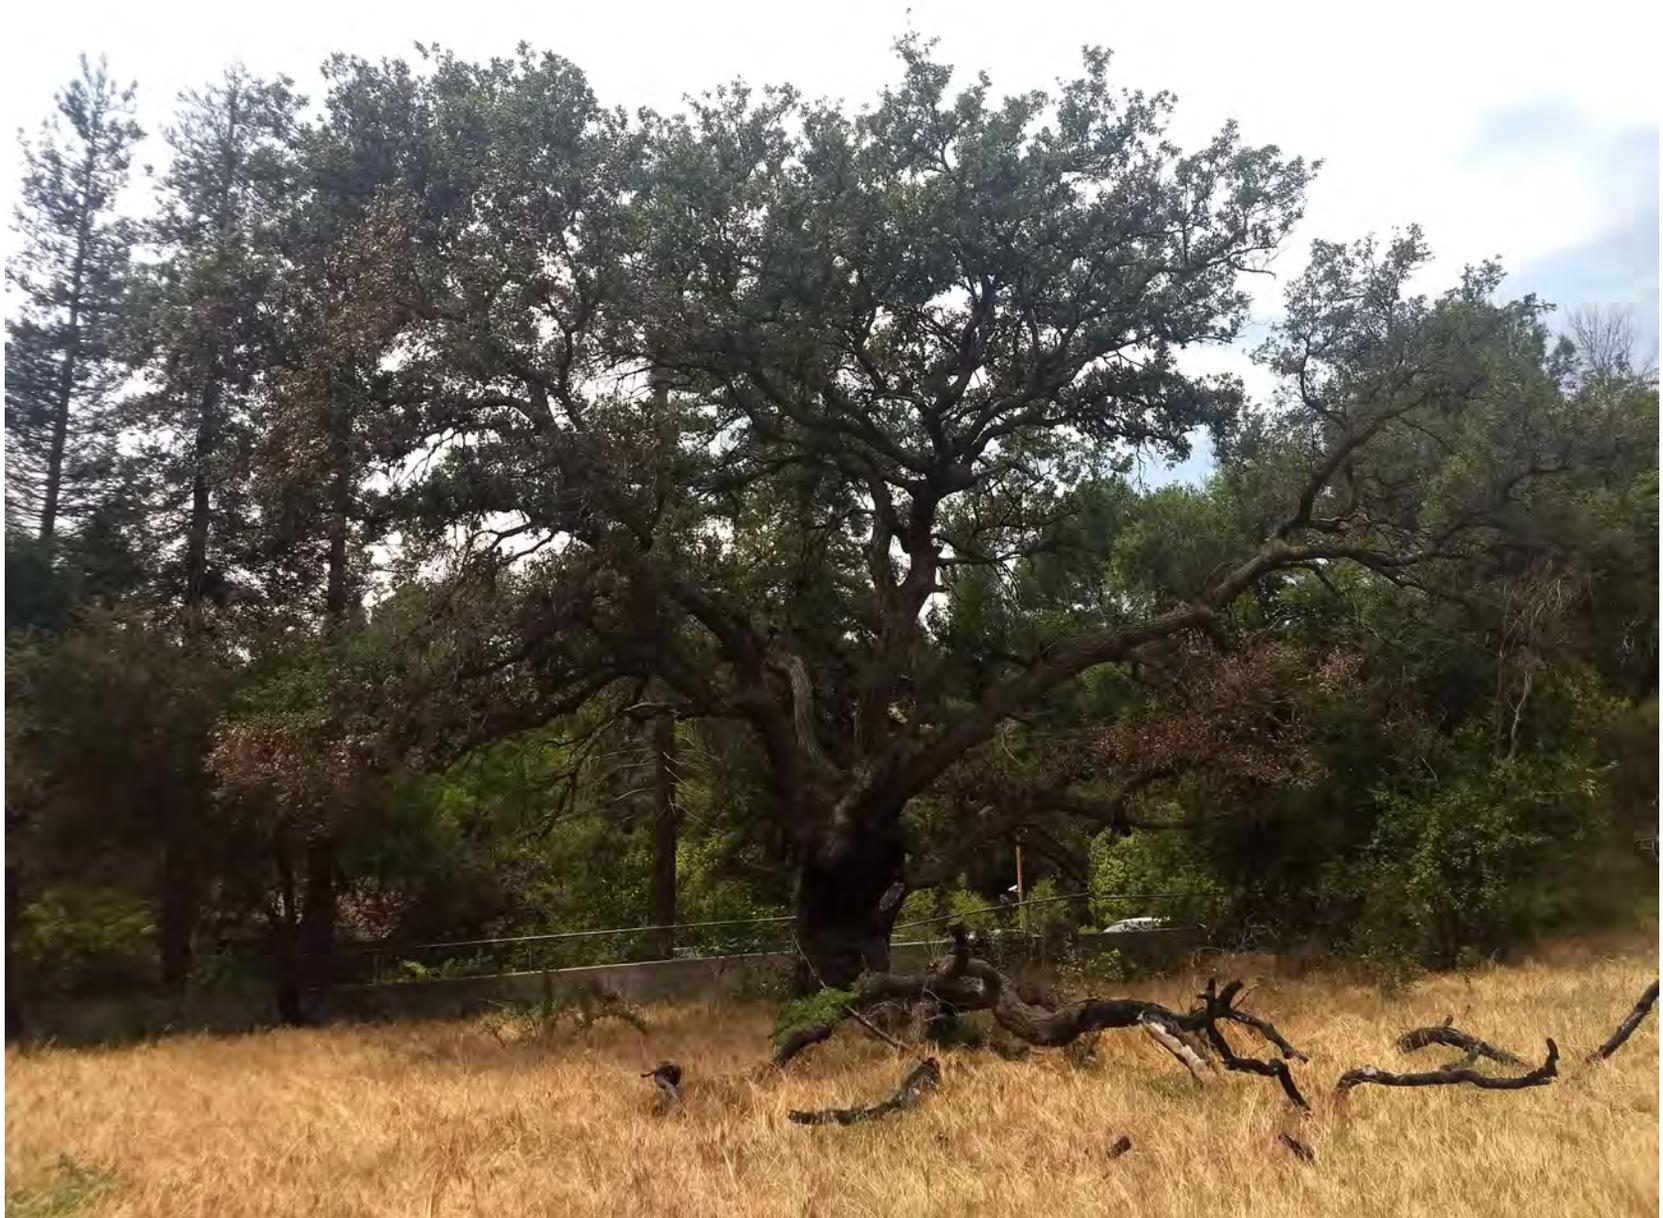
## Oak #26 (Hollow Trunk)

Tree #	Health Rating	Heritage Oak	Impact
#11	4	Y	Removal
#13	5		Removal
#15	1	Y	Removal
#16	5		Removal
#17	4		Removal
#23	3		Removal
#12	4	Y	26.1% TPZ Encroachment
#18	4		20.5% TPZ Encroachment
#19	4		17.9% TPZ Encroachment
#22	4		19.3% TPZ Encroachment
#25	4		34.5% TPZ Encroachment
#26	1	Y	6.1% TPZ Encroachment
#27	3		14.9% TPZ Encroachment
#28	3		19.4% TPZ Encroachment
#35	4	Y	6.9% TPZ Encroachment
#36	4		21.7% TPZ Encroachment

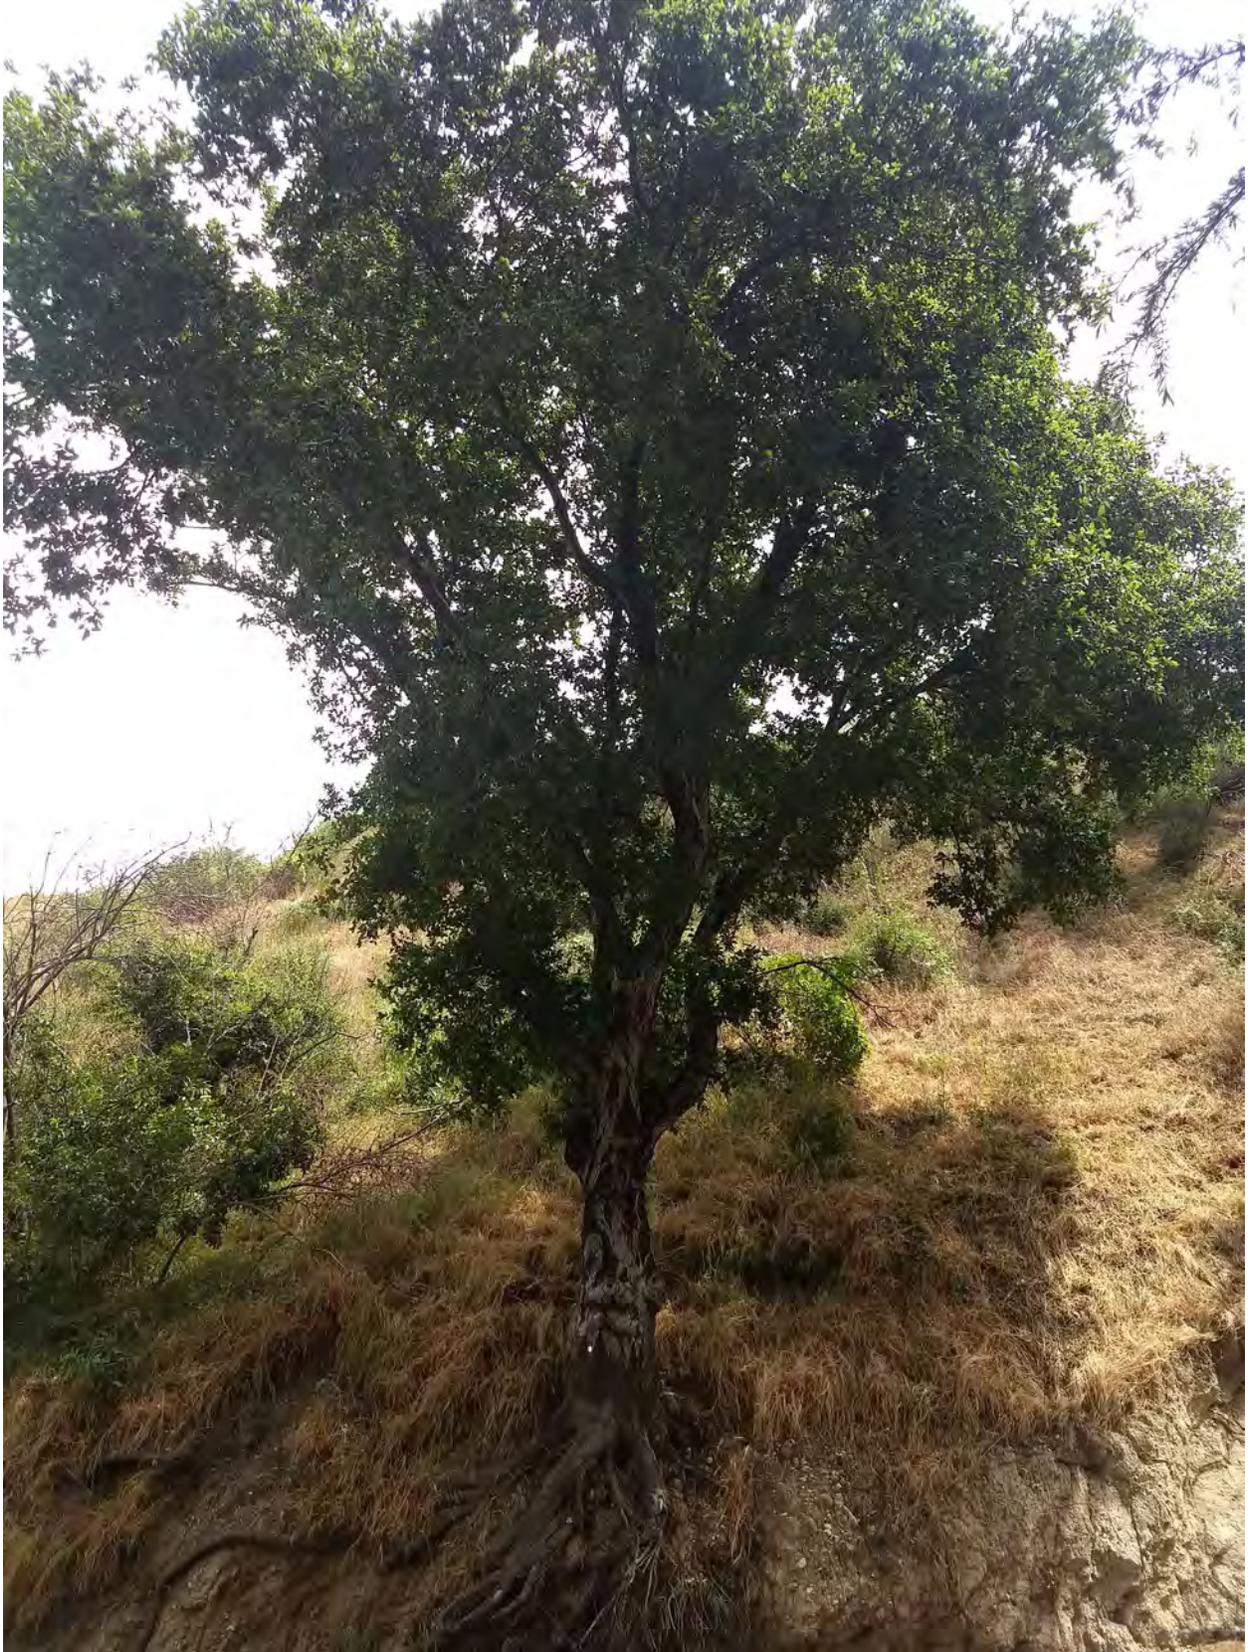
Oak #54

54	Coast	25	15	15								5					3	on road edge on cliff, exposed roots up to 6 ft
55	Coast	30	21	20								4		HR			4	
56	Can	45	65	25	20	25	35	40	20	12	20	4					4	burned, included bark, heritage oak
57	Can	30	22	22	3	5	10	12	20	20	20	3		HR		dead, thinning	3	burned, root rot and heart rot visible
