Jim Borer, Certified Arborist #496

January 3, 2022

Re: Existing Tree Inspection Report 18282 Philadelphia Street Whittier, Ca.

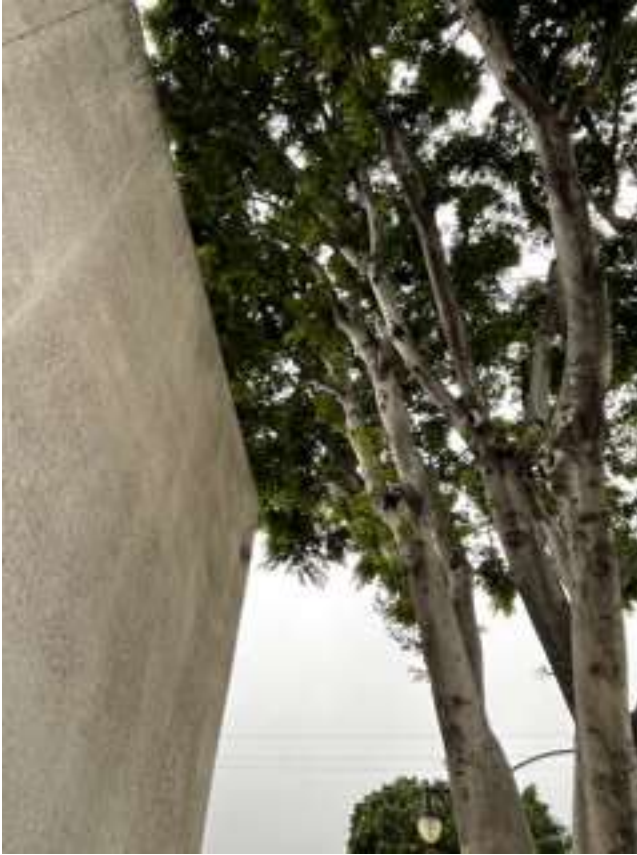
The canopies of tree numbers 1 and 2 have been pruned substantially but are still massive and broad in form and character.

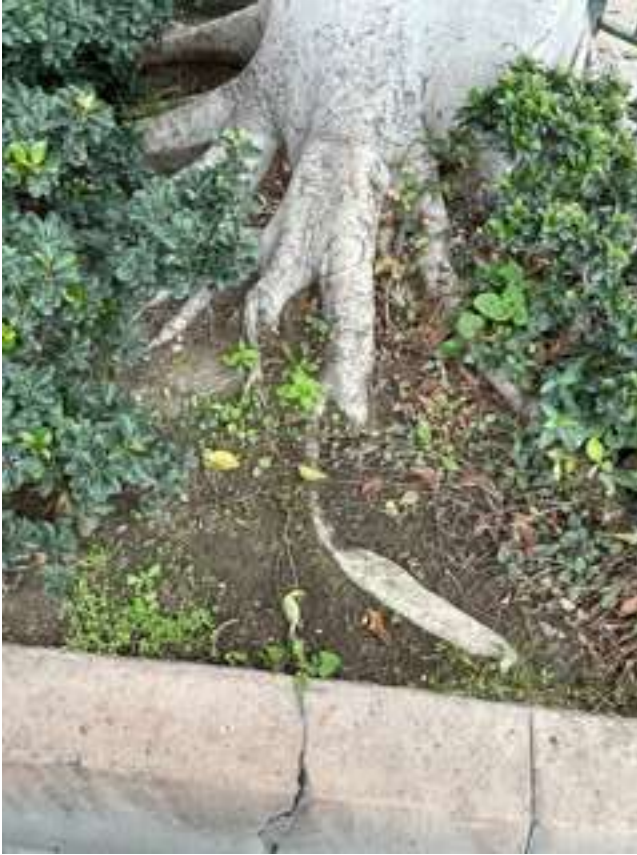
Surface roots extend outward for long distances in both open planters and beneath paved surfaces.

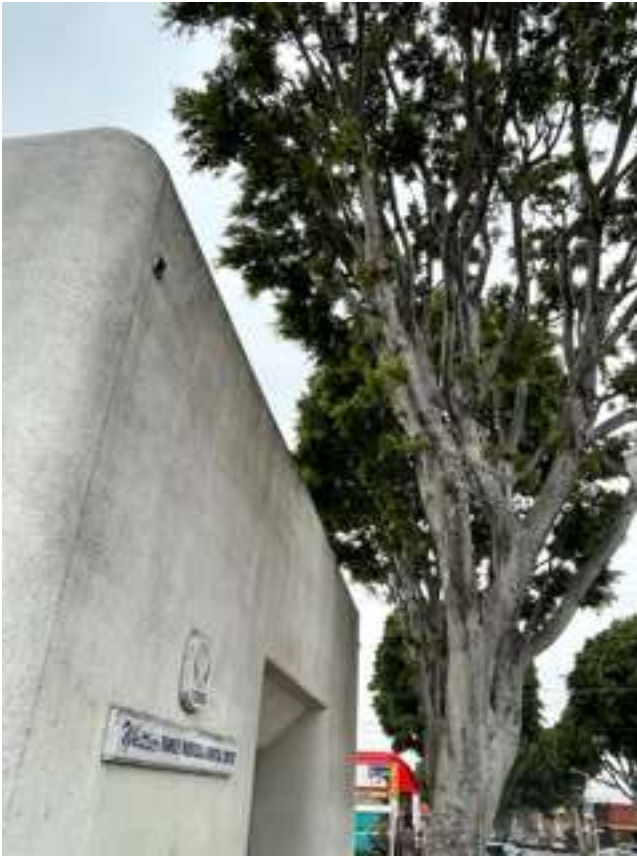
Tree number 2's canopy has been pruned yet hangs over the sidewalk and the building.

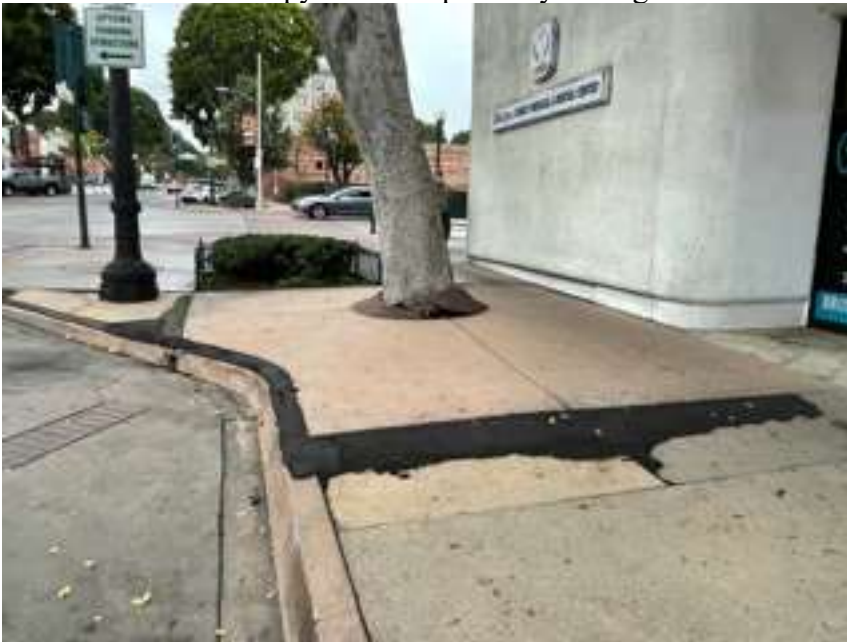
The black color ribbons are asphalt where the pavement has been uplifted by roots.

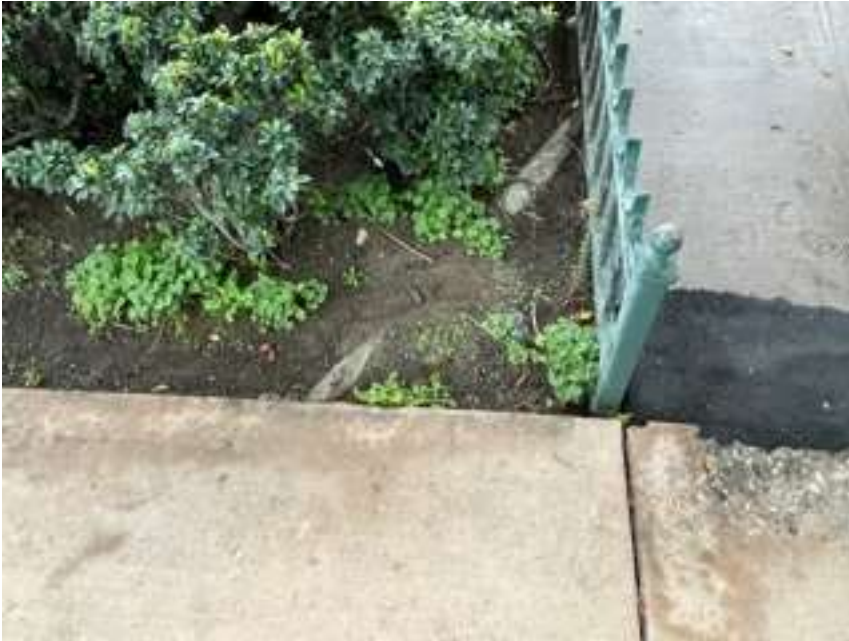
This picture depicts a root that is a good distance away from the tree's trunk on the soil surface.

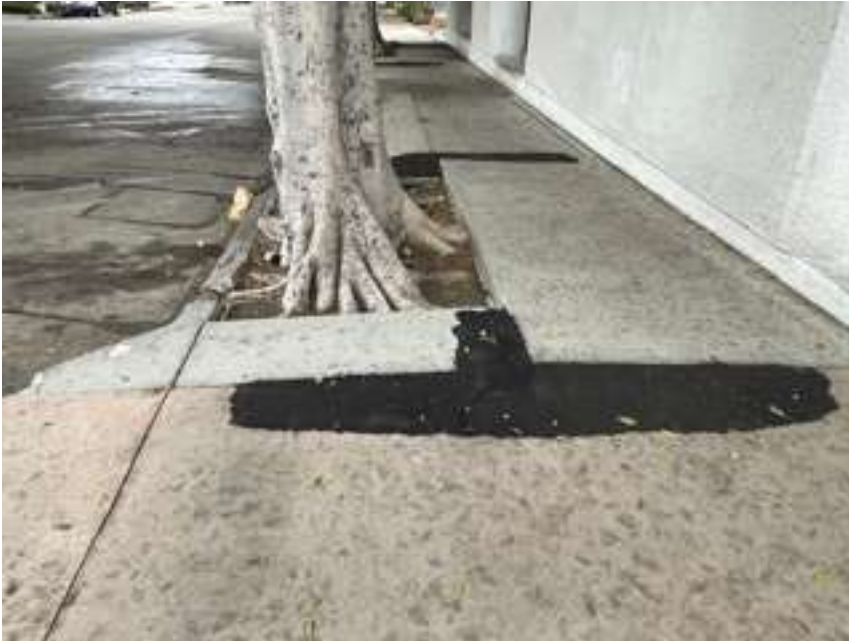
Tree number 3 with asphalt patches where it has grossly uplifted the adjacent sidewalk.

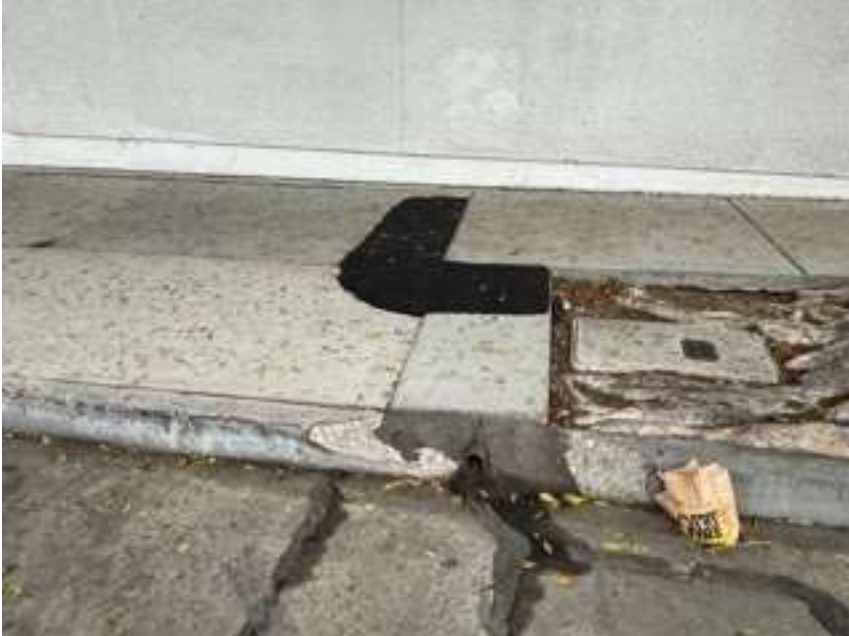
Tree number 3 at the eastern end of the planter frontage where it has been uplifted and patched.

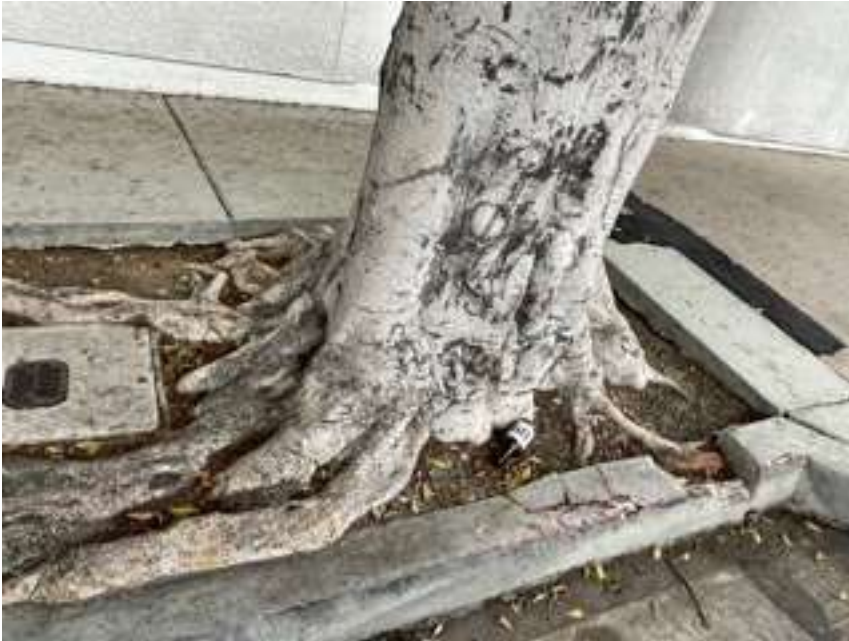
Tree number three where the curb along street frontage has been damaged by surface roots.

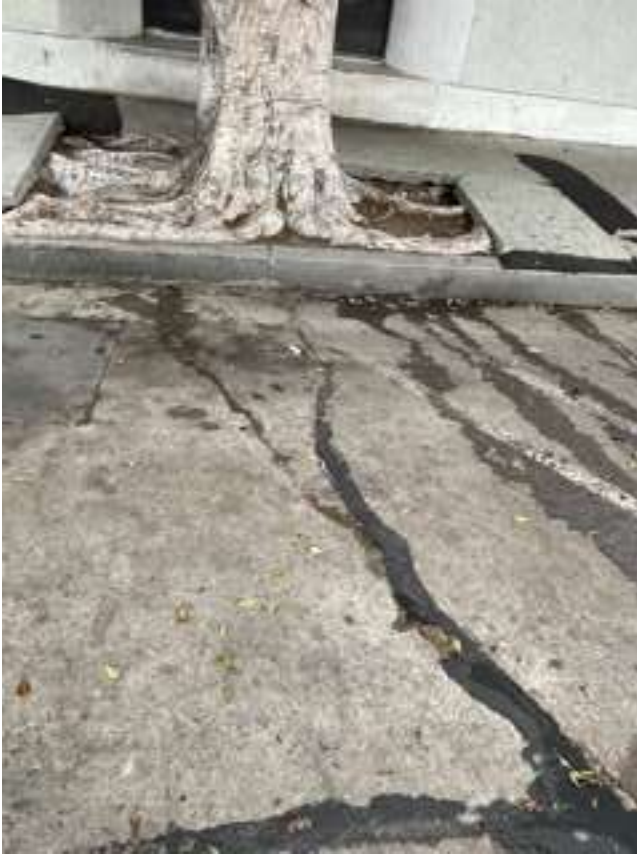
Fractured street surface adjacent to tree number four.

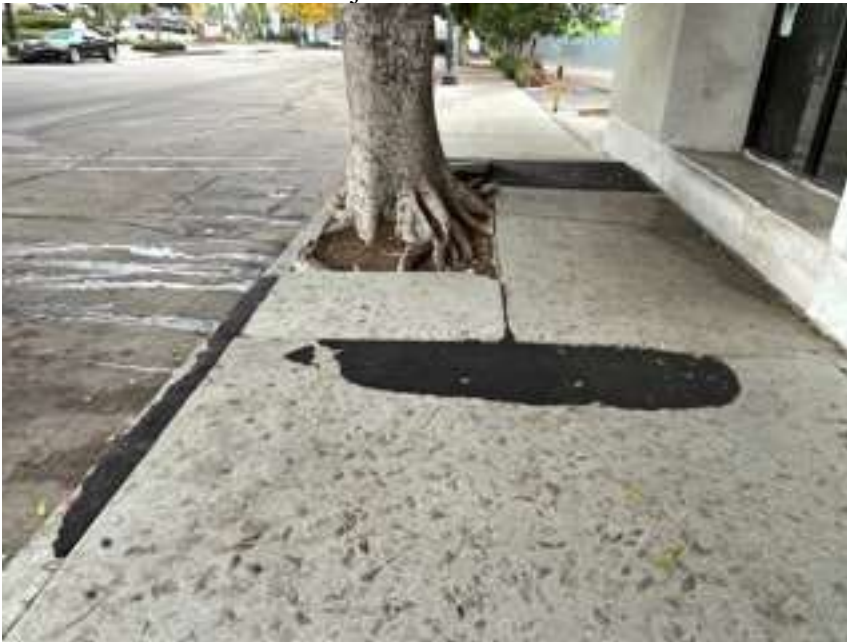
Tree number four where its surface rots have damaged adjacent sidewalk.

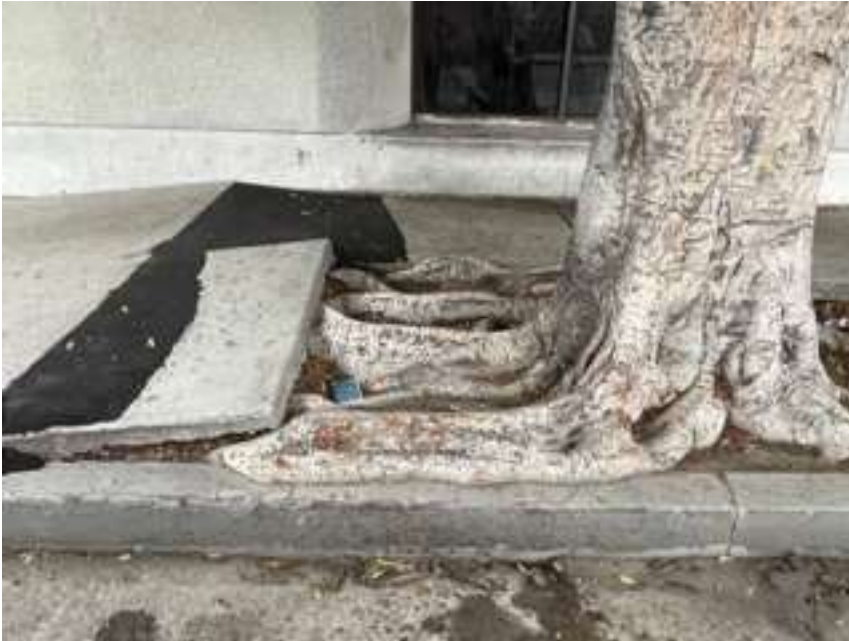
Tree number four where it has grossly uplifted sidewalk frontage.

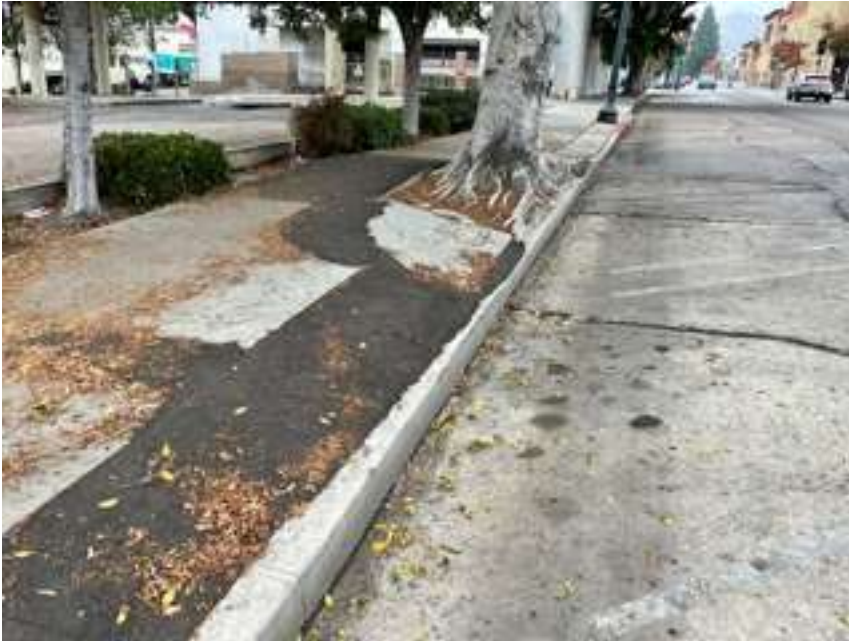
Tree number five where it has grossly uplifted the curb, sidewalk, and fractured adjacent street surface.

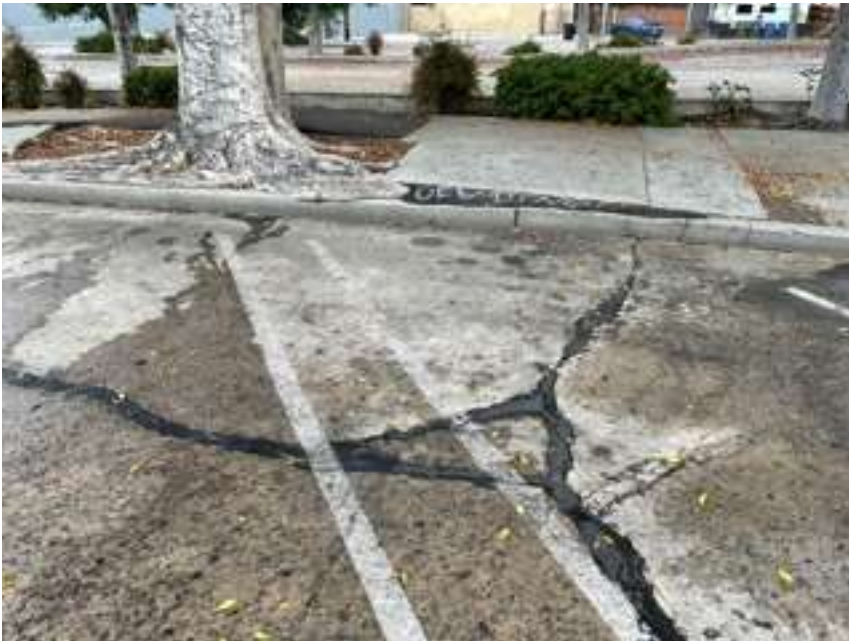
Tree number five uplifted adjacent street surface.

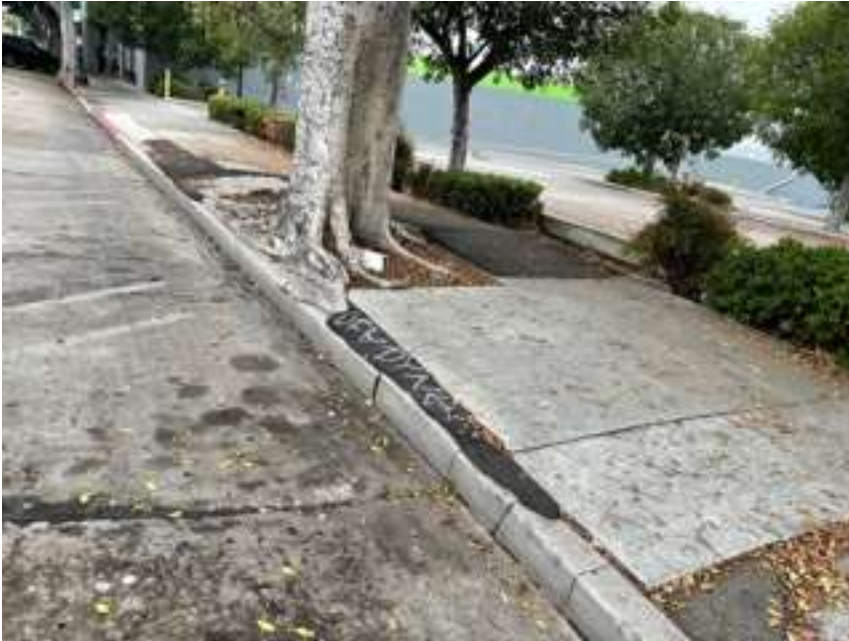
Tree number five overview of uplifting damage.

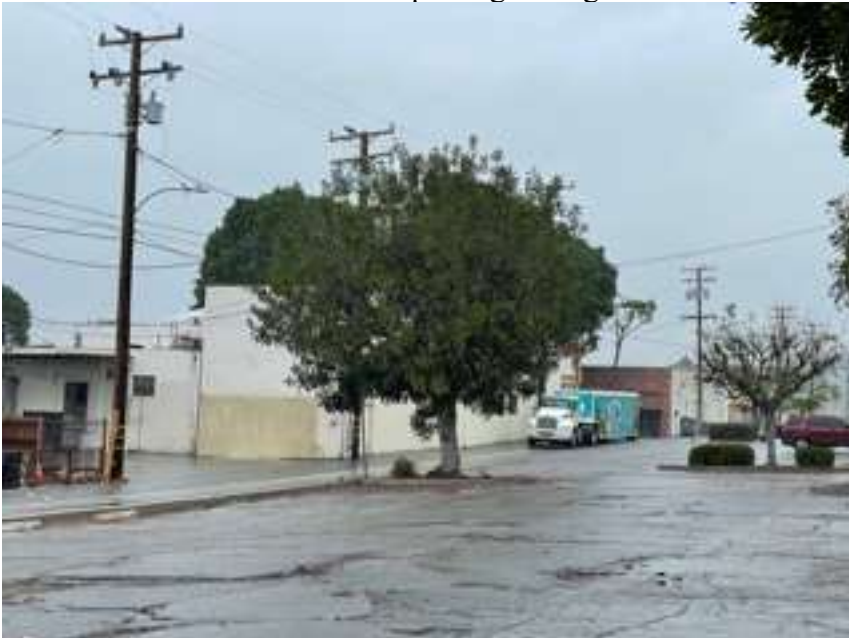
Tree number 16 is typically well foliage but inside of the dense canopy are profusions of twiggly branches where the woody branches were severely pruned irrespective of the presence of significant secondary branches that could have been reasonable places to perform the reductions..

16	<i>Cupaniopsis anac.</i>	carrotwood	14"	20' x 22'	Has been topped defects in branch Removal (severe decline)

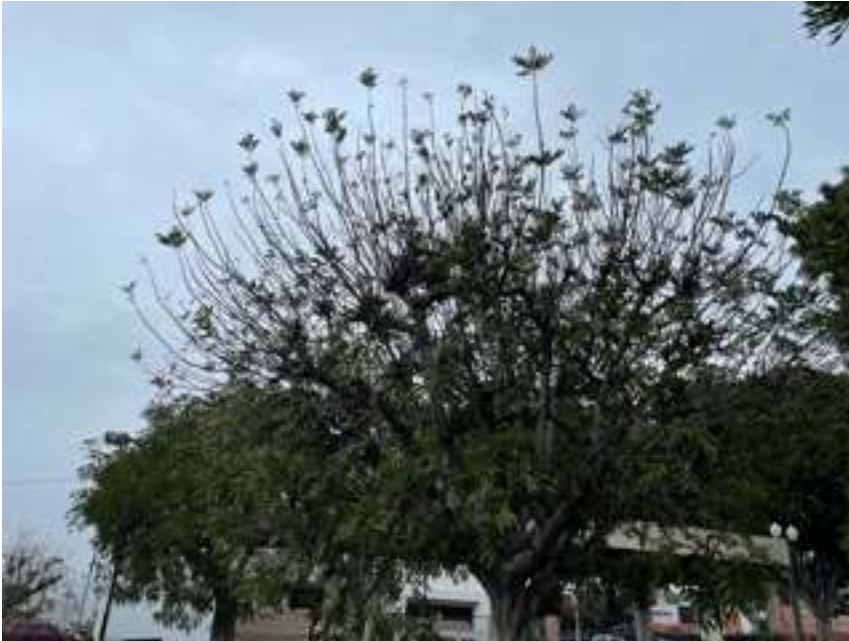
Decline of the systemic vigor is apparent in the uppermost canopy. The topping can be seen where the large woody branches end and develop into profusions of small diameter twiggy branches abruptly.

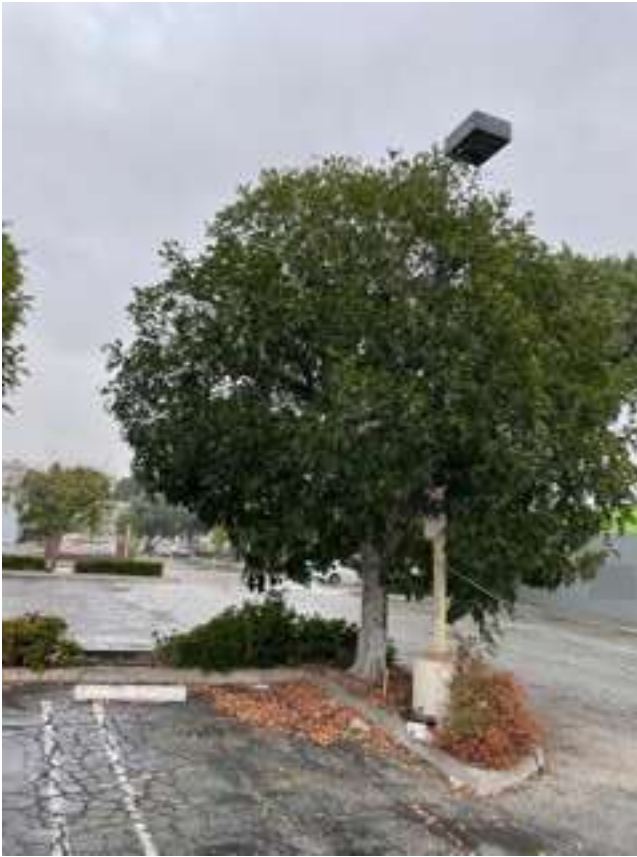
This tree's canopy is full but the trunk structure is in decline due to having been topped.

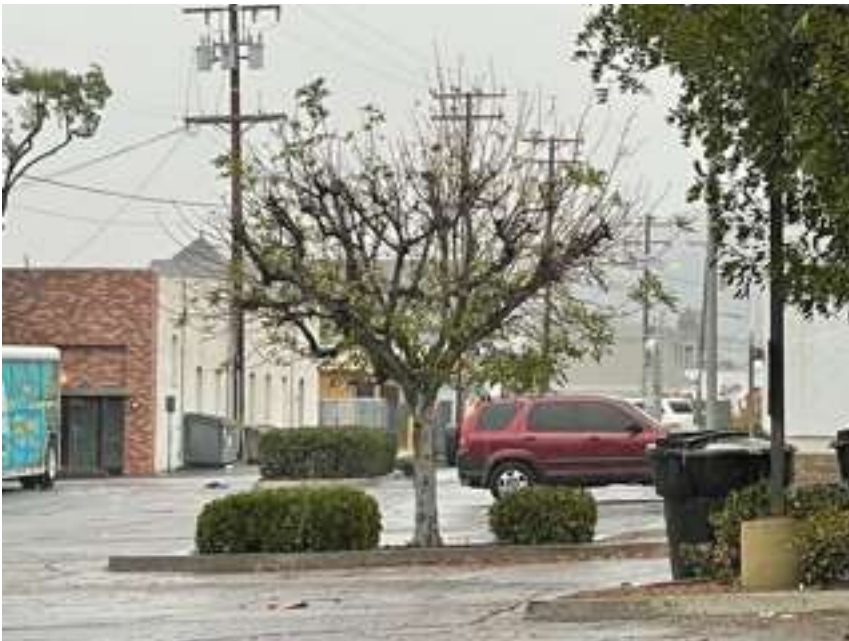
Tree number 17 exhibits severe systemic distress.

Removal
(severe defects)

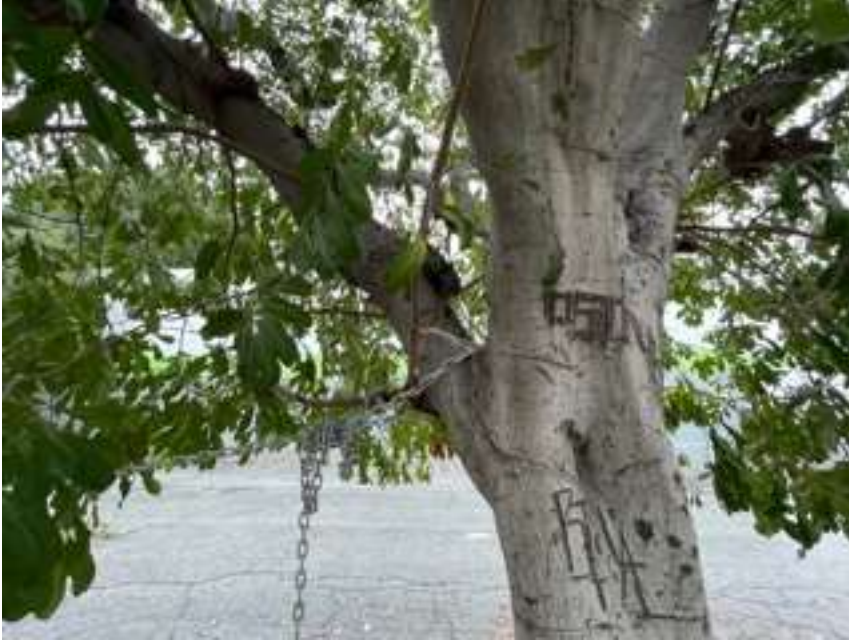
Many woody branches developing from a single point on the trunk are prone to failures.

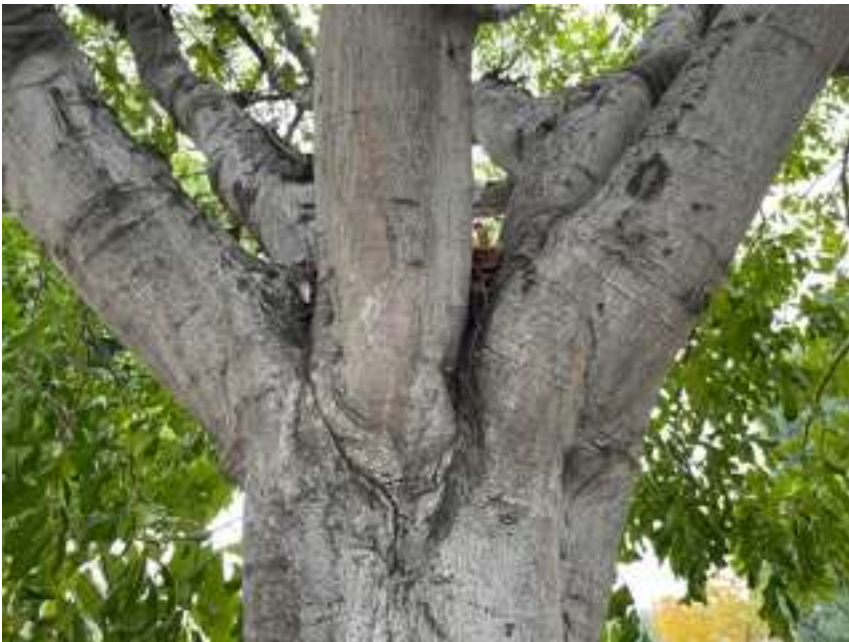
This photograph a typical condition of branch inclusion which is a defect that develops do to poor branch development patterns in early stages of life as an urban tree.

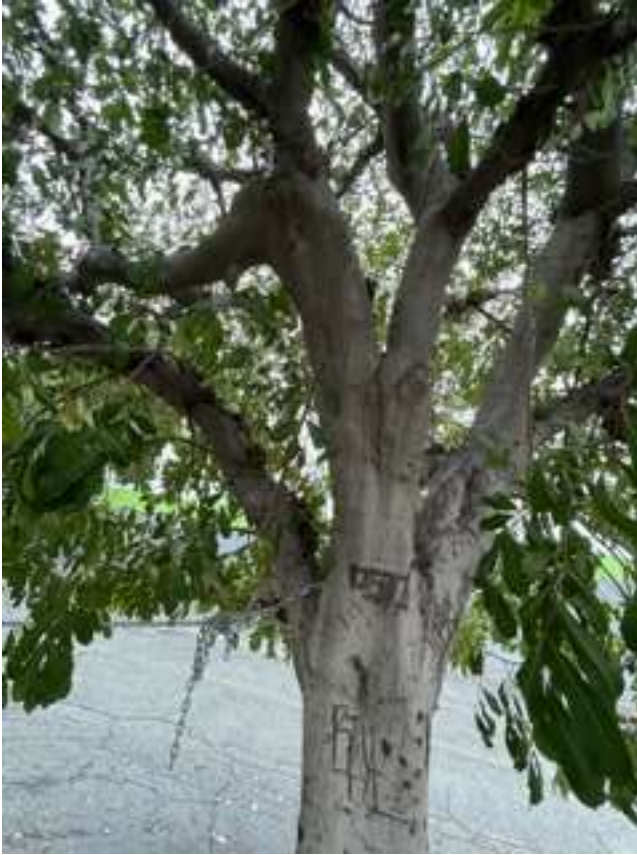
The affects of inclusion are that the secondary growth of woody branches eventually frces branch shear failures.
