Appendix B

Arborist Report

June 7th, 2021, Revised August 24th, 2021

Site: 575 Los Trancos Road, Palo Alto CA

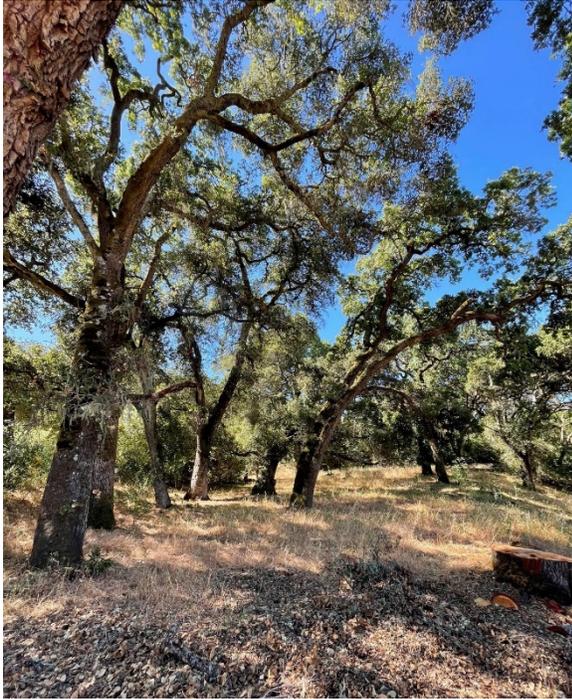
Showing oak tree #47

Coast live oak tree #47 is dead. The tree should be removed as soon as possible as it is a fire hazard for the site.

Coast live oak tree #47= 60’ wide canopy

Replacement trees= The tree is dead. No replacement trees are recommended.

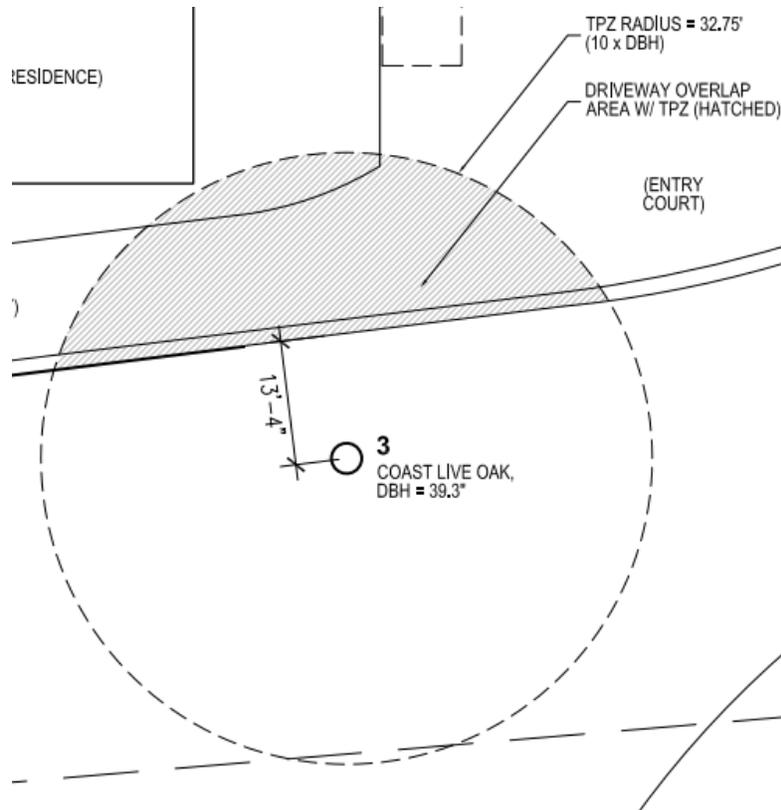
Showing percentage of root zone impacted for Oak tree #3

Coast Live Oak tree #3 is the closest tree to the proposed driveway. At 10 times the tree’s diameter the tree protection zone radius is 32.75 feet or a 3370 square foot area. The proposed driveway and retaining wall overlaps this area by 838 square feet. The tree’s root zone will be encroached by 24.9% as shown in the provided diagram below. This is within Best Management Practices acceptable threshold for a species with a good tolerance to construction impacts and in good condition (or 25%). The recommendations stated in the last paragraph will help to keep impacts at a minor level. This tree is also recommended to be deep water fertilized anytime between fall and early spring.

TREE #3 PROTECTION ZONE AREA = 3370 SF

DRIVEWAY OVERLAP AREA = 838 SF

TPZ % OVERLAP = $838 / 3370 = 24.9\%$
