Kielty Arborist Services LLC

June 21st, 2022

Site: Block 21 Project, San Mateo CA

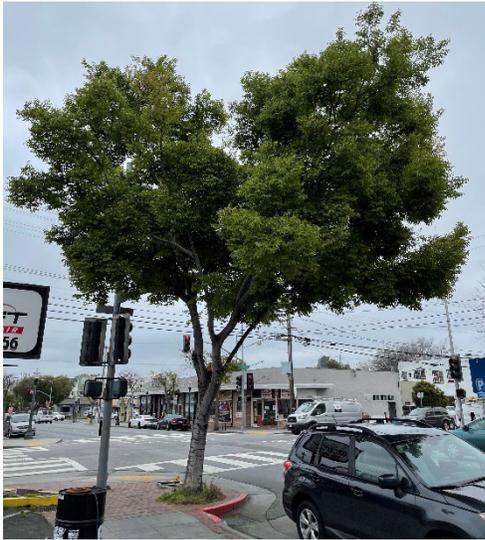
Showing Hackberry street tree #1

Trees #1 and #2 are Hackberry street trees. Both trees are in fair condition. The trees are located within the sidewalk in a small street tree planting pit surrounded by a metal grate. This species is known for aphids that produce copious honeydew excretions upon which blackish sooty mold grows creating a sticky mess on leaves and surfaces beneath infested trees. Systemic insecticides are generally used to control the problem.

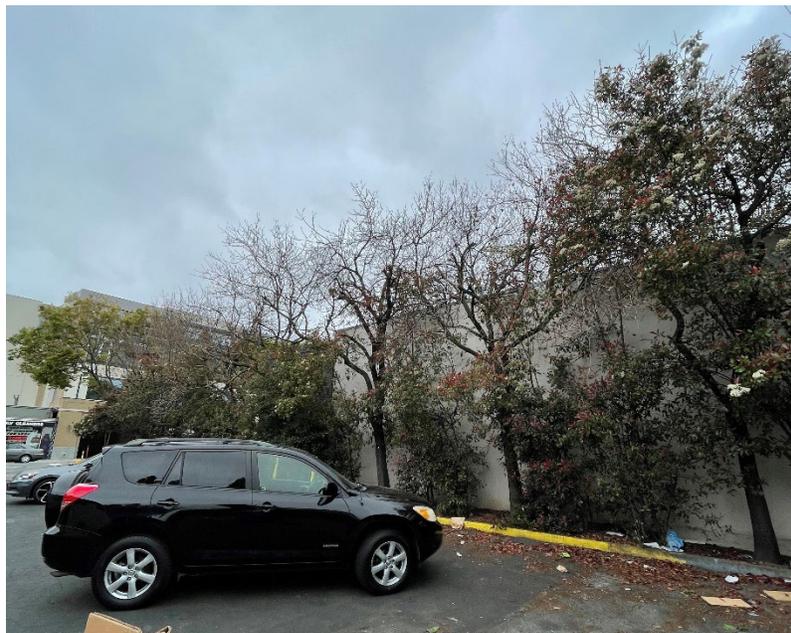
Showing trees #3-23

Trees #3-9 consist of Chinese Pistache trees that are in poor condition. The trees were given a poor condition rating as they have been topped in the past. The trees are located in a small planting strip between the adjacent neighboring building and the asphalt parking lot. Topping trees is not an approved practice due to risk of future limb failure, decay at the cut, weakening of roots, and constant pruning that is needed after such cut.

Trees #10-23 consist of Photinia trees/shrubs that are in poor condition. The photinias were planted in between the Chinese Pistache trees. All of the Photinias are codominant at grade with multiple trunks. They are growing in suppressed conditions caused by the Chinese Pistache trees.

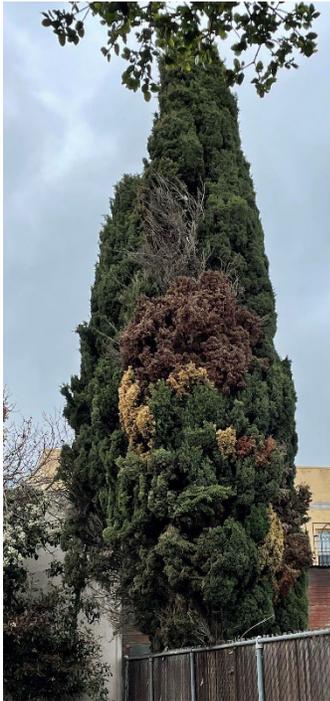
Italian Cypress trees #24-27, 29, and 30 are in poor condition. Cypress trees #29 and #30 are dead with Cypress tree #27 nearly dead due to Seiridium Canker disease. The remaining cypress trees are infected with Seiridium Canker disease with large areas of canker disease caused die back observed. The cypress trees are all located on the adjacent neighboring property at the property line and are likely considered to be a shared tree.

Showing large areas of canker caused die back

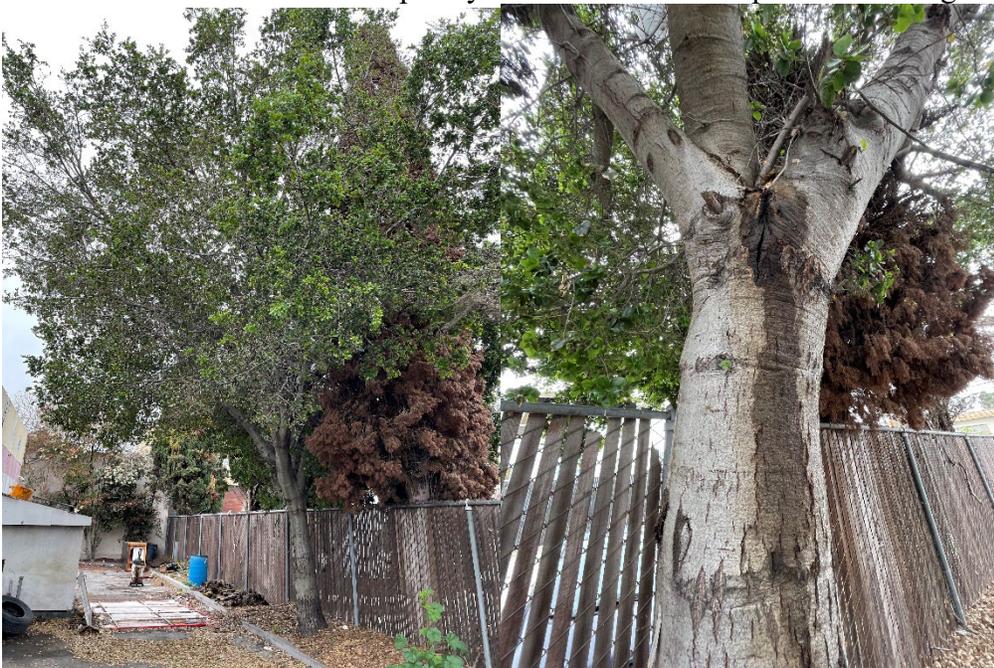
Showing Oak tree #28

Coast Live Oak tree #28 was given a fair condition rating. The tree has poor form as the tree is codominant at 7' with included bark observed. A bleeding canker was also observed at the codominant union. The tree is poorly located with hardscapes surrounding the tree on all sides.

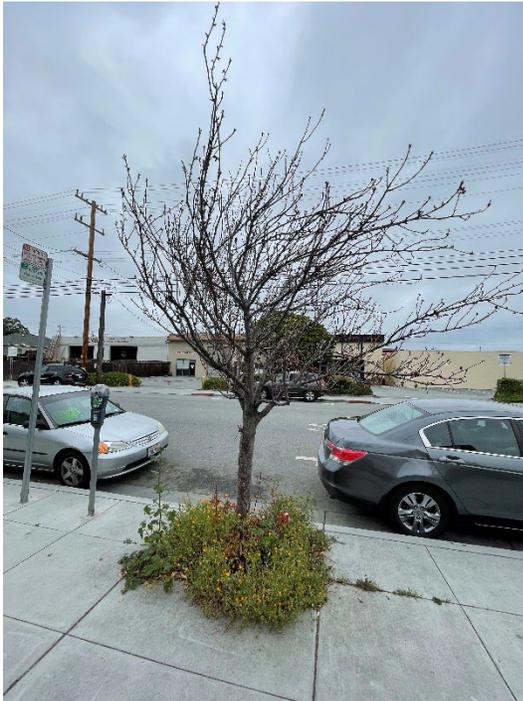
Showing Cherry street tree #31

Cherry tree #31 is in fair condition. The tree is a street tree located along Claremont.
