**RINCON PHASE 2 DECOMMISSIONING PROJECT –
EVALUATION OF EFFECTS AND EFFECTIVENESS OF THREE DIFFERENT TREATMENTS OF STATE
COASTAL CONSERVANCY PARCEL AT PUNTA GORDA,
VENTURA COUNTY COAST**

**GARY GRIGGS
CONSULTING COASTAL GEOLOGIST
321 ALTA AVENUE, SANTA CRUZ, CA. 95060
(831) 332-9318 – GRIGGS@UCSC.EDU**

INTRODUCTION AND SCOPE OF REPORT

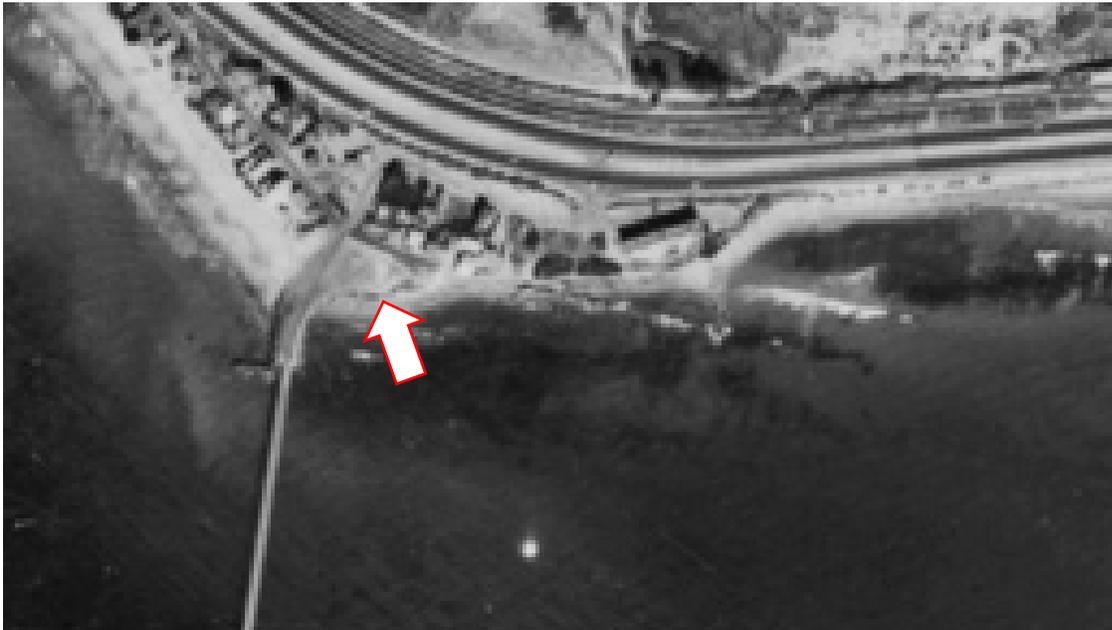
Figure 7. State Coastal Conservancy parcel in 1963 following 1959 construction of abutment and causeway. Dark area along the shoreline (arrow) appears to be rip rap that was placed in an arc extending from the abutment downcoast along the back beach.

The concrete abutment and protective revetment along with the causeway and island were constructed in 1959, although the aerial photograph from that year is of poor quality. By 1963, the shoreline next to the causeway abutment had retreated a total of about 160 feet (Figure 7). The seaward edge of the flatter upper surface of the parcel appears to be an eroded scarp. Eight years later, in 1971, the riprap is more evident and extends in an arc eastward for about 135 feet from the abutment across the downcoast shoreline (Figure 8).

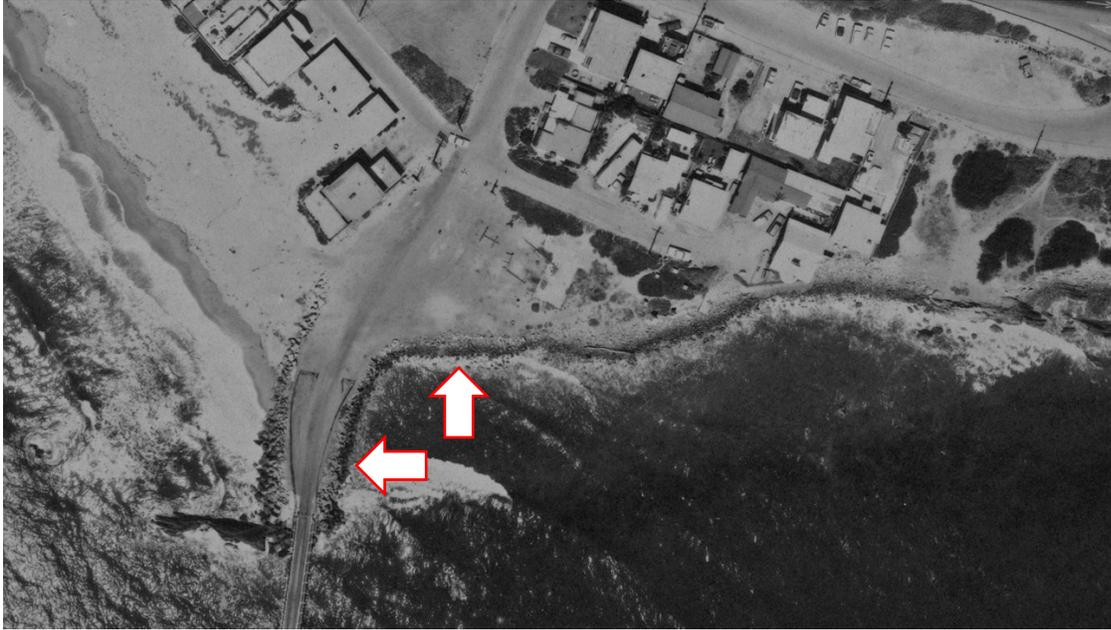
Figure 8. State Coastal Conservancy parcel in 1971 with riprap armoring the right side of the abutment and continuing downcoast in an arc along a portion of the shoreline (arrows).

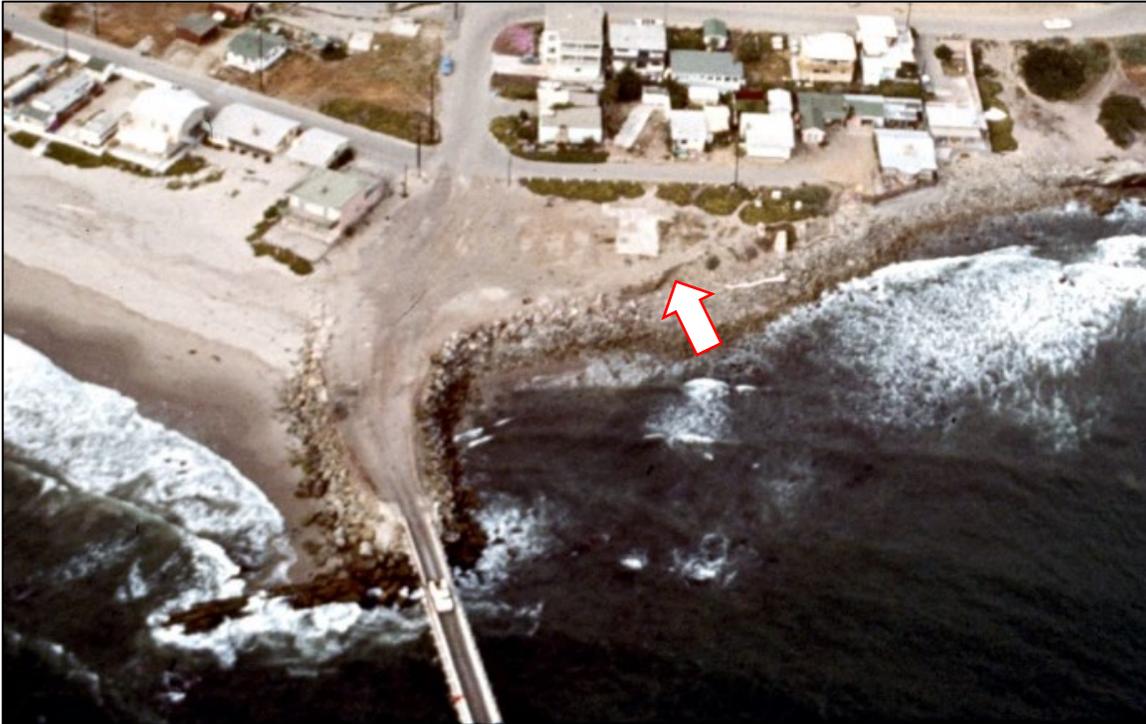
The 1972 oblique aerial photo illustrates a difference or contrast between the rock (riprap) adjacent to the abutment and what appear to be smaller cobbles scattered across the shoreline to the east (Figure 9). The cobbles have been overtopped and erosion has produced a scarp in the shoreline on the eastern side of the SCC parcel (Figure 9). It appears that the upper flat portion of the site is being used as a staging or storage area at this time. The 1987 aerial photo shows little additional shoreline change in this area (Figure 10).

Figure 9. SCC site in 1972. The downcoast or eastern side of the parcel shows a rocky beach but no riprap and a scarp that has been eroded into the low unarmored bluff (arrow) (California Coastal Records Project - Kenneth and Gabrielle Adelman).

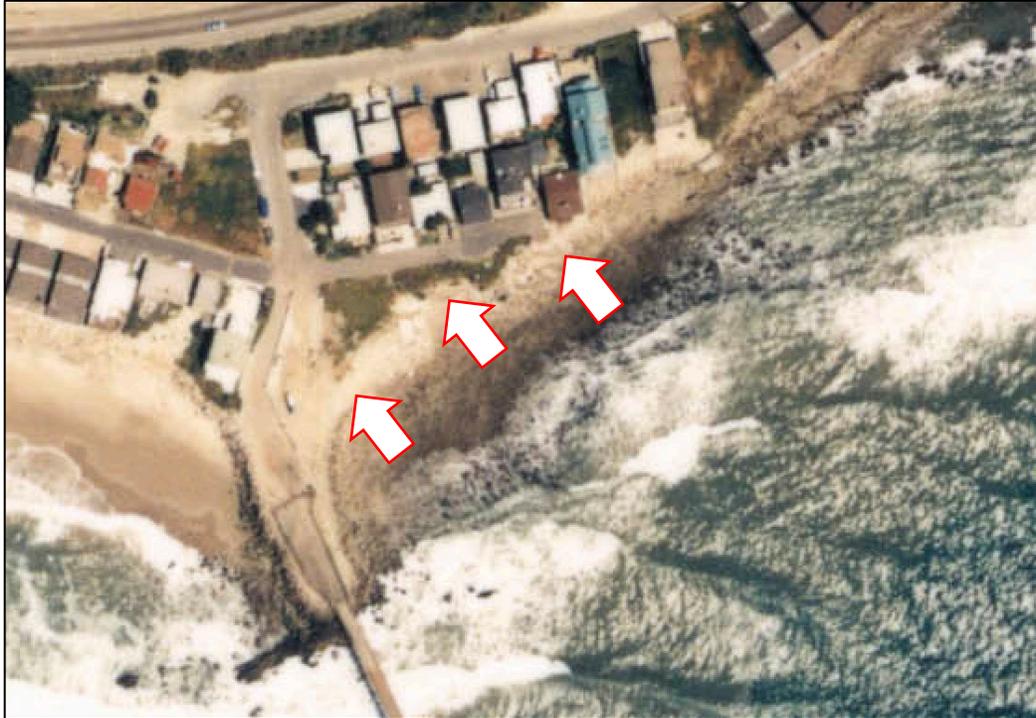
While riprap was placed completely around the concrete abutment and in an arc downcoast, by the time of the 1993 vertical photograph, some of the riprap appears to have spread or collapsed onto the beach and bluff edge has been eroded back, narrowing the flatter upper portion of the parcel (Figure 11).

Figure 11. 1993 photograph. Recent wave action appears to have overtopped and moved the riprap seaward and eroded the coastal bluff landward at arrows.

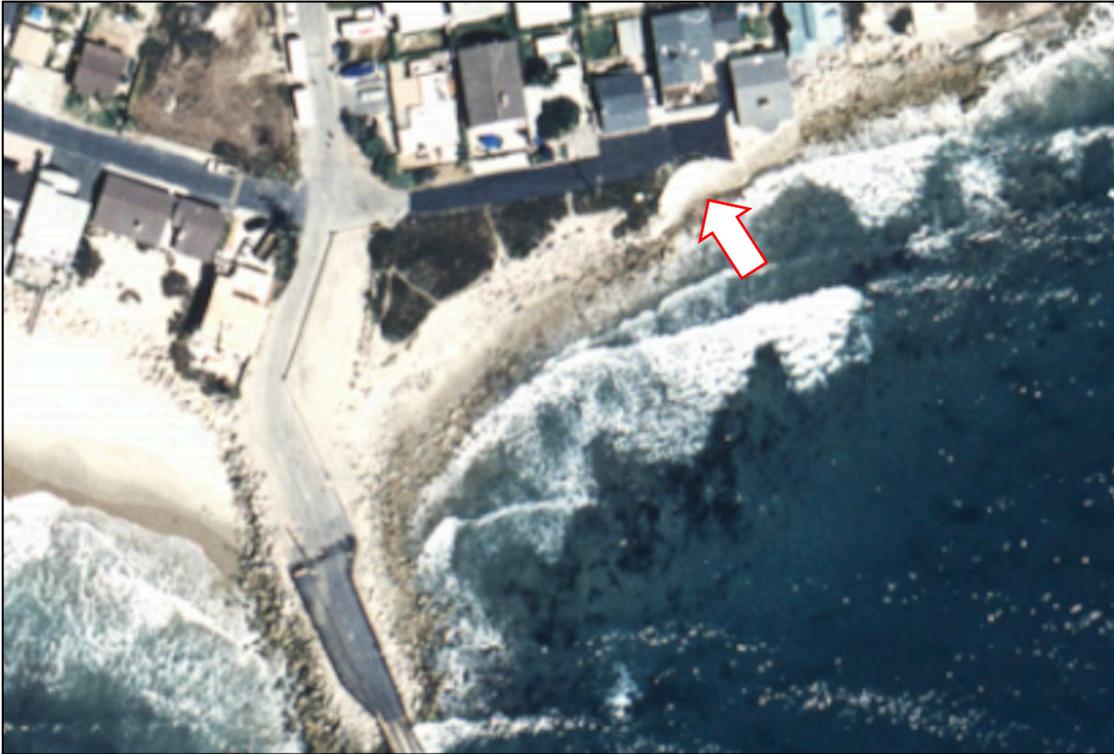
Eight years later in the 2001 aerial image, the riprap and rock along the shoreline has developed an arcuate profile and no additional erosion had taken place. A curved face concrete seawall has also now been built on the far eastern end of the SCC parcel to protect the house directly inland (Figure 12).

Figure 12. 2001 photograph showing eroded shoreline and curved-face concrete seawall at eastern edge of parcel (arrow).

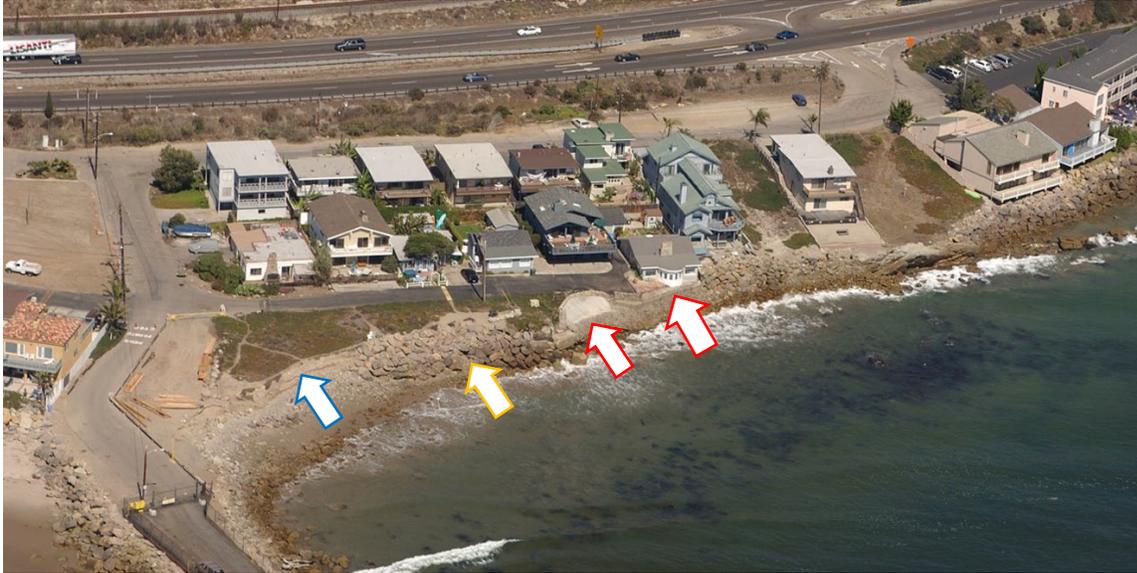
Figure 13. 2002 photograph showing two concrete seawalls at downcoast end of SCC parcel (red arrows) and riprap now added upcoast of the seawalls (orange arrow). The low bluff is now fronted with a scarp along its entire western section (blue arrow) (California Coastal Records Project – Kenneth and Gabrielle Adelman).

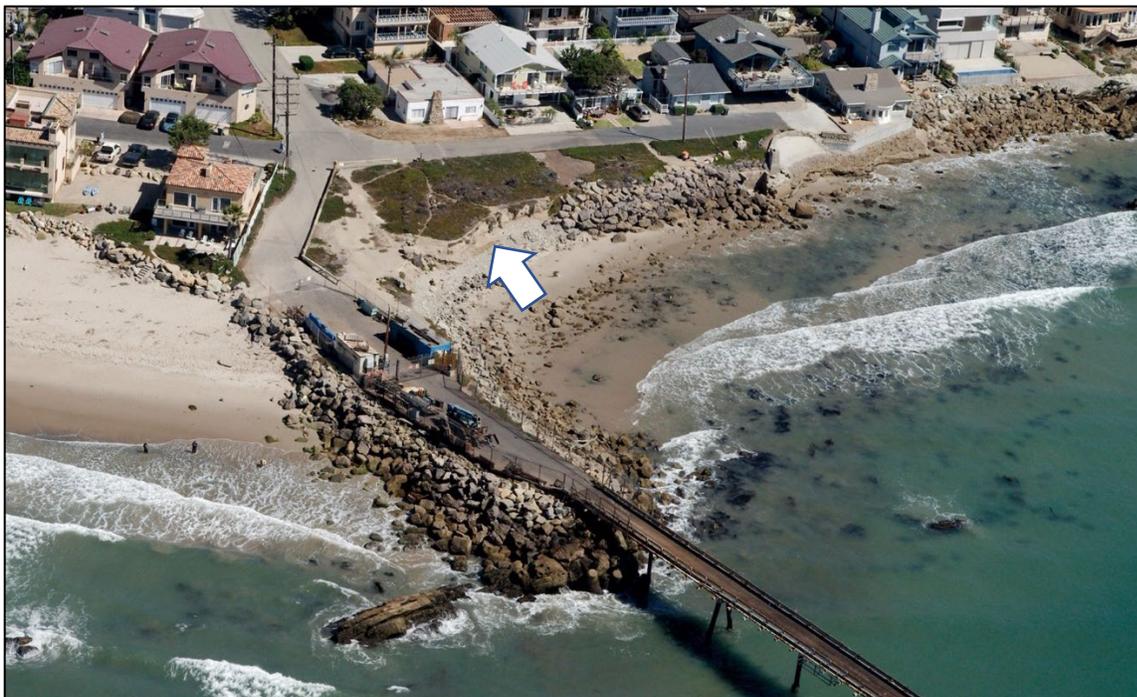
The most recent aerial photograph from the California Coastal Records Project (2013) shows some settling of the riprap along the abutment and seaward migration of the downcoast riprap. There doesn't appear to have been any additional retreat of the unprotected bluff immediately downcoast (Figure 14). It is likely due a combination of the 1) scattered rock along this unprotected rocky shoreline that disperses some of wave energy, and also 2) the wave shadow or protection offered by the causeway abutment to waves, such that any high energy waves from the dominant southwest sector undergo refraction and therefore lose energy before reaching the shoreline.

Figure 14. 2013 image of SCC parcel. The main section of eroded bluff backs the shoreline that is not armored (arrow). Original riprap adjacent to abutment has partially collapsed onto the beach (California Coastal Records Project – Kenneth and Gabrielle Adelman).

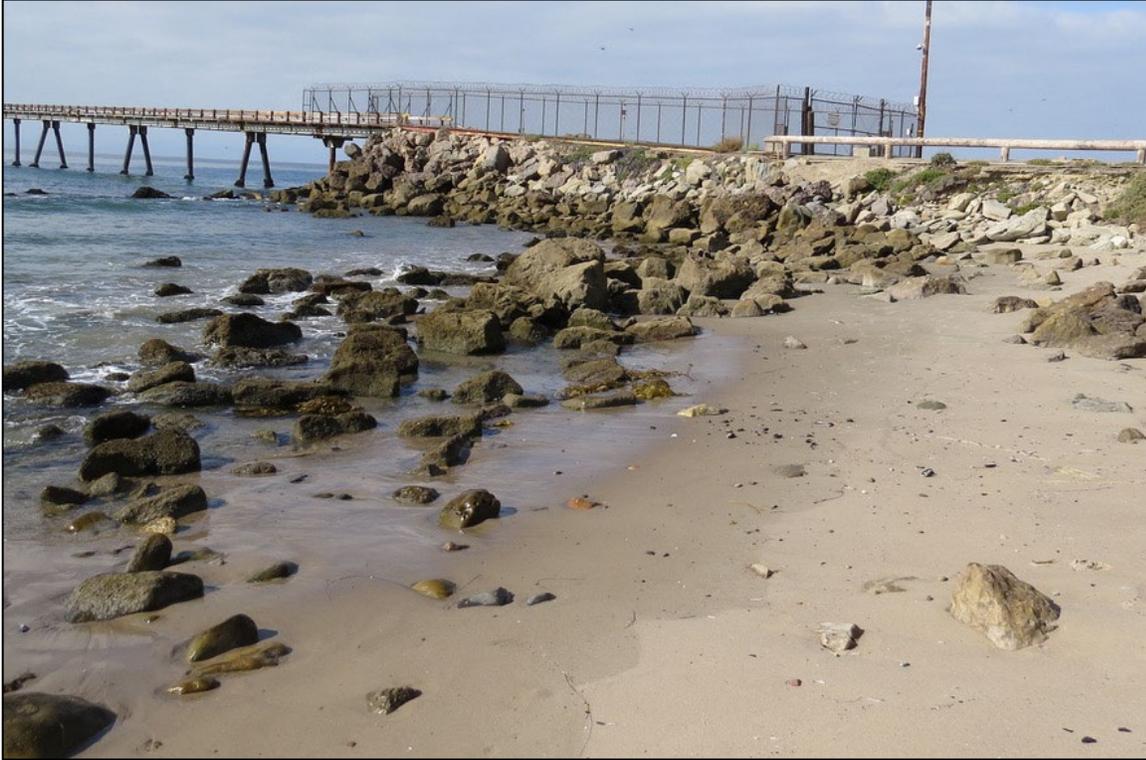
A field investigation on October 2, 2022, indicated that the Study Area contains a sandy beach with discontinuous boulders along the shoreline that have moved downcoast and seaward from the original 1959 causeway revetment (Figure 15). These boulders are of the same rock type as those flanking the abutment, so are what are referred to as "fugitives", or rocks which have moved from their original placement locations. These provide evidence for the forces that waves can exert, even on large riprap, at this location.

Figure 15. October 2, 2022, view towards the abutment and causeway showing riprap that has migrated east or downcoast since original emplacement in 1959.

The failed and scattered riprap along the shoreline immediately east of the abutment was likely due to either 1) outflanking on the unprotected downcoast end where erosion then led to collapse of the rock originally stacked against the low back beach bluff, or 2) wave overtopping of the riprap under conditions of high tides and large waves, which led to shoreline erosion and loss of support for the rock. Any additional riprap added along this unprotected section of shoreline would need to be designed and built to avoid these potential problems.

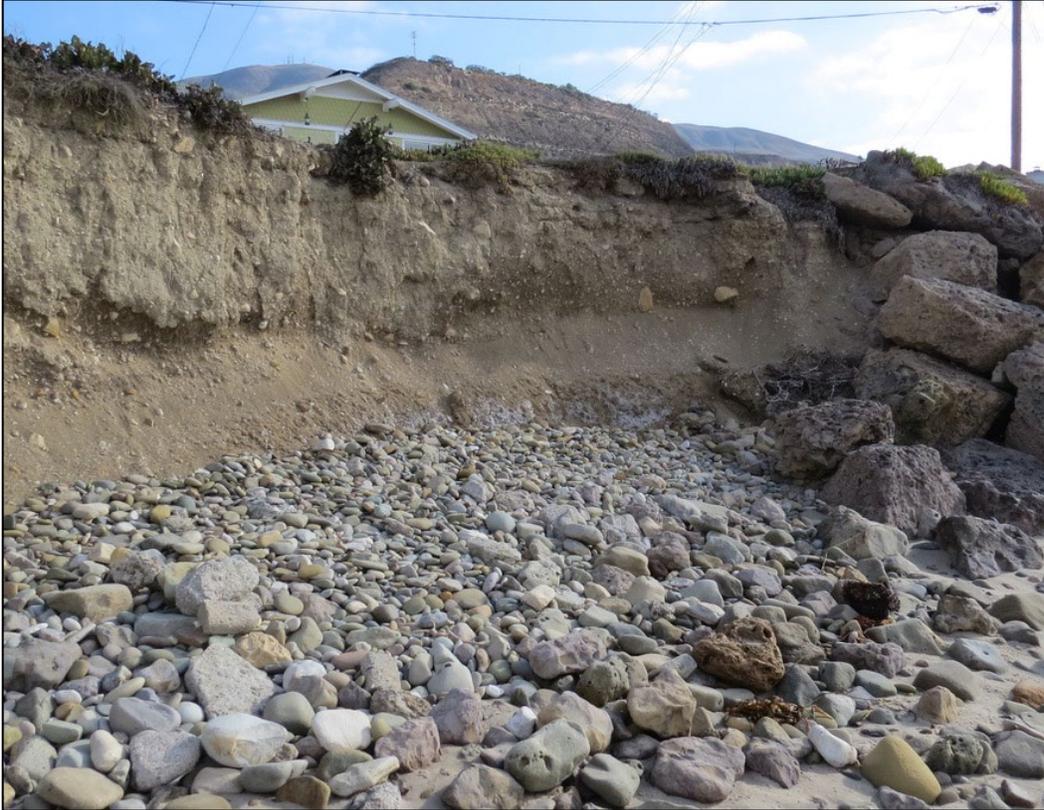
The near vertical eroding bluff backing the shoreline is about eight feet high and consists of a mixture of poorly sorted material which is believed to be the alluvial fan material brought to the shoreline from the inland drainage over thousands of years. This material is only loosely consolidated so has eroded easily when impacted by large storm waves at very high tides. The bluff is fronted by a low cobble berm that provides some protection from wave attack (Figure 16).

Figure 16. Eroding bluff immediately downcoast from abutment that is fronted by a cobble berm but no riprap.

Alternative 9C would include all of the components included in Plan 9A and would add riprap to armor the roughly 130 feet of shoreline that is presently unprotected. The additional riprap would extend from the existing intact riprap adjacent to the abutment to the riprap protecting the downcoast homes and Breakers Way (Figure 29). About 135 feet of the western or upcoast portion of the shoreline was originally protected by riprap when the abutment was constructed in 1959 (see Figure 9). Over the subsequent 62 years, however, the rock has been broken down and displaced by wave action so that it no longer provides significant protection to the upper portion of the parcel (see Figure 15). Wave erosion has left an approximately eight foot high near vertical bluff (see Figure 16).

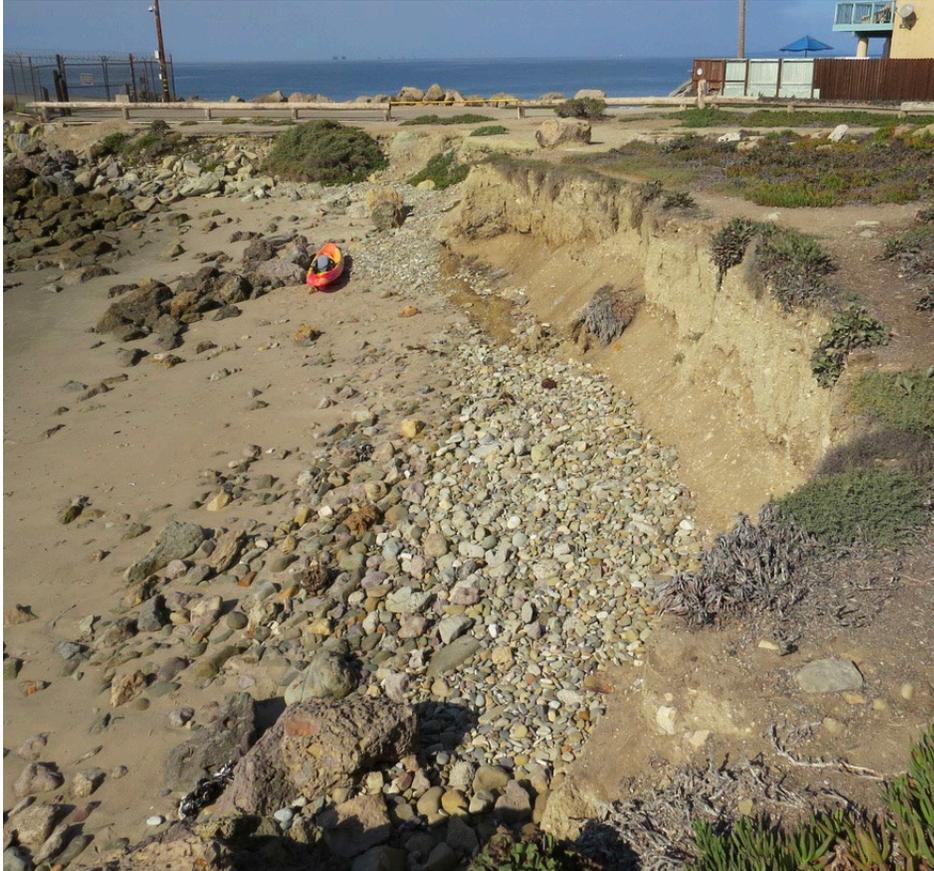
Figure 18. View of the flat upper portion of the SCC parcel and the bluff fronted by a cobble berm (October 2, 2022).

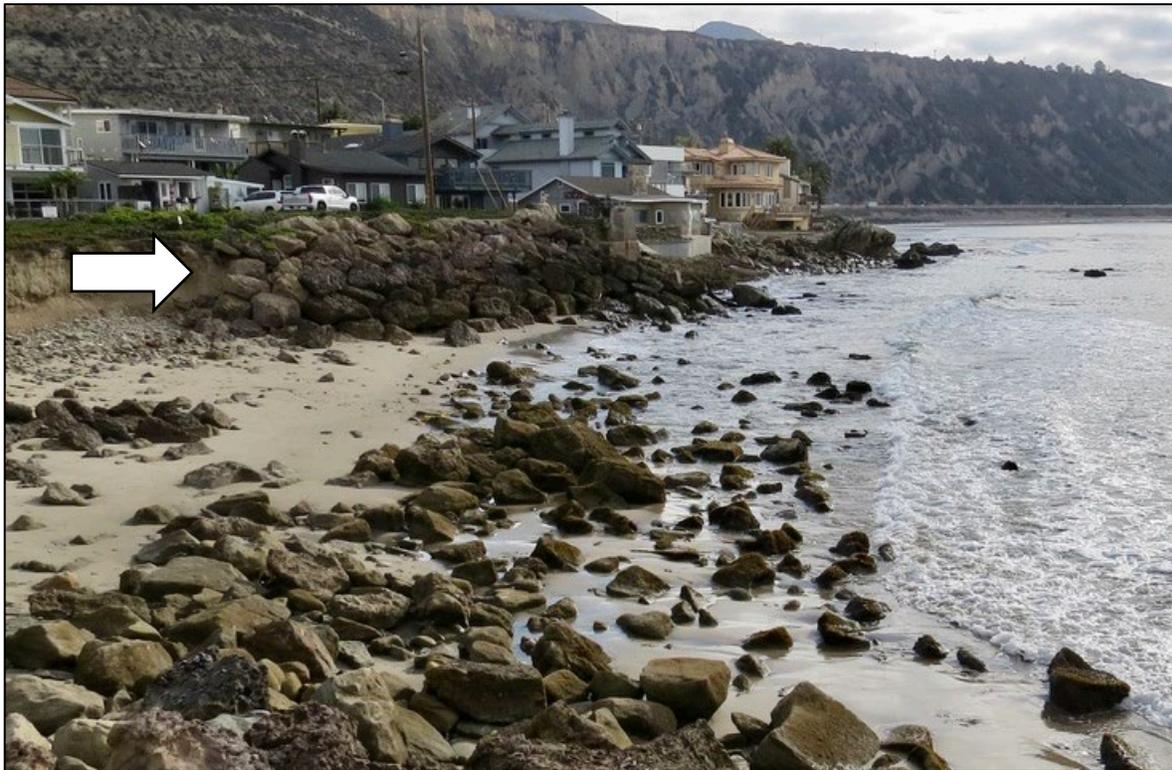
The existing riprap around the causeway abutment has performed well over the 62 years since its original placement, as has the rock protecting Breakers Way and the downcoast homes (Figure 30), which has been in place for at least 20 years. Additionally, the rip rap armoring the downcoast hotel has been in place since at least as far back as 1972 or 50 years. The rock revetment protecting Highway 101, both upcoast and downcoast of Punta Gorda have also performed well for over 50 years.

Figure 30. Riprap (arrow) protecting Breakers Way and downcoast homes and remnants of original 1959 riprap scattered along the shoreline.
