APPENDIX C:
ARBORIST REPORTS

Prepared for: City of Cupertino

Re: Arborist Report Peer Review 1655 S De Anza: City of Cupertino

Re: Arborist Report for 1655 S De Anza Blvd, Cupertino

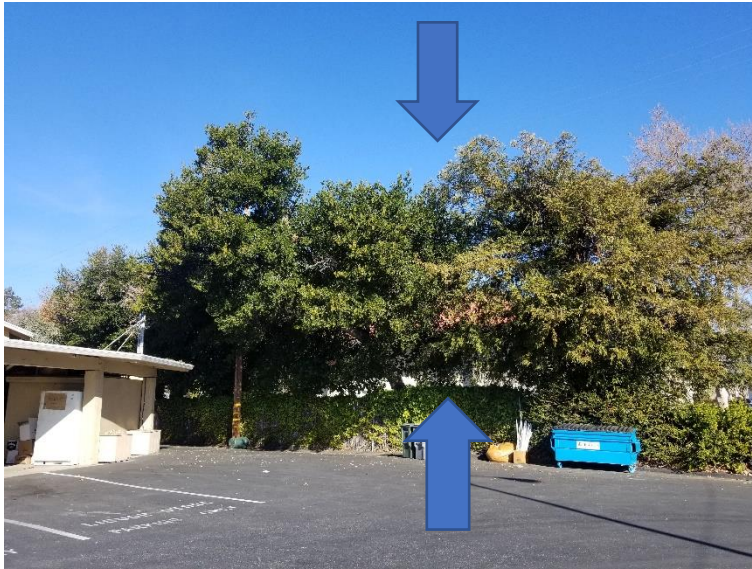
The above image shows a neighboring Coast Live Oak (*Quercus agrifolia*) slated for removal. The tree exhibited fair health and structure. Additionally, it could likely recover from root pruning due to sufficient energy reserves.

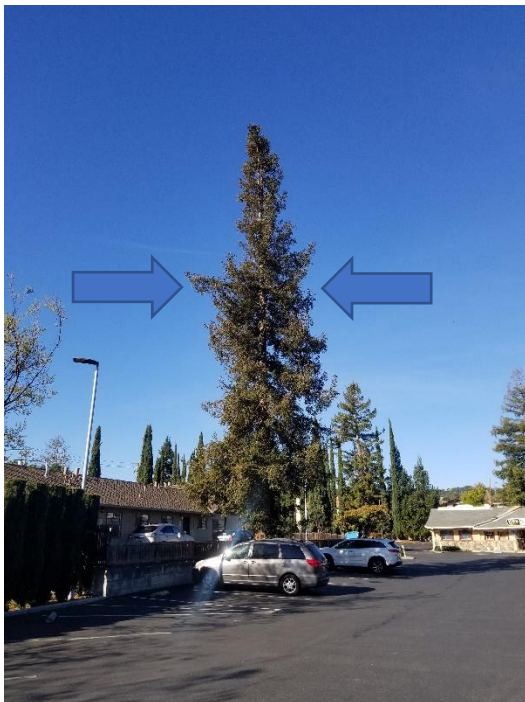
The above photo shows a drought-stressed Coast Redwood (*Sequoia sempervirens*) slated for removal within property lines. The tree is likely suffering from overexposure to the sun and wind and a prolonged California drought.

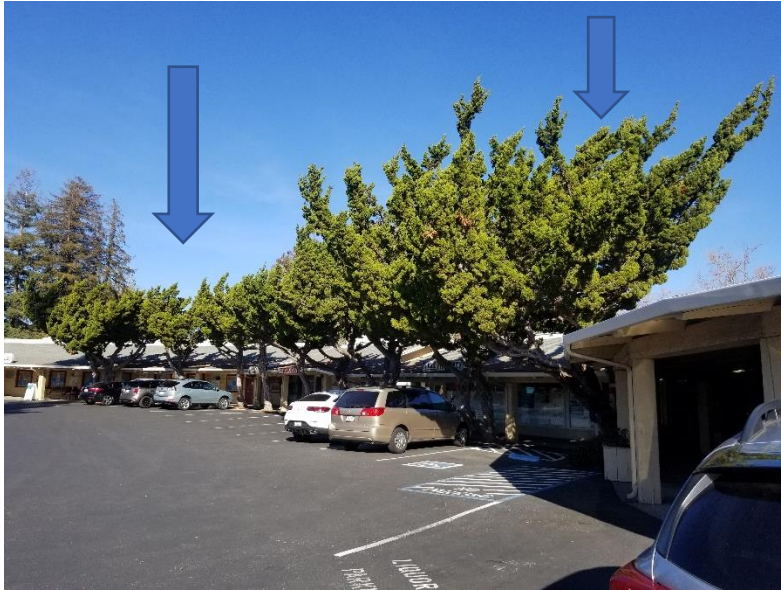
The above image shows a line of healthy Hollywood Junipers slated for removal near the center of the property. A few had codominant branching, though the branching had U-shaped branch unions conducive to structural stability (codominant branching is relatively normal for the species).

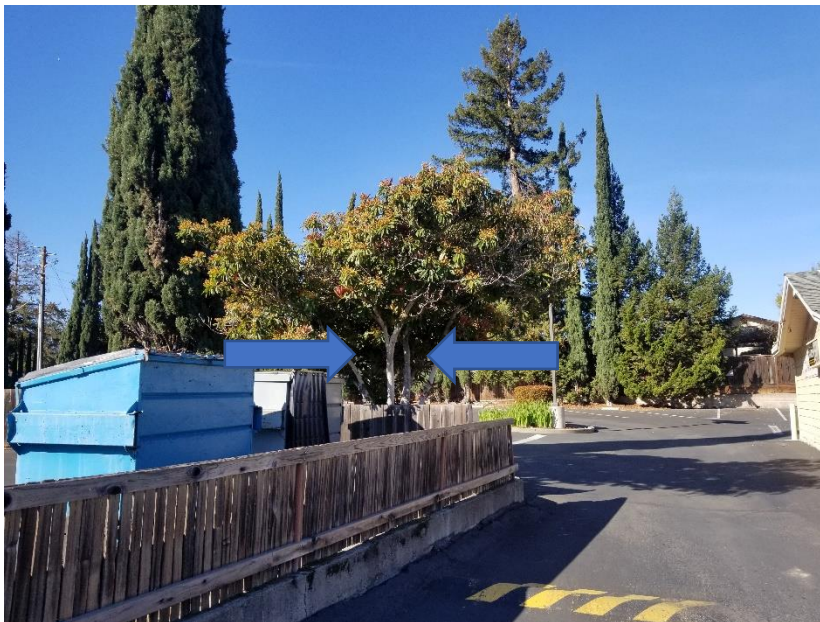
The above image shows a stunted bronze loquat slated for removal near the edge of the property. The tree exhibited fair health and structure. Stunted growth was likely due to drought stress and overexposure to the wind and sun.

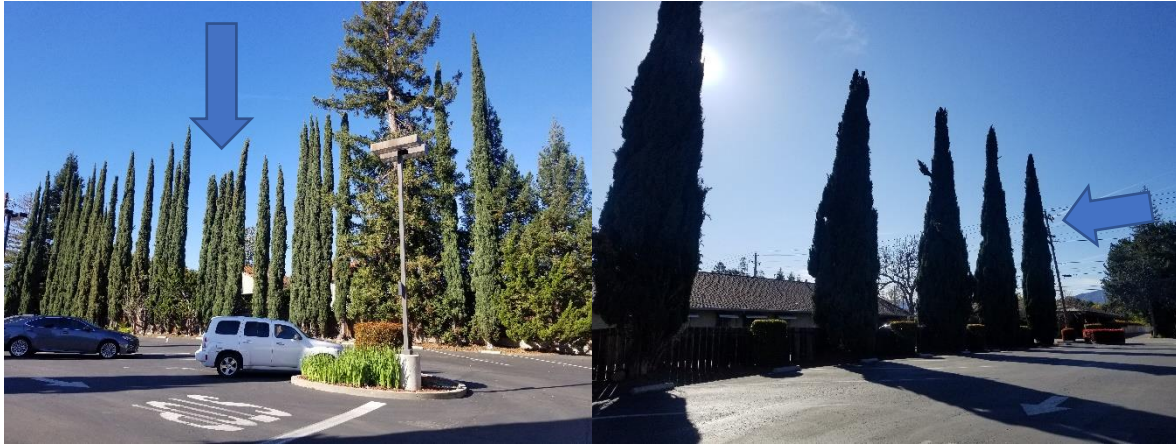
The above image shows rows of healthy Italian Cypress trees with good, upright structures along the two sides of the largest parking lot on the property. These are all large specimens that provide significant ecosystem services such as carbon storage and sequestration.

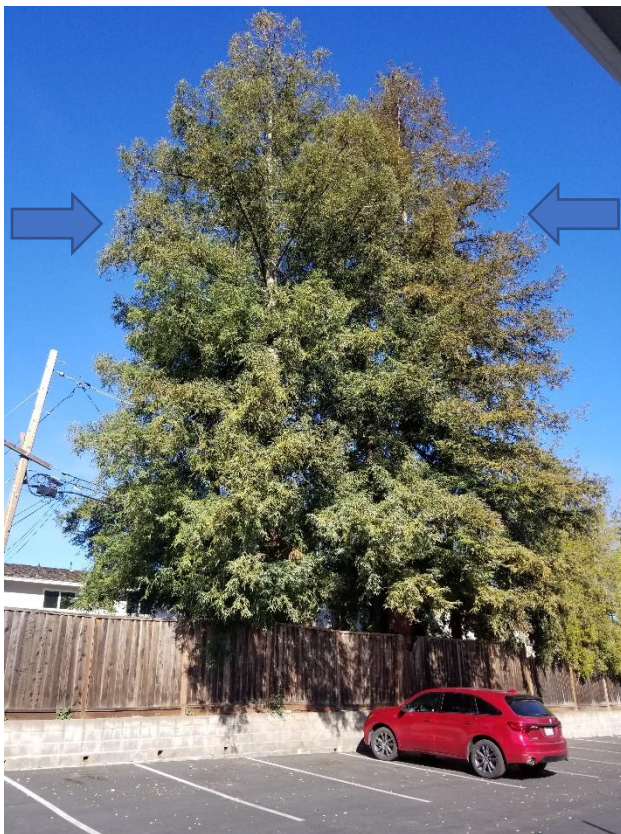
The above image shows two mature Coast Redwoods on the adjacent property that will have roots cut by construction (neither were in the original report). They both exhibited fair health and structure and have the potential to recover from root pruning due to sufficient energy reserves. They provide many benefits to the urban forest considering they are both mature, large specimens and California natives that other California organisms have coevolved with.

I recommend attempting to retain all the trees immediately bordering the property, including two Coast Redwoods, one Silver Dollar Gum, and two London Plane Trees in addition to the four Coast Live Oaks referenced in Ms. Tso's January 18, 2022, arborist report. I also recommend exploring the possibility of changing the proposed sidewalk and planters to include tree wells to preserve Trees #5, #6, and #16-21, adding them to the Tree Protection Plan. Tree #6 is the only one of these trees not in good condition; however, with watering and potential wind protection by the proposed building, this tree's condition may improve. Additionally, Tree #6 is a Coast Redwood, a famously resilient species with the ability to resprout even after total defoliation.

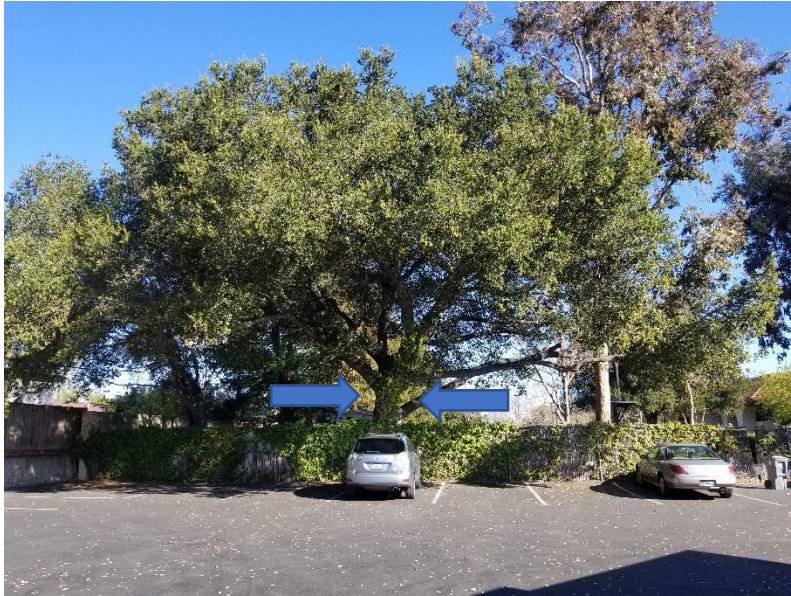
The above image shows another adjacent property, Oak; this Coast Live Oak is at the corner of the property, the farthest point from either nearby road. The tree exhibited fair health and structure and, like the other trees on adjacent properties, could likely recover from root pruning due to sufficient energy reserves.

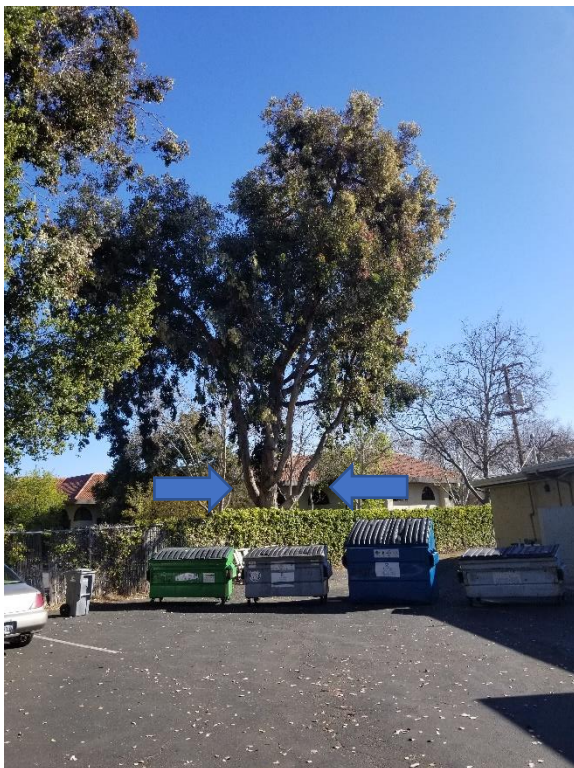
The above image shows a Silver Dollar Gum on the adjacent property that exhibited fair health and structure; this tree also showed sufficient energy reserves to recover from root pruning. This tree was not in the original report.

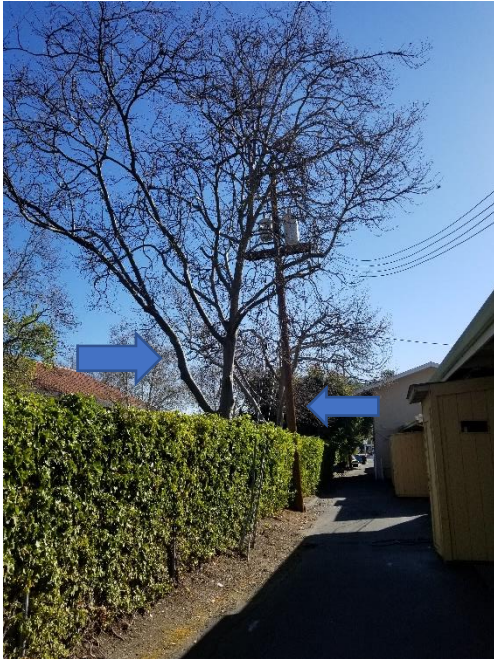
The above image shows two London Plane trees on the adjacent property that will have roots cut by construction; neither were listed in the original report. The trees exhibited fair health and structure. However, these trees did not yet have leaves, flowers, or fruit, so my assessment of these trees' health was limited.

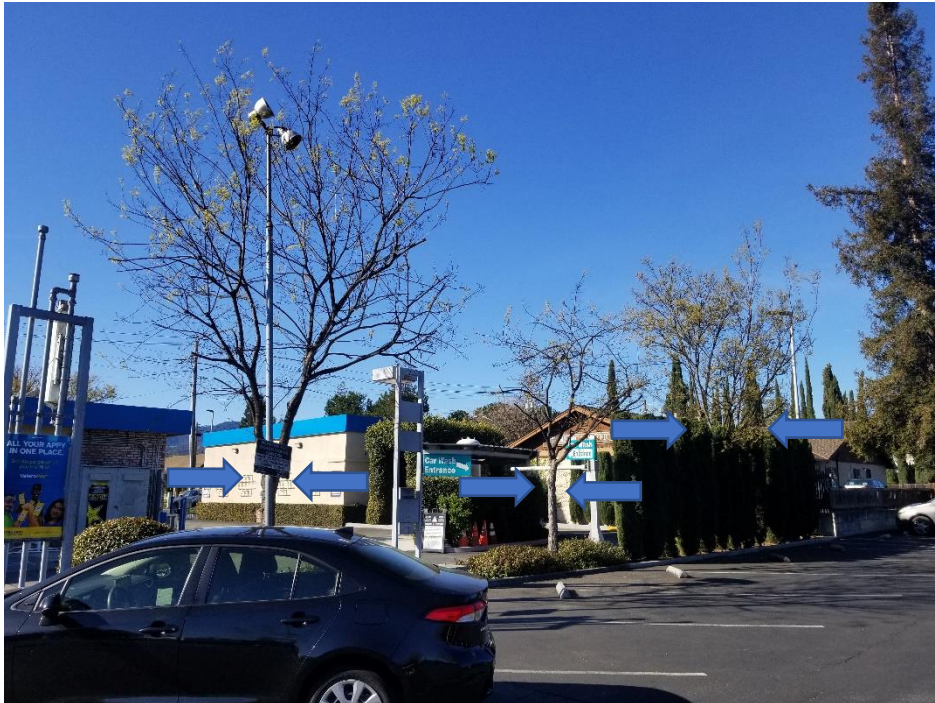
The image above shows three Chinese Hackberries in fair health and structure along the edge of the property; all three were recommended for removal and are directly in line with the proposed construction.

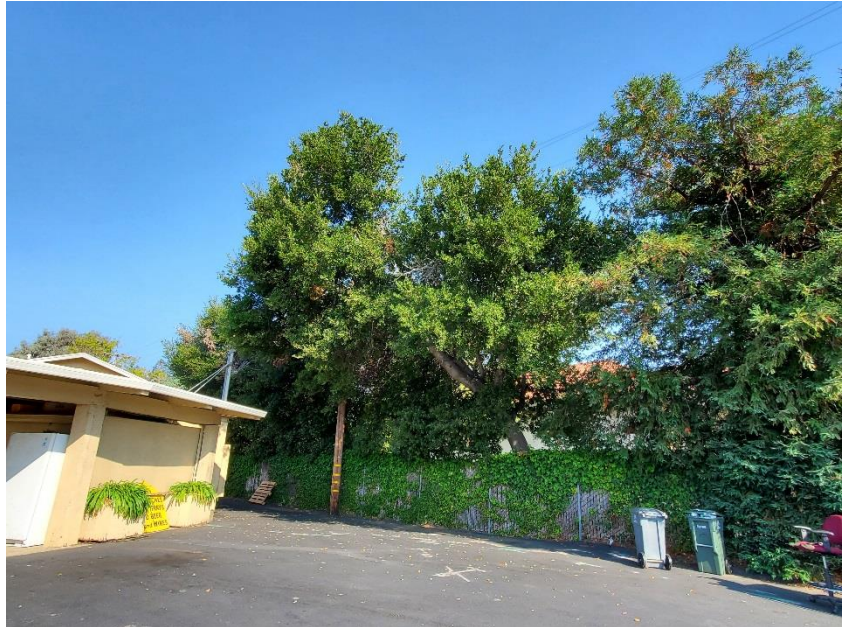
It is my opinion that one of the oaks will be subjected to excessive pruning as well as potentially significant root encroachment. This tree is a likely candidate for removal.

Figure 1.. The proposed mixed-use building will be approximately 10' from the property line. Trees #3 & 4 (above) may be subjected to significant root & canopy pruning.

4	Coast live oak	19.5	G	P	15	12	18	20	M	X	M-H	Off-site tree, not surveyed. Topped. 10' from proposed townhome; proposed walkway next to fence; proposed storm drain 8' to S. Will require significant clearance pruning.

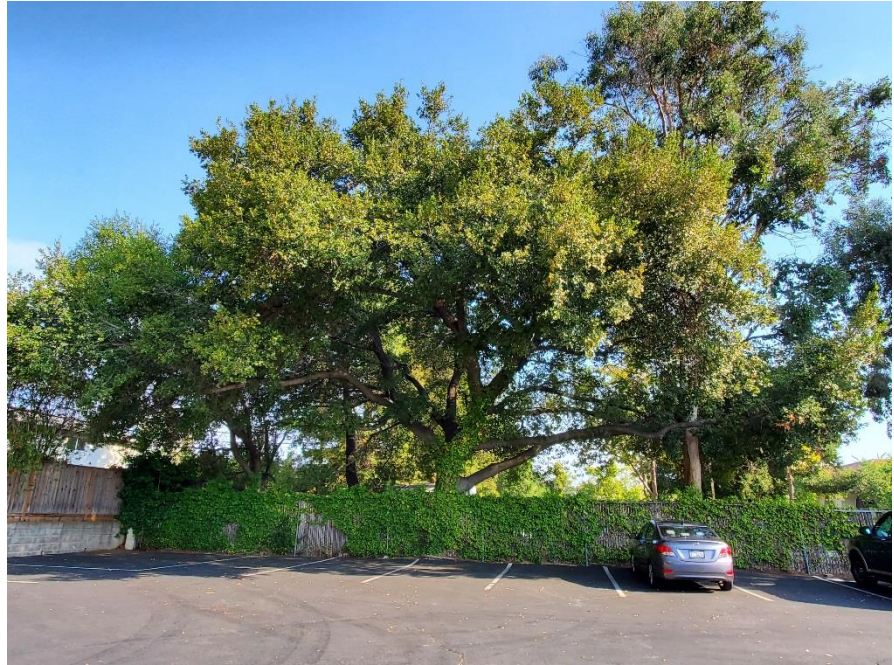
#	Species	DBH	Health	Structure	Dripline				Age	DE	CI	Comments	Action
					N	E	S	W					
2	Coast live oak	32	G	G-F	25	30	30	35	M	X	H	Off-site tree. Diameter estimated due to fence. Trunk flush to and deforming wire fence. Hardscape lifted by trunk. Ivy climbing into canopy. Branches stripped of interior foliage for clearance over parking. Several large scaffolds from short height on trunk (but not co-dominant). Low-growing scaffold branch 40' to SW. Proposed walkway within 1' of trunk, 11' from proposed townhome. Will require major clearance pruning.	Recommend moving proposed walkway further from tree, i.e. switch with landscape strip, to reduce impact on trunk flare. Pruning shall be minimized (work scaffolding around limbs) but may still cause decline. Project arborist on site during demo, grading; if root loss is excessive, tree may need to be removed.
3	Coast live oak	20.5, 23.5	G	P	30	20	12	20	M	X	M-H	Off-site tree, not surveyed. Co-dominant stems; topped at 15' for power line clearance. Noticeable leaf damage by gall wasps. Dense canopy. 10' from proposed townhome; proposed walkway next to fence; proposed storm drain 8' to S. Will require significant clearance pruning.	Recommend moving proposed walkway further from tree, i.e. switch with landscape strip. Pruning shall be done by certified personnel. Project arborist on site during demo, grading; if root loss is excessive, tree may need to be removed.

Figure 2. Significant canopy reduction will be needed for oak #2 – some large limbs will need to be completely removed back to the trunk. The pruning shall be done in stages, as needed, to the minimum amount needed for each phase of construction.

Oak #2 will also be subjected to over-pruning, which may affect its health more than the grading (Figure 2). The current structure of the tree requires more aggressive pruning, with larger pruning cuts. For instance, two of its lower large-diameter scaffold branches are up to 30'-35' long, with their interior branches removed for clearance over the parking lot. Now, it is not possible to shorten the branches back to smaller secondary branches without leaving unattractive stubs. They will likely have to be removed back at their attachment, which results in a large wound next to the trunk. I recommend doing the minimum amount of pruning needed at each stage of construction, rather than completing the clearance pruning all at once. The pruning contractor shall be certified by the International Society of Arboriculture (ISA), and shall work with the relevant sub-contractor(s) to determine the minimum amount of clearance pruning. Regardless, this oak may still need to be removed if the combined root loss and clearance pruning is excessive.

- Pruning of tree #2 shall be kept to a minimum at each stage of construction; temporary scaffolding shall be worked around large branches wherever possible. All pruning shall be performed by personnel certified by the International Society of Arboriculture (ISA; "Certified Tree Worker" or "Certified Arborist"). All pruning shall adhere to ISA and American National Standards Institute (ANSI) Standards and Best Management Practices.
