Tree Report

**Protected Tree Report  
for  
Skilled Nursing Facility at  
Barlow Respiratory Hospital  
2000 Stadium Way  
Los Angeles, CA 90026**

January 14, 2021

**SUBJECT:** Tree Inventory and Protected Tree Report at Barlow Respiratory Hospital –  
2000 Stadium Way

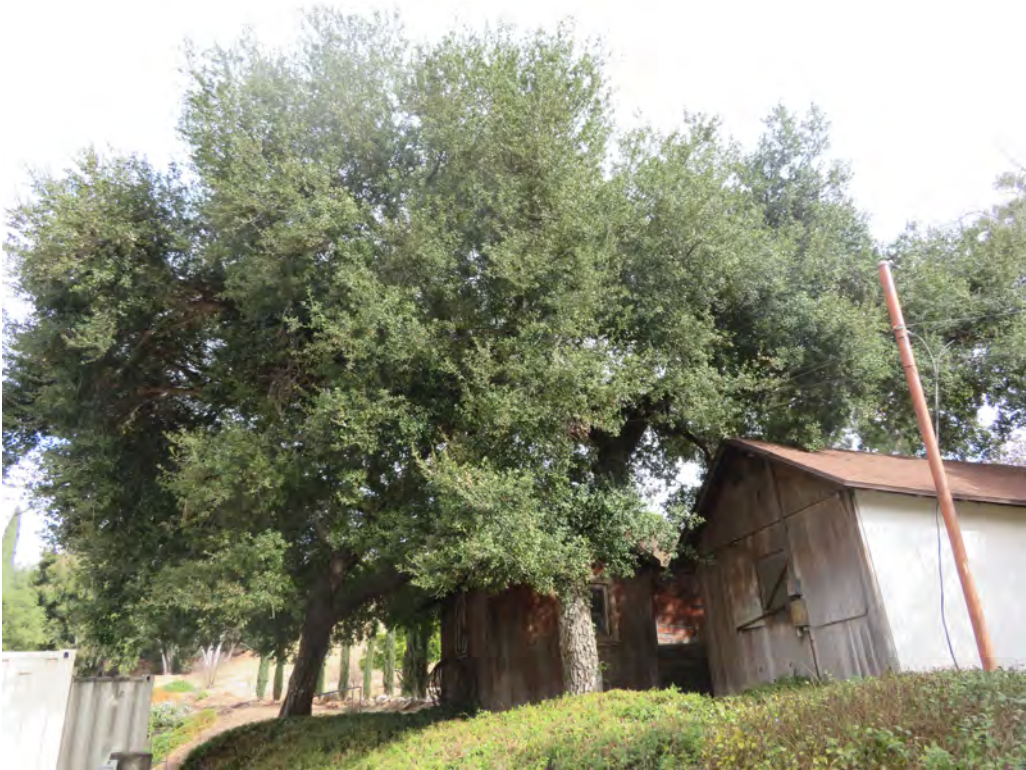
Tree 19 (center)

Tree 19- The proposed project includes demolition of two small wooden structures within the canopy dripline of this tree, as well as removal of existing ground cover around the tree and installation of new landscape and a sitting area. Demolition activities could impact the tree's root system and canopy if machinery is used within its canopy dripline. Changes to the landscape under the tree could result in root system impacts if the existing vegetation is not removed carefully or if irrigation trenches and planting holes are dug in the canopy dripline. In addition, changes to the tree's watering regime as a result of new landscape installation could result in decline of the tree's health. Finally, because a sitting area will be constructed under the canopy of the tree, the tree should be assessed for structural issues and may need safety pruning.

Demolition of wooden structures near Trees 19 and 20- The two small wooden structures located within the canopy driplines of Trees 19 and 20 must be demolished carefully to minimize damage to the root systems and canopies of those trees. The structures shall be demolished using manual labor (no machinery) within the canopy driplines. When the foundations of the structures will be demolished, it should be done in a backwards direction within the canopy driplines, starting closest to the trunks of the trees and working away from them. All personnel, equipment, and debris should remain on the foundation as it is removed to prevent disturbance of the exposed soil under the canopy driplines.

Safety pruning- The **Project Arborist** shall be consulted prior to safety pruning of Trees 19 and 20. Any pruning will be carried out by an ISA Certified Arborist, or under the direction of the **Project Arborist**. All pruning shall conform to ANSI A-300 pruning standards at a minimum.

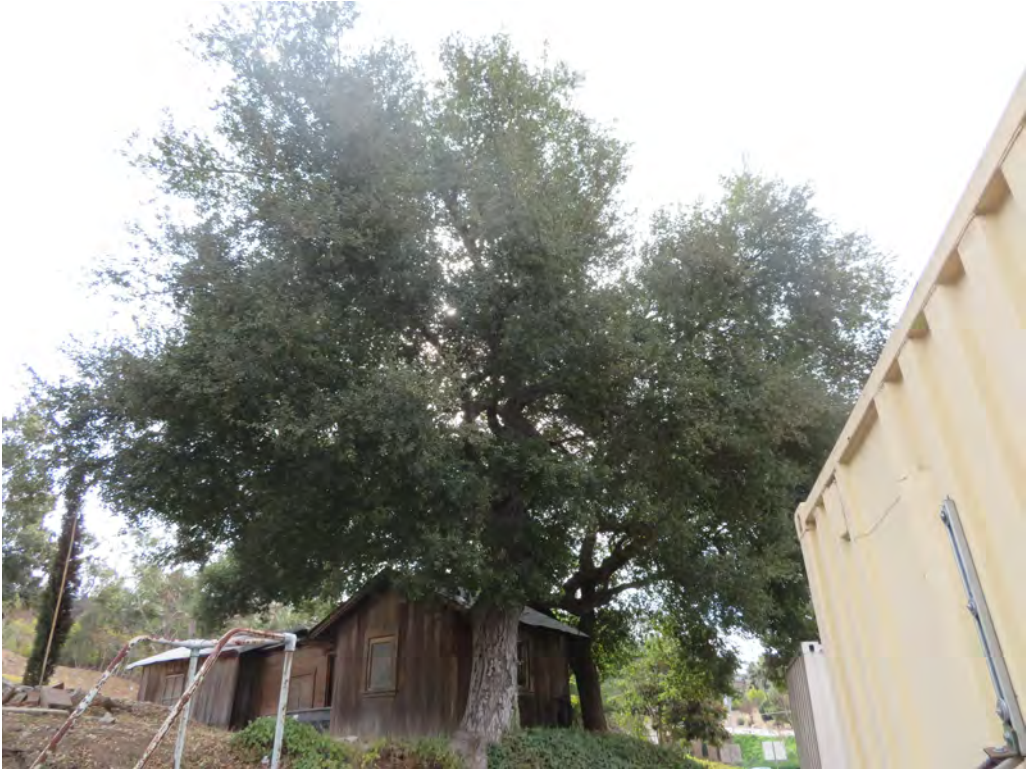
Tree 20

Tree 20- The proposed project includes demolition of two small wooden structures within the canopy dripline of this tree, excavation for a parking area curb within eight feet to the northeast of the tree's trunk, and removal of existing ground cover around the tree and installation of new landscape and a sitting area. If there are significant roots at the northeast of this tree's root system that must be cut during excavation for the parking area curb, this tree will be majorly impacted and possibly destabilized. In addition, this tree will be subject to the same impacts as described for Tree 19. In order to better understand the impact severity of the excavation for the parking area curb, we have provided a recommendation for exploratory trenching near Tree 20.

Exploratory trenching near Tree 20- Prior to excavation and construction of the northeast parking area, an exploratory trench shall be dug along the parking area curb edge within 15 feet of the trunk of Tree 20. The trench shall be as deep as the required excavation and subgrade activity for the curb and parking area, and as wide as necessary (away from the tree) to accommodate digging. ***The exploratory trench shall be dug using hand tools or an AirSpade only***, and any roots less than two inches in diameter shall be cut cleanly using a sharp saw or pruning tool. No roots two inches or larger in diameter shall be cut during digging. The ***Project Arborist*** shall inspect the exploratory trench and the exposed roots that are two inches or larger in diameter and provide mitigation recommendations accordingly.

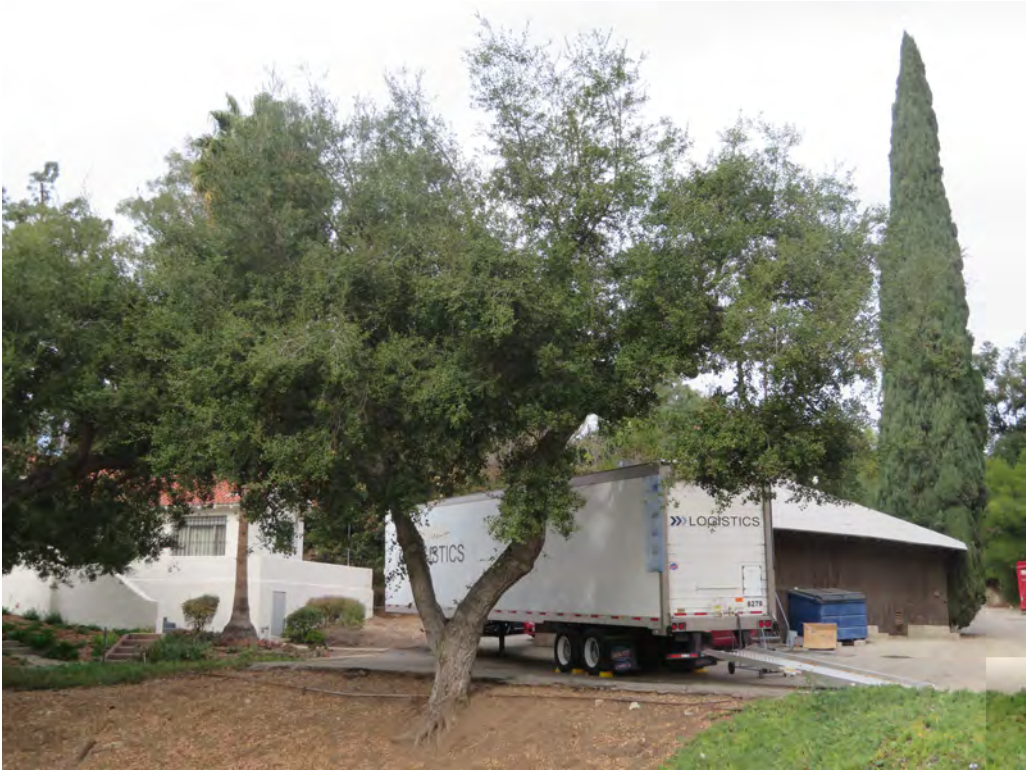
Trees 22 and 23- The proposed project includes excavation for a parking area curb within 15 feet to the south of Tree 22 and 10 feet to the south of Tree 23, and possible landscape installation within their canopy driplines. We anticipate impacts to these trees from root cutting during parking area excavation and landscape installation, as well as impacts due to changes to the watering regime for new landscape around these trees.

Excavation near Trees 22 and 23- If roots are encountered during excavation for the parking area curb near Trees 22 and 23, cuts should be made cleanly with a sharp saw or pruning tool, far enough behind any damage that all split and cracked root portions are removed. The cut should be made at right angles to the root so that the wound is no
