TREE PROTECTION REPORT

660 UNIVERSITY AVENUE

PALO ALTO, CALIFORNIA

Prior: December 20, 2023
Current: February 7, 2024

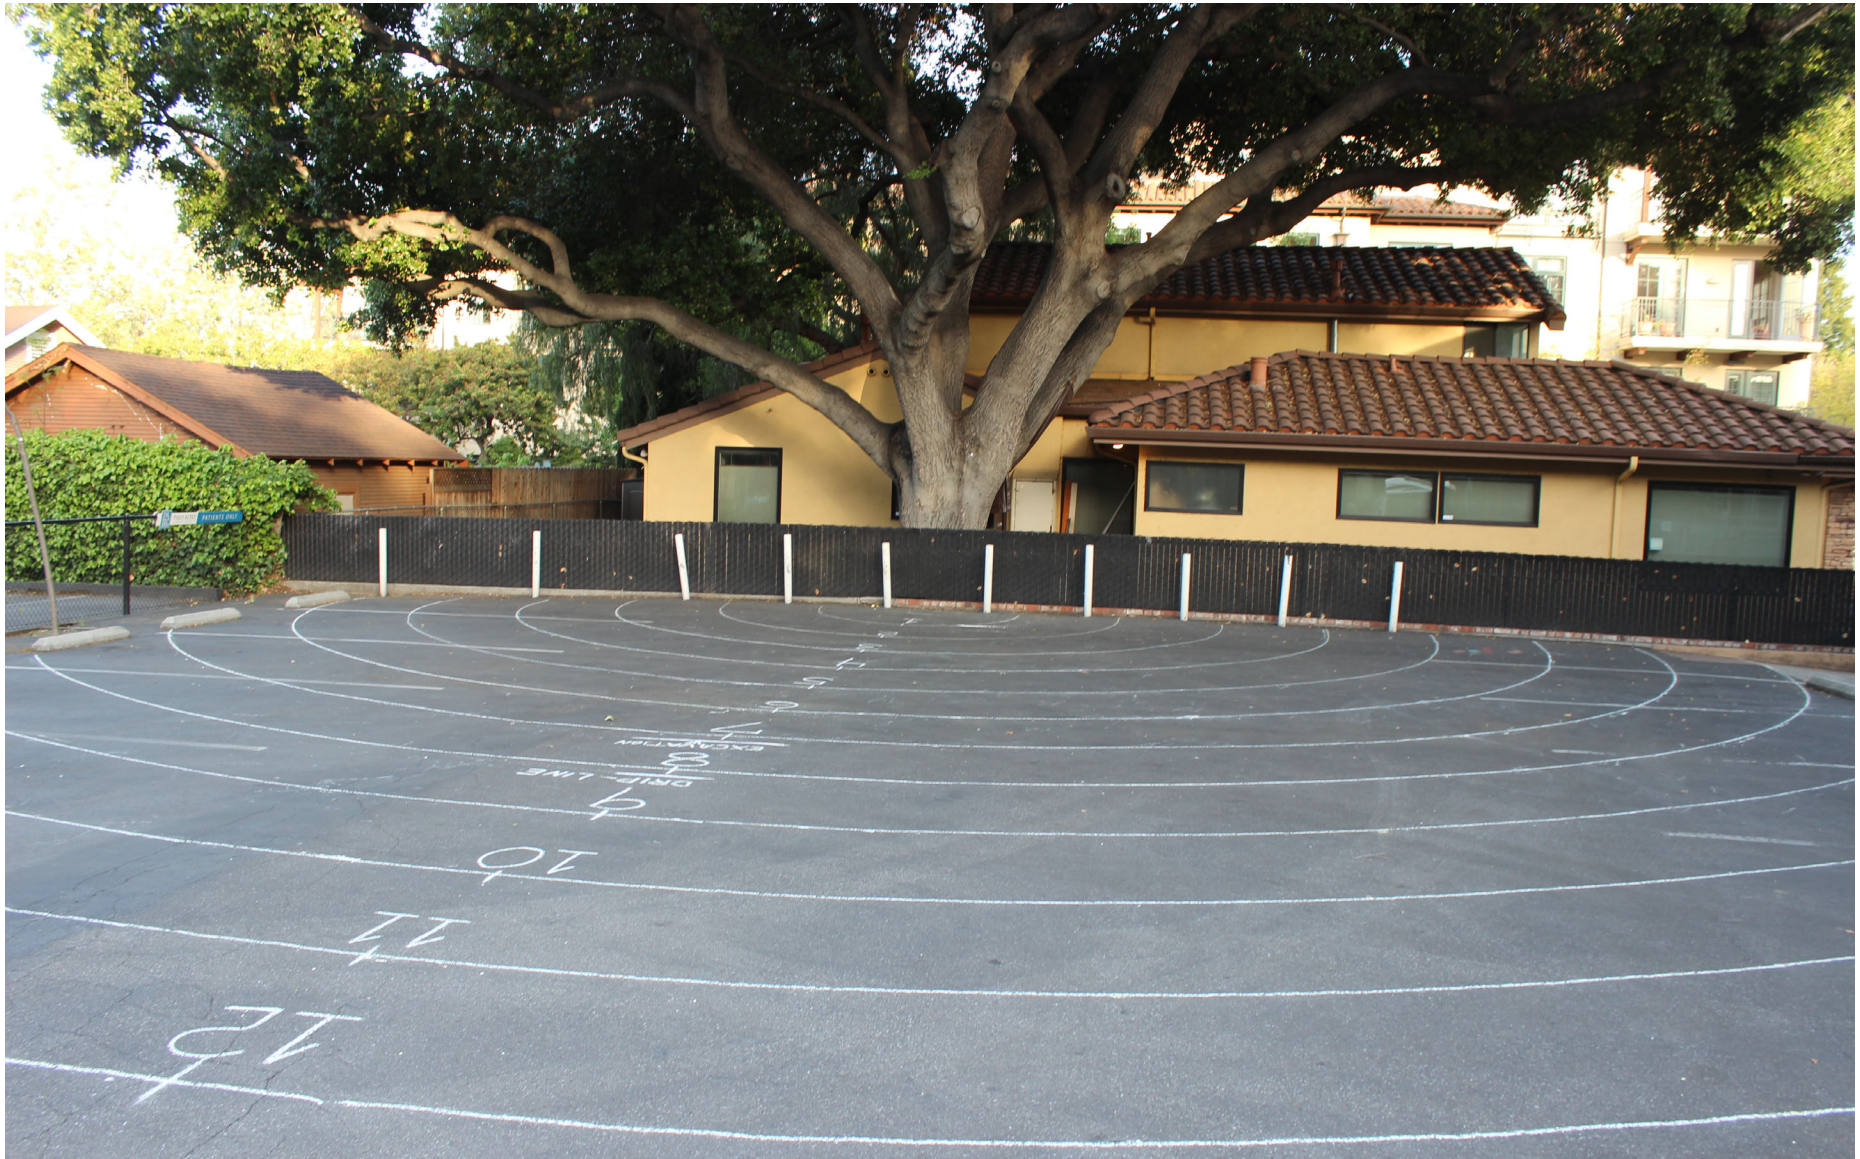
These chalk lines represent the locations of half circle scans. Scan #8 represents the edge of the canopy drip-line. Scan #7 represents the edge of the proposed excavation for the below ground garage about 30 feet away from the Oak tree.

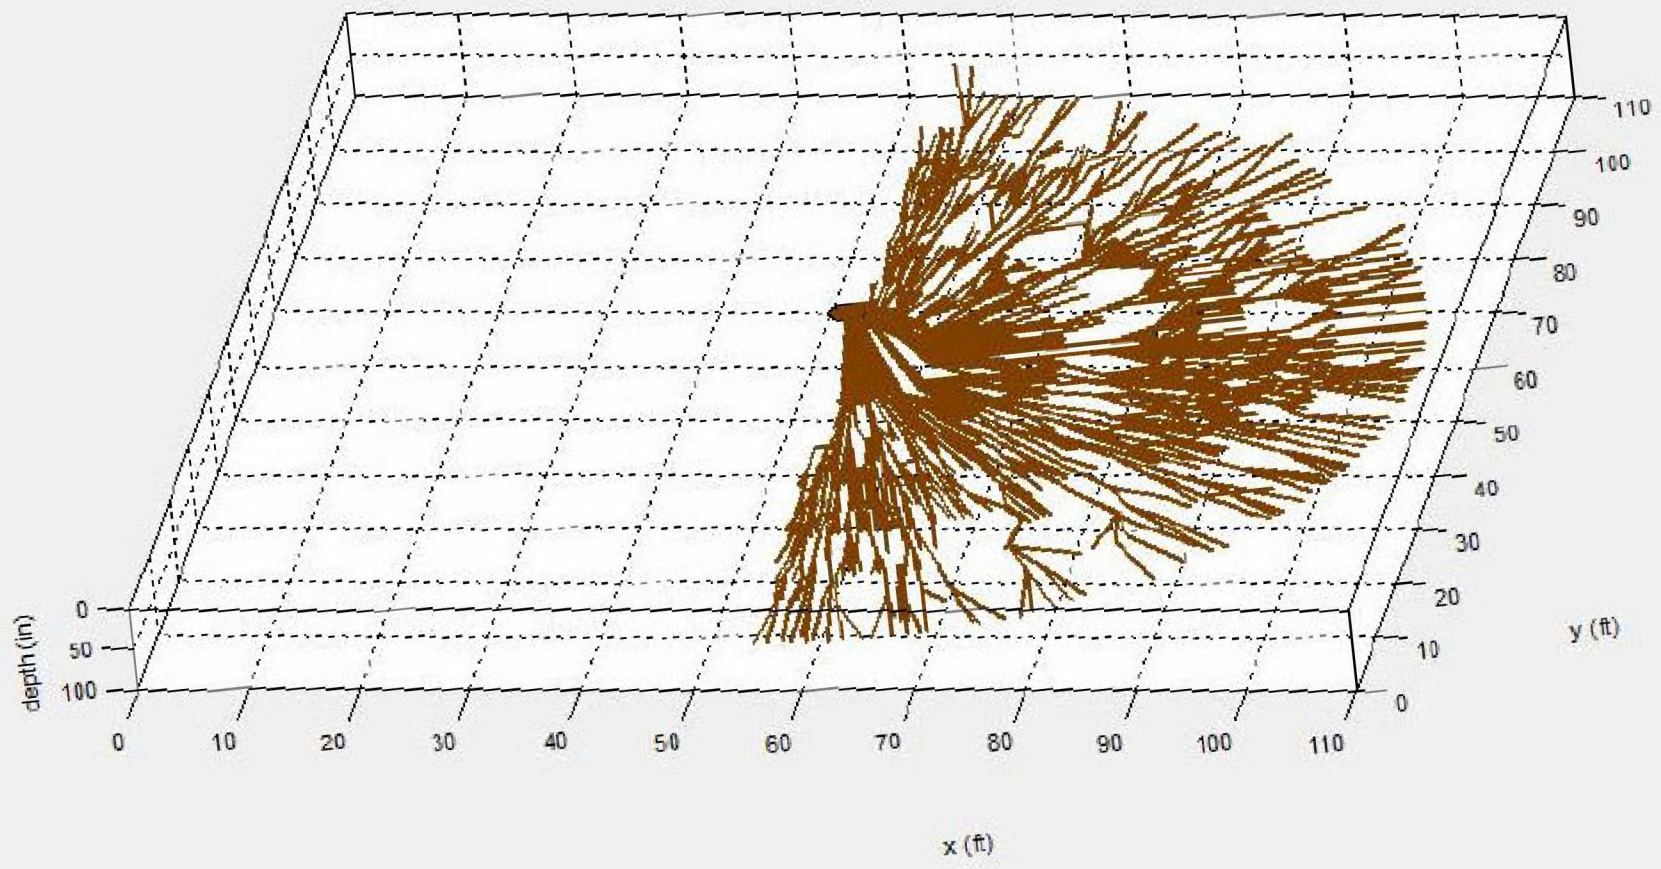
Root Morphology Map

This is a conceptual 3D Top-Down diagram of what the root structure may look like below the ground of Oak Tree #1572 on University Avenue. It is obtained from the root data collected from the 12 half circle scans performed over the asphalt parking lot.

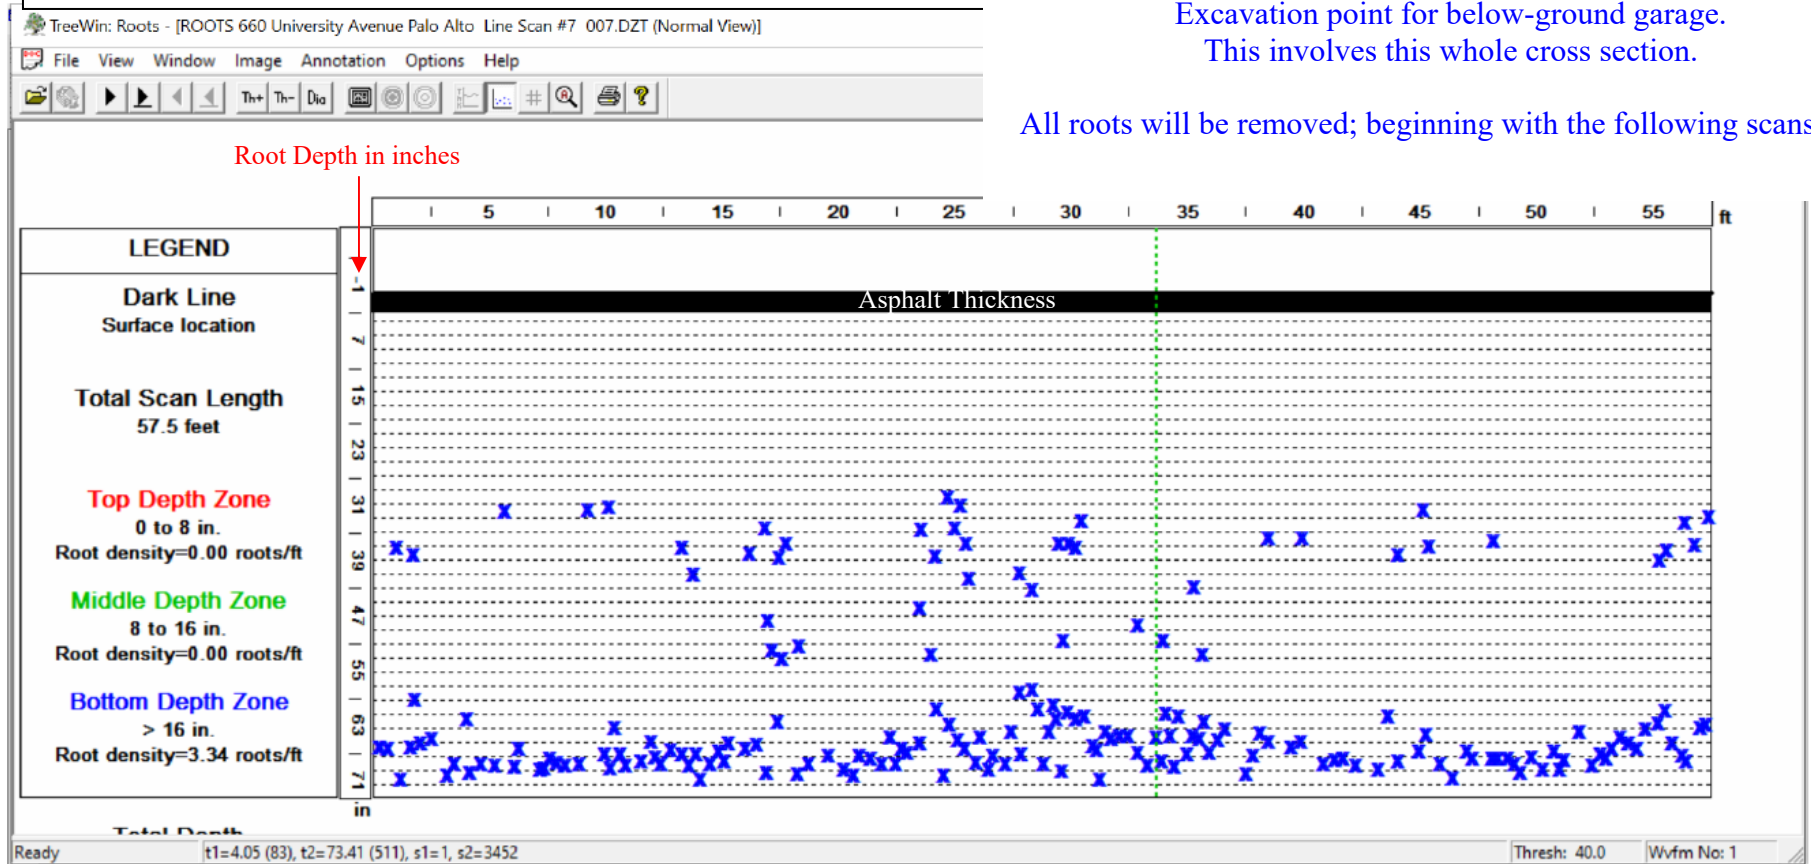
May 8, 2022 660 University Avenue Palo Alto, California.
 Scan #7 Line scan over parking lot 31 feet away from Oak tree #1572

Excavation point for below-ground garage.
 This involves this whole cross section.

All roots will be removed; beginning with the following scans 7-12
