ARBORIST REPORT

February 26, 2021
Revised August 11, 2021
Revised December 20, 2021
Revised March 7, 2022
5899.00

1020 Terra Bella Avenue
Mountain View, CA

Alta Housing

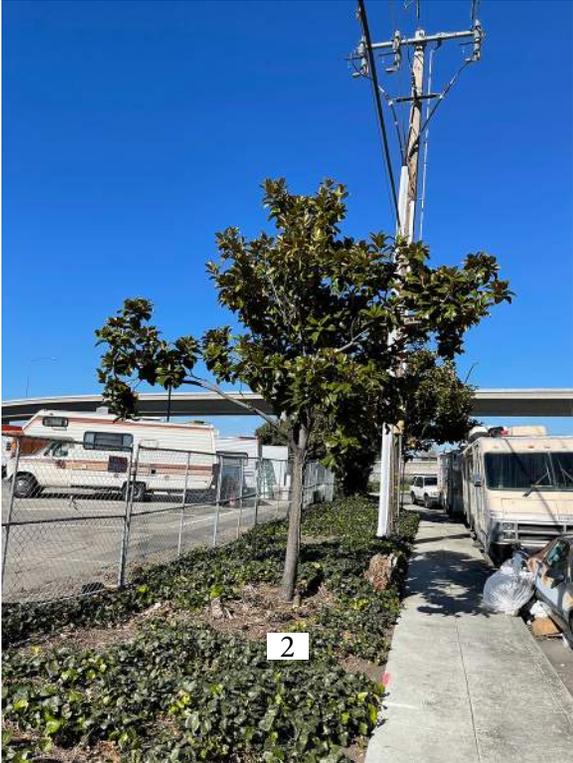
2

The Magnolia tree is a younger specimen and is in good to moderate shape. It is located on the east site of the Public Storage site on San Rafael Avenue. Tree number two is under the powerlines which could be an issue long term if topping occurs. As Magnolia are a moderate water use tree ensuring that adequate irrigation is being applied would help the vigor of these trees. This tree is not a good candidate for transplanting.

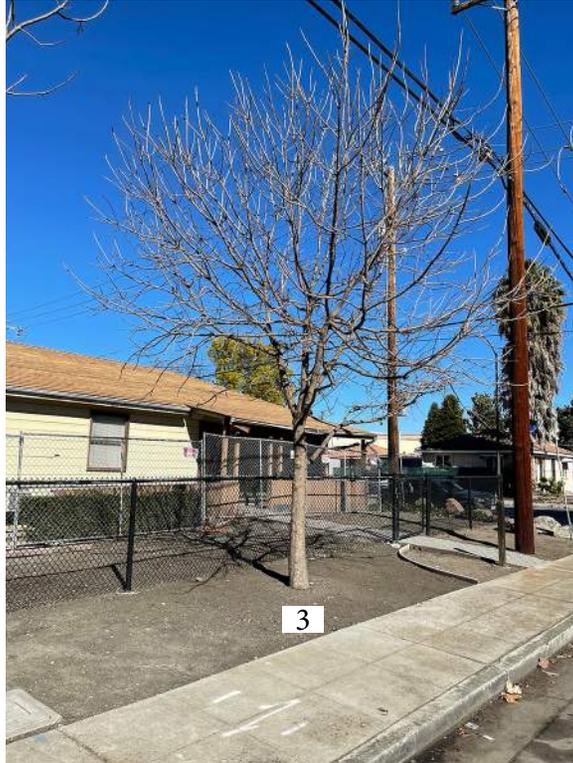
3

The Pistache trees are younger specimens and are in good shape. These trees, as all along the street frontage, are under power lines that could be problematic long term if topping occurs. These trees are not good candidates for transplanting.

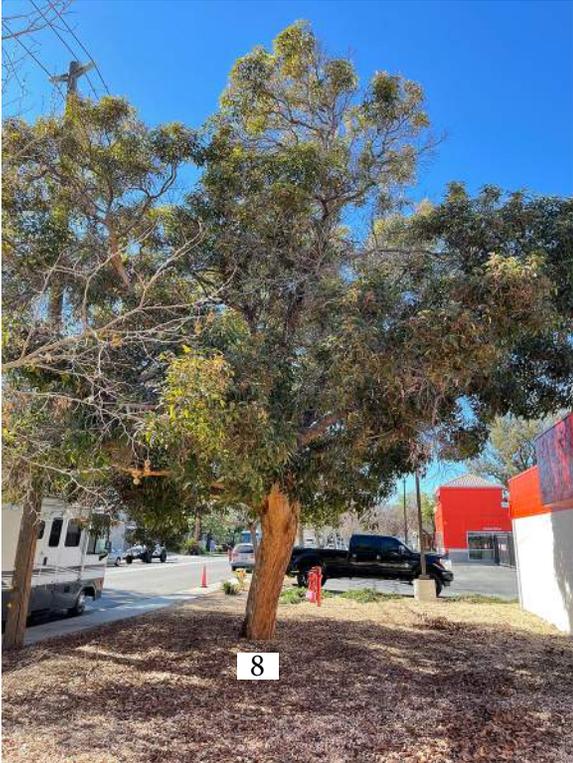
8

The Red Gum trees are mature specimens and are in good shape and are a significant canopy tree at the front of the Public Storage site. The internal branching structure of these trees could benefit from a structural pruning effort. These trees, as all along the street frontage, are under power lines that could be problematic long term if topping occurs. These trees are not good candidates for transplanting.

Upon reviewing the plan set dated 12/22/2021, here are recommendations to consider for retaining Tree #8 and to lessen the impact of construction:

- Avoid installing utility lines underneath the dripline of the tree
- Avoid constructing decking/footings underneath the dripline of the tree
- New plantings underneath the dripline of the tree should match the WUCOLS water use rating, which is low.
- The structural plans should be reviewed by the design team to see the extent of the building's footings under the dripline of the tree and consider alternatives, if possible.
