Tree Survey and Arborist Report

for an approximate 16.8-acre Site

On the NE C/O State St. and Campus Ave.

Report Date: June 13, 2022

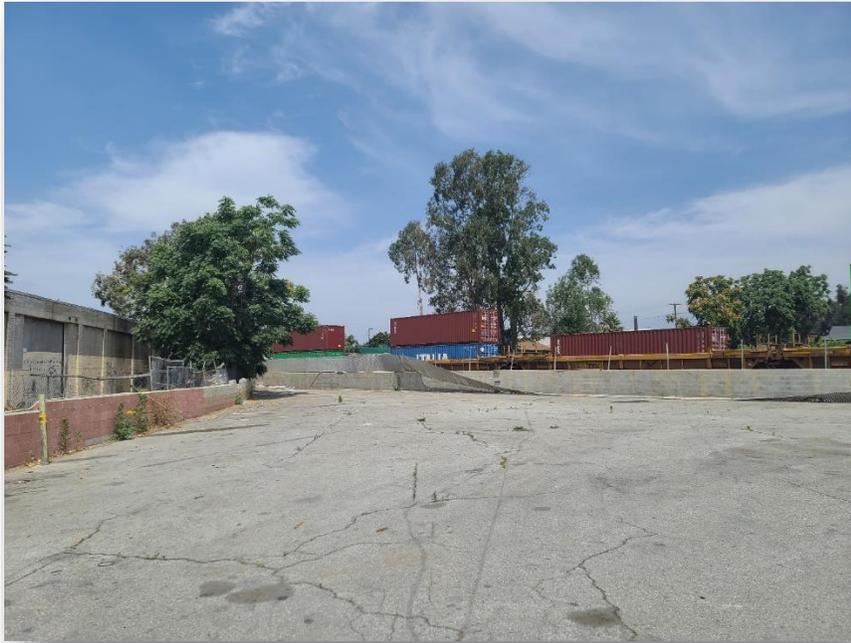
Plate 1a. This is a northwestern view from within the project site at a historic spur railway (to the left of the block wall). Invasive vegetation has sprouted and taken root.

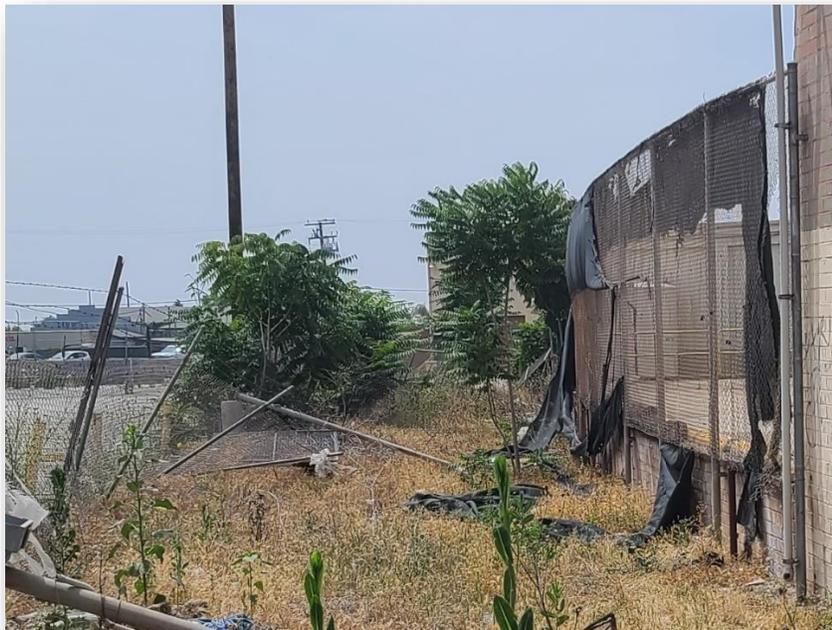
Plate 1b. This is a southern view within the historic railway spur line with volunteer sprouting of invasive tree species.

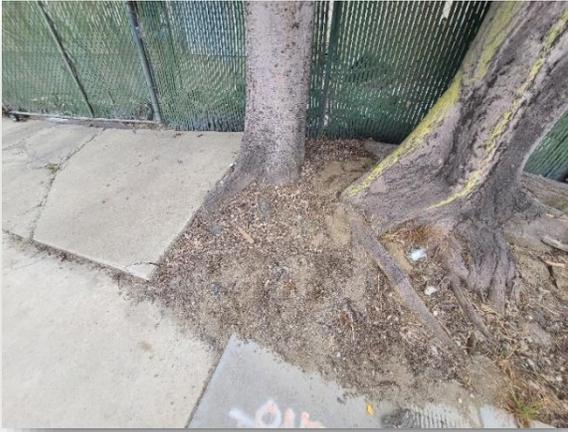
Plate 2. This is a view of two trees within close proximity with competing canopies (#145 and #146).

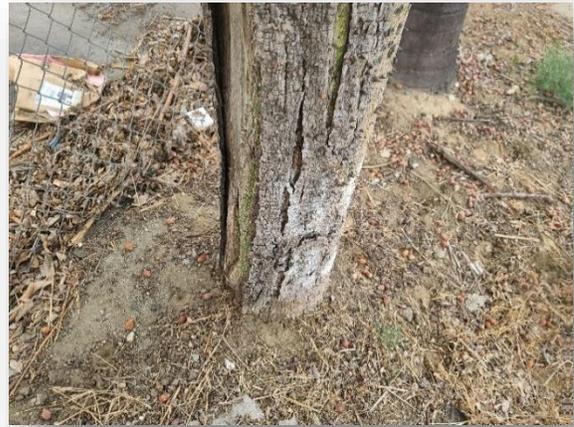
Plate 3. This is a view of longitudinal decay within a stem of a tree (#148).

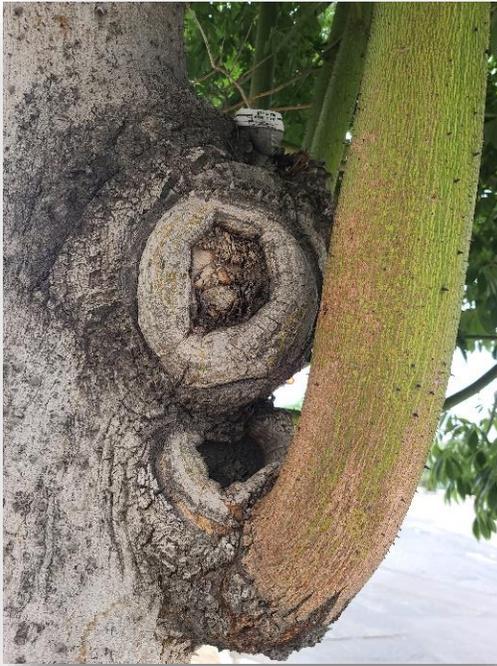
Plate 4. This is a view of an epicormic sprout, adjacent to an unclosed branch cut, that matured with poor attachment (tree #145).

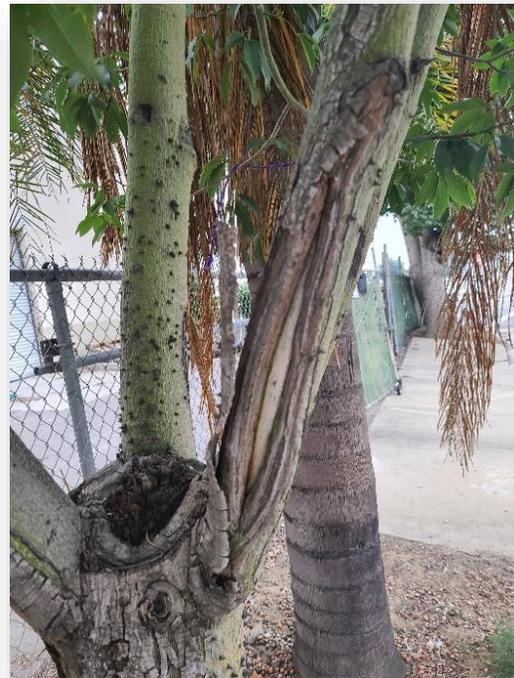
Plate 5. This is a view of “waters-sprouting” from callus tissue where a central stem has decayed. (#148).

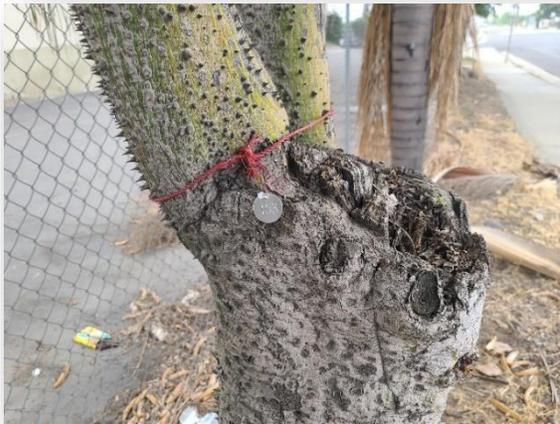
Plate 6. This is a view two sprouting limbs near adjacent decayed tissue (#153).

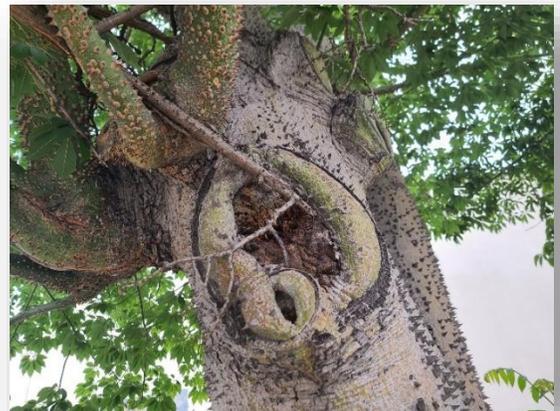
Plate 7. This is a view of an unclosed branch cut with decayed tissue (#155).

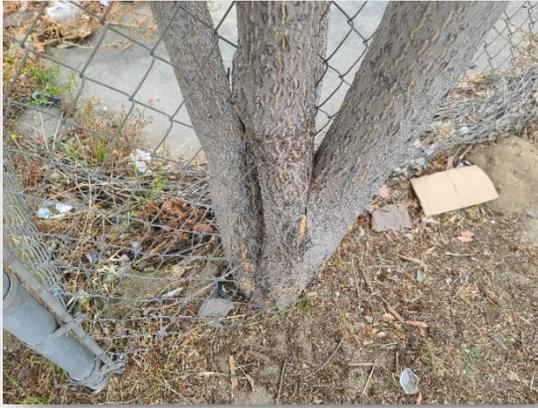
Plate 8. This is a view of a tree with an embedded chain link fence (#159).

Fair form and vigor, Crowded canopy										10	8			
158	Swiss Floss	26						26	34	10	22	10	2-3 2-3 2-3	Preserve
Off-set canopy mass, Prune strategically to preserve										16	10			
159	Tree of Heaven	4	5	3	3			15	24	6	6	8	3 3-4 2-3	Remove
Embedded in fence, Poor crotch attachment										6	6			
160	Magenta Lilly Pilly	11						28	28	6	8	6	3 3 3	Remove
Decay on stem, Sidewalk in critical root zone										6	6			
161	Magenta Lilly Pilly	12						12	36	10	10	4	3 3 3	Remove
Decay mid-stem										10	6			
162	Chinaberry	26						26	40	10	20	12	3 3 3	Remove
Offset canopy mass, Poor aesthetics, Topped branch with water sprouts										10	12			
UT1	Tree of Heaven	3	4	5				12	16	12	8	4	2 3 3	Remove
In planter, Multi-stem, Poor placement										13	4			
163	Arizona Ash	10.5						10.5	35	8	6	10	3 3-4 3	Remove
Internal decay, Poor placement, Next to building										8	2			
164	Tree of Heaven	7						7	24	2	10	6	3 3 3	Remove

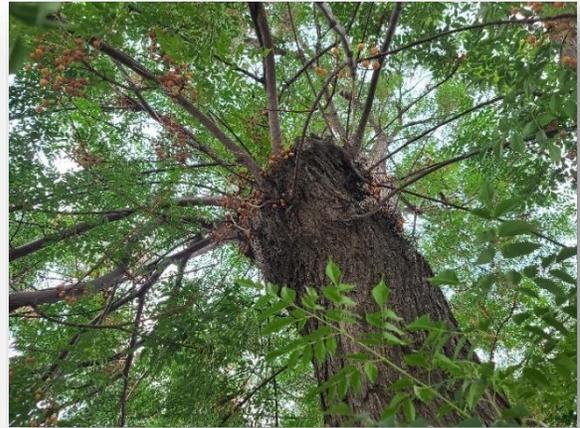
Plate 9. This is a view of “water sprouting” from a topped limb (#162).

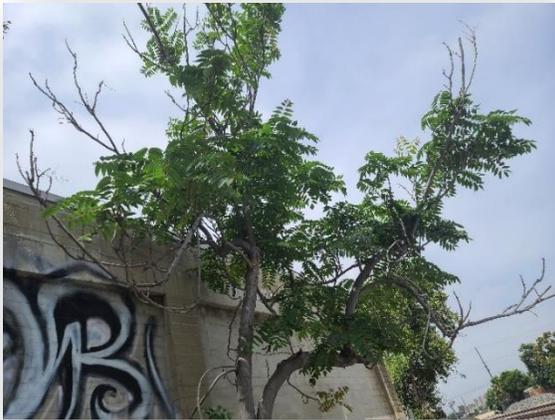
Plate 10. This is a view of canopy dieback (#164).

Dieback in canopy, Decline, Poor location										2	4			
165	Red River Gum	17						17	42	14	10	10	2-3 3 2-3	Preserve
Can save if building is demolished										14	10			
166	Tree of Heaven	8	6.5	3	7			24.5	25	10	10	12	3 3 2-3	Remove
Decay in stem, Next to building										10	8			
167	Tree of Heaven	5.5						5.5	22	8	8	6	3 3 3	Remove
Decay in stem, large canker										8	6			
168	Tree of Heaven	6.5						6.5	25	6	4	6	3 3 3	Remove
Decay in stem, large canker										6	6			
169	Tree of Heaven	5	6	6	7			24	32	6	10	16	3 3 3	Remove
Decay in stem, large canker										6	12			
170	Tree of Heaven	9						9	35	12	12	8	2-3 3 2	Preserve
Decay in stem, large canker										12	8			
171	Tree of Heaven	4.5						4.5	12	1	8	1	3-4 3 3	Remove
Poor aesthetics										1	1			
172	Tree of Heaven	2.5	2.5	2.5	2			9.5	18	4	6	4	3 3 2	Remove
Multi-stem, good vigor, Poor form										4	4

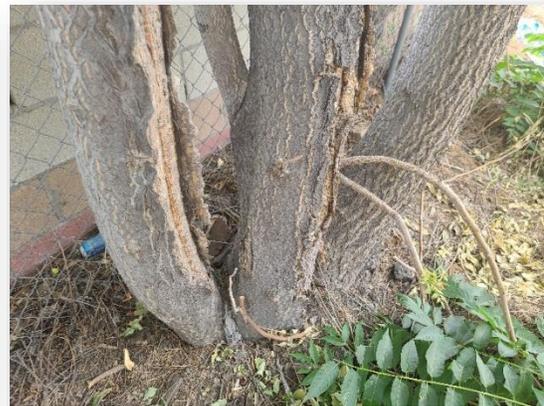
Plate 11. This is a view of medial longitudinal decay along stems of a tree (#169).

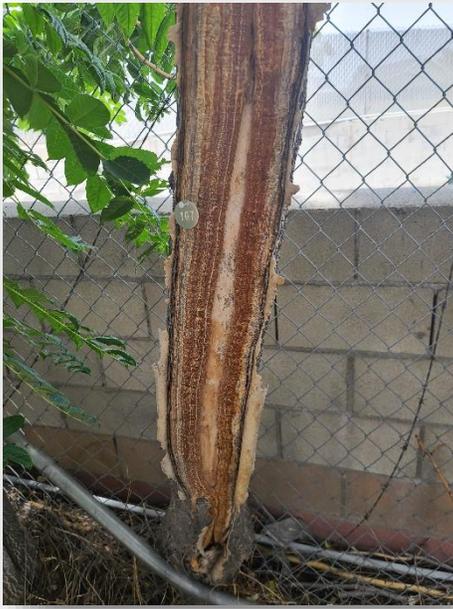
Plate 12. This is a view of a large canker within stem (#167).

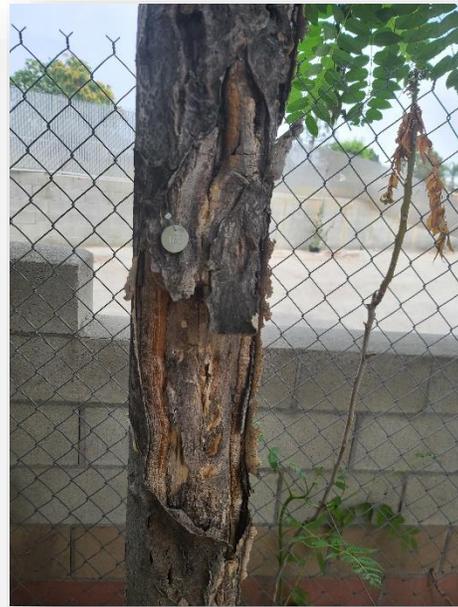
Plate 13. This is another view of a large area of decay within a stem (#168).

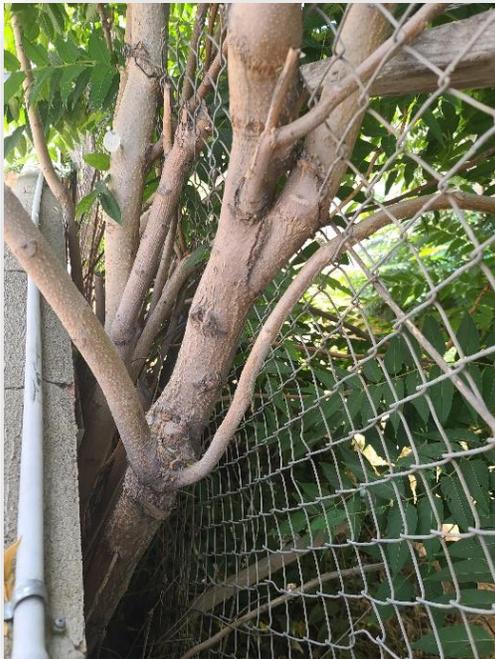
Plate 14. This is a view of a poor location with a tree between a fence and block wall (#177).

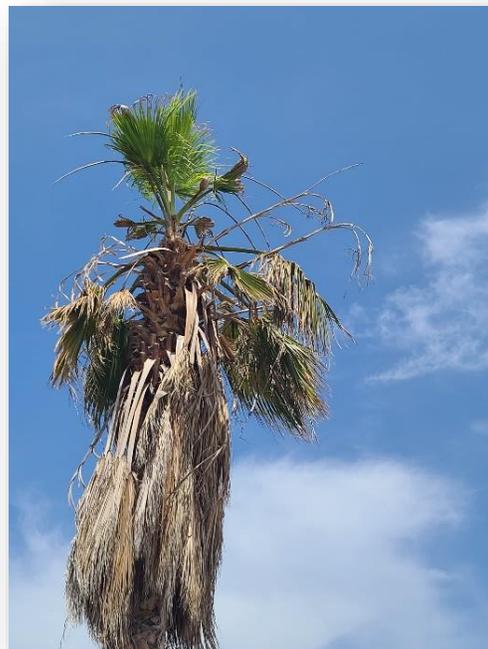
Plate 15. This is a view of canopy dieback within a palm (#178).
