Tree Inventory Report

**CITY OF LOS ANGELES TREE INVENTORY REPORT
THE BLOC, 700 S. FLOWER STREET, 700 W. 7TH
STREET, AND 711 S. HOPE STREET
LOS ANGELES, CALIFORNIA 90017**

MAY 26, 2022

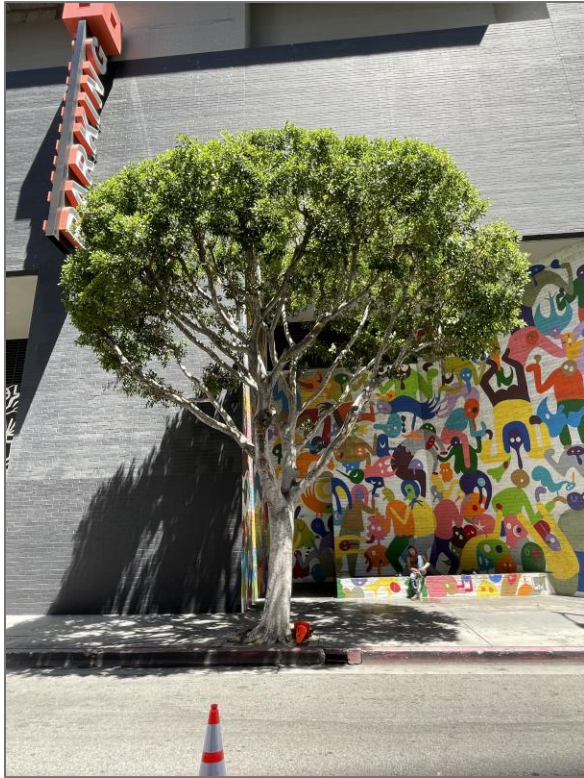
TREE #ST-9

ST9	Indian laurel fig	<i>Ficus microcarpa</i>	16.8	27	13/07/15/10	A	B	ROW	Slight mechanical scarring Sidewalk displacement
ST10	Indian laurel fig	<i>Ficus microcarpa</i>	17	29	09/03/17/11	A	B-	ROW	Slight mechanical scarring
ST11	Indian laurel fig	<i>Ficus microcarpa</i>	18.6	29	03/13/14/13	A	B	ROW	Slight mechanical scarring Sidewalk displacement

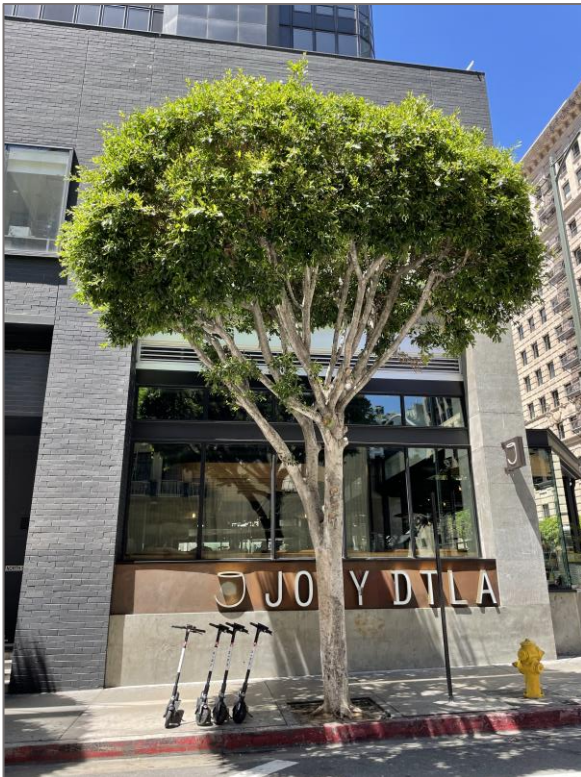
TREES #ST-20

ST20	Indian laurel fig	<i>Ficus microcarpa</i>	14.3	28	06/07/11/11	A	B	ROW	Slight mechanical scarring
ST21	Mexican fan palm	<i>Washingtonia robusta</i>	BT-29	35	06/06/06/05	A	B	ROW	Sidewalk displacement
ST22	Indian laurel fig	<i>Ficus microcarpa</i>	7.8	19	06/05/06/05	A	B	ROW

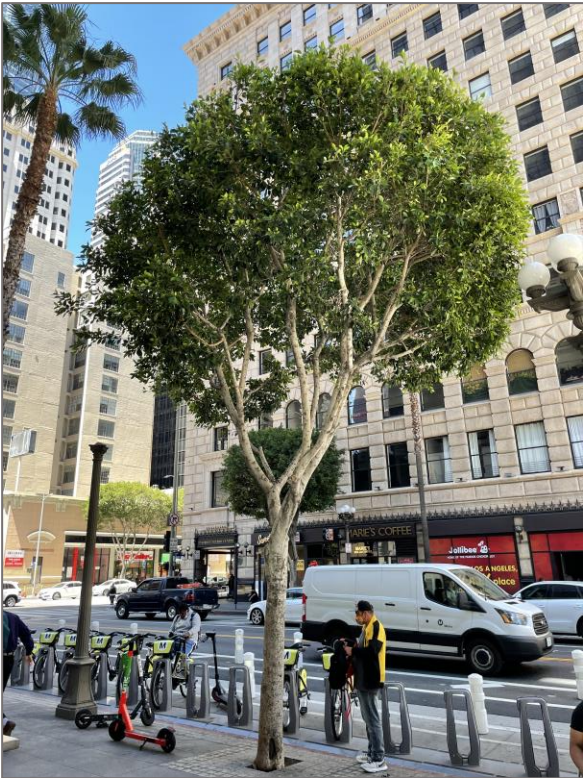
TREE #ST-23

Tree #	Common Name	Botanical Name	Diameter at 4.5 feet (DBH)* in inches	Height (feet)	Canopy Spread (N/E/S/W) in feet	Health	Structure	"Protected" or "Significant"	Comments
ST23	Indian laurel fig	<i>Ficus microcarpa</i>	9	23	06/08/10/07	A	B-	ROW	Basal wound
ST24	Mexican fan palm	<i>Washingtonia robusta</i>	BT-21	27	05/05/05/05	A	B	ROW	
ST25	Indian laurel fig	<i>Ficus microcarpa</i>	10.6	24	09/09/09/08	A	B	ROW
