PHASE I ENVIRONMENTAL SITE ASSESSMENT

Vacant Property
Assessor Parcel Numbers 418-122-021 and 418-160-006
Northwest of Pennsylvania Avenue & I-10
Beaumont, California 92223

CDR Group
2914 East Katella Avenue, Suite 200
Beaumont, California 92867
Tel: (714) 289 2255

May 9, 2019

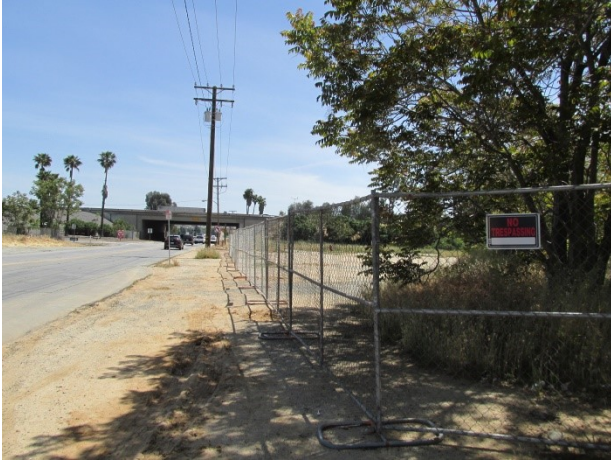
1. View of the subject property near the northeast corner, facing south

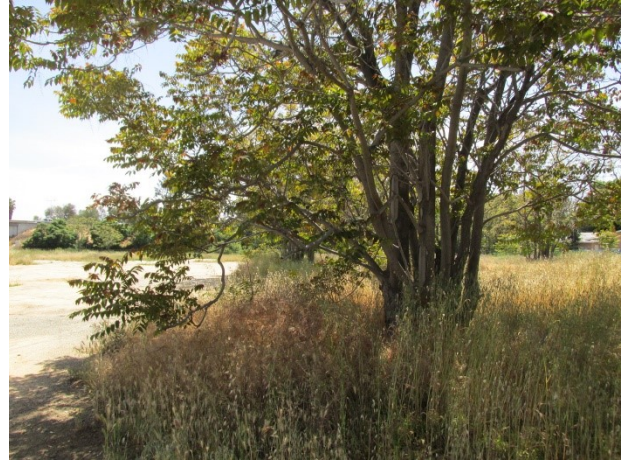
2. View of the subject property near the northeast corner, facing southwest

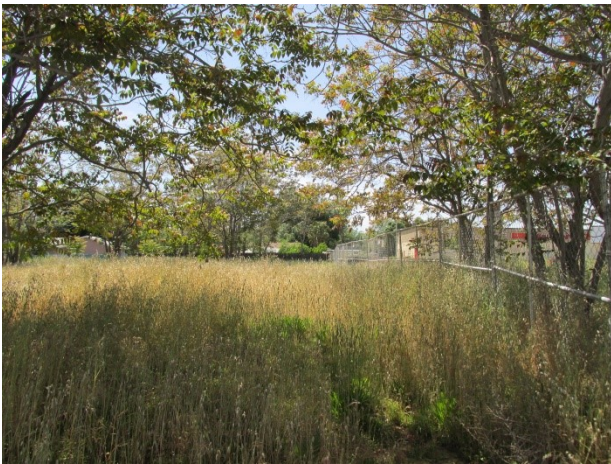
3. View of the subject property near the northeast corner, facing west

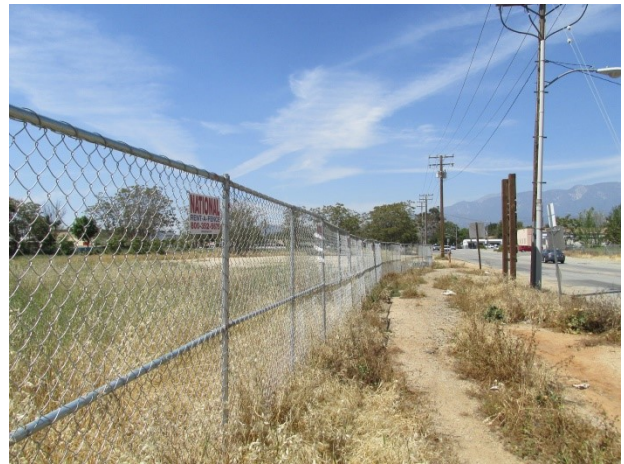
4. View of the subject property near the southeast corner, facing north

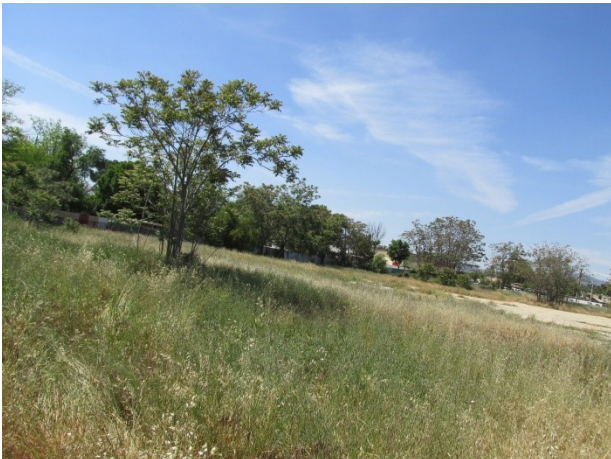
5. View of the subject property near the southeast corner, facing northwest

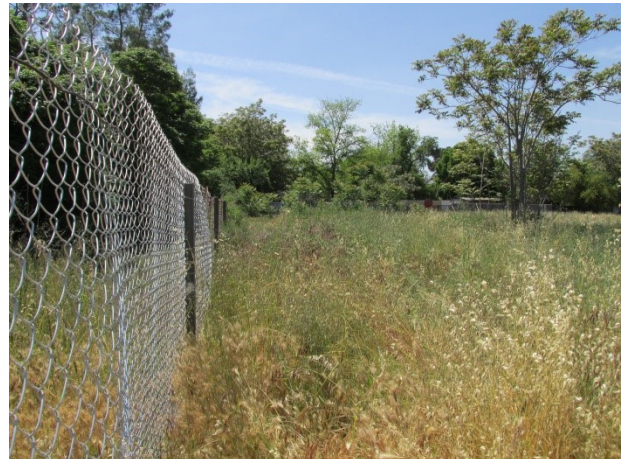
6. View of the subject property near the southeast corner, facing west

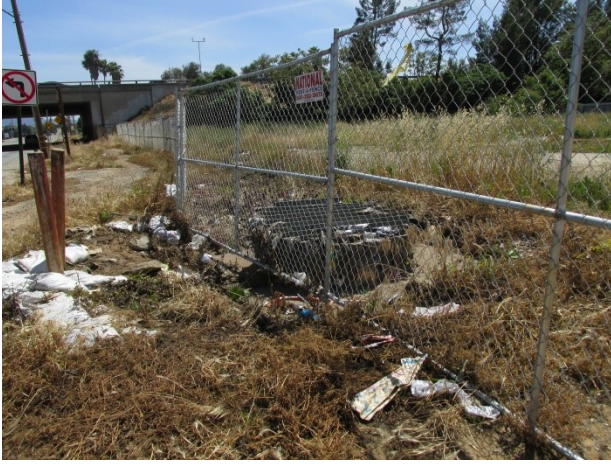
7. View of the stormwater drain centrally located near the eastern boundary

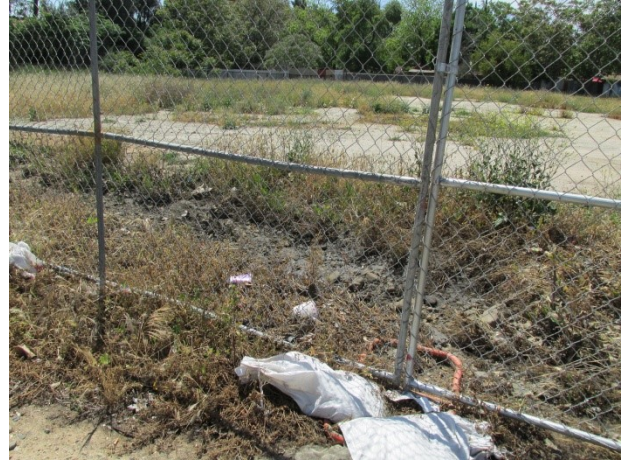
8. View of the stormwater drainage centrally located near the eastern boundary

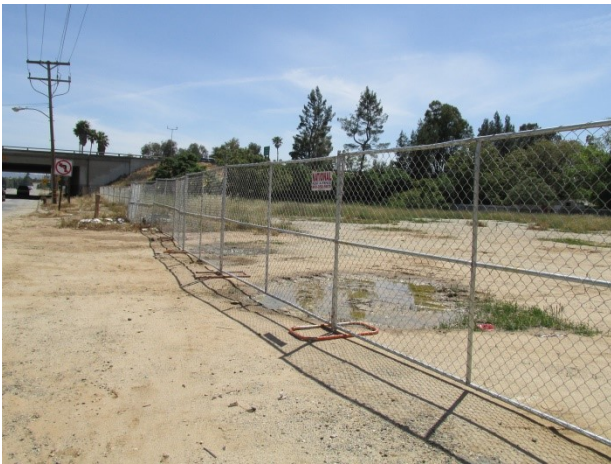
9. View of the pooled water adjacent to the stormwater drain

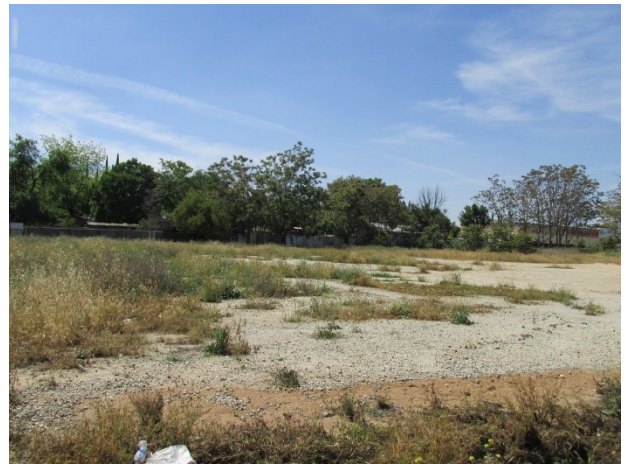
10. View of the central portion of the subject property from the eastern boundary, facing west

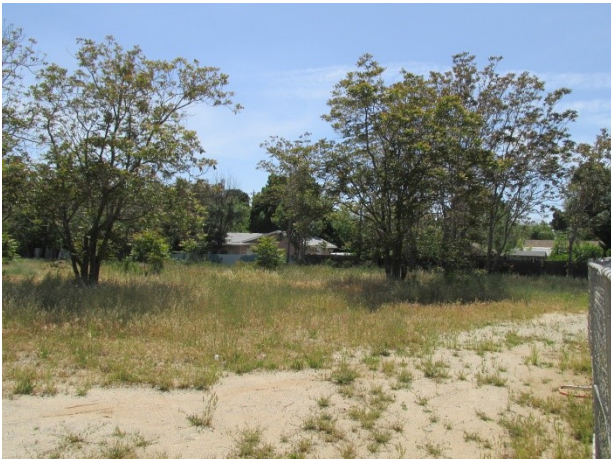
11. View of the northern portion of the subject property from the eastern boundary, facing west

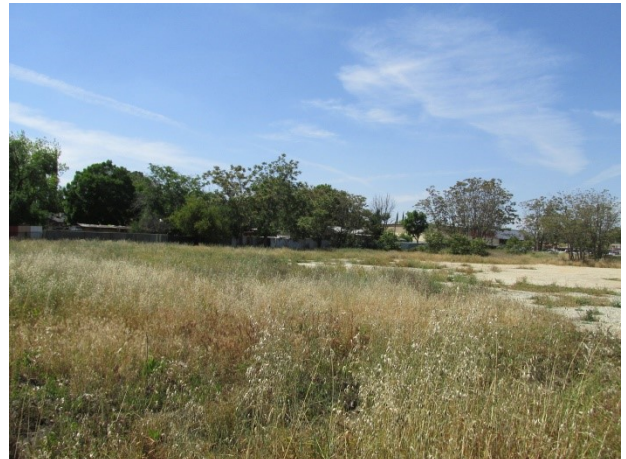
12. View of the southern portion of the subject property from the eastern boundary, facing west

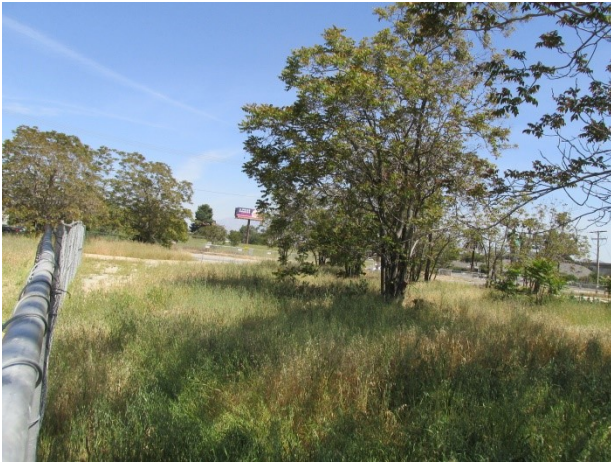
13. View of the subject property near the north-west corner, facing east

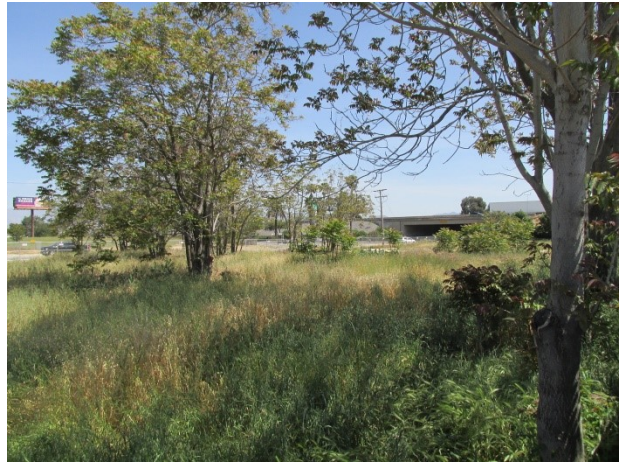
14. View of the subject property near the north-west corner, facing southeast

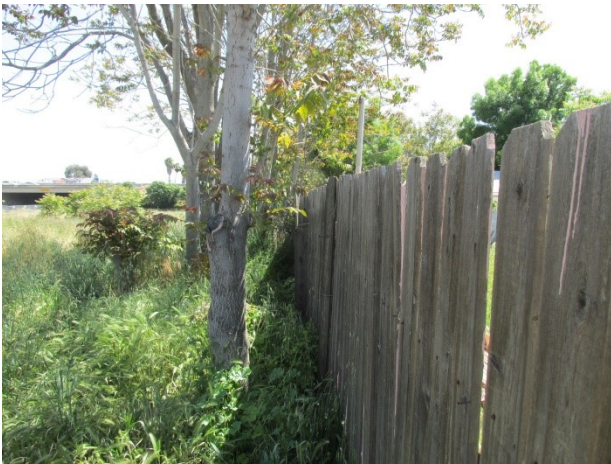
15. View of the subject property near the north-west corner, facing south

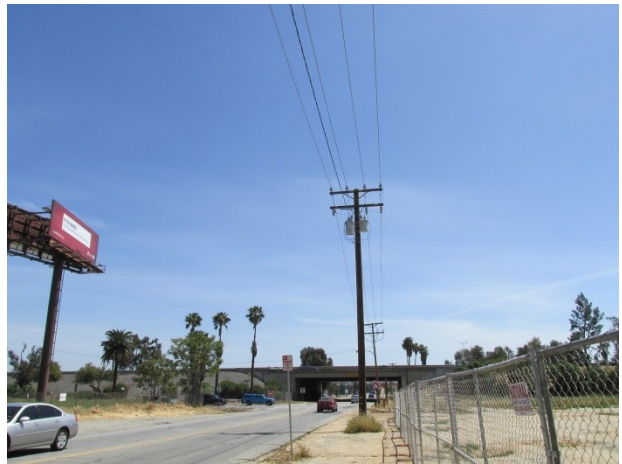
16. View of the adjacent roadway

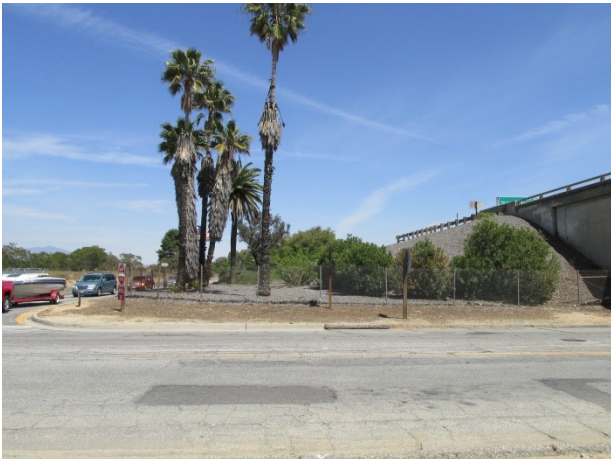
17. View of the adjacent property to the east, beyond the roadway

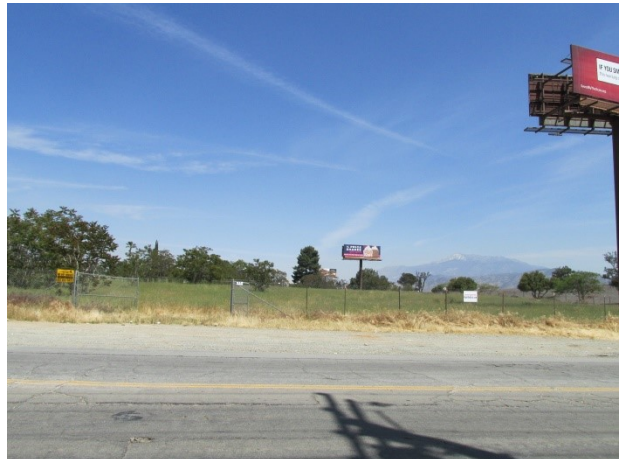
18. View of the adjacent property to the east, beyond the roadway

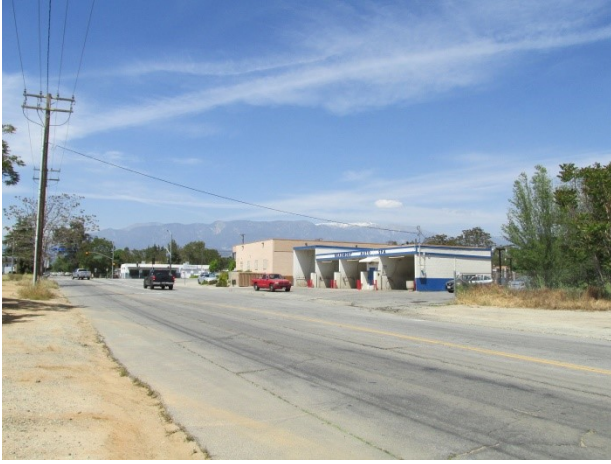
19. View of the adjacent property to the northeast, beyond the roadway

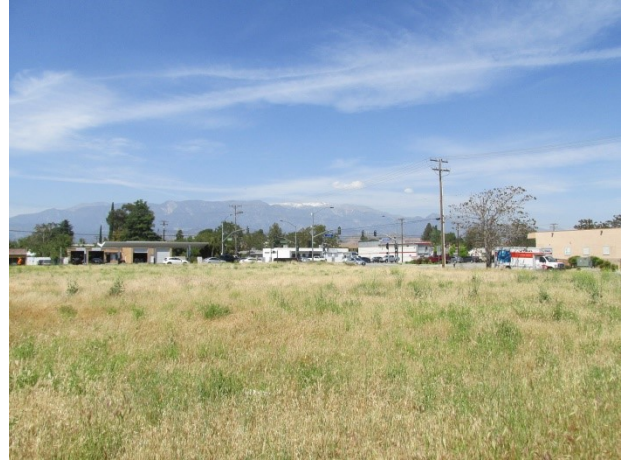
20. View of the adjacent property to the north of the subject property

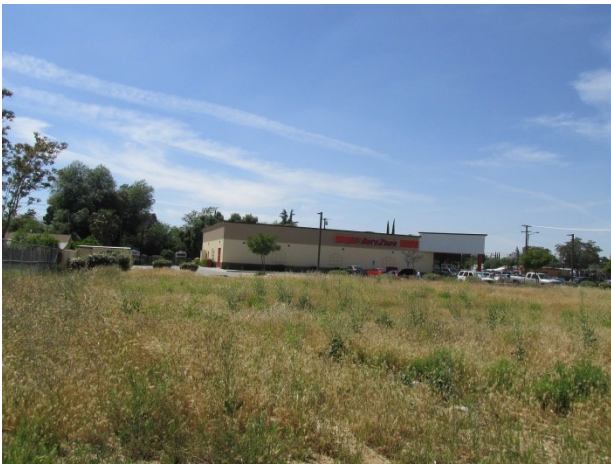
21. View of the adjacent property to the northwest of the subject property

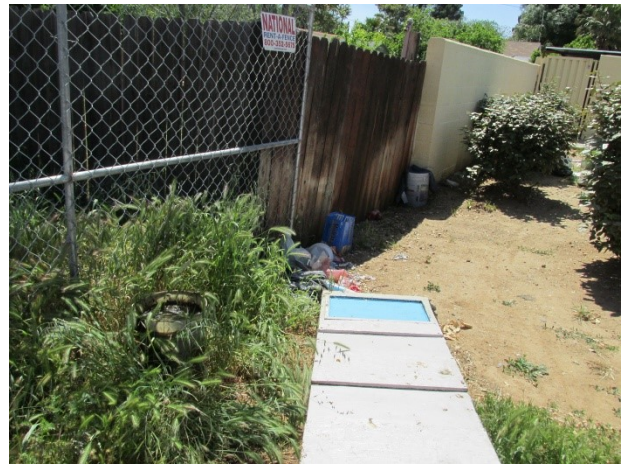
22. View of the household debris on the adjacent property to the northwest of the subject property.

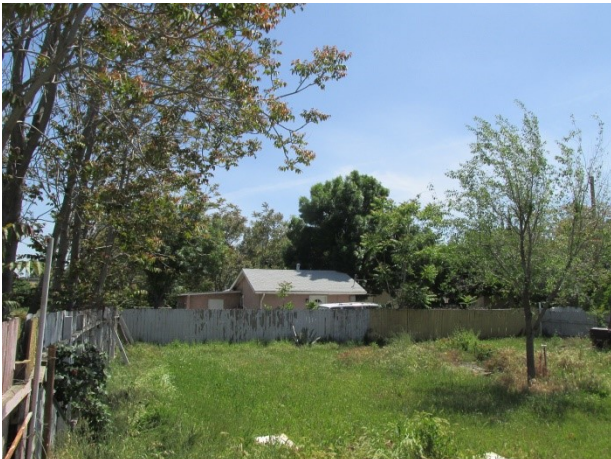
23. View of the adjacent property to the west of the subject property

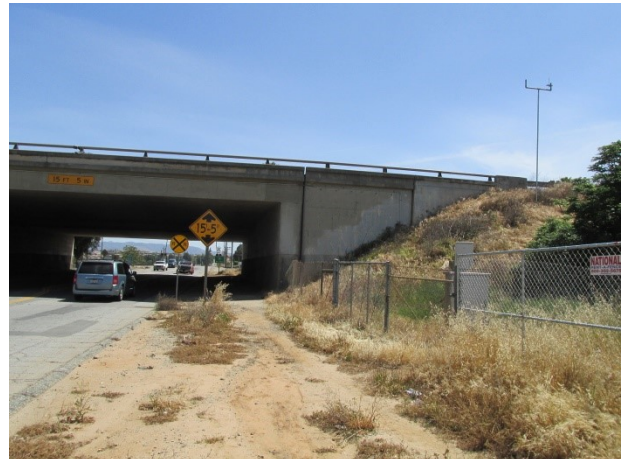
24. View of the adjacent property to the south of the subject property
