Arborist Report

5644 Gibbons Dr., Carmichael, CA 95608

September 23, 2021

Photos of heritage valley oak (tree# 297)

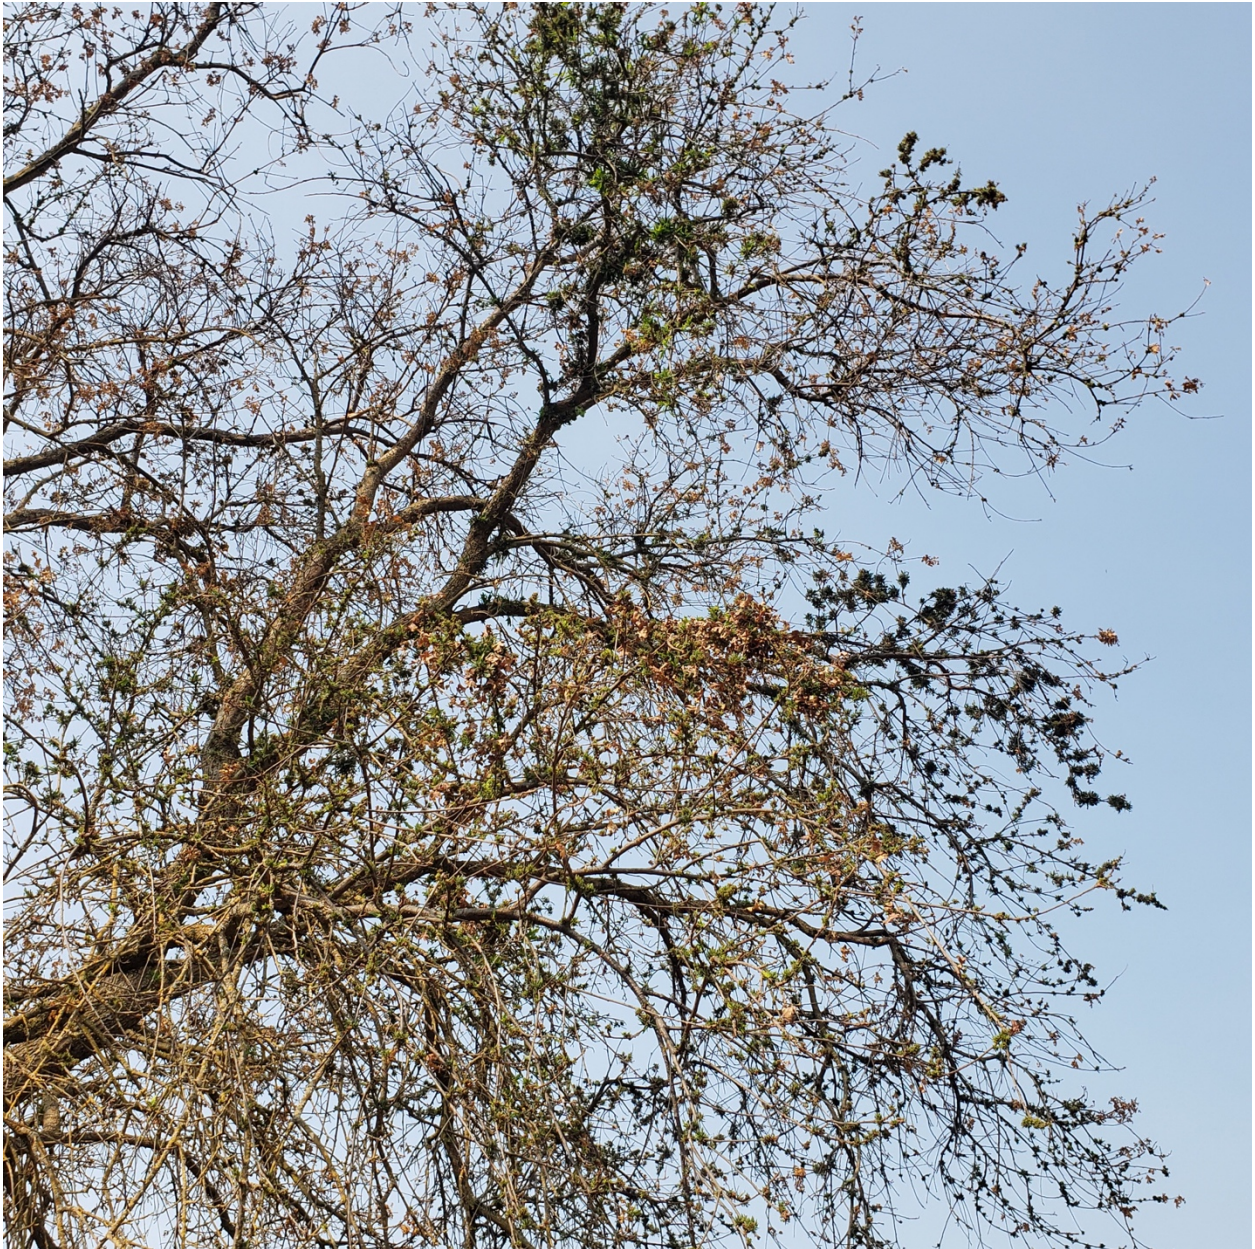
The heritage valley oak (tag # 297) is mostly dead. The green leaves it still exhibits are tiny and clustered in small patches in various spots in the canopy. Upon approaching this tree I had the impression it had been poisoned since I have seen these tiny, clustered leaves before on trees with herbicide poisoning. Upon inspection of the trunk, a drilled hole was observed on the east side of the trunk at ground level. Also at three different spots on the trunk are areas where the bark had been axed away to expose the wood beneath. These four wounds are where I believe an herbicide was administered to kill this tree. See the photos below.

Photo 1: This tree's canopy is mostly bare except for patchy clusters of shrunken leaves.

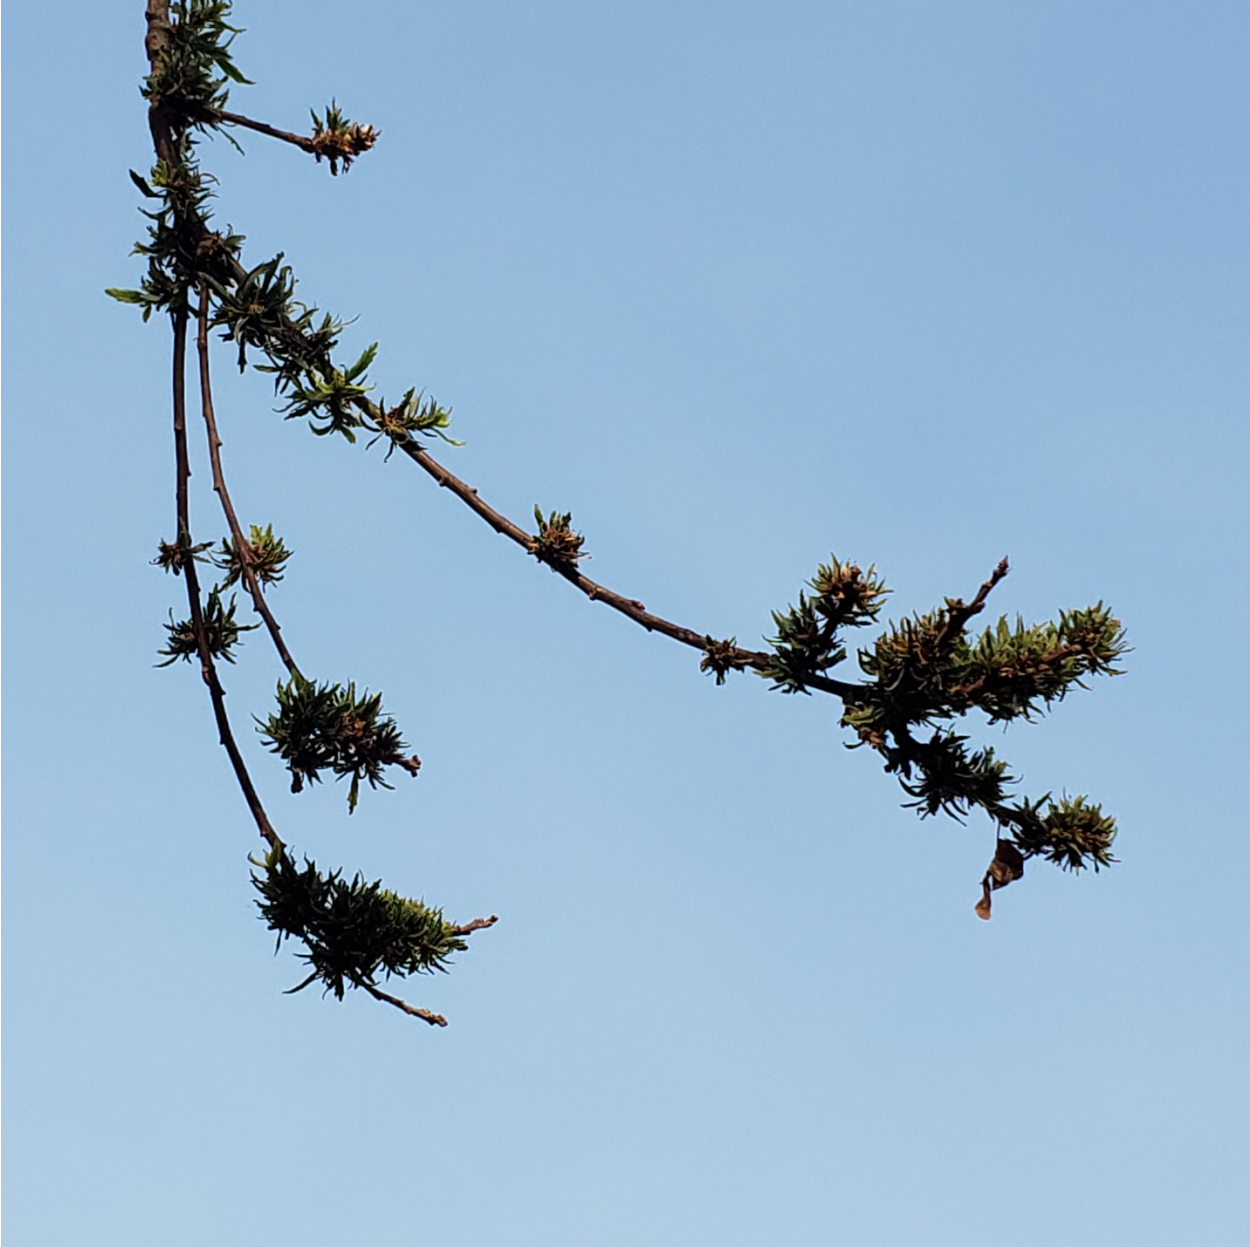
Photo 2: Close up of small leaf clusters on twigs of valley oak (tree # 297). These leaves are approximately one-tenth their healthy size.

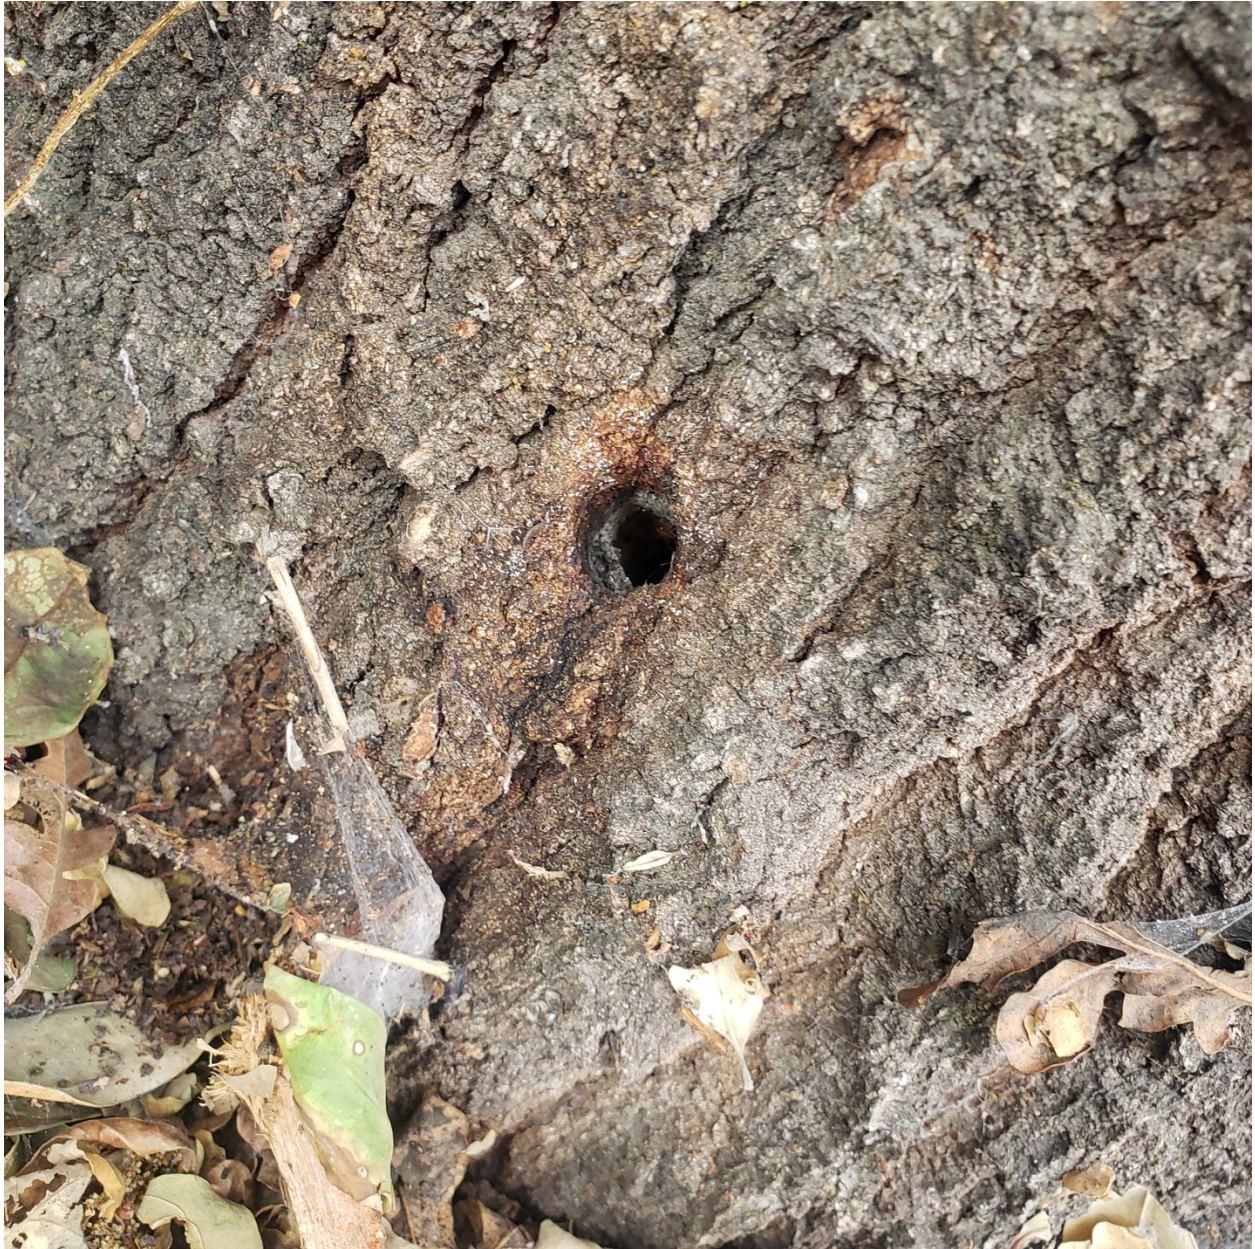
Photo 3: Hole drilled into the east side of the base of the tree (# 297). The hole is approximately $\frac{3}{4}$ " in diameter.

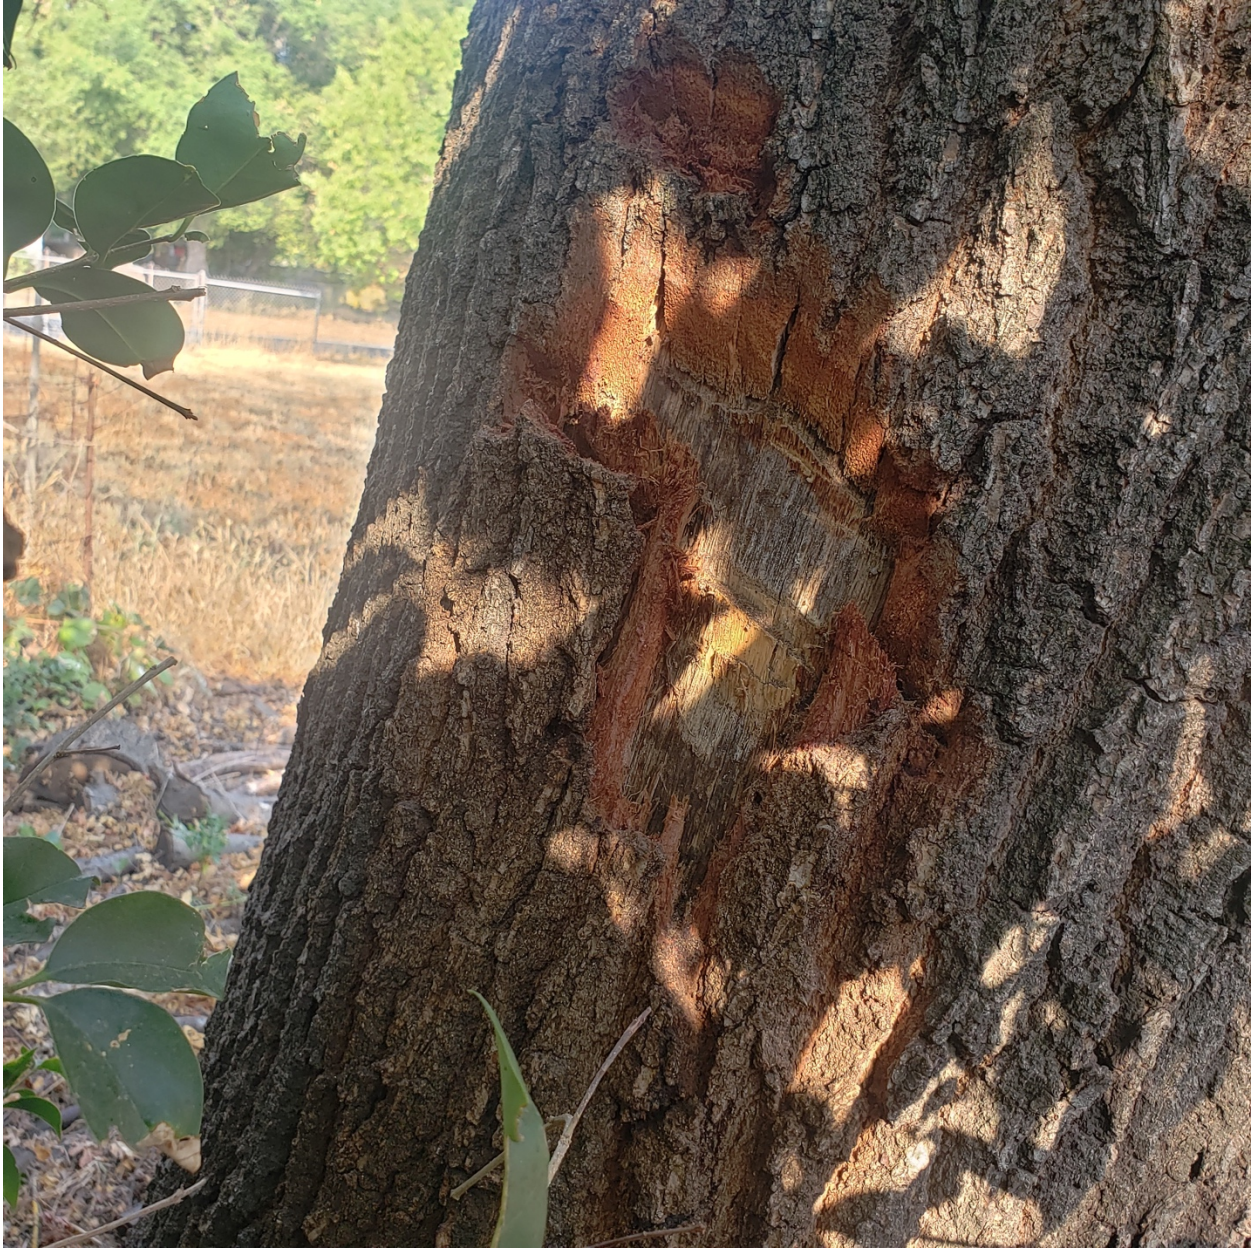
Photo 4: One of the three areas of bark on tree # 297 that was axed away to expose the wood underneath. These wounds would allow an herbicide to be introduced systemically into the tree's vascular system.
