## PRELIMINARY INVENTORY ARBORIST REPORT

RE: 7599 Stockton Blvd, APN 051-0180-021-0000, jurisdiction of Sacramento County, California

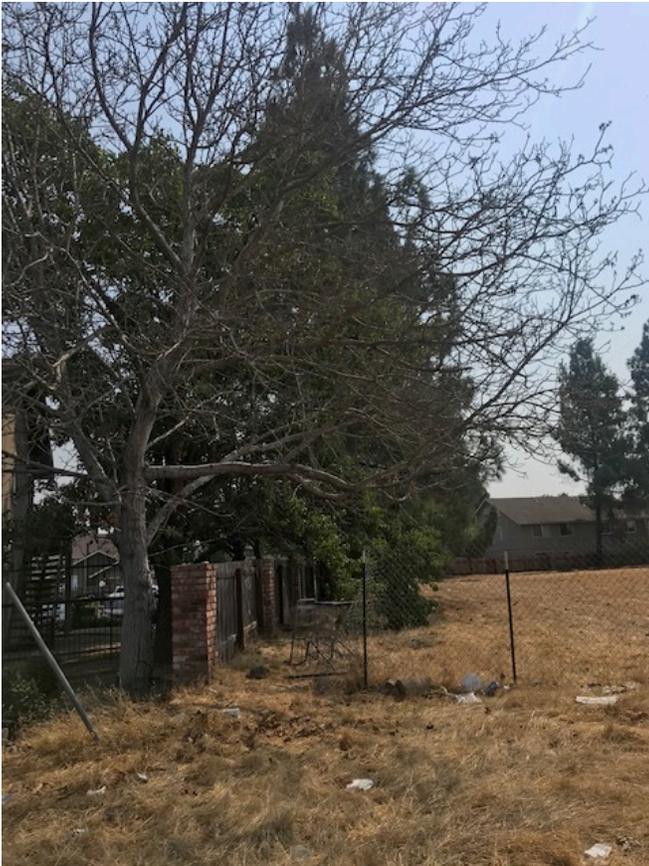
Photo 1, looking east from Stockton Blvd  
Dead offsite walnut showing on the left

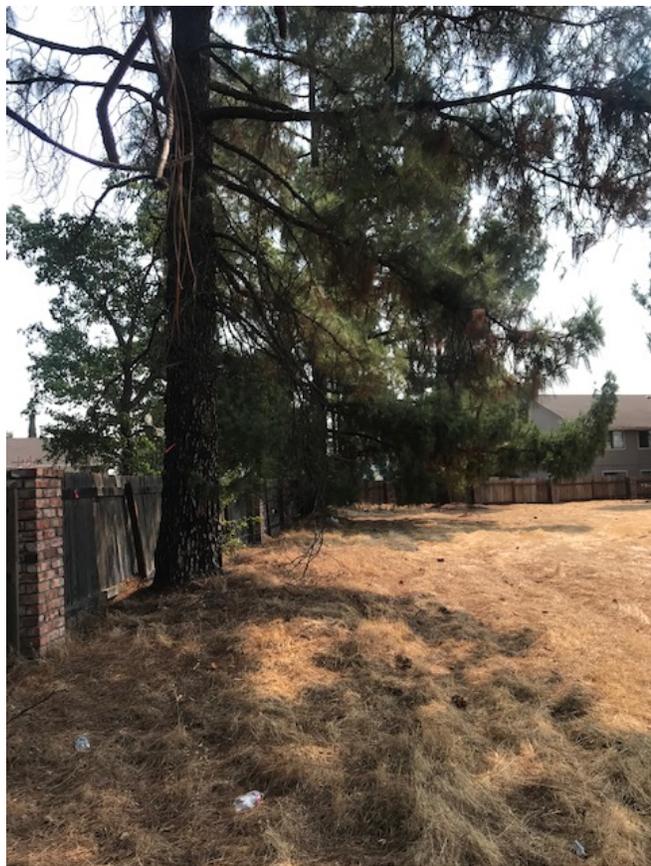
5468		Canary Island Pine	Pinus canariensis	20	54	15	3 Fair - Minor Problems	Proposed for Removal	Light burn around trunk up to 4' minor damage to lowest branches.
5469	Yes	Ornamental Pear	Pyrus calleryana	18	54	20	2 Major Structure or Health Problems	To be Protected during development	Offsite tag on fence. Trunk is 6' adjacent to Fence line north. Canopy hangs into sight to ground 10' south. <b>Install protection fencing a minimum of 6' from fence (12' from trunk). Any clearance pruning shall be supervised by project arborist</b>
5470	Yes	English Walnut	Juglans regia	16,10	54	20	0 Dead	No Impact, already dead	Offsite tag on fence trunk is 18" adjacent to Fence line north. Tree and canopy are dead. dead canopy extends over site 20'.

Photo 2, also looking east at tree 5468

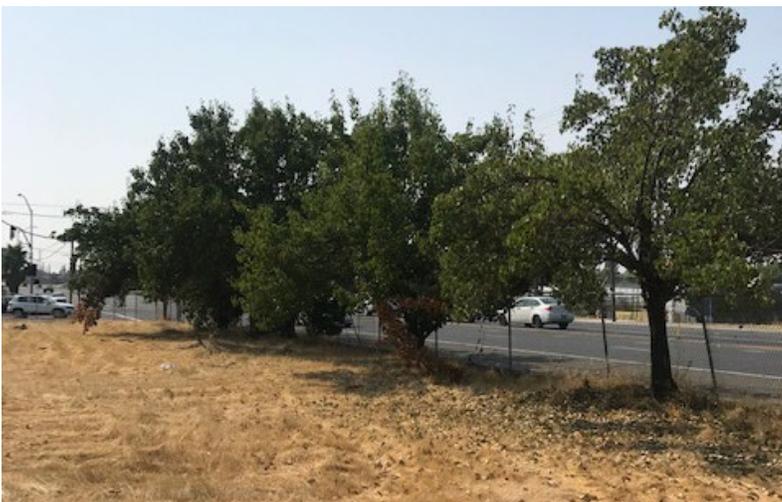
Photo 3, looking south at the ornamental pear trees along  
Stockton Blvd.
