April 27, 2020

TO: c/o Mike Muelrath
Kenzo Estates, Inc.
3200 Monticello Road
Napa, CA 94558

Subject: Landslide Hazard Evaluation, Kenzo Estates Vineyard
APN's 033-130-046, 033-190-014, and 033-190-015

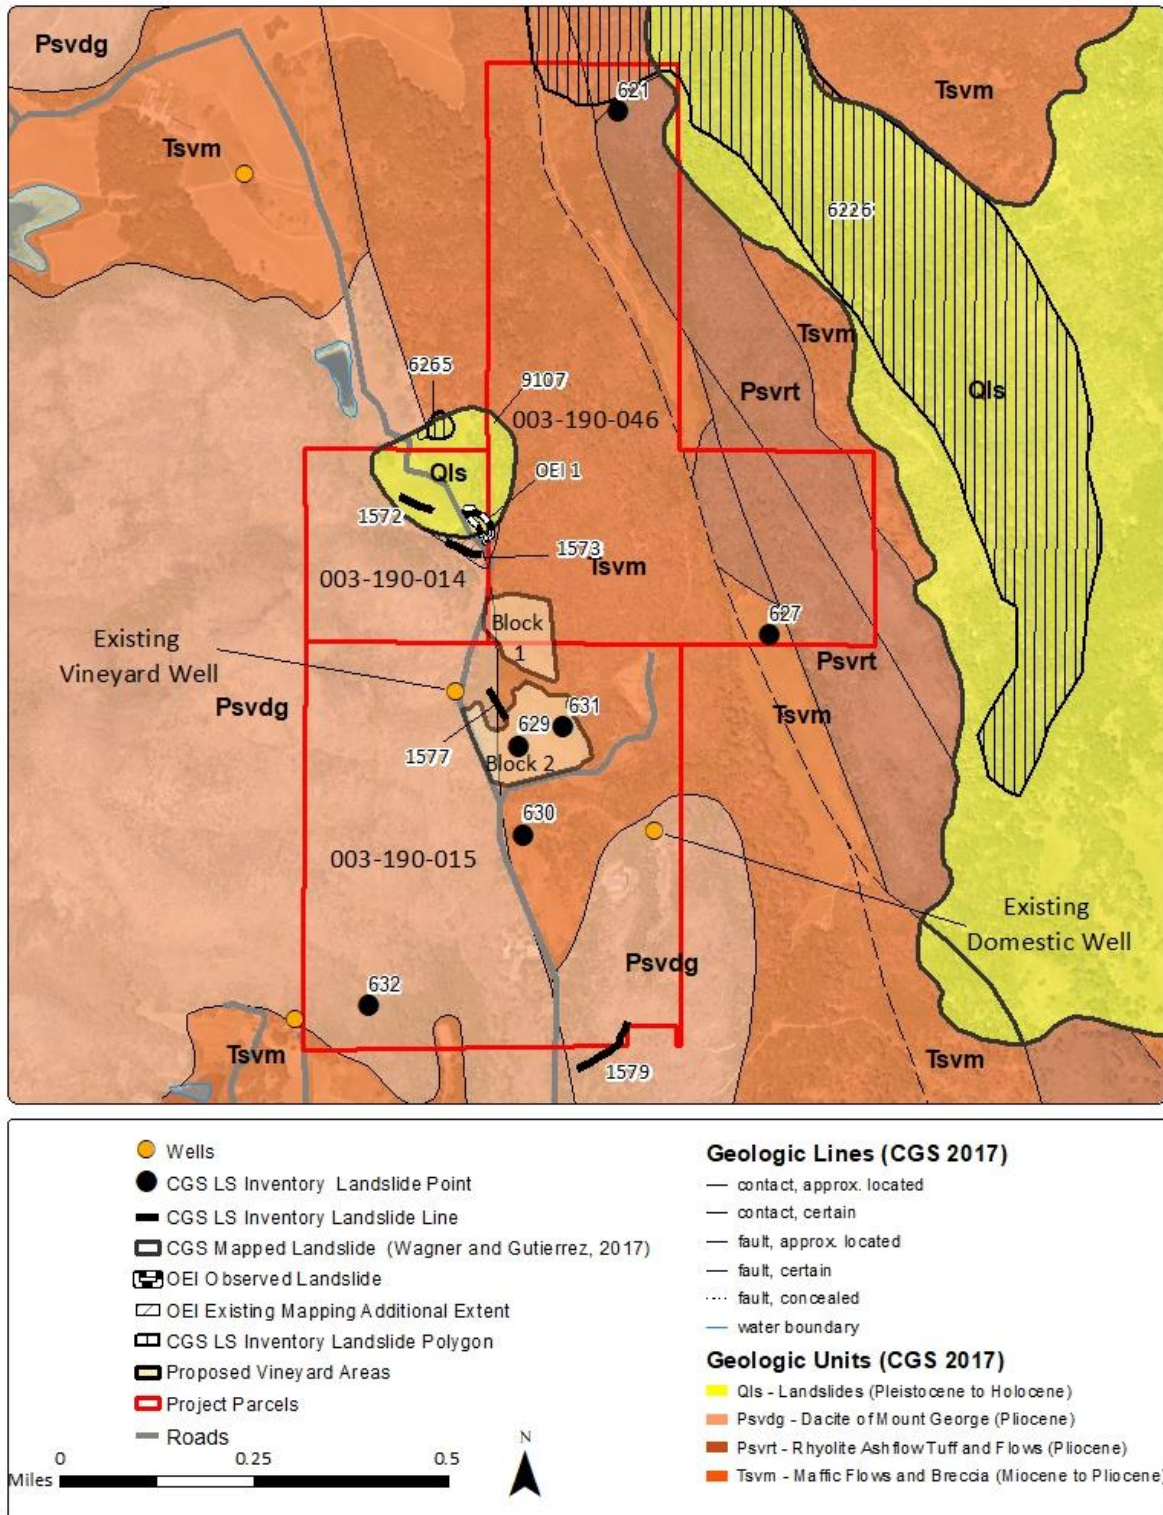
Two Quaternary landslides (map unit Qls) were previously mapped on the project parcels. The smaller of the two (approximately 14 acres in area, #9107 in the CGS geodatabase) is located

adjacent to Wild Horse Valley Road and covers the northeastern corner of western parcel (APN 033-190-014) and a small portion of the northern parcel (APN 033-130-046). A much larger, landscape-scale landslide complex (approximately 4,900 acres) is mapped to the east of the project parcels (Figure 1). A small portion of this landslide is mapped intersecting the northeast corner of the northern parcels. Specific details of these two slides are not reported in the CGS work; however, past mapping efforts by USGS classified some of these landslides as discussed in the next section. Reconnaissance confirmed the mapped bedrock geology. The site has numerous outcroppings of volcanic rocks of varied colors, weathering, and textures.

Figure 1. Surficial geology of the project parcel (Wagner and Gutierrez, 2017) and Existing mapped landslides from the California Geological Survey Landslide Inventory map (CGS, 2016).

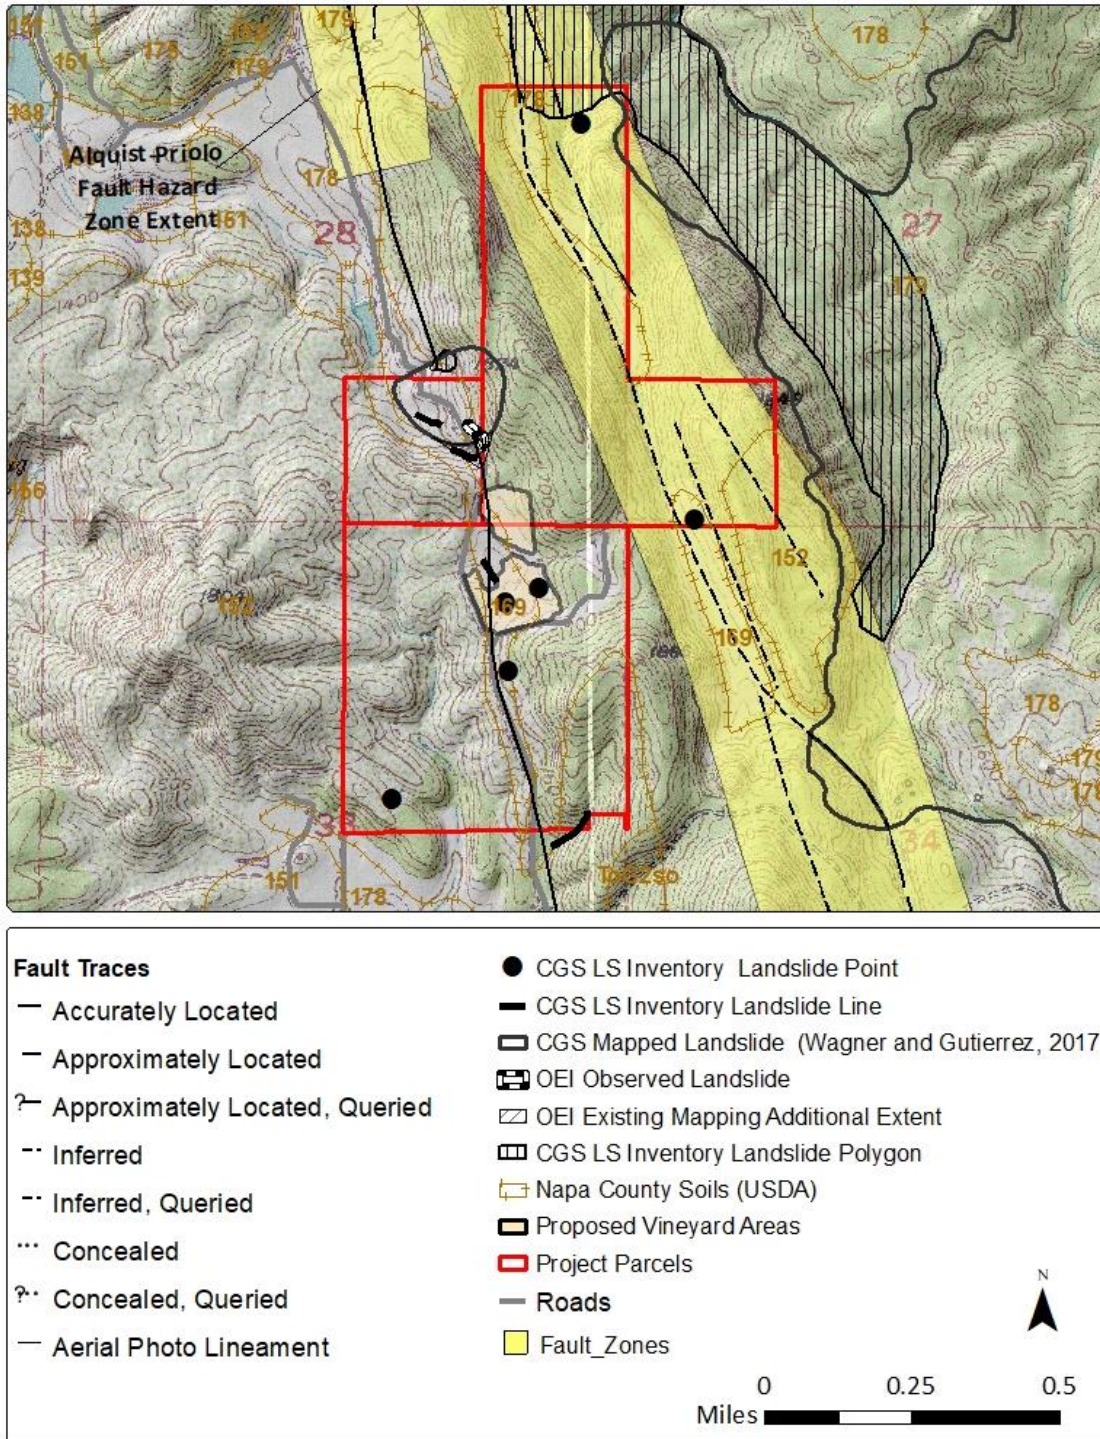
Numerous fault traces associated with the Green Valley Fault are mapped in the project vicinity; some are contacts between the mapped geologic units. Figures 1, and 2 show the locations and classifications of the locally mapped faults. All faults are classified as having experienced Holocene fault displacement (during the past 11,700 years) without historic record of displacement by the 2010 California Geologic Survey Fault Activity Map (CGS 2010). Some of these traces are mapped within the Alquist-Priolo Fault Hazard Zone (CGS 2018, see Figure 2); however, the existing residences and other inhabited developed areas (including the proposed vineyard areas) are not within these zones and an evaluation of slope stability related to earthquakes is not required.

Figure 2. Alquist-Priolo Fault hazard areas near the project parcels from California Geological Survey Seismic Hazards Program (CGS 2018) , distribution of USDA Soil types (see Table 2 for soil types), and Landslides on the project parcels, CGS California Landslide Inventory Landslides shown are from Dwyer, Noguchi and O'Rourke (USGS 1976) Wagner and Gutierrez (CGS 2017) and OEI (2020).

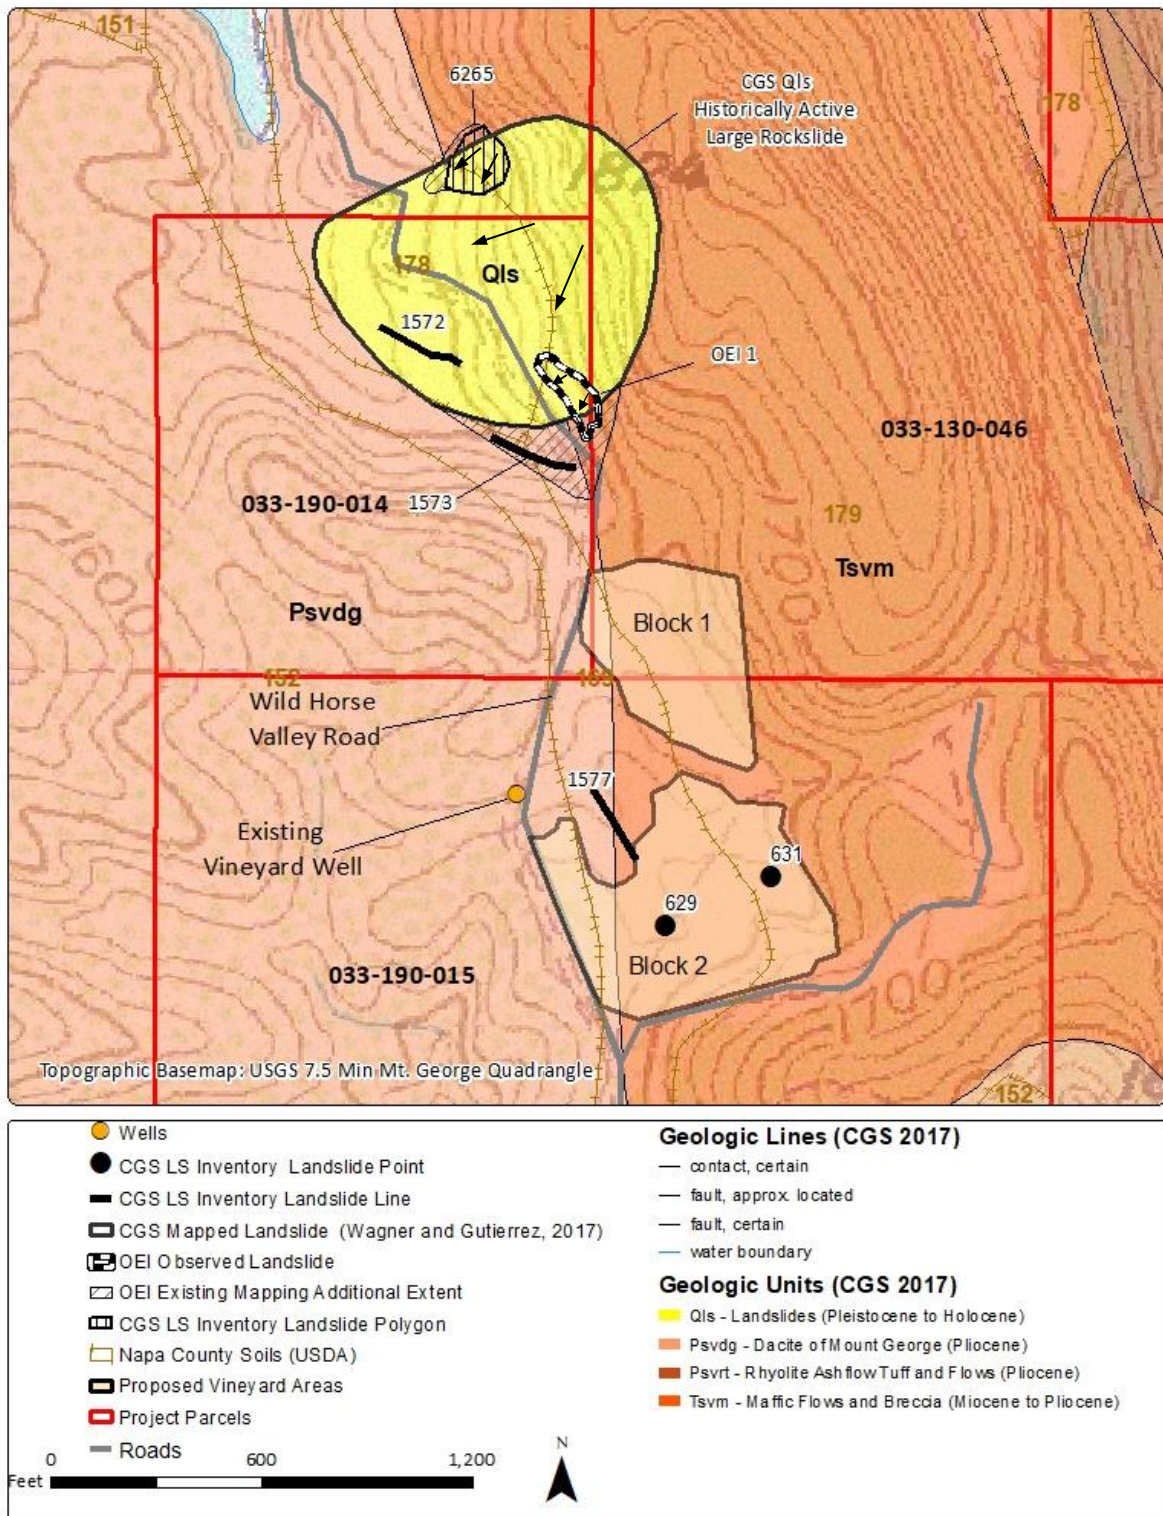
infrastructure within the northern parcel is a small portion of a new landslide (OEI 1, Figure 3), also mapped in the southeastern edge of the northern parcel near Wild Horse Canyon Road. The majority of OEI 1 is located on the western parcel and is described below.

Landslide #6265 is located on the northern flank of the larger Landslide #9107 Historically Active Large Rockslide (Figure 3). The toe of #6265 is located approximately 50 feet from Wild Horse Canyon Road in a convergent swale. Landslide #6265 is described as a “definite” landslide (USGS 1976); however, the landslide type is not described. Field observations revealed the landslide to be a Historically Active Debris Slide (Figure 3, Photo 1) but no evidence of recent movement was observed. A small seep of groundwater was observed within the body of the landslide. Landslide #6265 presents a low hazard to Wild Horse Road and no design recommendations or other actions are needed to address this degree of hazard.

Figure 3. Proposed project area showing areas visited and landslides mapped by Dwyer, Noguchi and O'Rourke (USGS 1976), Wagner and Gutierrez (CGS 2017) and OEI (2020).

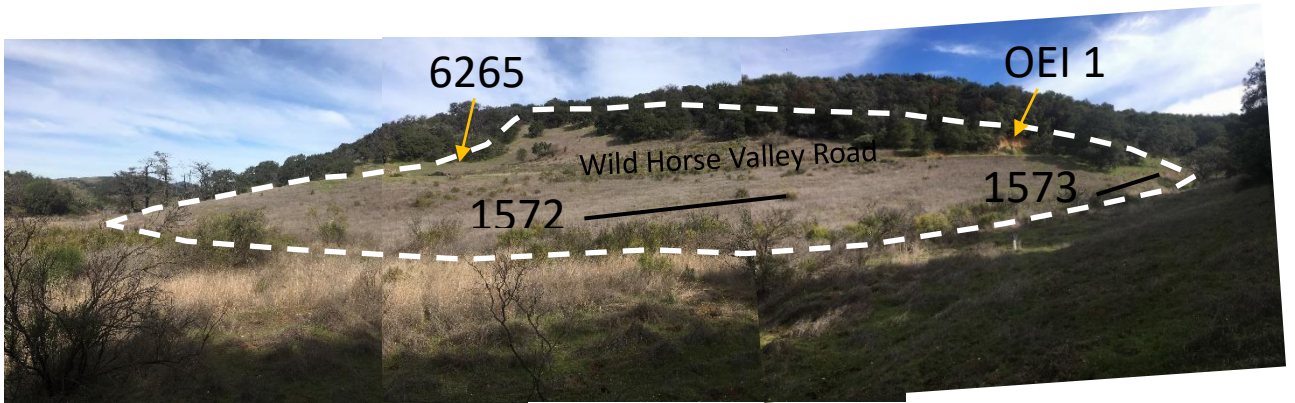
On the western project parcel no landslides were mapped by others near the vineyard areas. Mapped landslides are located further north on the western parcel and are all located within the large unnamed landslide mapped by CGS (#9107) in the Preliminary Geologic Map of the Napa and Bodega Bay (CGS, 2017, Figures 1 and 4). This landslide, which is mapped across a portion of Wild Horse Canyon Road, was observed to be a Historically Active Large Rockslide (Photos 1 and 2). Slopes up to 58% at the steepest portions near the head of the landslide while the main body has slopes between 25% and 35%. Two smaller landslides were observed within its extent, Landslide #6265 mapped by USGS 1976 and OEI 1 mapped during the site visit by OEI in 2020. Landslides #1572 and #1573 are also mapped within and near the large rockslide. These features were visited in the field and it was determined that they had identified linear topographic expressions of transverse ridges or cracks associated with the toe of the large rockslide. The extent of the large rockslide was expanded to include all of Landslide OEI 1 and Landslide #1573 (Figures 1 and 3).

Photo 1. Oblique view to the northeast of CGS QIs. Dashed line shows approximate extent and locations of 6265 and OEI 1 indicated by arrows, linear features 1572 and 1573 approximately located in toe (foreground) indicated by black lines.

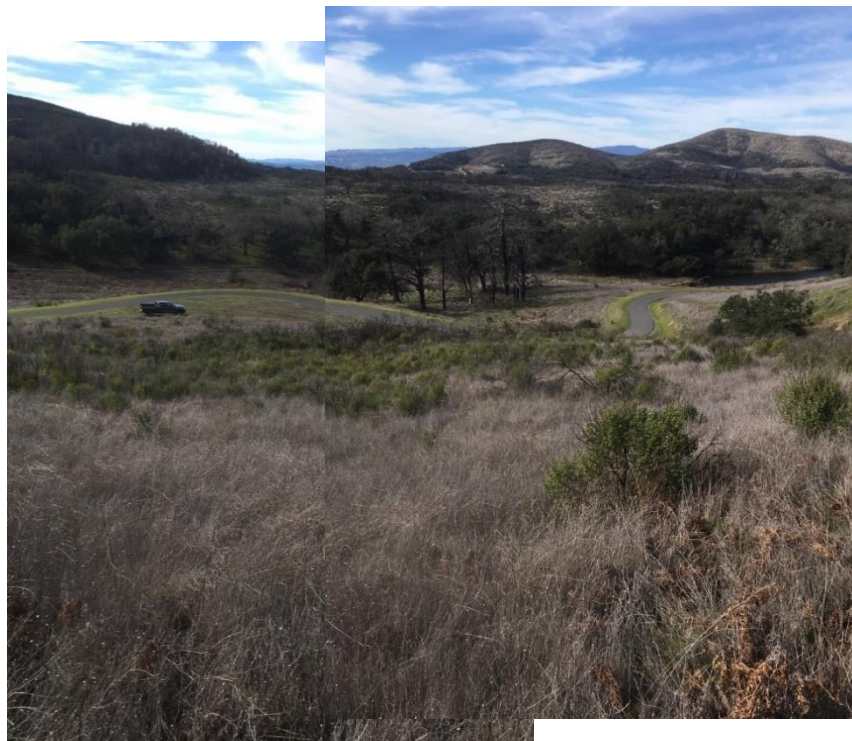
Photo 2 View to the southwest of CGS QIs of main body of slide.

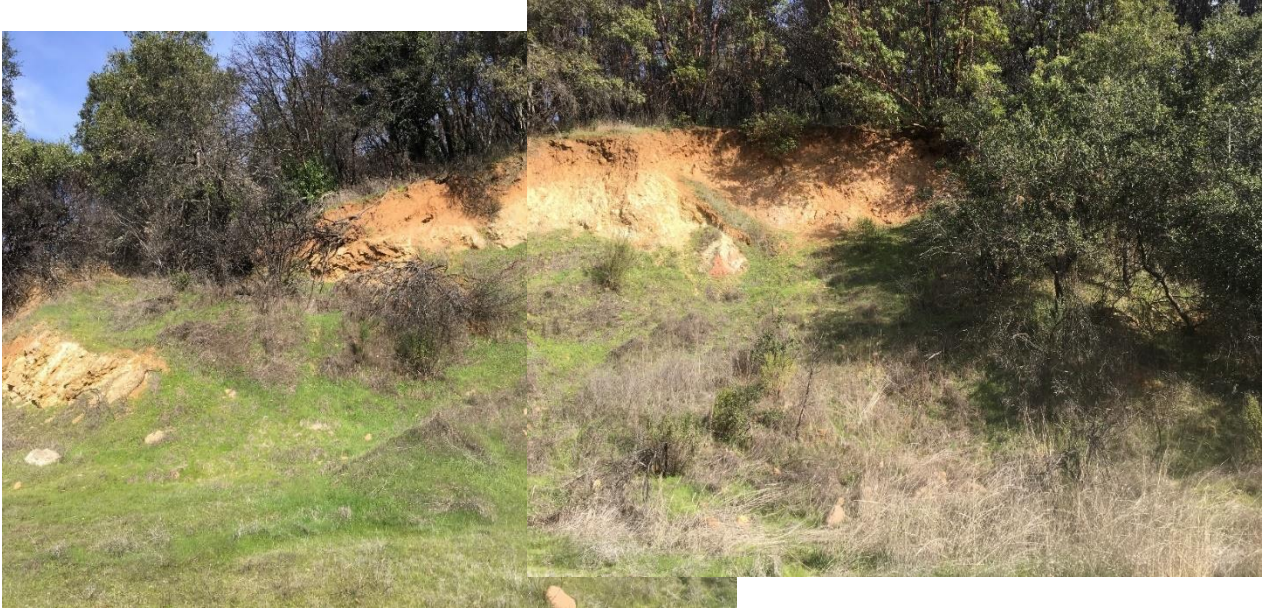
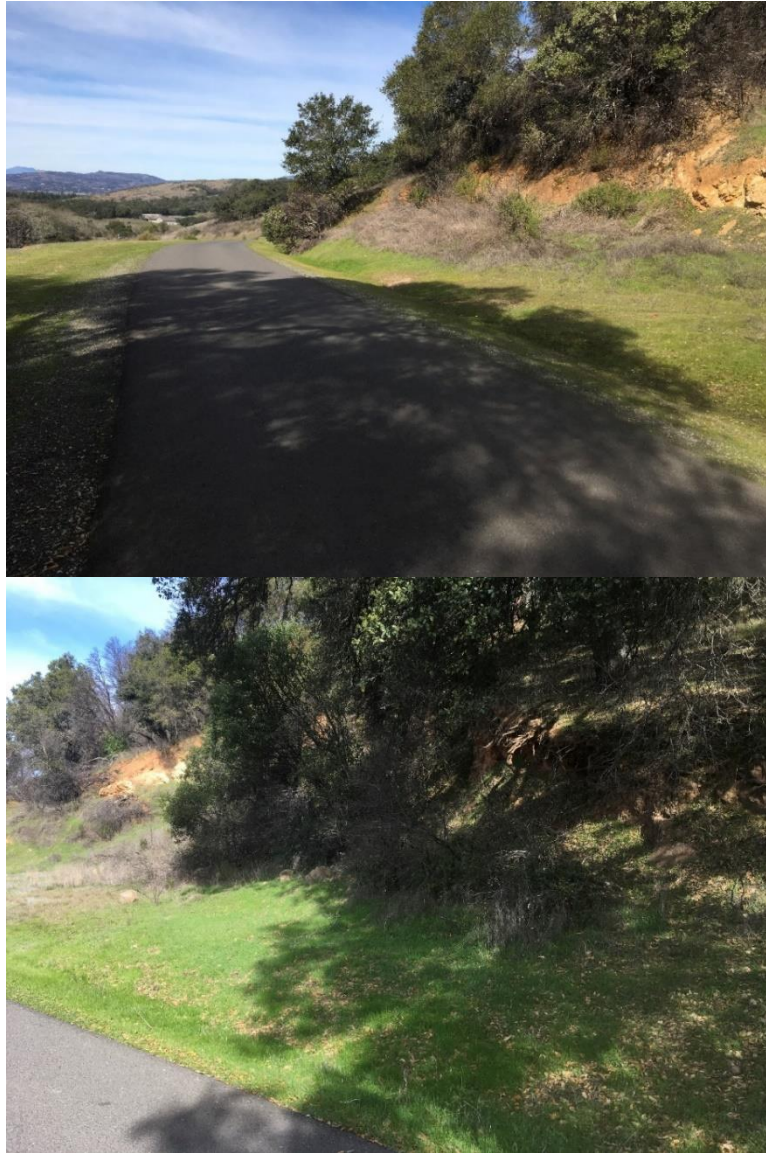
Landslide OEI 1 is a newly mapped active cutslope failure (Figure 3, Photos 3 and 4). Based on aerial photo review it appears that this landslide occurred between the years 2011 and 2014. A fresh vertical to over-hanging soil scarp is present along the width of the landslide and fresh deposits from recent unraveling of the scarp are present. The nearest portion of the landslide is within 25 feet of the road with the steepest portions located almost 100 feet from the road. There is a flat area used as a pullout between the road and the failure. This setback may be evidence that this area was associated with an old quarry site used for road building. No evidence of impacts to the road (tension cracks or hummocks) were observed; in light of this and the distance from the road Landslide OEI 1 presents a low hazard to Wild Horse Road and so no actions are recommended.

Photo 3. View to the northeast of main scarp and deposit of OEI 1.

Photo 4. Views north and northeast of OEI 1 and Wild Horse Valley Road.

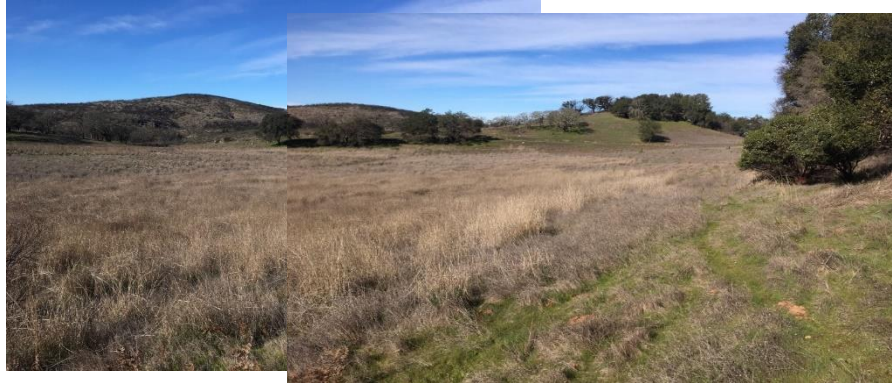
I inspected the perimeter of the southern portion of proposed Block 1 on the southern parcel and all of Block 2 reviewing slopes and ground conditions (Figure 3, Photos 5, 6 and 7). Slopes matched those presented in the ECP with maximum slopes of 30% in the southeastern corner of Block 2. In addition, I visited five of the six mapped landslides and assessed their classification, activity and stability (Figure 3, Table 1). Landslide #632 in the southeastern portion of the southern parcel was not visited as it is located outside of the project influence and away from

Photo 5. View to west from southeast corner of typical ground conditions in Block 1.

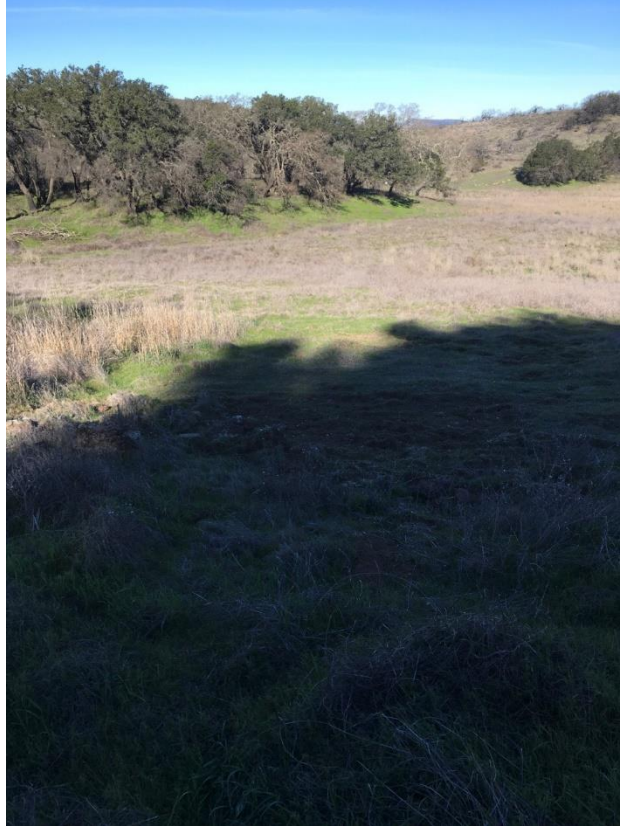
Outcrops of volcanic materials, including bedrock, boulders and cobbles, are present throughout the steeper portions of the proposed vineyard block areas (eastern edge of Block 1 and south portion of Block 2 as shown in Photo 6). In the northern project parcel evidence of significant amounts of rock removal to prepare the nearby vineyard fields indicates shallow depths to bedrock and rock in similar soils and geology as the project site. The presence of this volcanic rock lying at or near the surface throughout much of the steeper proposed vineyard site indicates that the site is not generally susceptible to landslide processes in the absence of fractures or structural dip slopes parallel to surface slope. The volcanic rock has high strength, and overlying soils types are relatively thin and described as having cohesive characteristics (clay rich loams) and on slope gradients that are far below typical thresholds of instability.

Photo 6. View to the northwest of Block 2, rock exposed at surface in the left of the picture.

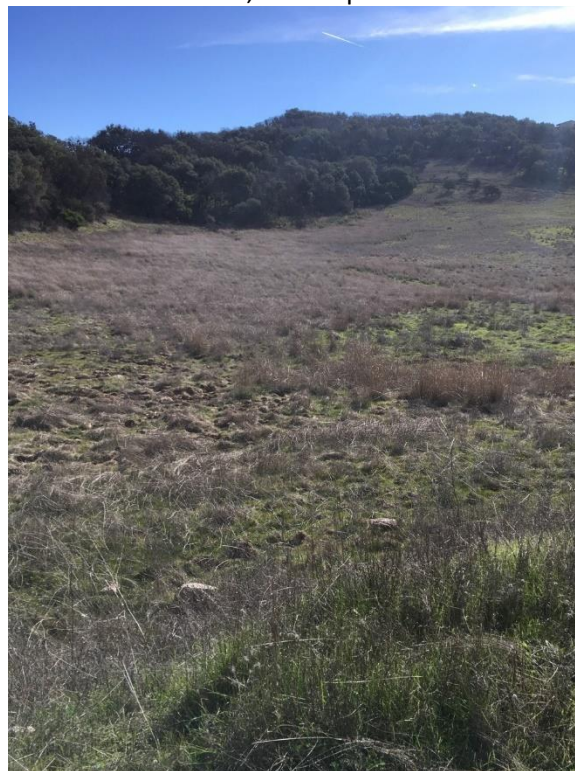
Photo 7. View to the south of surface conditions in Block 2.

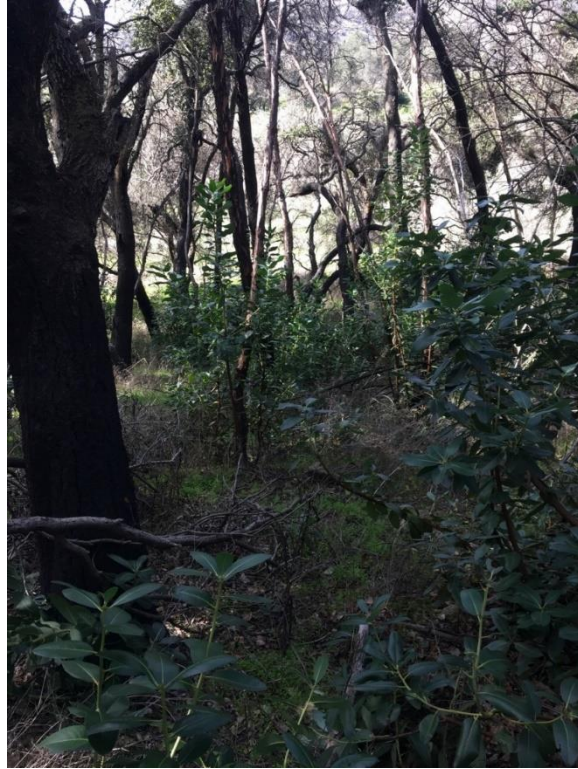
Photo 8. View of vegetation conditions on hillside east of proposed vineyard Block 1.
