7446 8th Street Parcel Map

Arborist Report

APN: 207-0011-001-0000 and 207-0011-003-0000
Address: 7446 8th Street, Rio Linda
Control Number: PLNP2021-00129

September 2021 | 05047.00002.001

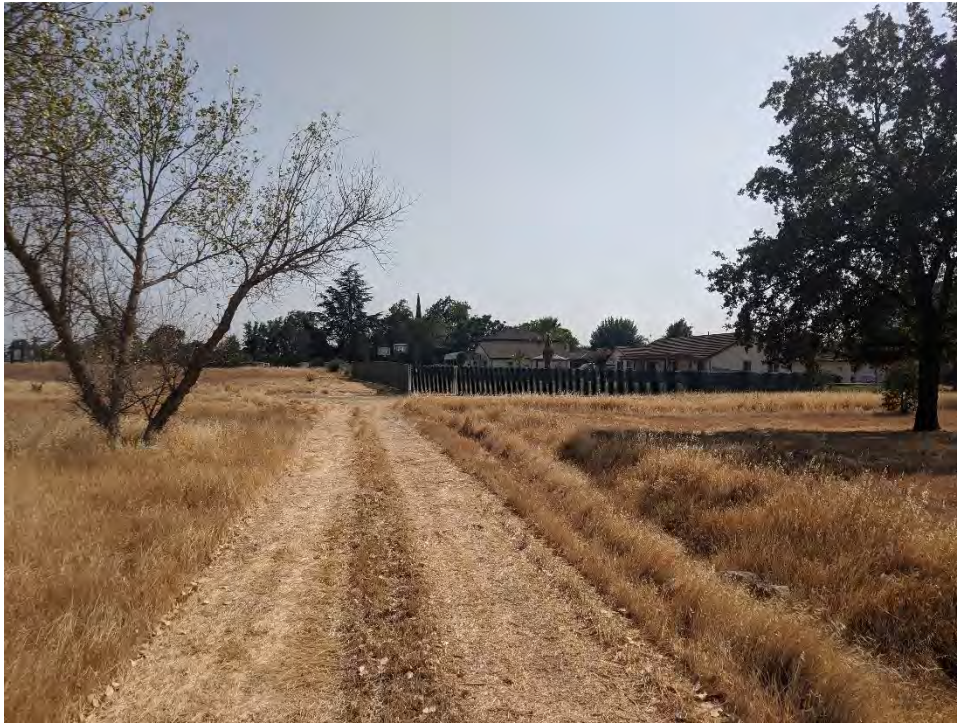
Photo 1. View of cottonwood and valley oak trees located in the non-native grassland on APN 207-0011-001-0000.

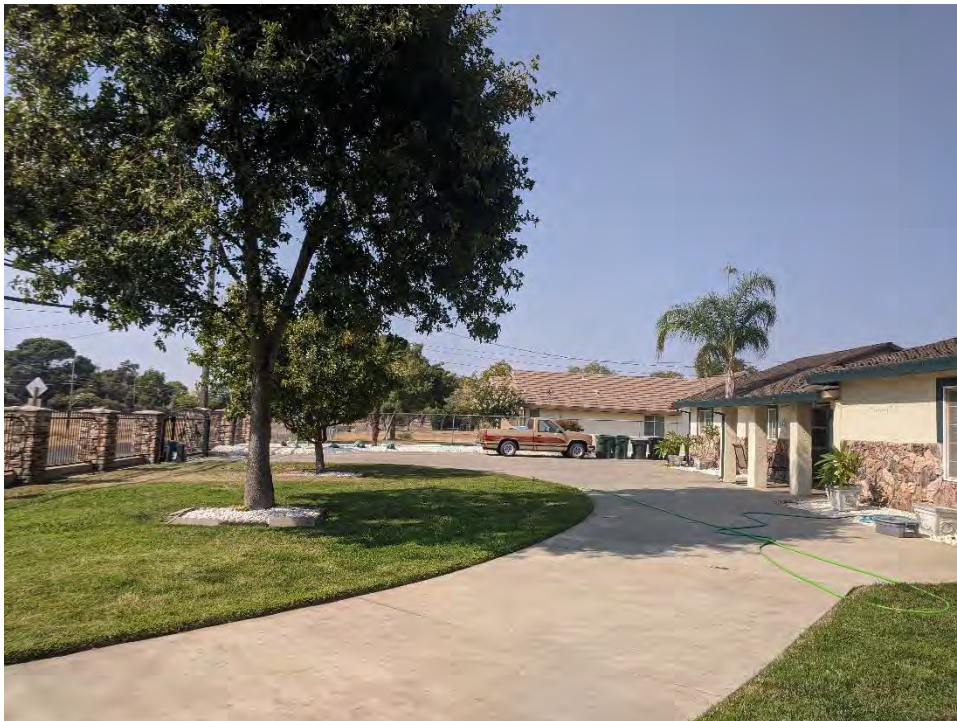
Photo 2. View of various ornamental trees in the front of the residence on APN 207-0011-001-0000.

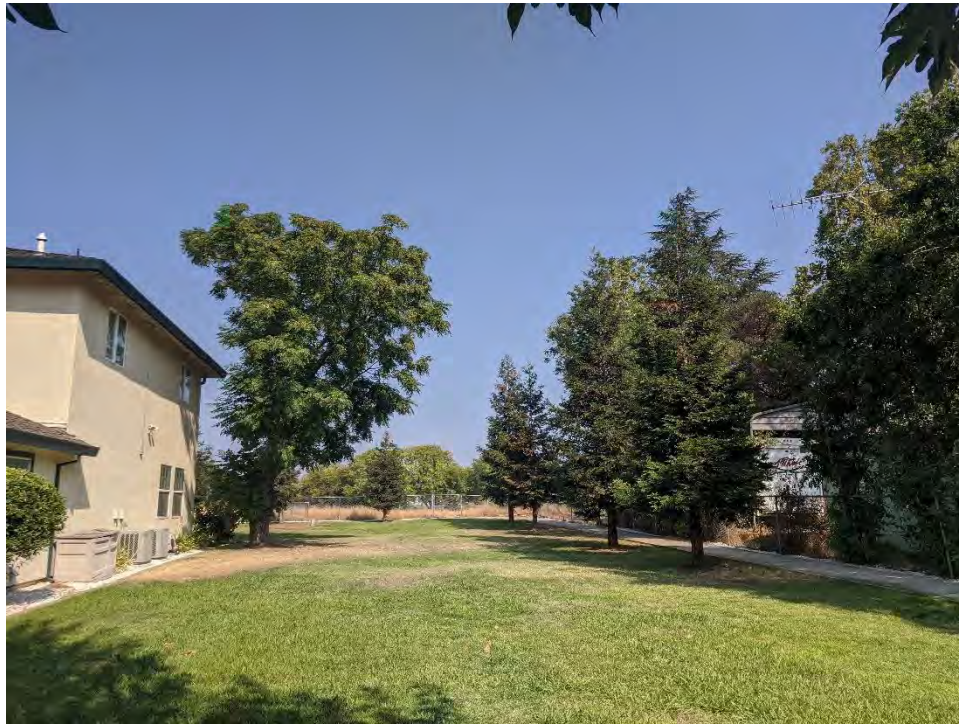
Photo 3. View of coastal redwoods and a chinaberry tree located south of the residence on APN 207-0011-001-0000.

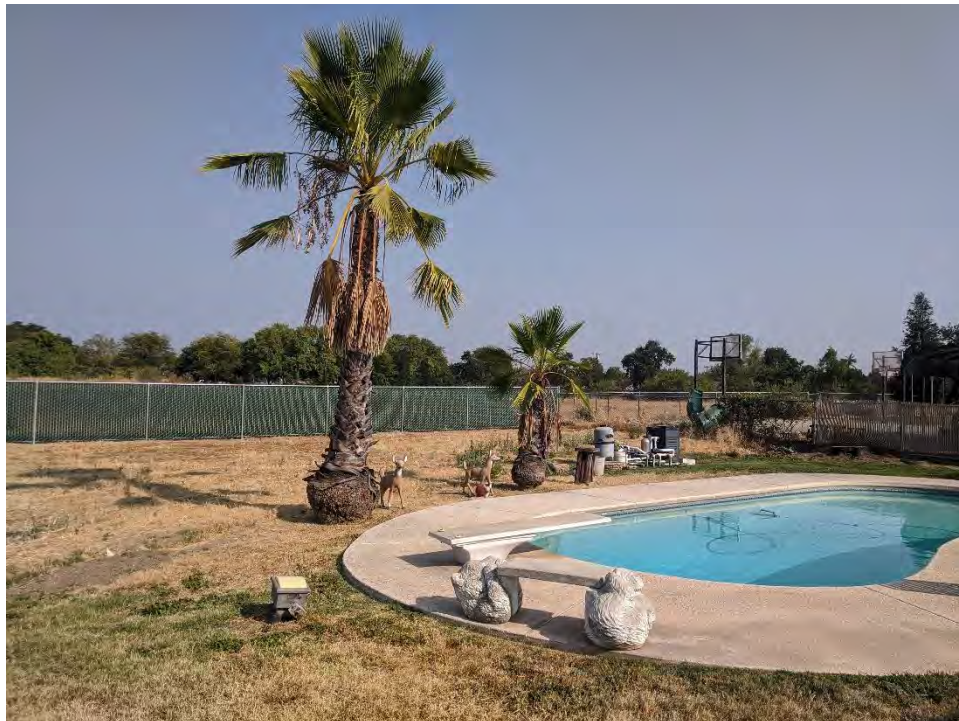
Photo 4. View of two Mexican fan palms (Tree #303 and #302) located next to a swimming pool behind the southern residence on APN 207-0011-001-0000.

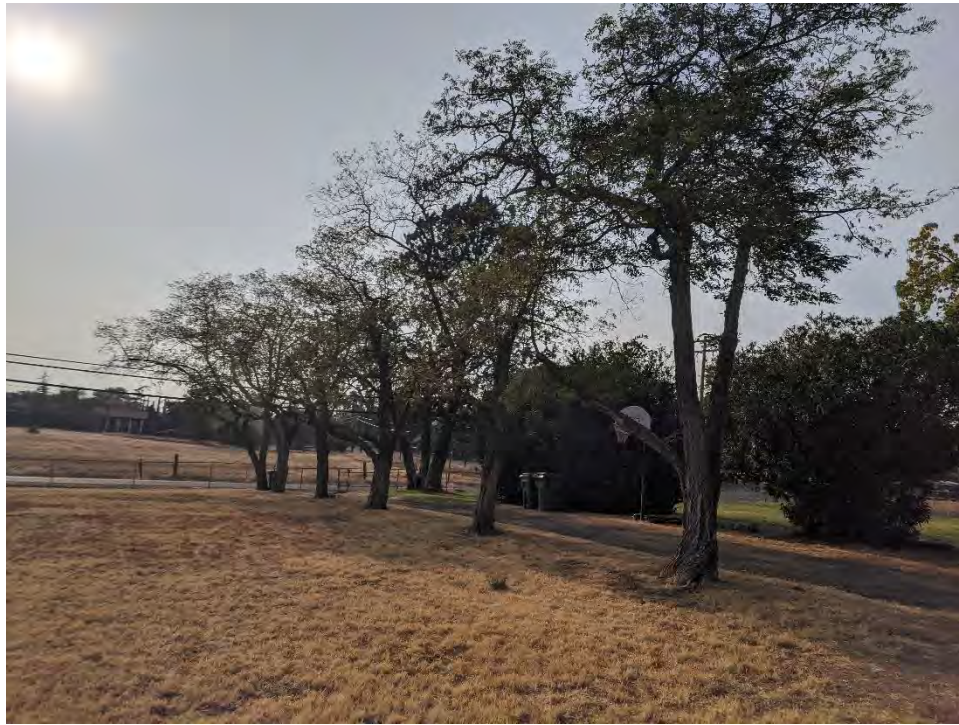
Photo 5. View of a line of honey locust trees located adjacent to a driveway on APN 207-0011-001-0000.

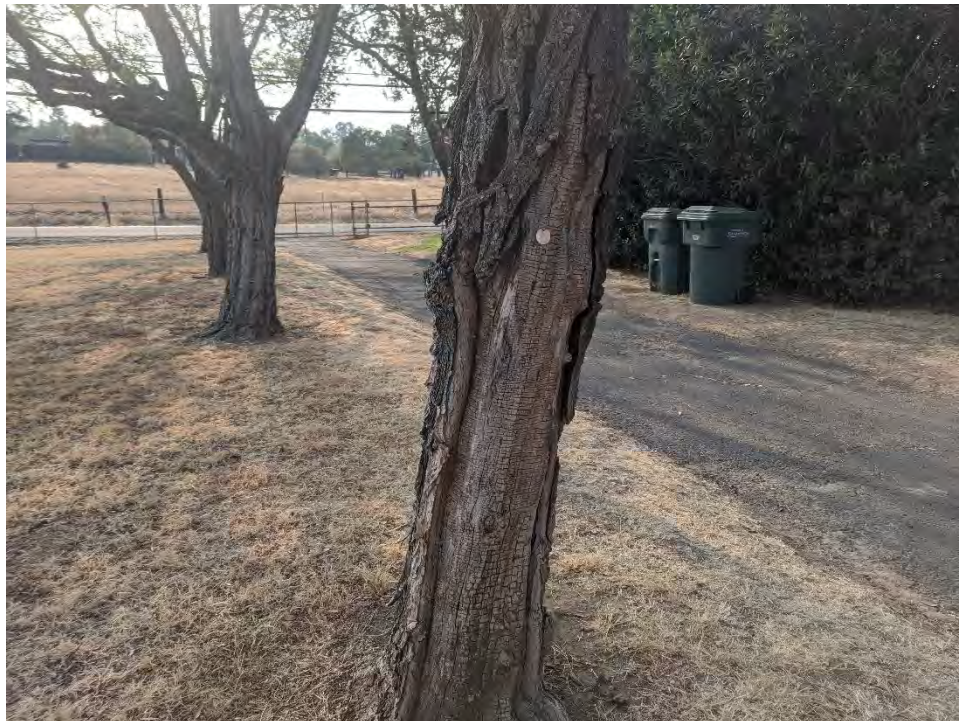
310	<i>Gleditsia triacanthos</i> honey locust	13	10	25	F	F	3	turf grass	pruning cuts, trunk wound, scarce crown	No
311	<i>Gleditsia triacanthos</i> honey locust	18	15	30	P	FP	1	turf grass	trunk wound, trunk rot, scarce crown, recommend for removal	No

Photo 6. View of a large trunk wound and trunk rot in a honey locust (Tree #308) on APN 207-0011-001-0000.

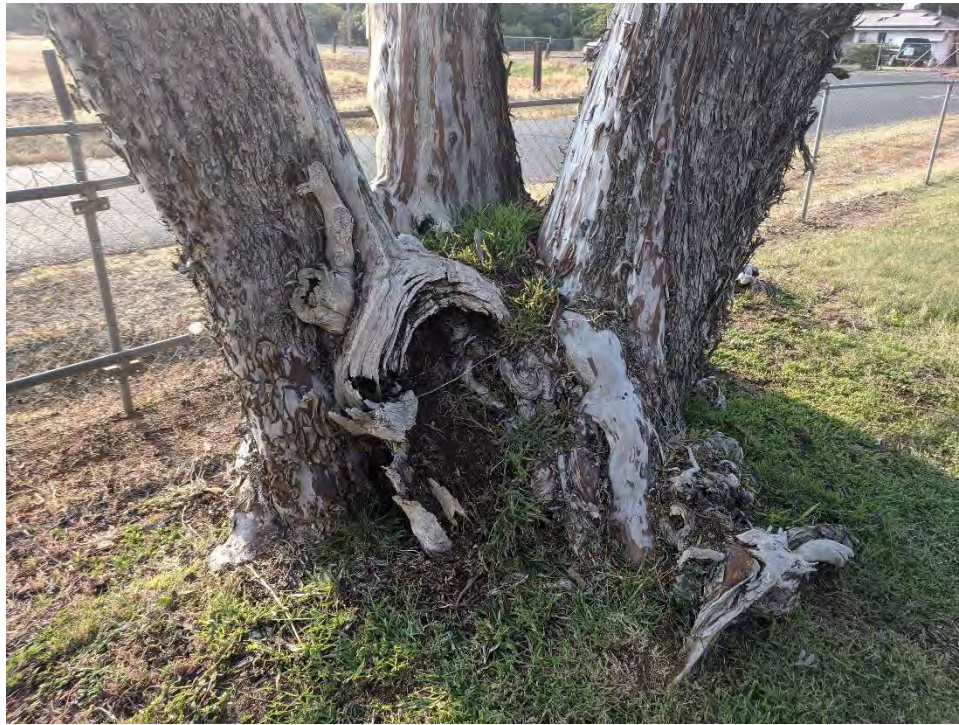
Photo 7. View of a basal trunk wound and rot in an Arizona cypress (Tree #313) on APN 207-0011-001-0000.

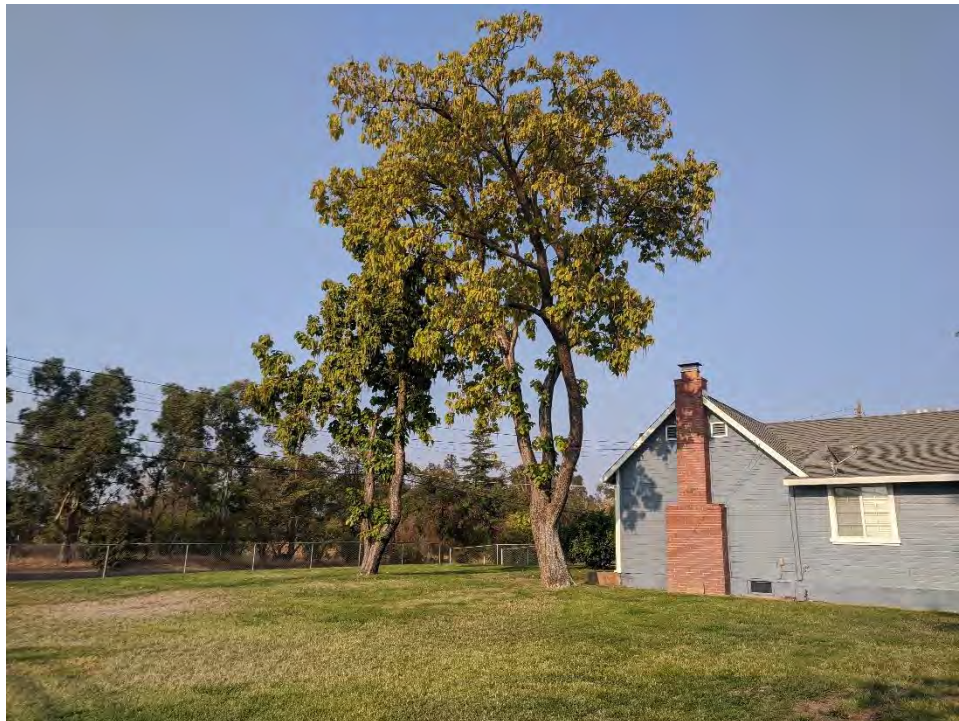
Photo 8. View of two catalpa trees (Tree #314 and #315) located next to the northern residence on APN 207-0011-001-0000.
