LEAD-BASED PAINT TESTING REPORT

**759 NORTH ECKHOFF STREET
ORANGE, CALIFORNIA**

OCTOBER 2, 2020

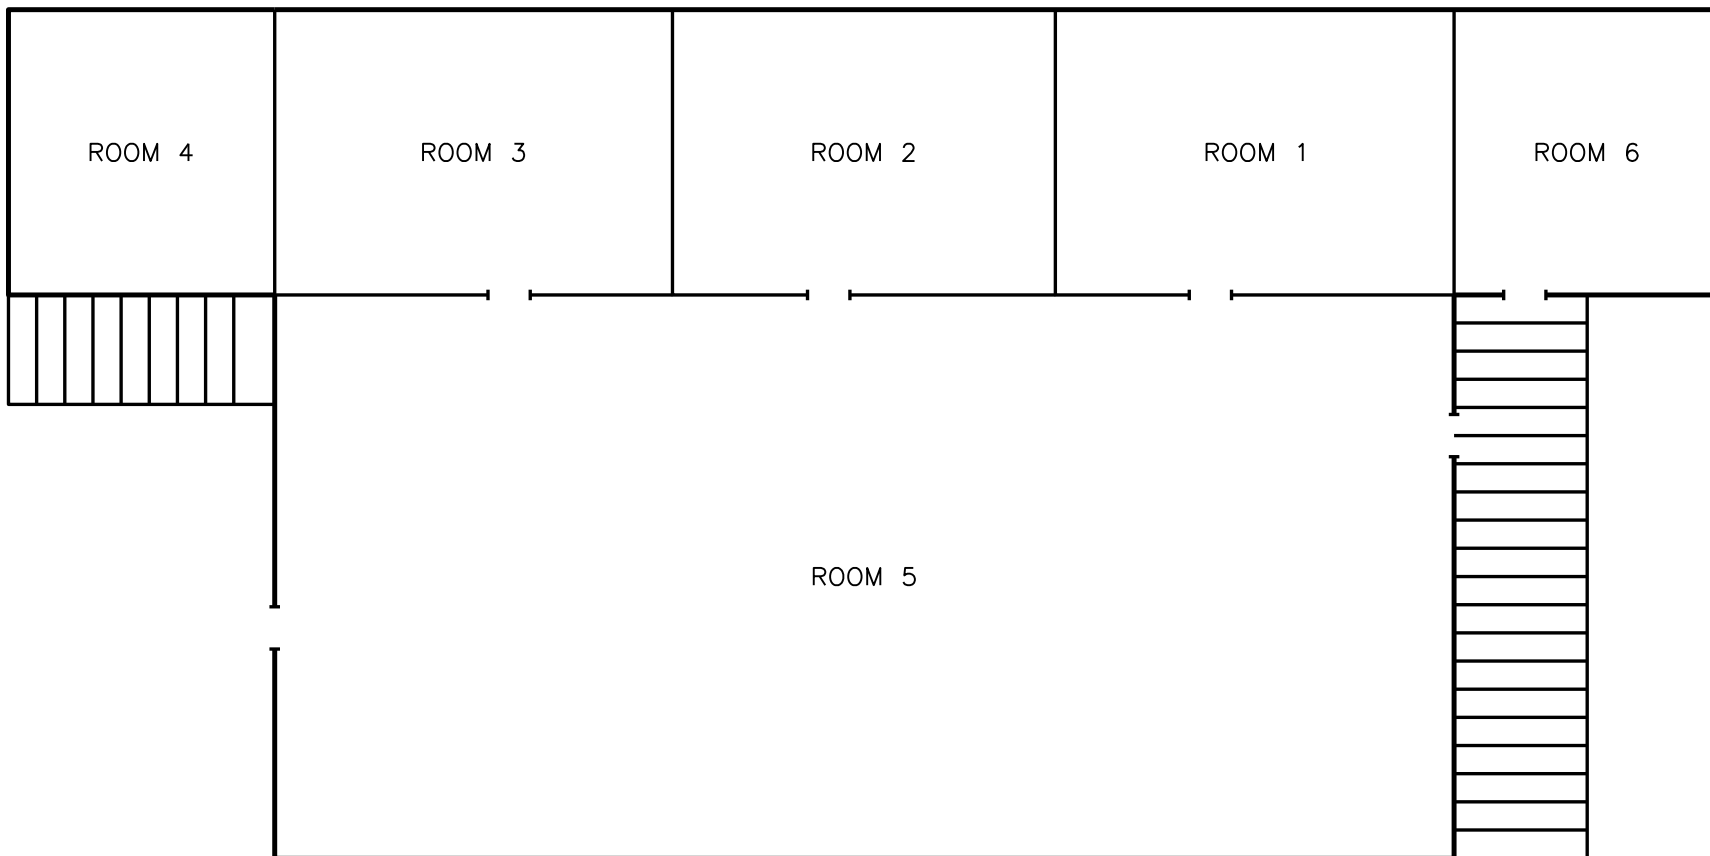
BUILDING 1 & 3

Sample	Area	Room Equivalent	Side Tested	Component	Substrate	Color	Condition	Lead (mg/cm ²)	Results	Quantities For Entire Area	Comments
77	Interior	2nd Floor Conference Room	A	Wall	Drywall	Grey	Intact	0.02	Negative		
78	Interior	2nd Floor Conference Room	B	Wall	Drywall	Grey	Intact	0.01	Negative		
79	Interior	2nd Floor Conference Room	C	Wall	Drywall	Grey	Intact	0.01	Negative		
80	Interior	2nd Floor Conference Room	D	Wall	Drywall	Grey	Intact	0.03	Negative		
81	Interior	2nd Floor Conference Room	A	Door	Metal	Blue	Intact	0.01	Negative		
82	Interior	2nd Floor Conference Room	A	Door Frame	Metal	Blue	Intact	0.01	Negative		
83	Interior	2nd Floor Conference Room	C	Window Frame	Metal	Blue	Intact	0.00	Negative		
84	Interior	2nd Floor Hallway	A	Wall	Drywall	White	Intact	0.00	Negative		
85	Interior	2nd Floor Hallway	B	Wall	Drywall	White	Intact	0.00	Negative		
86	Interior	2nd Floor Hallway	C	Wall	Drywall	White	Intact	0.00	Negative

87	Interior	2nd Floor Hallway	C	Door	Wood	Brown	Intact	0.00	Negative		
88	Interior	2nd Floor Hallway	C	Door Frame	Metal	Brown	Intact	0.00	Negative		
89	Interior	2nd Floor Hallway	C	Window Frame	Metal	Blue	Intact	0.11	Negative		
90	Interior	2nd Floor Office	A	Wall	Drywall	White	Intact	0.01	Negative		
91	Interior	2nd Floor Office	B	Wall	Drywall	White	Intact	0.00	Negative		
92	Interior	2nd Floor Office	C	Wall	Drywall	White	Intact	0.00	Negative		
93	Interior	2nd Floor Office	D	Wall	Drywall	White	Intact	0.00	Negative		
94	Interior	2nd Floor Office	C	Door	Metal	Blue	Intact	0.01	Negative		
95	Interior	2nd Floor Office	C	Door Frame	Metal	Blue	Intact	0.02	Negative		
96	Interior	2nd Floor Office	D	Window Frame	Metal	Blue	Intact	0.02	Negative

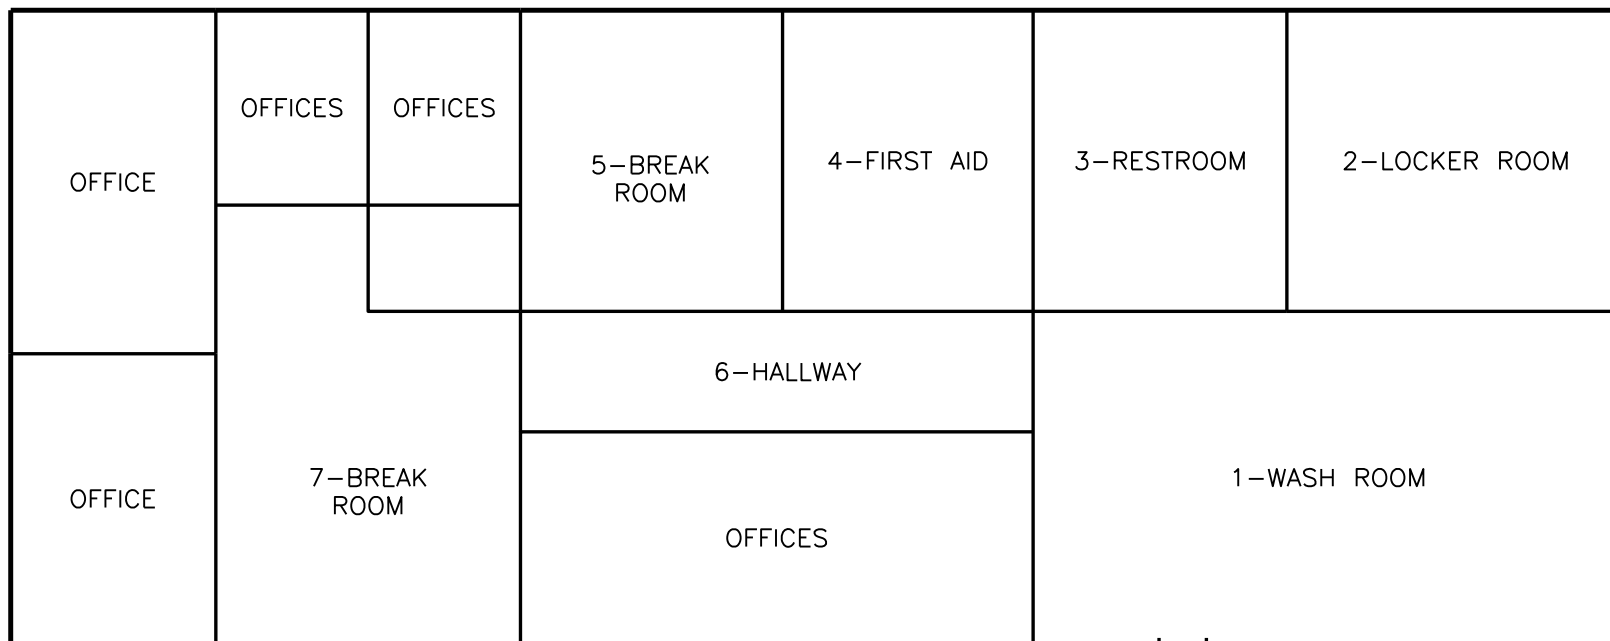
BUILDING 1 & 3
 (B-3 AREA, FIRST FLOOR)

Sample	Area	Room Equivalent	Side Tested	Component	Substrate	Color	Condition	Lead (mg/cm ²)	Results	Quantities For Entire Area	Comments
97	Interior	1-Wash Room	A	Wall	Drywall	White	Intact	0.00	Negative		
98	Interior	1-Wash Room	B	Wall	Drywall	White	Intact	0.00	Negative		
99	Interior	1-Wash Room	C	Wall	Ceramic Tile	White	Intact	0.00	Negative		
100	Interior	1-Wash Room	D	Wall	Ceramic Tile	White	Intact	0.00	Negative		
101	Interior	1-Wash Room	A	Door	Metal	Blue	Intact	0.01	Negative		
102	Interior	1-Wash Room	A	Door Frame	Metal	Blue	Intact	0.01	Negative		
103	Interior	1-Wash Room	D	Shelf	Wood	White	Intact	0.00	Negative		
104	Interior	2-Locker Room	A	Wall	Ceramic Tile	White	Intact	0.00	Negative		
105	Interior	2-Locker Room	B	Wall	Ceramic Tile	White	Intact	0.00	Negative		
106	Interior	2-Locker Room	C	Wall	Ceramic Tile	White	Intact	0.00	Negative		
107	Interior	2-Locker Room	D	Wall	Ceramic Tile	White	Intact	0.00	Negative

108	Interior	2-Locker Room	A	Door	Metal	Blue	Intact	0.00	Negative		
109	Interior	2-Locker Room	A	Door Frame	Metal	Blue	Intact	0.02	Negative		
110	Interior	2-Locker Room	---	Floor	Ceramic Tile	Tan	Intact	0.00	Negative		
111	Interior	2-Locker Room	---	Ceiling	Drywall	White	Intact	0.00	Negative		
112	Interior	3-Restroom	A	Wall	Ceramic Tile	Tan	Intact	0.00	Negative		
113	Interior	3-Restroom	B	Wall	Ceramic Tile	Tan	Intact	0.01	Negative		
114	Interior	3-Restroom	C	Wall	Ceramic Tile	Tan	Intact	0.00	Negative		
115	Interior	3-Restroom	D	Wall	Ceramic Tile	Tan	Intact	0.00	Negative		
116	Interior	3-Restroom	D	Door	Metal	Blue	Intact	0.00	Negative		
117	Interior	3-Restroom	D	Door Frame	Metal	Blue	Intact	0.00	Negative		
118	Interior	3-Restroom	---	Floor	Ceramic Tile	Tan	Intact	0.00	Negative		
119	Interior	3-Restroom	---	Ceiling	Drywall	White	Intact	0.00	Negative		
120	Interior	4-First Aid & 5-Break Room	A	Wall	Drywall	White	Intact	0.00	Negative

121	Interior	4-First Aid & 5-Break Room	B	Wall	Drywall	White	Intact	0.00	Negative		
122	Interior	4-First Aid & 5-Break Room	C	Wall	Drywall	White	Intact	0.01	Negative		
123	Interior	4-First Aid & 5-Break Room	D	Wall	Drywall	White	Intact	0.01	Negative		
124	Interior	4-First Aid & 5-Break Room	D	Window Frame	Metal	Brown	Intact	0.01	Negative		
125	Interior	4-First Aid & 5-Break Room	---	Floor	Ceramic Tile	Brown	Intact	0.00	Negative		
126	Interior	6-Hall	A	Wall	Drywall	White	Intact	0.00	Negative		
127	Interior	6-Hall	B	Wall	Drywall	White	Intact	0.00	Negative		
128	Interior	6-Hall	C	Wall	Drywall	White	Intact	0.00	Negative		
129	Interior	6-Hall	D	Wall	Drywall	White	Intact	0.00	Negative		
130	Interior	6-Hall	A	Door	Wood	White	Intact	0.00	Negative		
131	Interior	6-Hall	A	Door Frame	Metal	Brown	Intact	0.00	Negative		
132	Interior	6-Hall	C	Window Frame	Metal	Brown	Intact	0.00	Negative		
133	Interior	7-Break Room	A	Wall	Drywall	White	Intact	0.00	Negative

134	Interior	7-Break Room	B	Wall	Drywall	White	Intact	0.00	Negative		
135	Interior	7-Break Room	C	Wall	Drywall	White	Intact	0.00	Negative		
136	Interior	7-Break Room	D	Wall	Drywall	White	Intact	0.00	Negative		
137	Interior	7-Break Room	B	Door	Wood	White	Intact	0.00	Negative		
138	Interior	7-Break Room	B	Door Frame	Metal	White	Intact	0.00	Negative		
139	Interior	7-Break Room	C	Window Frame	Metal	Brown	Intact	0.00	Negative

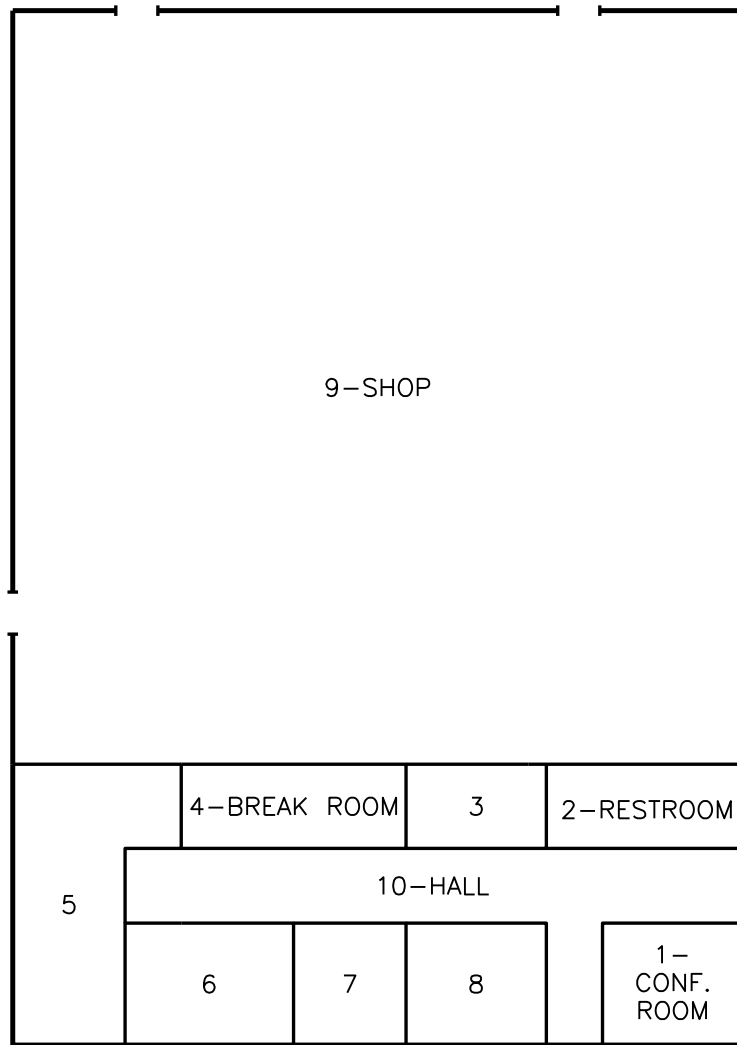
BUILDING 6

Sample	Area	Room Equivalent	Side Tested	Component	Substrate	Color	Condition	Lead (mg/cm ²)	Results	Quantities For Entire Area	Comments
207	Exterior	Building 6	A	Wall	Concrete	Tan	Intact	0.00	Negative		
208	Exterior	Building 6	B	Wall	Stucco	Tan	Intact	0.00	Negative		
209	Exterior	Building 6	C	Wall	Stucco	Tan	Intact	0.01	Negative		
210	Exterior	Building 6	D	Wall	Stucco	Tan	Intact	0.00	Negative		
211	Exterior	Building 6	D	Lower Wall	Stucco	Brown	Intact	0.00	Negative		
212	Exterior	Building 6	D	Door	Metal	Brown	Intact	0.00	Negative		
213	Exterior	Building 6	D	Door Frame	Metal	Brown	Intact	0.00	Negative		
214	Exterior	Building 6	D	Post	Metal	Black	Intact	0.00	Negative		
215	Exterior	Building 6	D	Support	Metal	Blue	Intact	0.00	Negative		
216	Exterior	Building 6	D	Rail	Metal	Grey	Intact	0.00	Negative		
217	Exterior	Building 6	D	Post	Wood	Brown	Intact	0.00	Negative		
218	Exterior	Building 6	C	Bumper	Metal	Yellow	Intact	0.00	Negative

219	Exterior	Building 6	D	Pipe	Metal	Tan	Intact	0.00	Negative		
220	Exterior	Building 6	D	Bumper	Metal	Red	Intact	0.00	Negative		
221	Interior	1-Conference	A	Wall	Drywall	White	Intact	0.00	Negative		
222	Interior	1-Conference	B	Wall	Drywall	White	Intact	0.00	Negative		
223	Interior	1-Conference	C	Wall	Drywall	White	Intact	0.00	Negative		
224	Interior	1-Conference	D	Wall	Drywall	White	Intact	0.00	Negative		
225	Interior	1-Conference	B	Door	Wood	Brown	Intact	0.00	Negative		
226	Interior	1-Conference	B	Door Frame	Metal	Brown	Intact	0.00	Negative		
227	Interior	2-Restroom	A	Wall	Drywall	White	Intact	0.00	Negative		
228	Interior	2-Restroom	B	Wall	Drywall	White	Intact	0.00	Negative		
229	Interior	2-Restroom	C	Wall	Drywall	White	Intact	0.00	Negative		
230	Interior	2-Restroom	D	Wall	Drywall	White	Intact	0.00	Negative		
231	Interior	2-Restroom	A	Door	Wood	Brown	Intact	0.00	Negative		
232	Interior	2-Restroom	A	Door Frame	Metal	Brown	Intact	0.00	Negative

233	Interior	2-Restroom	D	Wall	Ceramic Tile	Brown	Intact	0.00	Negative		
234	Interior	2-Restroom	---	Floor	Ceramic Tile	Tan	Intact	0.00	Negative		
235	Interior	4-Break Room	A	Wall	Drywall	White	Intact	0.00	Negative		
236	Interior	4-Break Room	B	Wall	Drywall	White	Intact	0.00	Negative		
237	Interior	4-Break Room	C	Wall	Drywall	White	Intact	0.00	Negative		
238	Interior	4-Break Room	D	Wall	Drywall	White	Intact	0.00	Negative		
239	Interior	4-Break Room	C	Door	Wood	Brown	Intact	0.00	Negative		
240	Interior	4-Break Room	C	Door Frame	Metal	Brown	Intact	0.00	Negative		
241	Interior	4-Break Room	D	Lower Cabinet	Wood	Brown	Intact	0.00	Negative		
242	Interior	9-Shop	A	Wall	Drywall	White	Intact	0.00	Negative		
243	Interior	9-Shop	B	Wall	Concrete	White	Intact	0.00	Negative		
244	Interior	9-Shop	C	Wall	Concrete	White	Intact	0.00	Negative		
245	Interior	9-Shop	A	Door	Wood	Brown	Intact	0.00	Negative		
246	Interior	9-Shop	A	Door Frame	Metal	Brown	Intact	0.00	Negative

247	Interior	9-Shop	A	Roll Door	Metal	Grey	Intact	0.00	Negative		
248	Interior	9-Shop	A	Roll Door Frame	Metal	Grey	Intact	0.00	Negative		
249	Interior	9-Shop	C	Door	Metal	Grey	Intact	0.00	Negative

Sample	Area	Room Equivalent	Side Tested	Component	Substrate	Color	Condition	Lead (mg/cm ²)	Results	Quantities For Entire Area	Comments
250	Interior	9-Shop	C	Door Frame	Metal	Grey	Intact	0.00	Negative		
251	Interior	9-Shop	A	Tread	Wood	Brown	Intact	0.00	Negative		
252	Interior	9-Shop	A	Riser	Wood	Brown	Intact	0.00	Negative		
253	Interior	9-Shop	A	Rail	Wood	Brown	Intact	0.00	Negative		
254	Interior	9-Shop	A	Post	Metal	Yellow	Intact	0.00	Negative		
255	Interior	9-Shop	A	Post	Metal	Brown	Intact	0.00	Negative		
256	Interior	9-Shop	A	Floor	Concrete	Blue	Intact	0.00	Negative		
257	Interior	9-Shop	A	Floor	Concrete	Red	Intact	0.00	Negative		
258	Interior	10-Hall	A	Wall	Drywall	White	Intact	0.00	Negative		
259	Interior	10-Hall	B	Wall	Drywall	White	Intact	0.00	Negative		
260	Interior	10-Hall	C	Wall	Drywall	White	Intact	0.00	Negative		
261	Interior	10-Hall	D	Wall	Drywall	White	Intact	0.00	Negative		
262	Interior	10-Hall	B	Door	Wood	Brown	Intact	0.00	Negative

263	Interior	10-Hall	B	Door Frame	Metal	Brown	Intact	0.00	Negative		
264	Interior	10-Hall	A	Window Frame	Metal	Brown	Intact	0.00	Negative

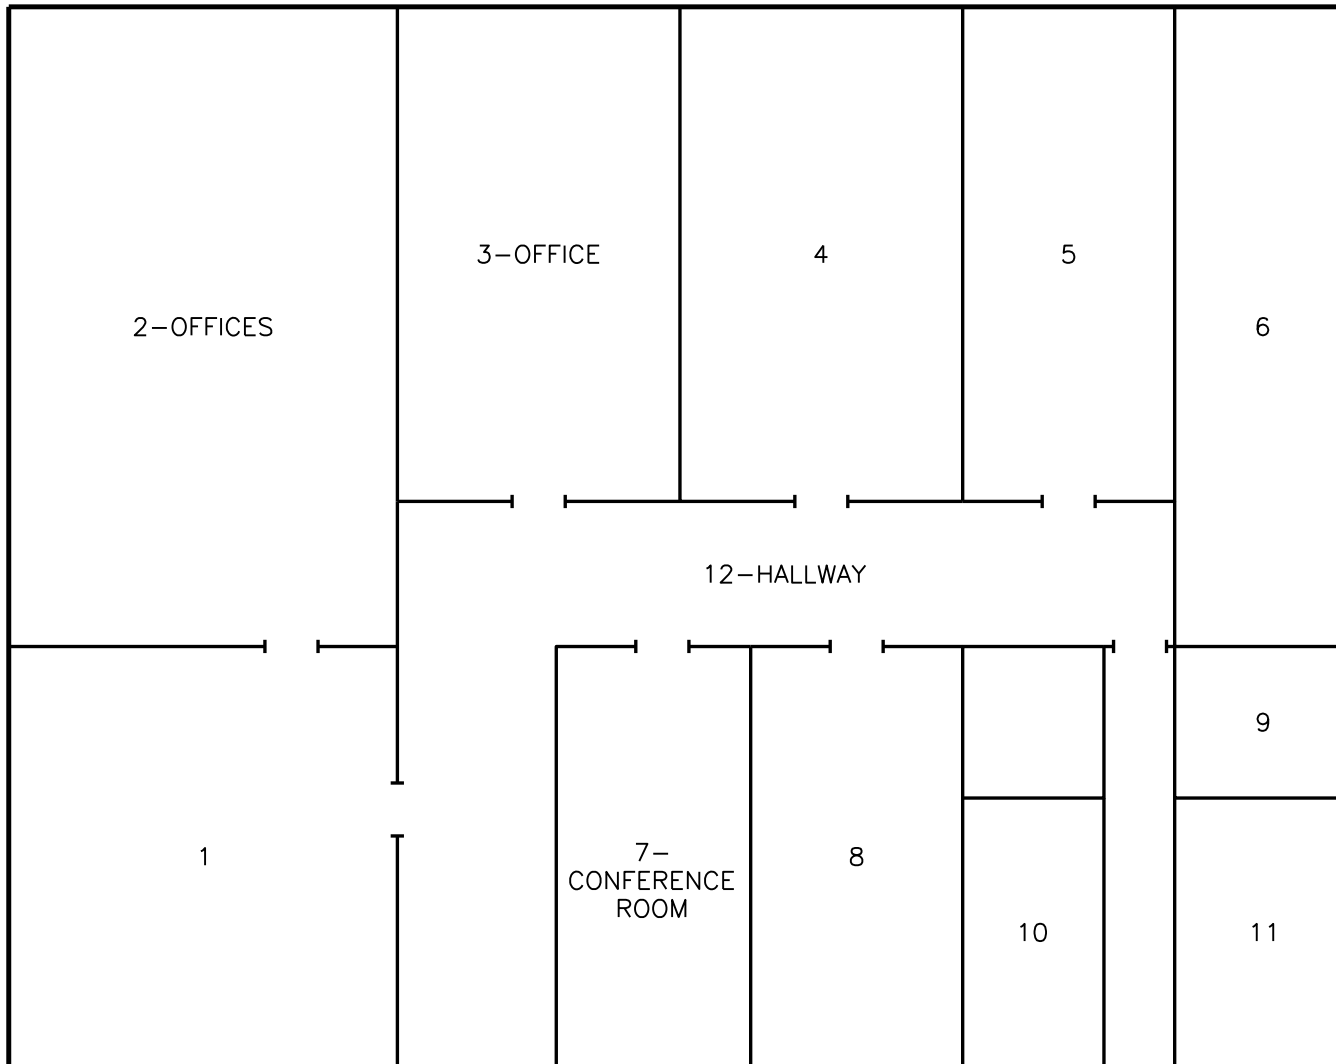
BUILDING 7

Sample	Area	Room Equivalent	Side Tested	Component	Substrate	Color	Condition	Lead (mg/cm ²)	Results	Quantities For Entire Area	Comments
265	Exterior	Building 7	A	Wall	Stucco	Tan	Intact	0.00	Negative		
266	Exterior	Building 7	B	Wall	Stucco	Tan	Intact	0.00	Negative		
267	Exterior	Building 7	C	Wall	Stucco	Tan	Intact	0.00	Negative		
268	Exterior	Building 7	D	Wall	Stucco	Tan	Intact	0.00	Negative		
269	Exterior	Building 7	C	Door	Wood	Brown	Intact	0.00	Negative		
270	Exterior	Building 7	C	Door Frame	Wood	Brown	Intact	0.00	Negative		
271	Exterior	Building 7	A	Door	Metal	Brown	Intact	0.00	Negative		
272	Exterior	Building 7	A	Door Frame	Metal	Brown	Intact	0.00	Negative		
273	Exterior	Building 7	C	Gutter	Wood	Brown	Intact	0.00	Negative		
274	Exterior	Building 7	D	Eave	Stucco	Tan	Intact	0.00	Negative		
275	Exterior	Building 7	D	Fascia	Wood	Brown	Intact	0.00	Negative		
276	Exterior	Building 7	D	Gutter	Metal	Tan	Intact	0.00	Negative

277	Interior	6	A	Wall	Drywall	Tan	Intact	0.00	Negative		
278	Interior	6	B	Wall	Drywall	Tan	Intact	0.00	Negative		
279	Interior	6	C	Wall	Drywall	Tan	Intact	0.00	Negative		
280	Interior	6	D	Wall	Drywall	Tan	Intact	0.00	Negative		
281	Interior	6	A	Door Frame	Wood	Tan	Intact	0.00	Negative		
282	Interior	6	C	Window Frame	Metal	Grey	Intact	0.00	Negative		
283	Interior	6	B	Wall	Concrete	White	Intact	0.00	Negative		
284	Interior	7-Conference Room	A	Wall	Drywall	Tan	Intact	0.00	Negative		
285	Interior	7-Conference Room	B	Wall	Drywall	Tan	Intact	0.00	Negative		
286	Interior	7-Conference Room	C	Wall	Drywall	Tan	Intact	0.00	Negative		
287	Interior	7-Conference Room	D	Wall	Drywall	Tan	Intact	0.00	Negative		
288	Interior	7-Conference Room	C	Door	Wood	Tan	Intact	0.00	Negative		
289	Interior	7-Conference Room	C	Door Frame	Wood	Tan	Intact	0.00	Negative		
290	Interior	7-Conference Room	A	Window Frame	Wood	Tan	Intact	0.00	Negative

291	Interior	8	A	Wall	Drywall	Tan	Intact	0.00	Negative		
292	Interior	8	B	Wall	Drywall	Tan	Intact	0.00	Negative		
293	Interior	8	C	Wall	Drywall	Tan	Intact	0.00	Negative		
294	Interior	8	D	Wall	Drywall	Tan	Intact	0.00	Negative		
295	Interior	8	C	Door	Wood	Tan	Intact	0.00	Negative		
296	Interior	8	C	Door Frame	Wood	Tan	Intact	0.00	Negative		
297	Interior	9	A	Wall	Drywall	Tan	Intact	0.00	Negative		
298	Interior	9	B	Wall	Drywall	Tan	Intact	0.00	Negative		
299	Interior	9	C	Wall	Drywall	Tan	Intact	0.00	Negative		
300	Interior	9	D	Wall	Drywall	Tan	Intact	0.00	Negative		
301	Interior	9	C	Door Frame	Wood	Tan	Intact	0.00	Negative		
302	Interior	9	---	Floor	Ceramic Tile	Tan	Intact	0.00	Negative		
303	Interior	9	---	Ceiling	Drywall	White	Intact	0.00	Negative		
304	Interior	9	---	Ladder	Metal	Yellow	Intact	0.00	Negative		
305	Interior	11	A	Wall	Drywall	White	Intact	0.00	Negative		
306	Interior	11	B	Wall	Drywall	White	Intact	0.00	Negative

307	Interior	11	C	Wall	Drywall	White	Intact	0.00	Negative

Sample	Area	Room Equivalent	Side Tested	Component	Substrate	Color	Condition	Lead (mg/cm ²)	Results	Quantities For Entire Area	Comments
308	Interior	11	D	Wall	Drywall	White	Intact	0.00	Negative		
309	Interior	11	D	Door	Wood	Brown	Intact	0.00	Negative		
310	Interior	11	D	Door Frame	Wood	Brown	Intact	0.00	Negative		
311	Interior	11	D	Wall	Ceramic Tile	Tan	Intact	0.00	Negative		
312	Interior	12-Hallway	A	Wall	Drywall	Tan	Intact	0.00	Negative		
313	Interior	12-Hallway	B	Wall	Drywall	Tan	Intact	0.00	Negative		
314	Interior	12-Hallway	C	Wall	Drywall	Tan	Intact	0.00	Negative		
315	Interior	12-Hallway	D	Wall	Drywall	Tan	Intact	0.00	Negative		
316	Interior	12-Hallway	D	Baseboard	Wood	Grey	Intact	0.00	Negative		
317	Interior	12-Hallway	A	Door	Wood	Tan	Intact	0.00	Negative		
318	Interior	12-Hallway	A	Door Frame	Wood	Tan	Intact	0.00	Negative
