Preliminary Tree Report
Columbus Park

Preliminary Tree Report

Columbus Park

San Jose CA

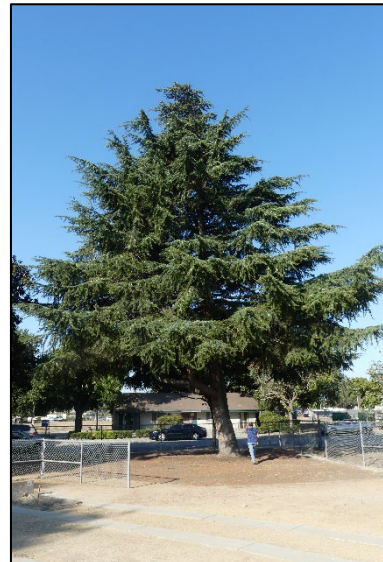
Photo 5. Looking west at Deodar cedar #146.

- Calif. buckeye #156 and 197 were semi-mature trees located along Taylor Street. Both were in excellent condition.
- Calif. pepper #111 was 8 in. and in fair condition with a crown that was one-sided to the E.
- Chinese hackberry #166 and 167 were located in a park area near Spring Street. Both trees were 14 in. and in good condition.
- Coffeeberry #131 was a large shrub in poor condition.
- Deodar cedar #146 was 35 in. and in good condition with codominant trunks at 5 ft. and a well-formed canopy (Photo 5).

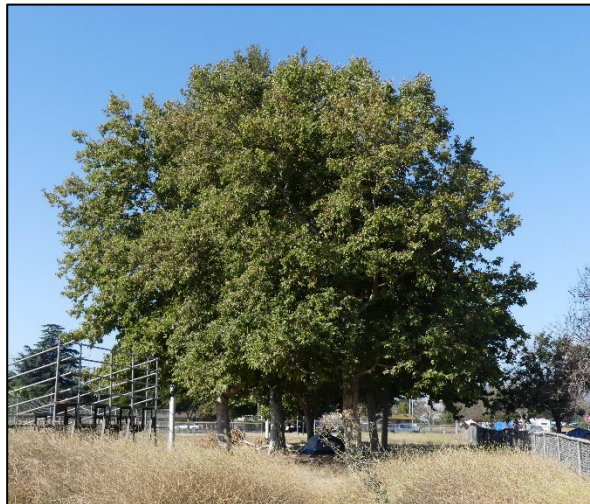
Photo 10. Looking west at grove of western sycamores.

- Western redbud #191 was a large, multi-stem shrub in excellent condition.
- Western sycamores #170, 171, 172 and 173 formed a grove along Asbury Street (Photo 10). Trees were mature in development with trunks diameters between 14 and 29 in. Trees #172 and 173 were in good condition while #170 and 171 were excellent.
