Consulting Arborist's Report

Tree Evaluation Report

For: Terraces in Murrieta

Dated: 1/11/2022

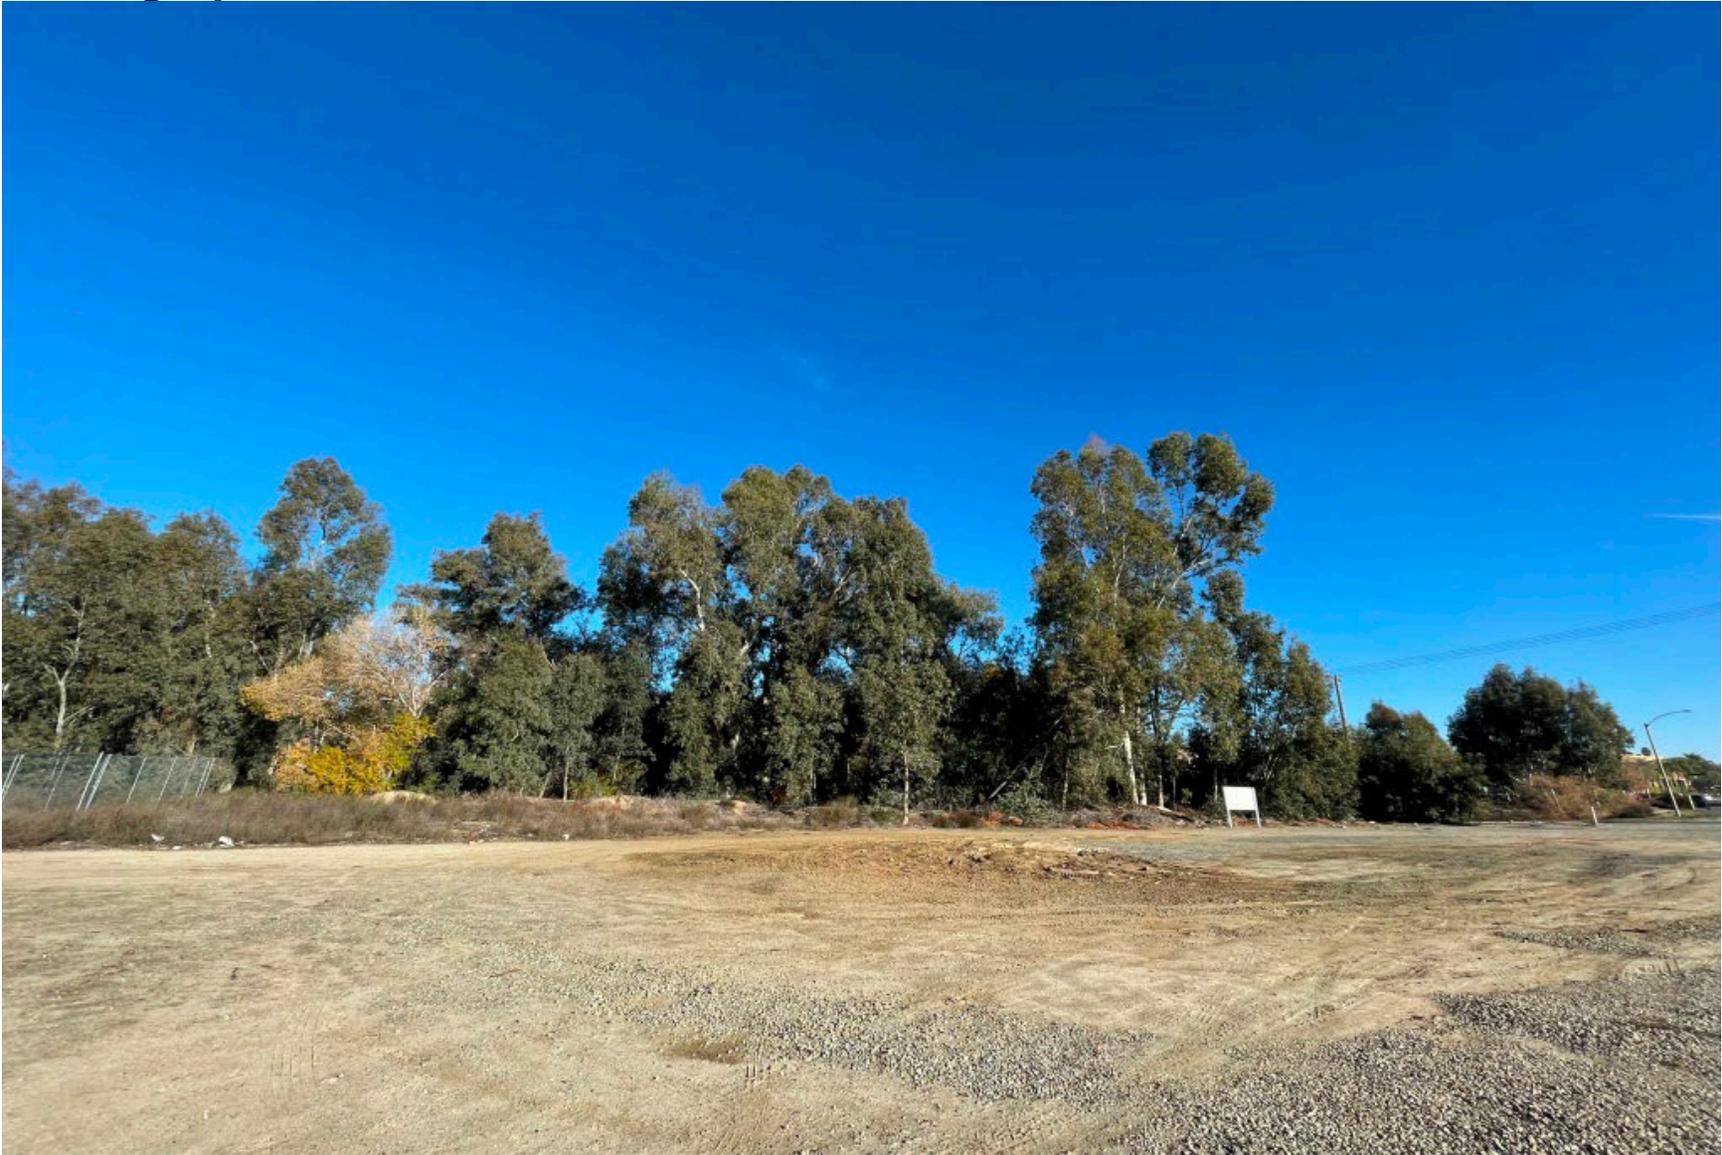
The north part of the outflow area, looking northwest from the corner. Tree #1 is at the far right.

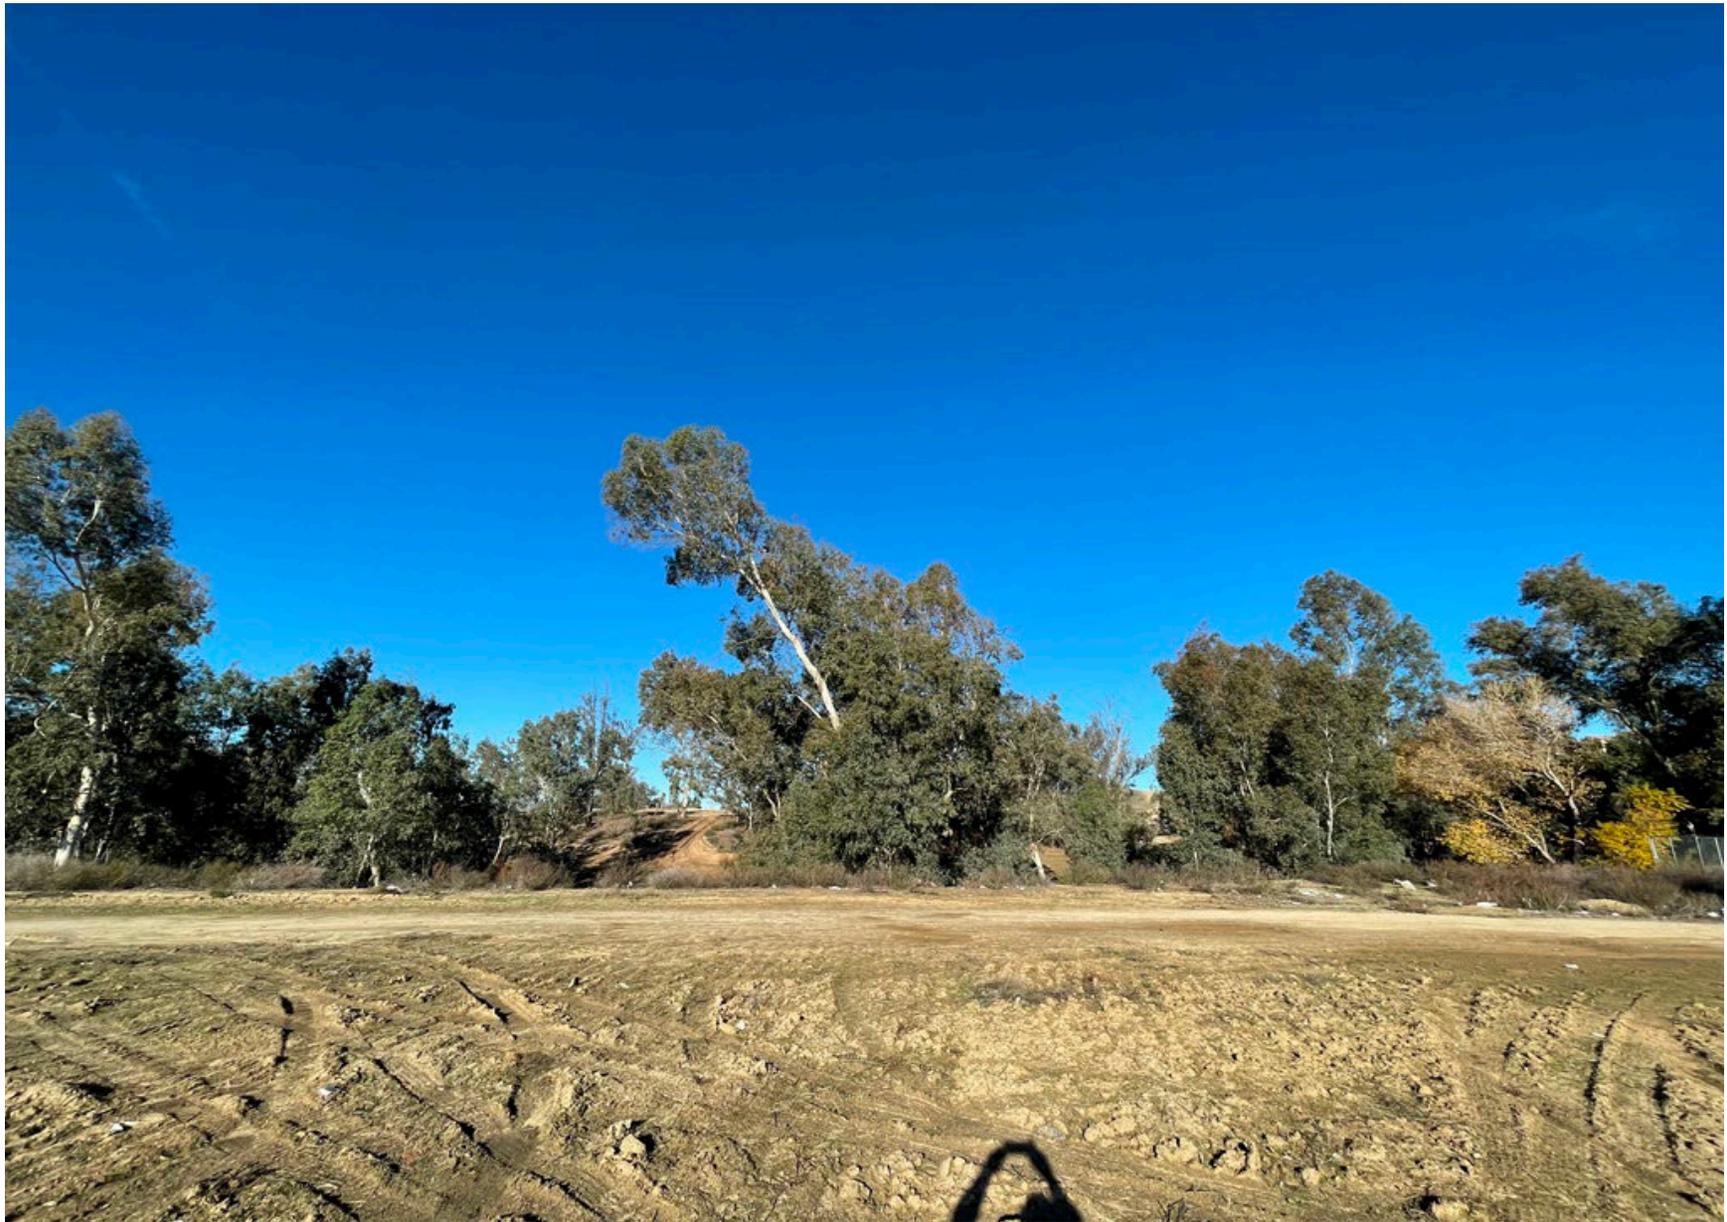
The south part of the outflow area, looking northwest from the corner.

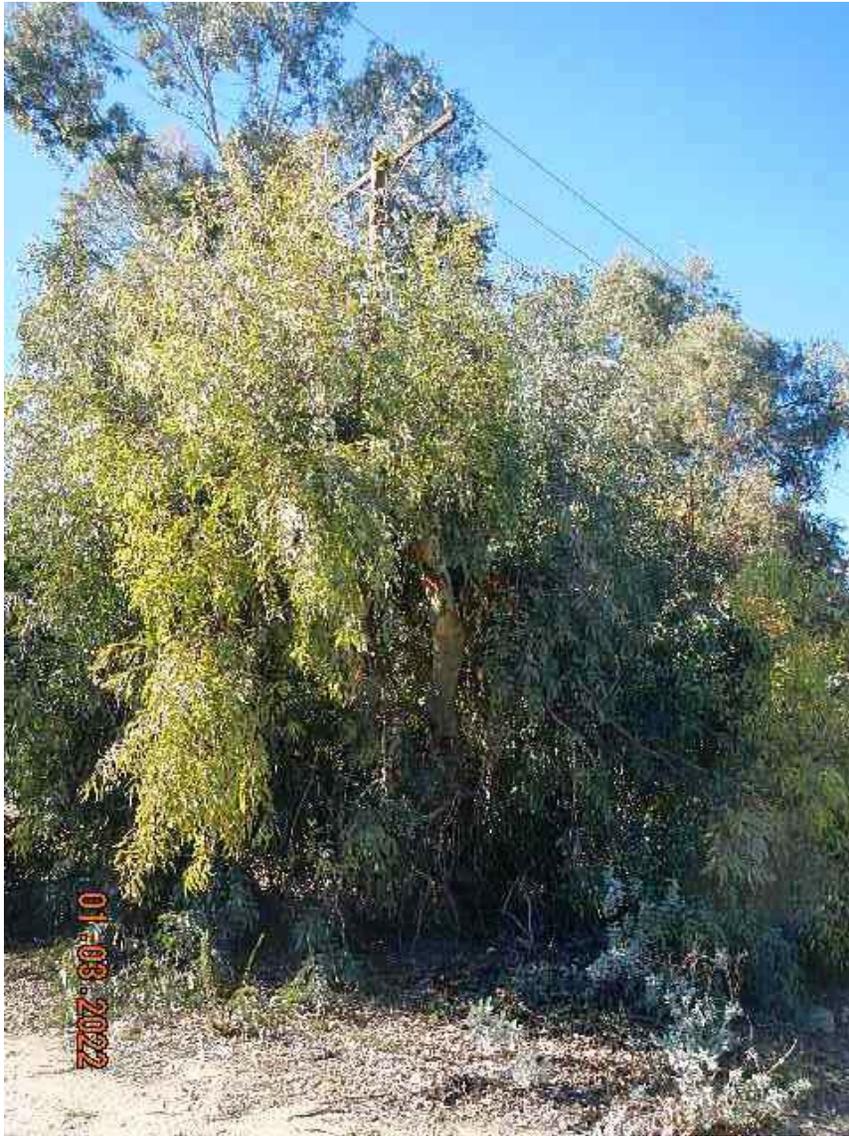
Tree #1 is topped for wires

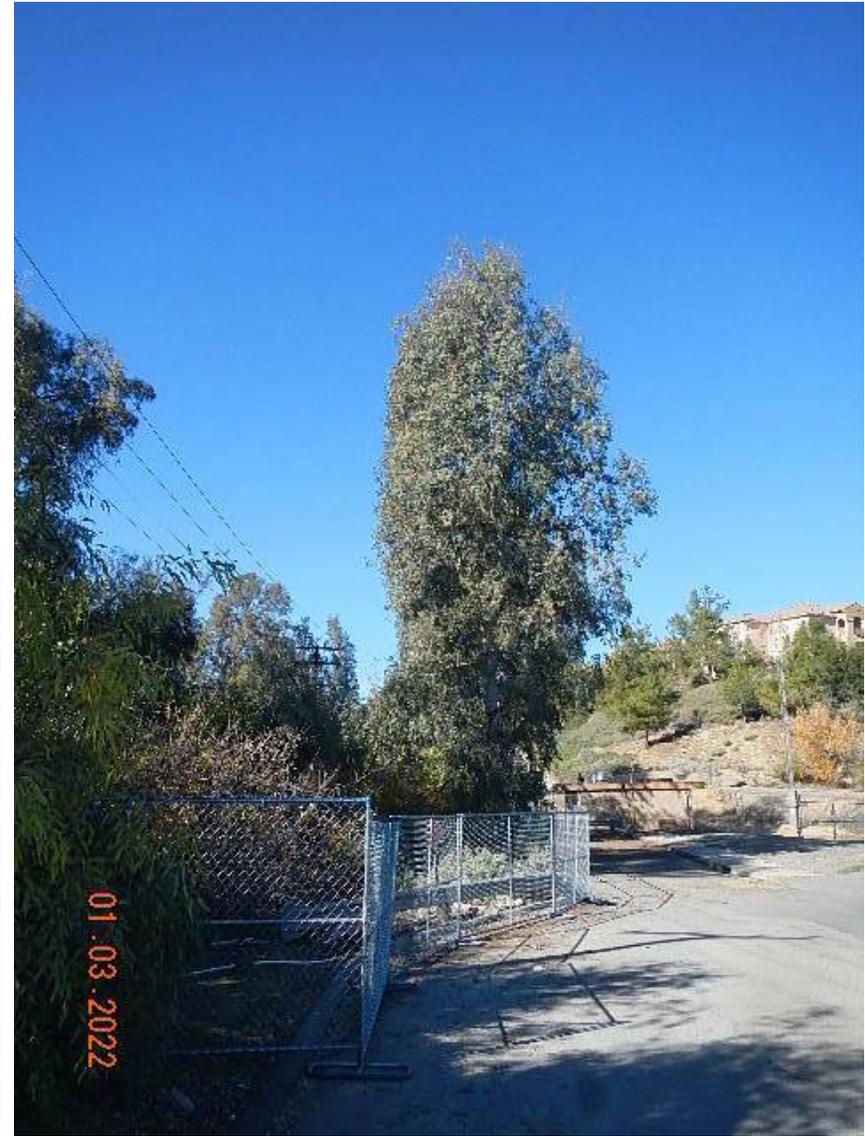
Tree #6 is just far enough away to avoid topping.

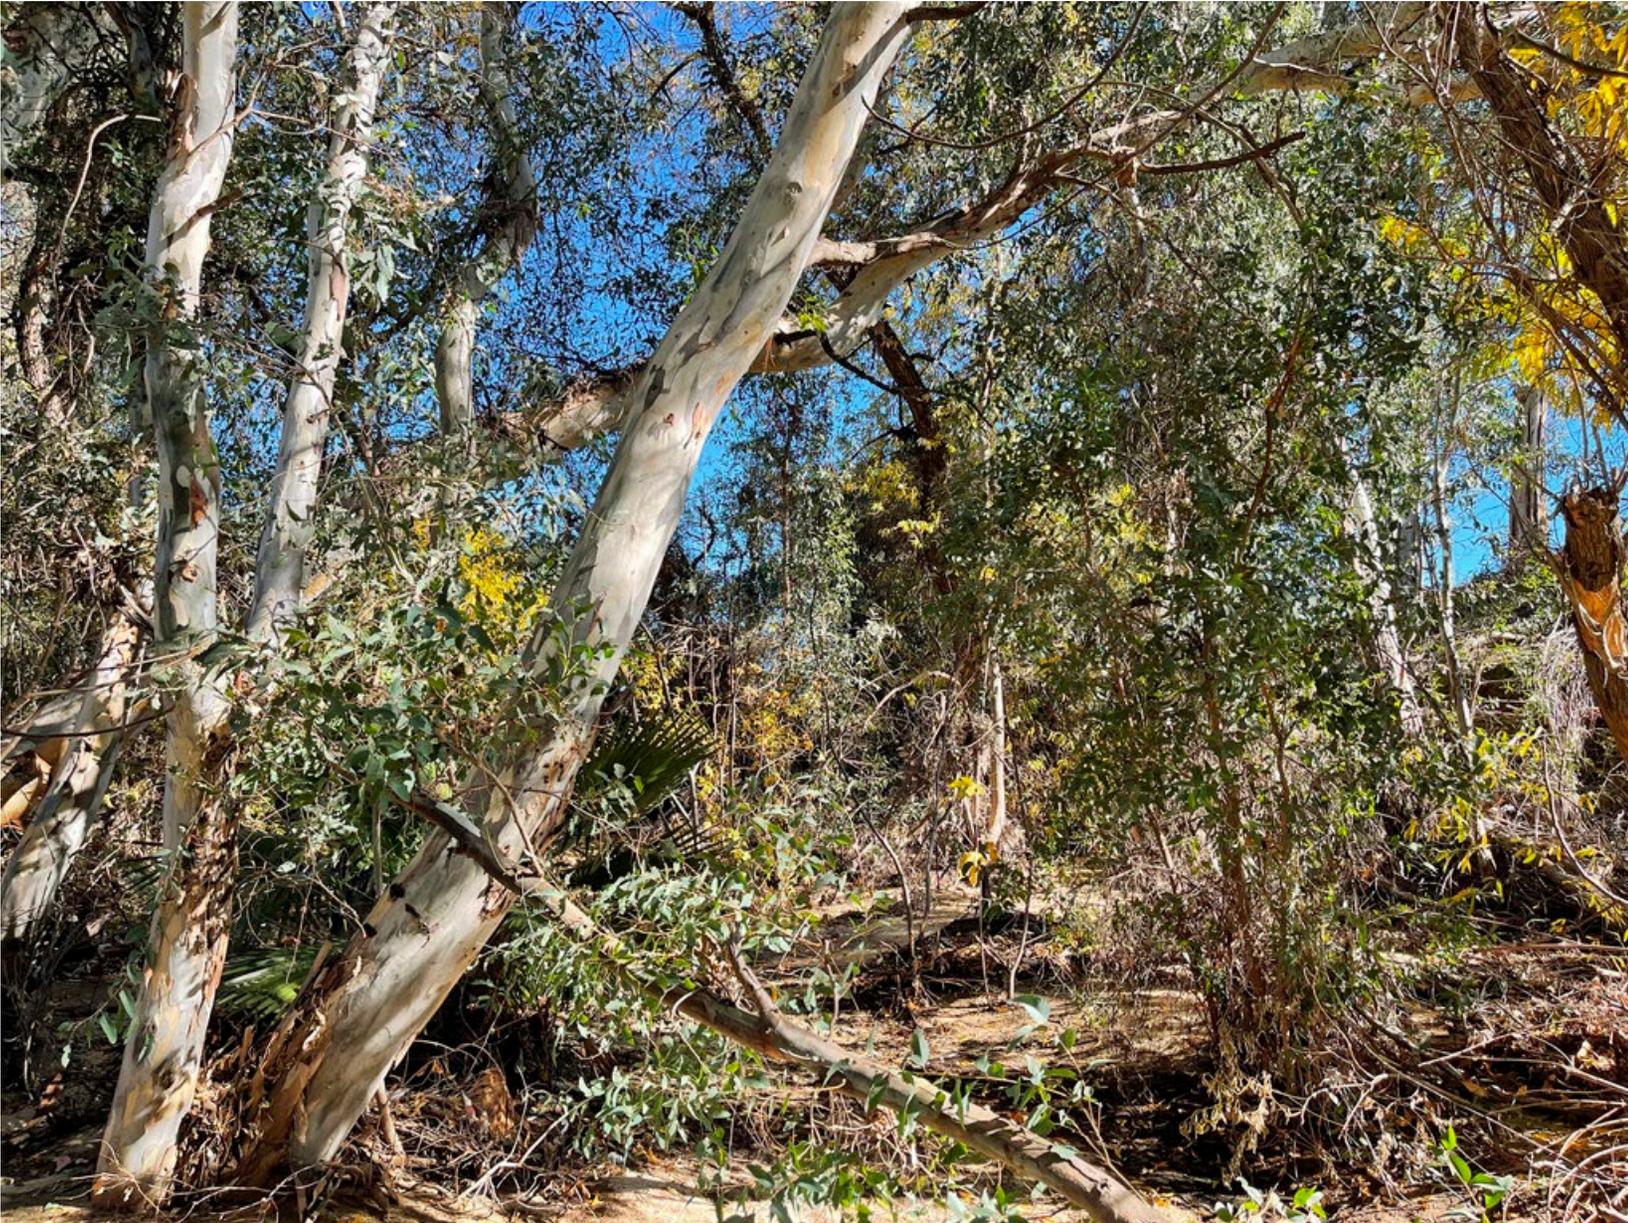
Note jumble of trees, leaning trees, fallen limbs and seedlings in the outflow area

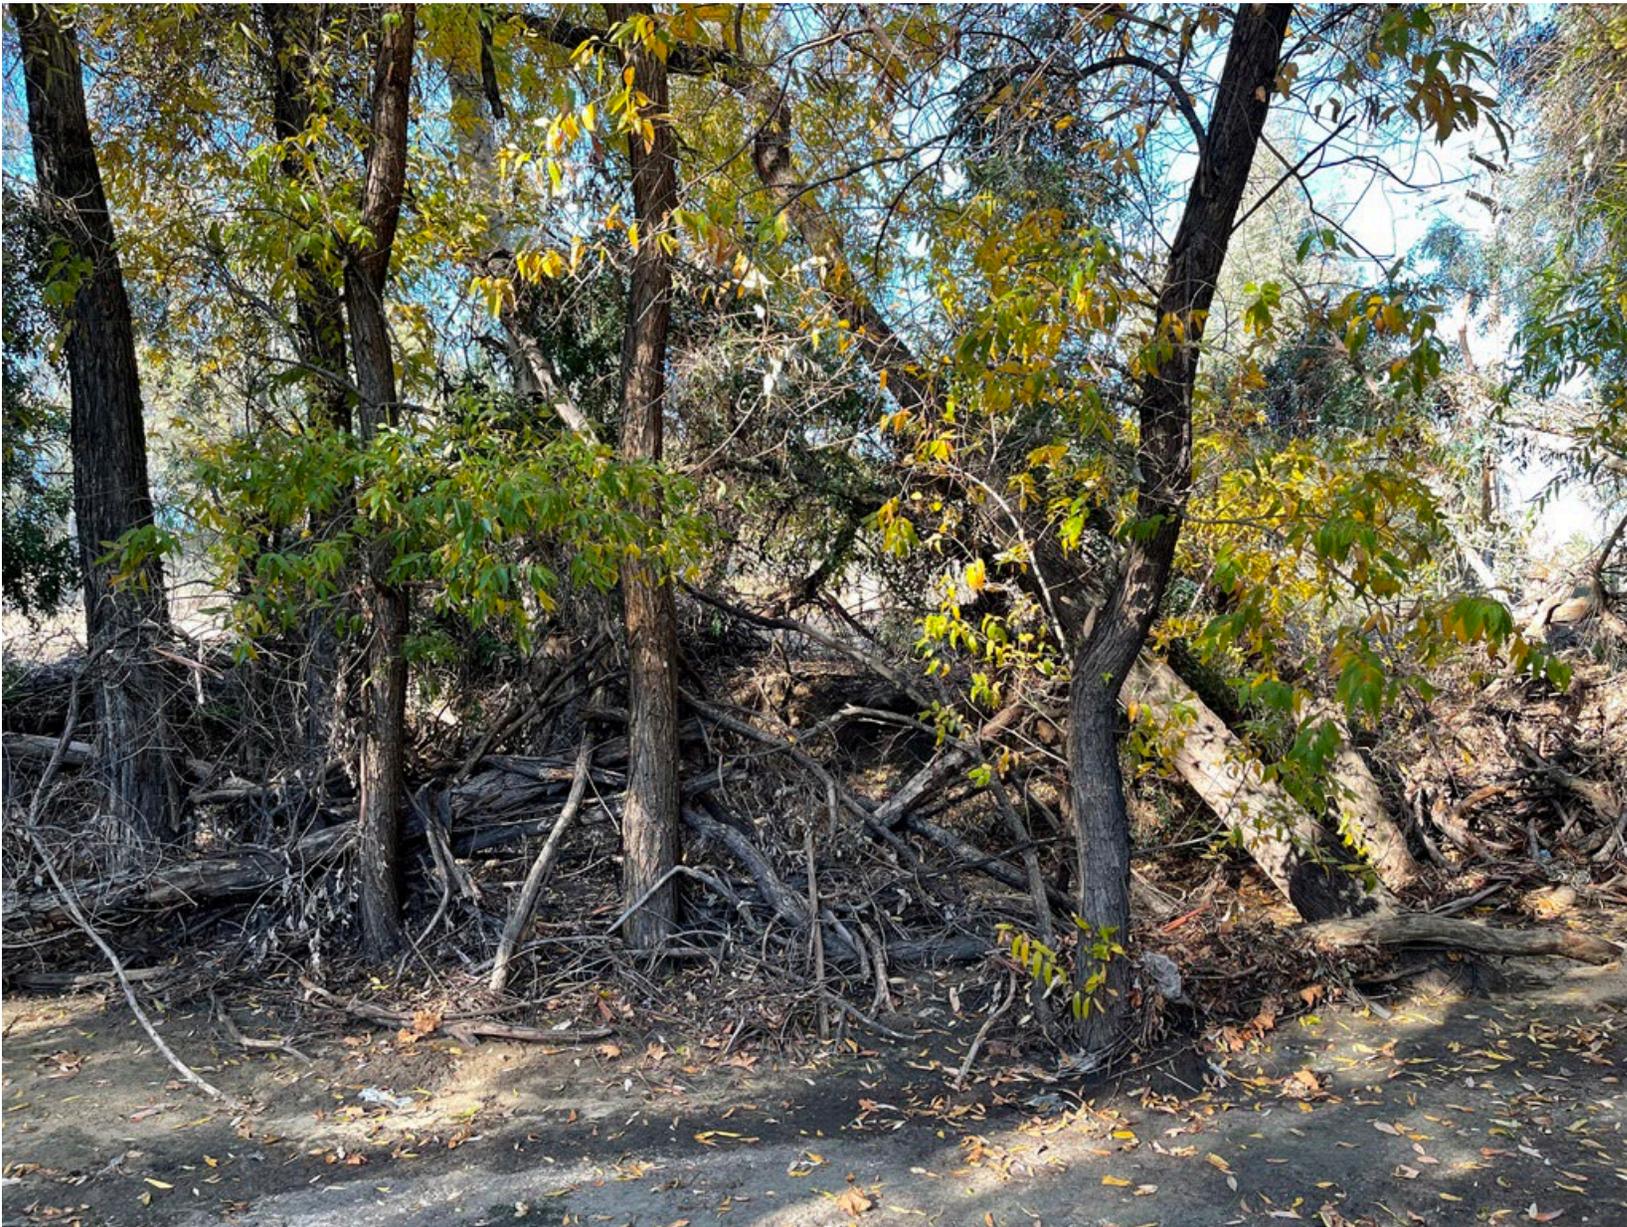
There are five Arroyo willows in this one group, and parts of others

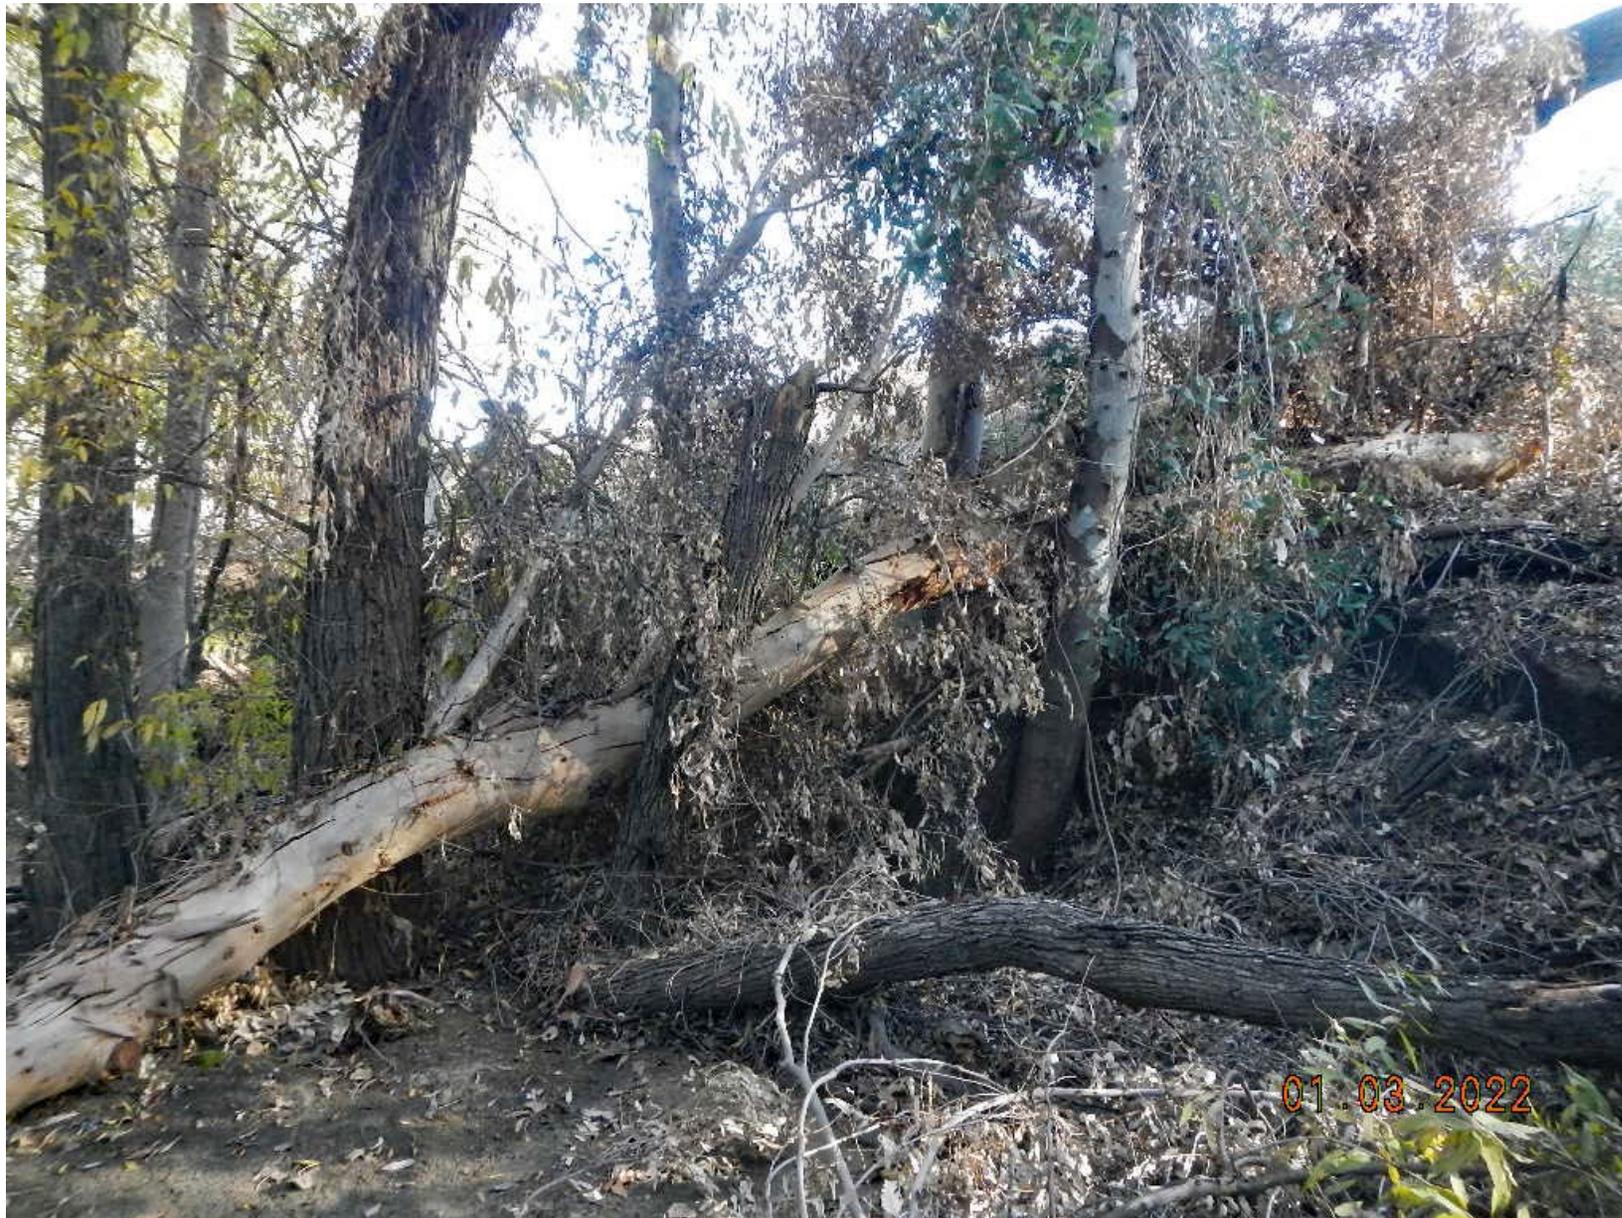
This red gum fell through another group of willow and broke one.

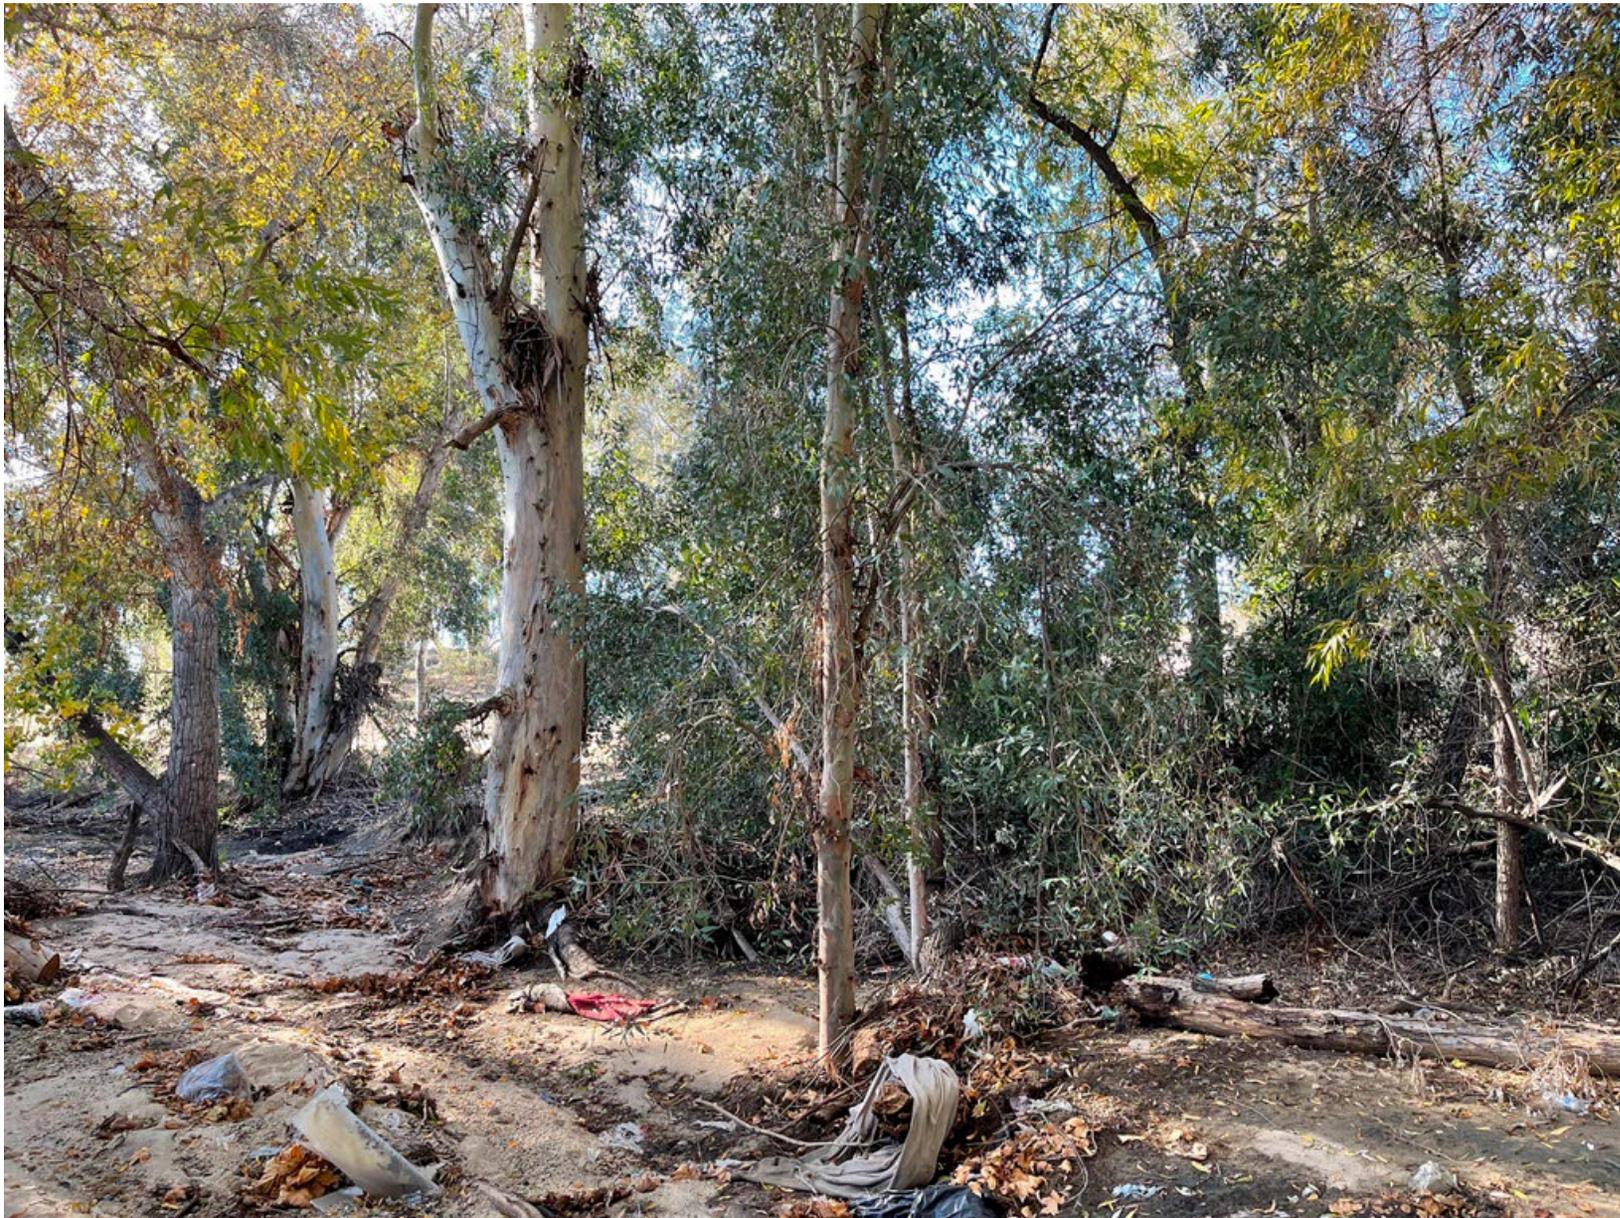
Note the debris in the watercourse.

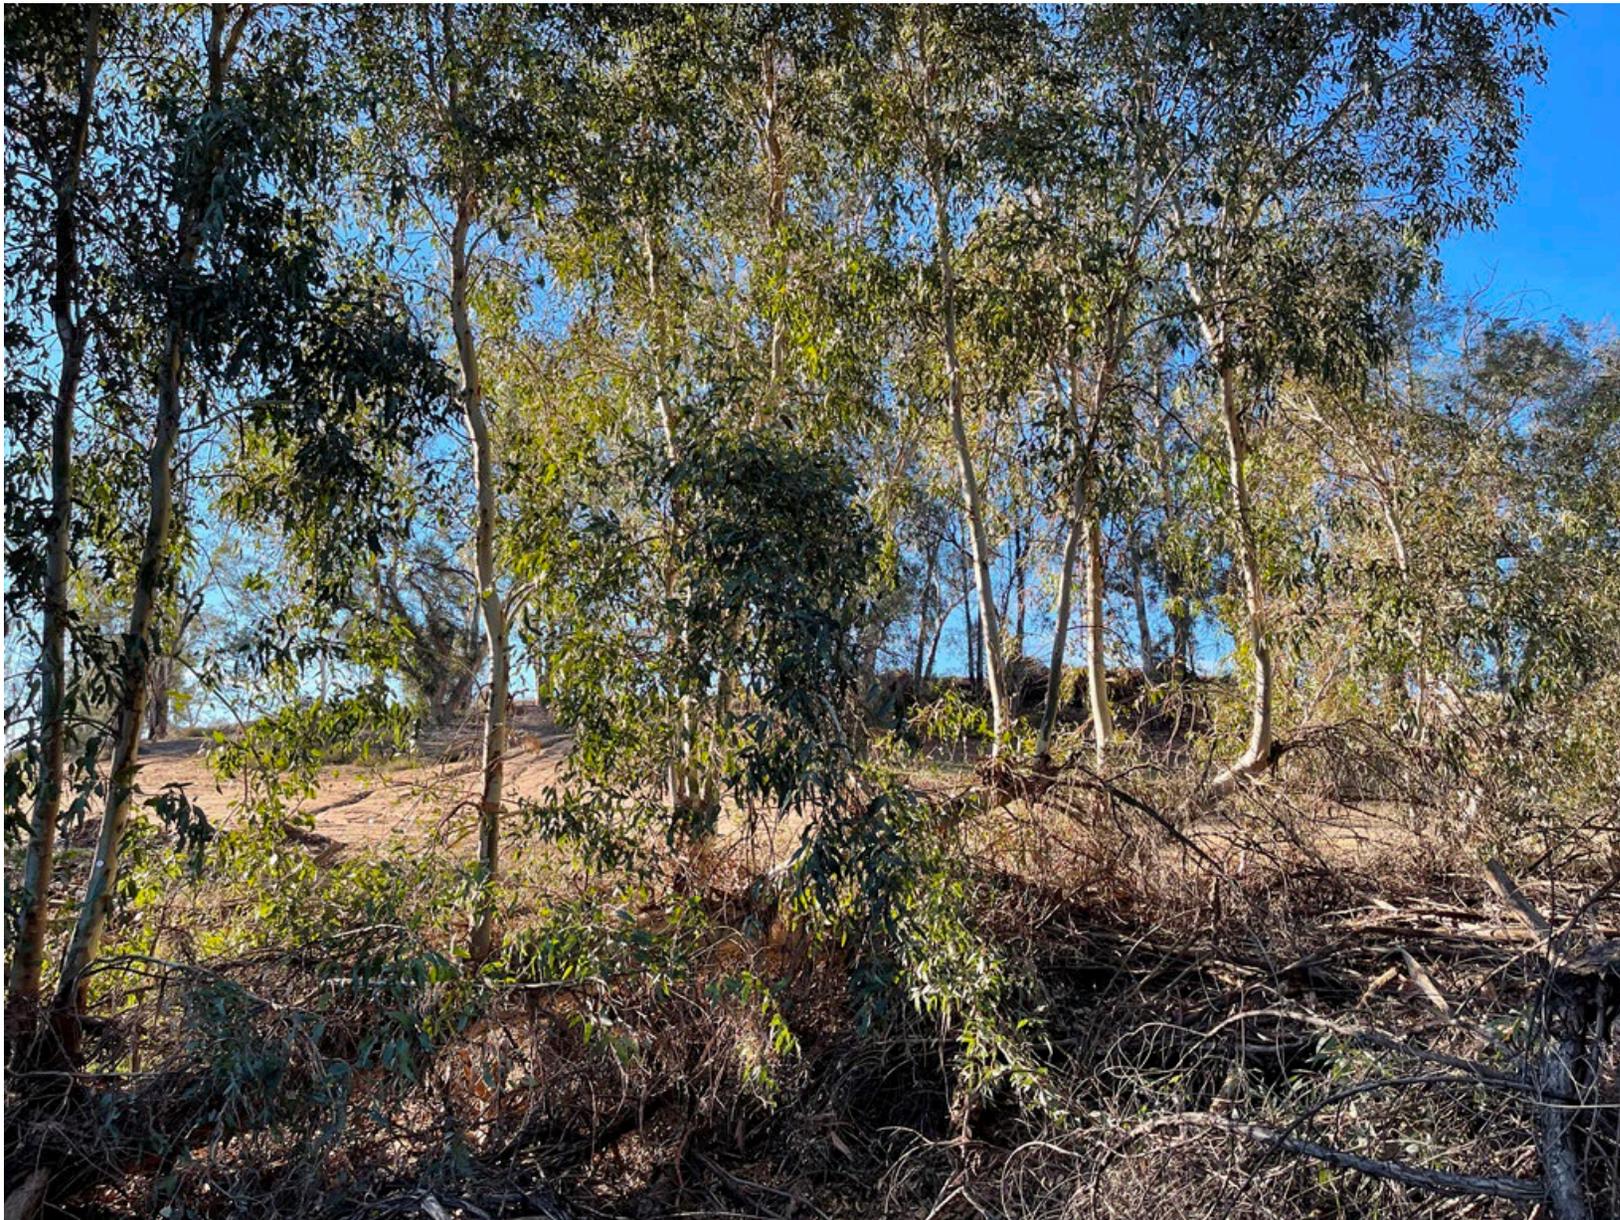
The edge of the outflow area, with the parallel group of redgums behind.

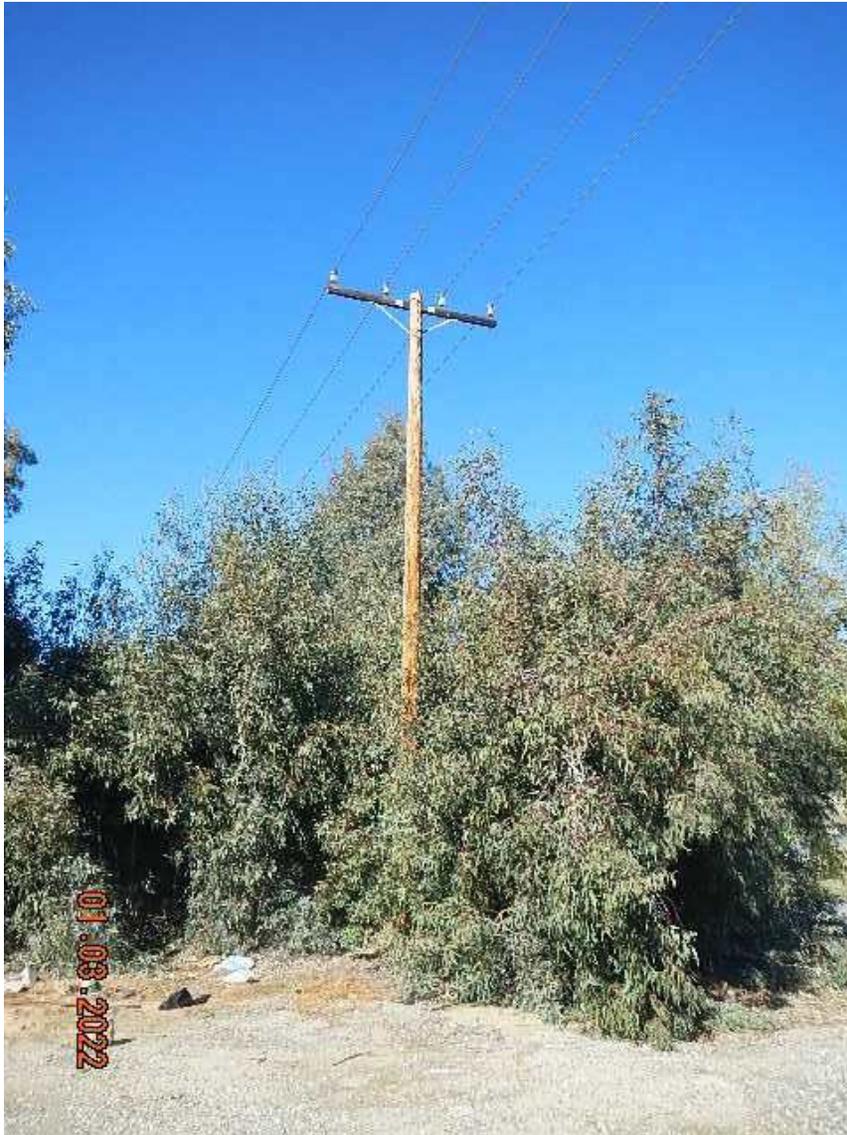
Overhead wires necessitated the topping of many trees in the arroyo.

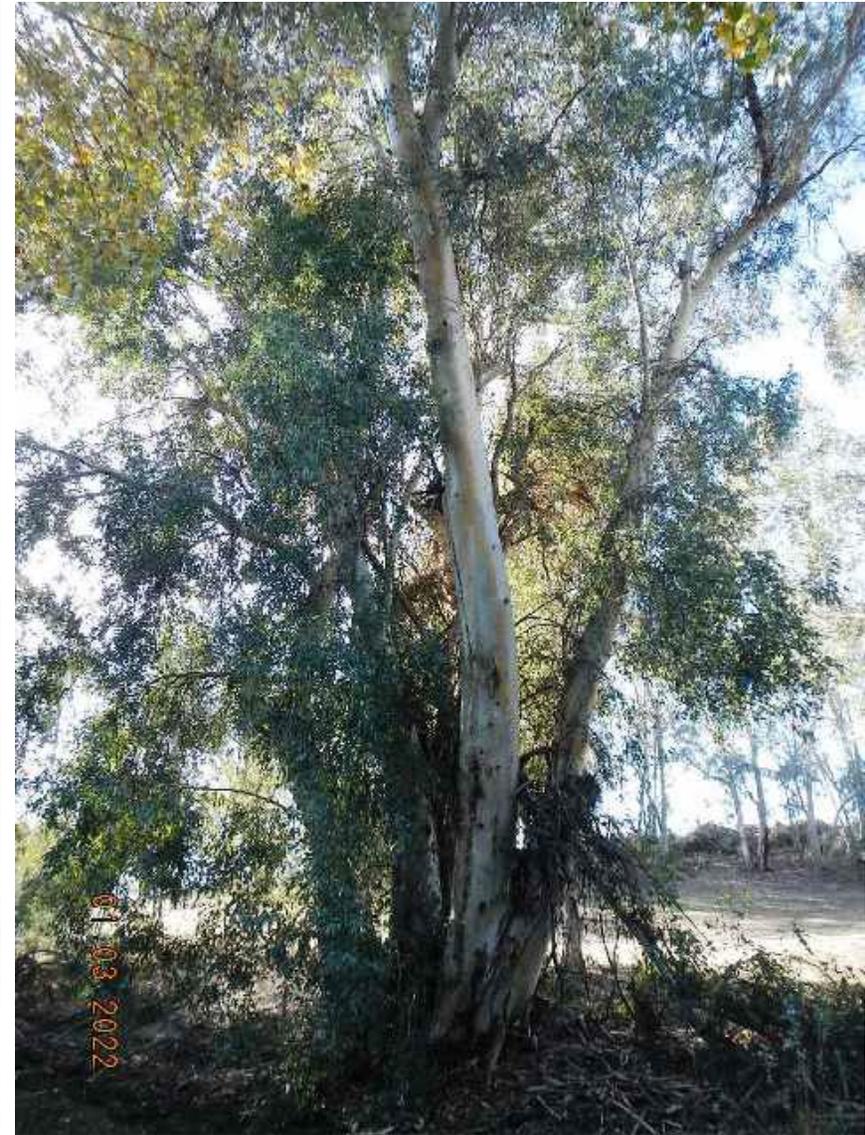
Many of the redgums have crowded trunks pressing against each other.

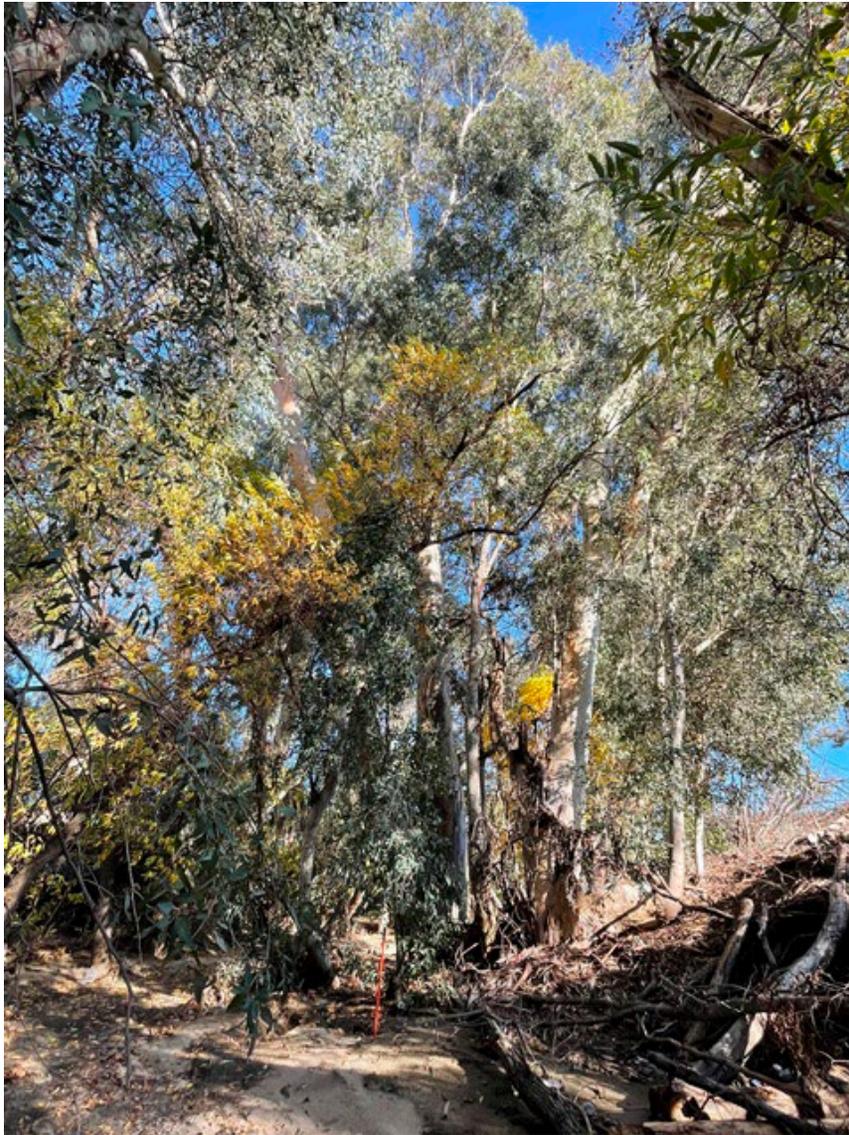
Looking north in about the middle of the outflow area.

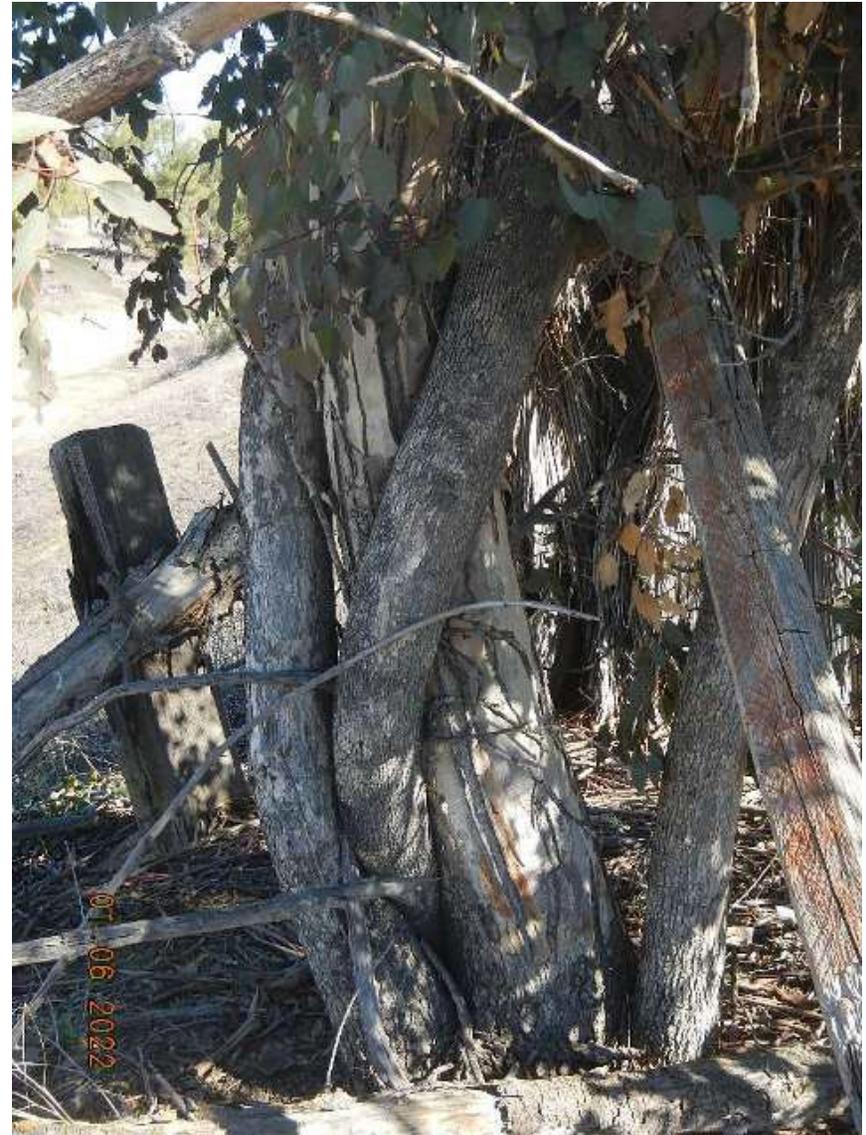
A multi-trunk red gum behind the northmost home on Vista Murrieta.

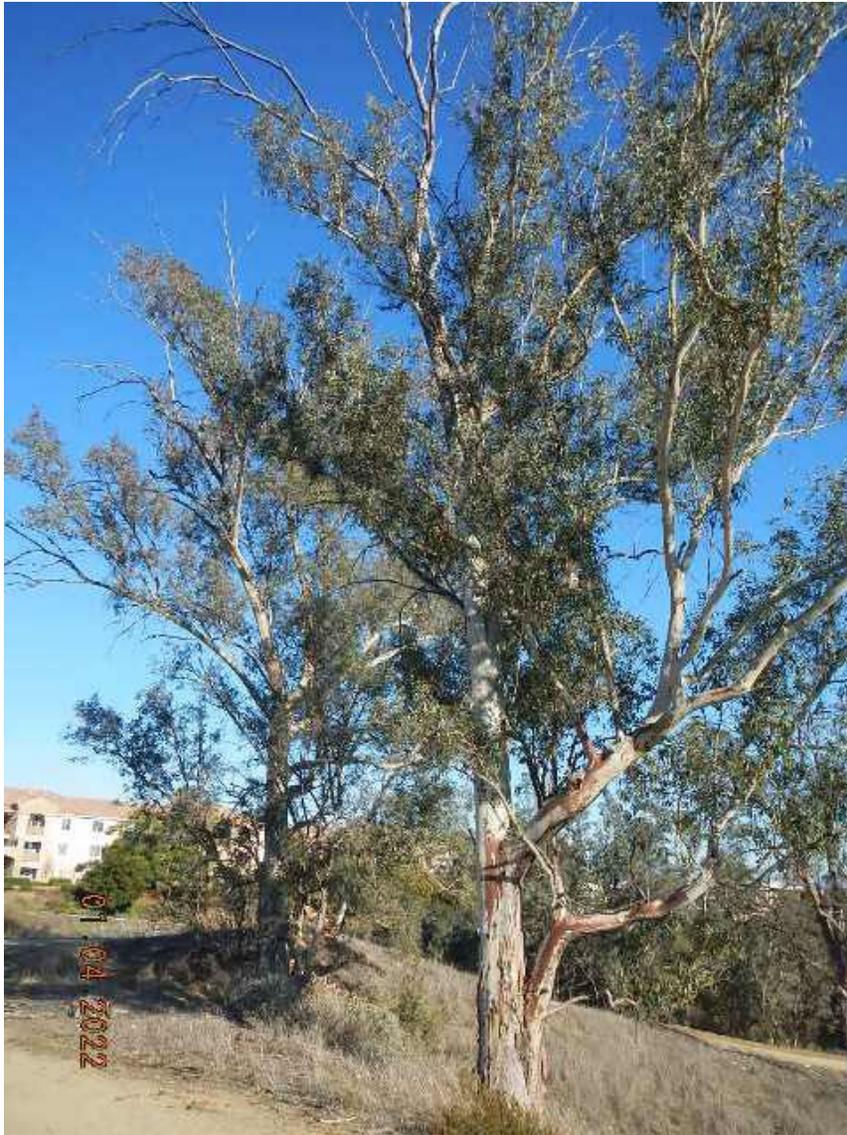
Note dieback, sparse foliage and epicormic shoots near #137

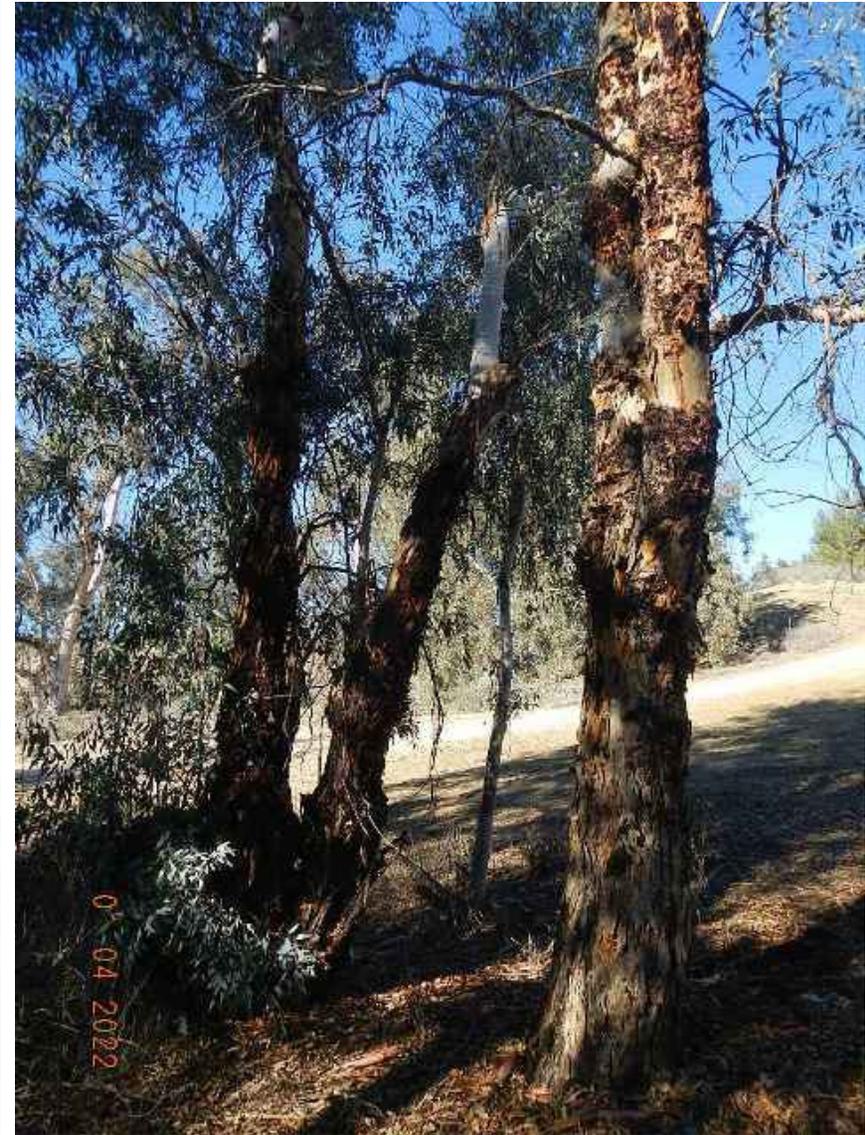
Trees #138 and #139 are infected, perhaps with Phytophthora.
