Consulting Arborist's Report

Tree Evaluation Report

For: Terraces in Murrieta

Dated: 1/11/2022

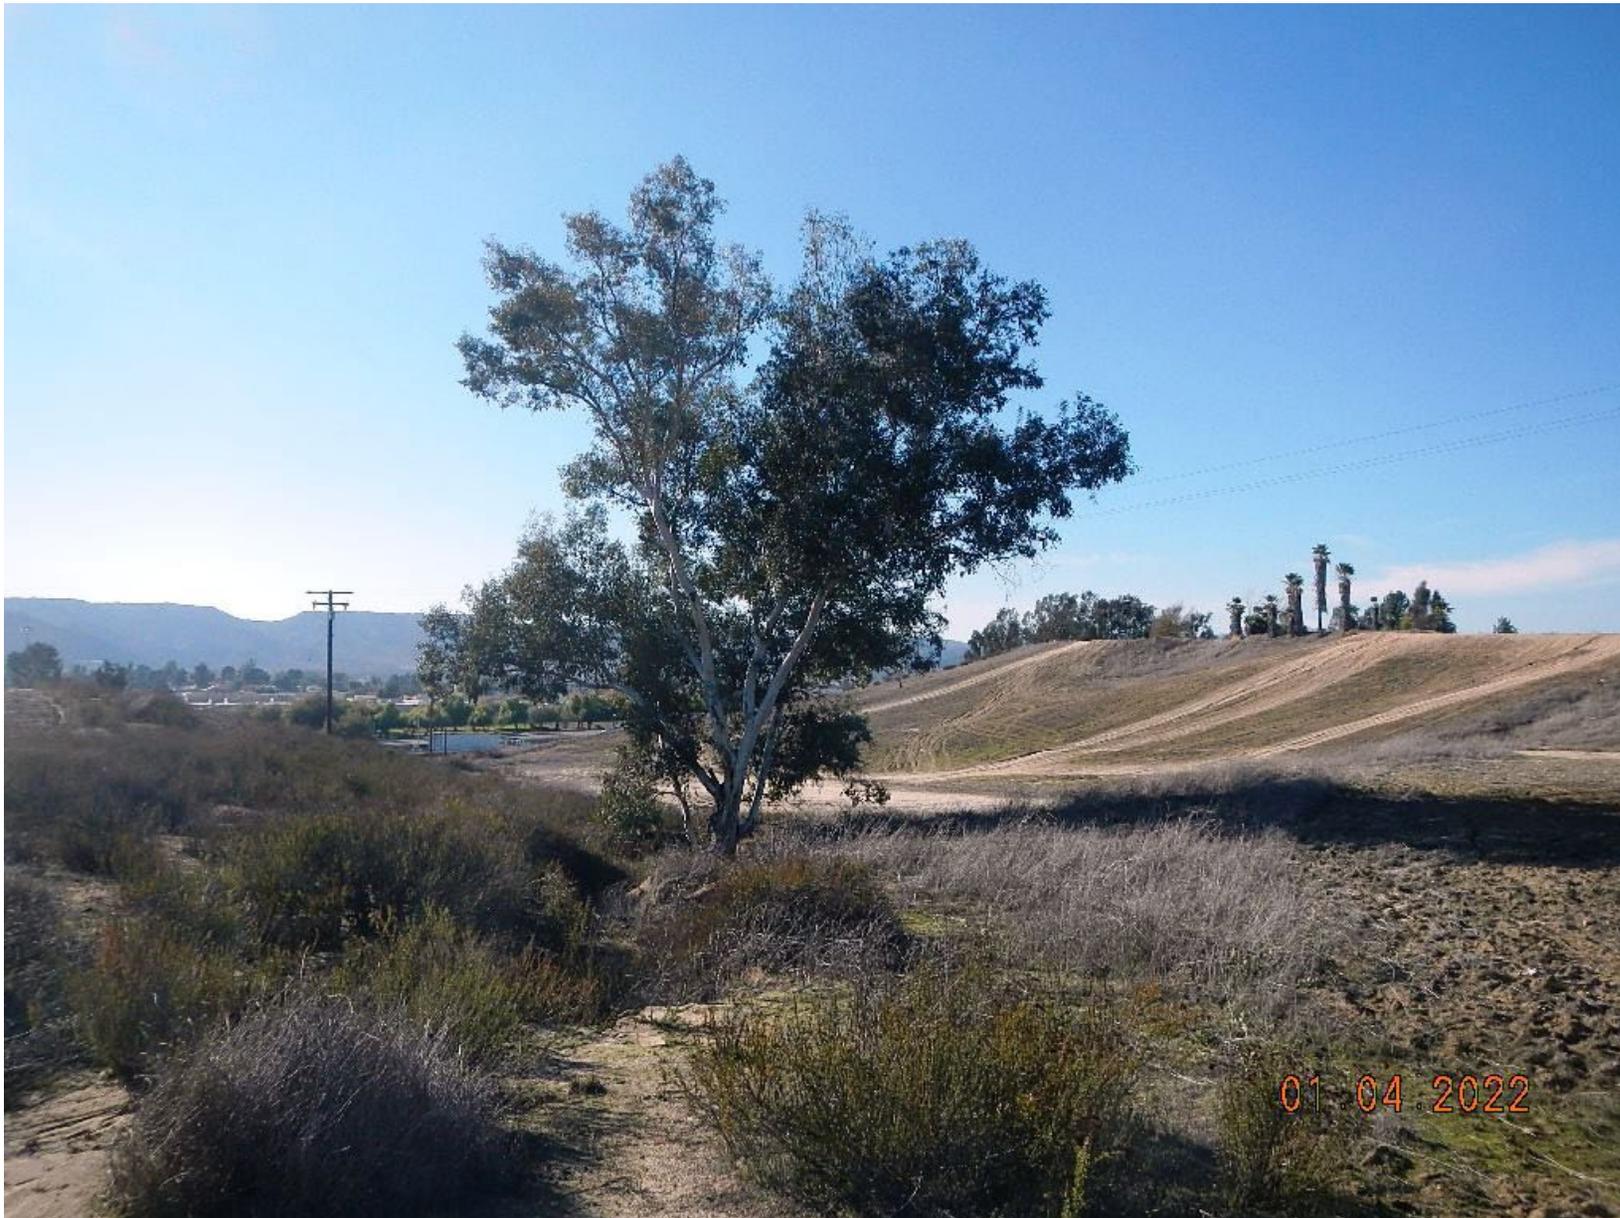
#173 in a ravine in the central part of the site.

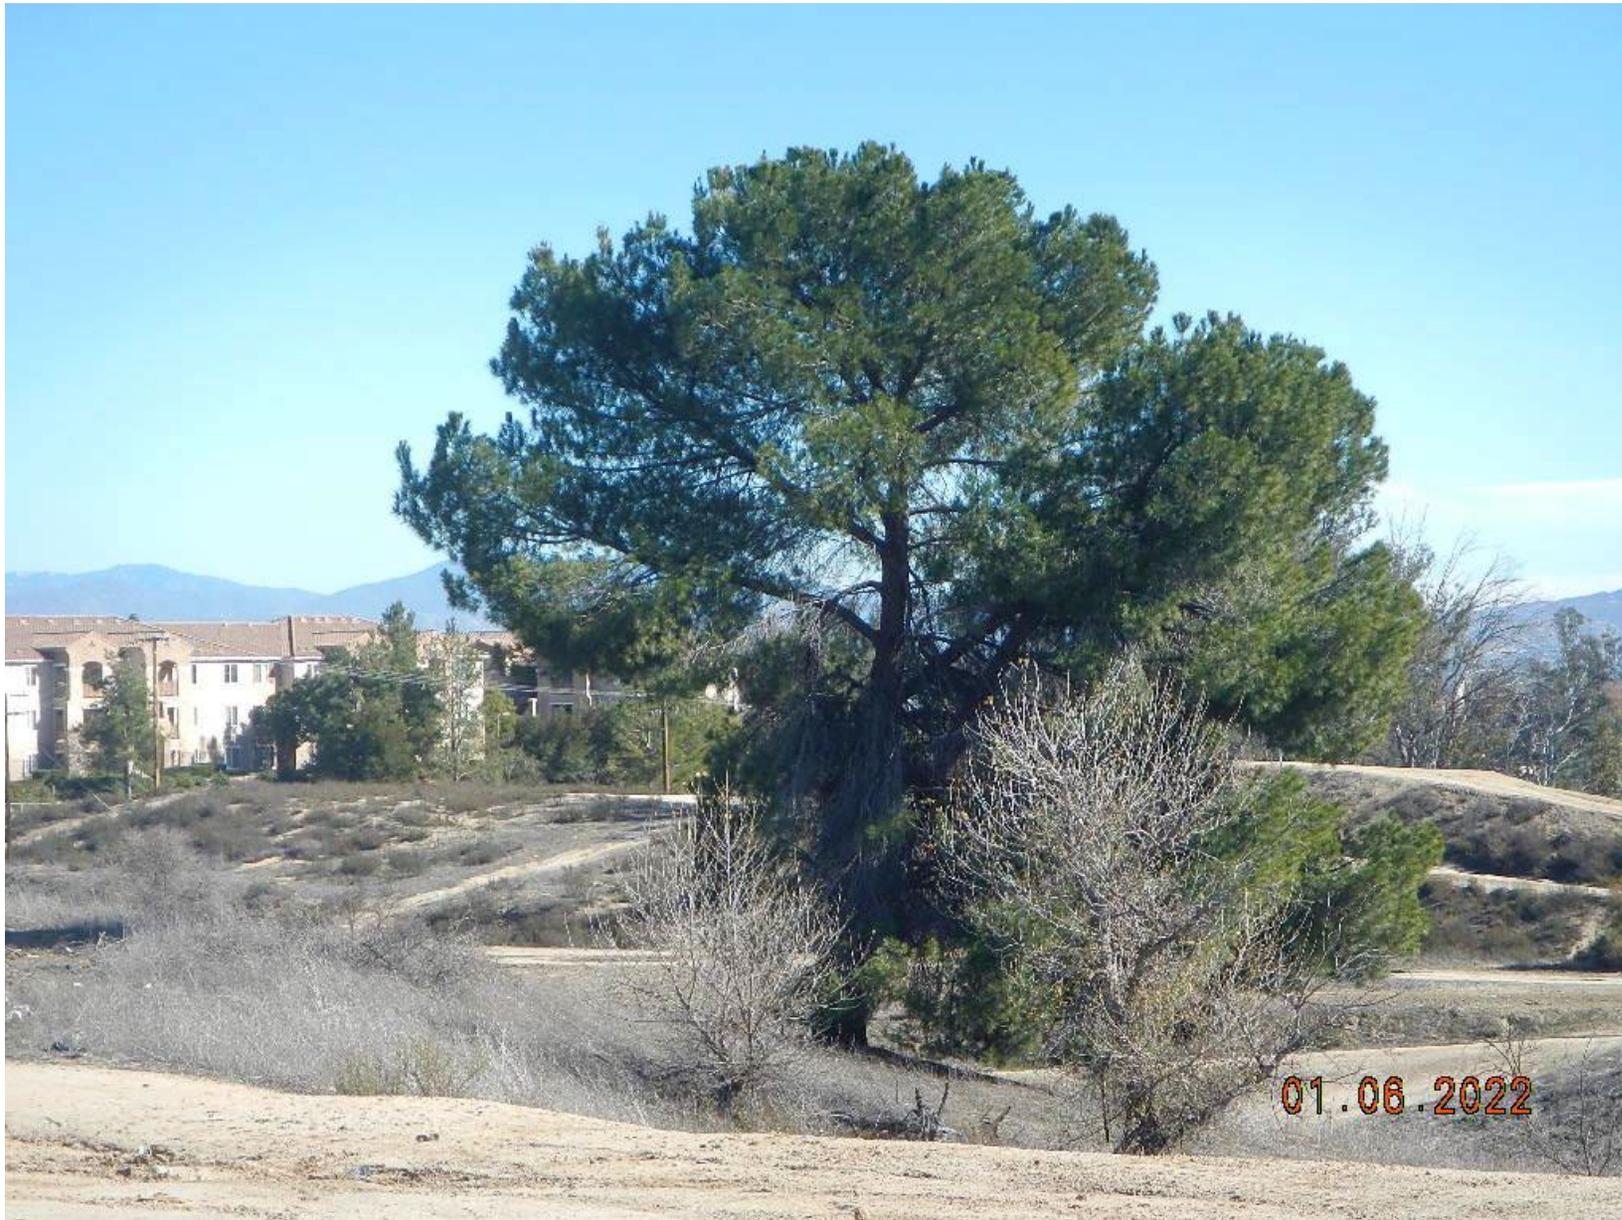
#197 Aleppo pine in a ravine in the central part of the site.

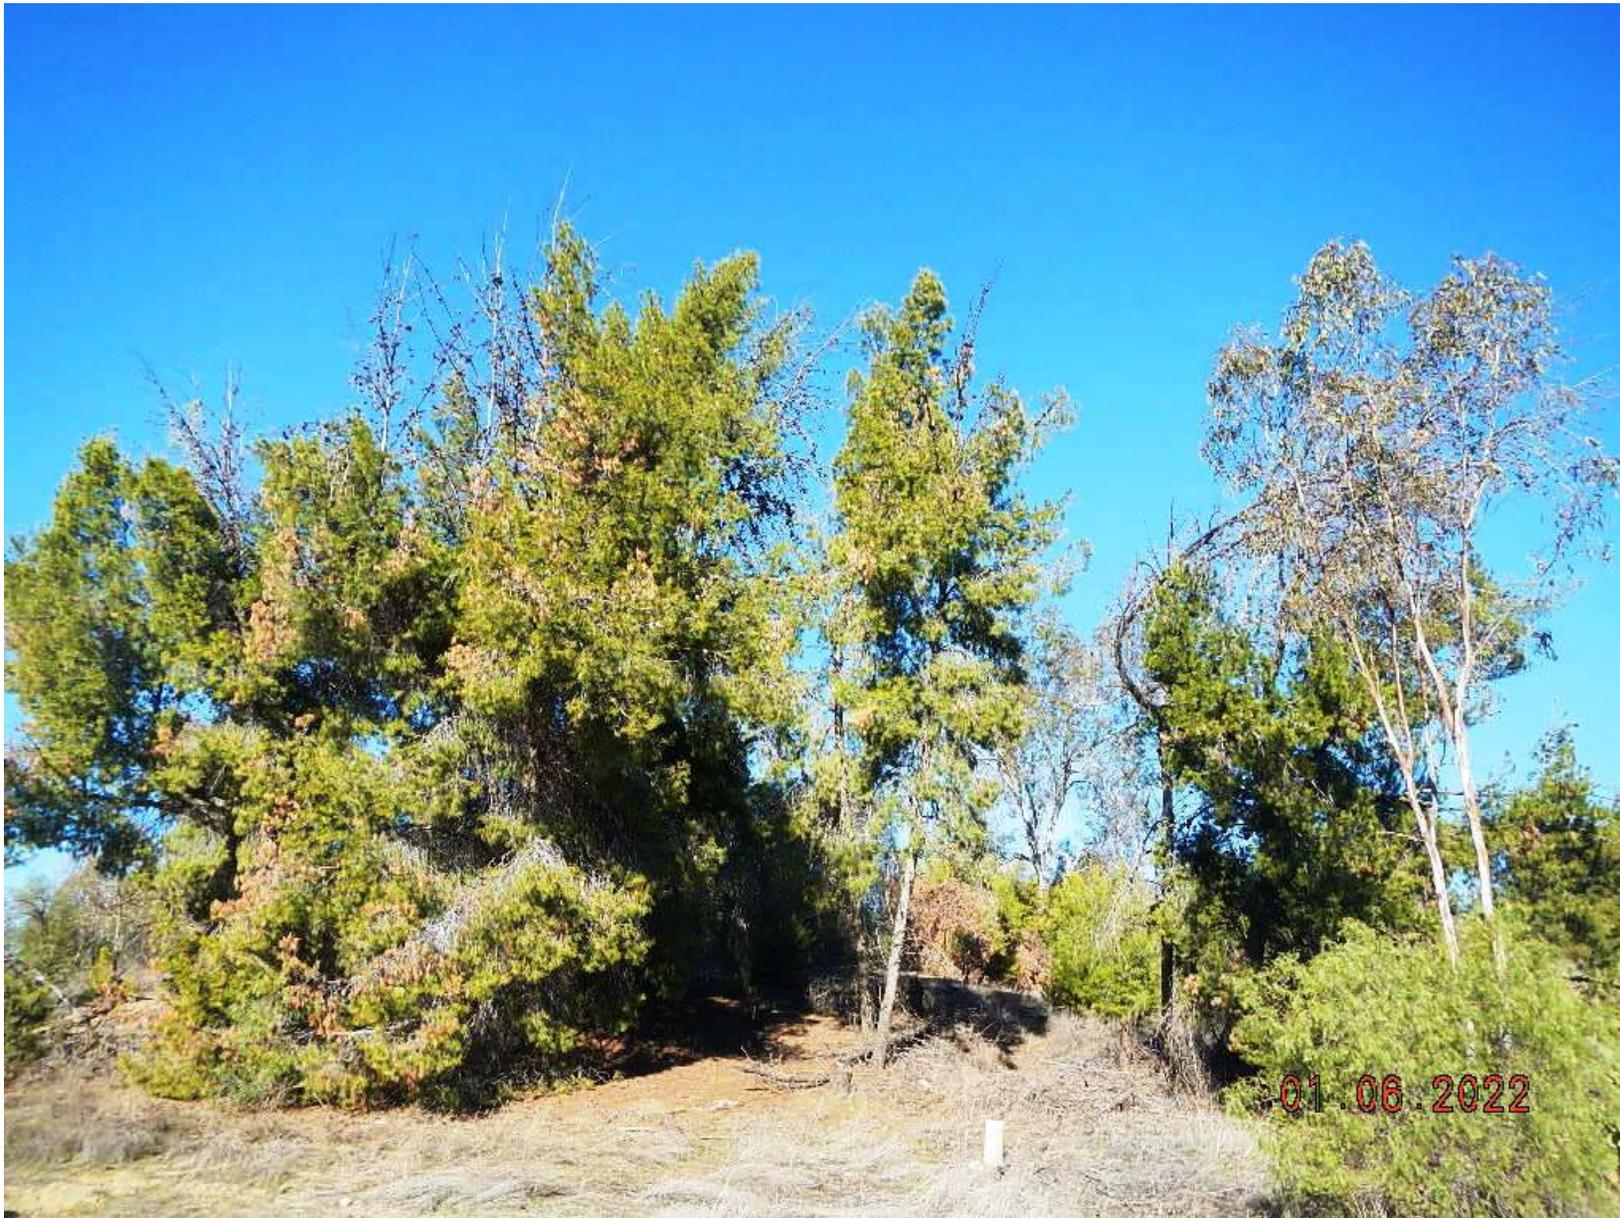
Aleppo pines in severe drought stress. Note dieback and chlorotic foliage.

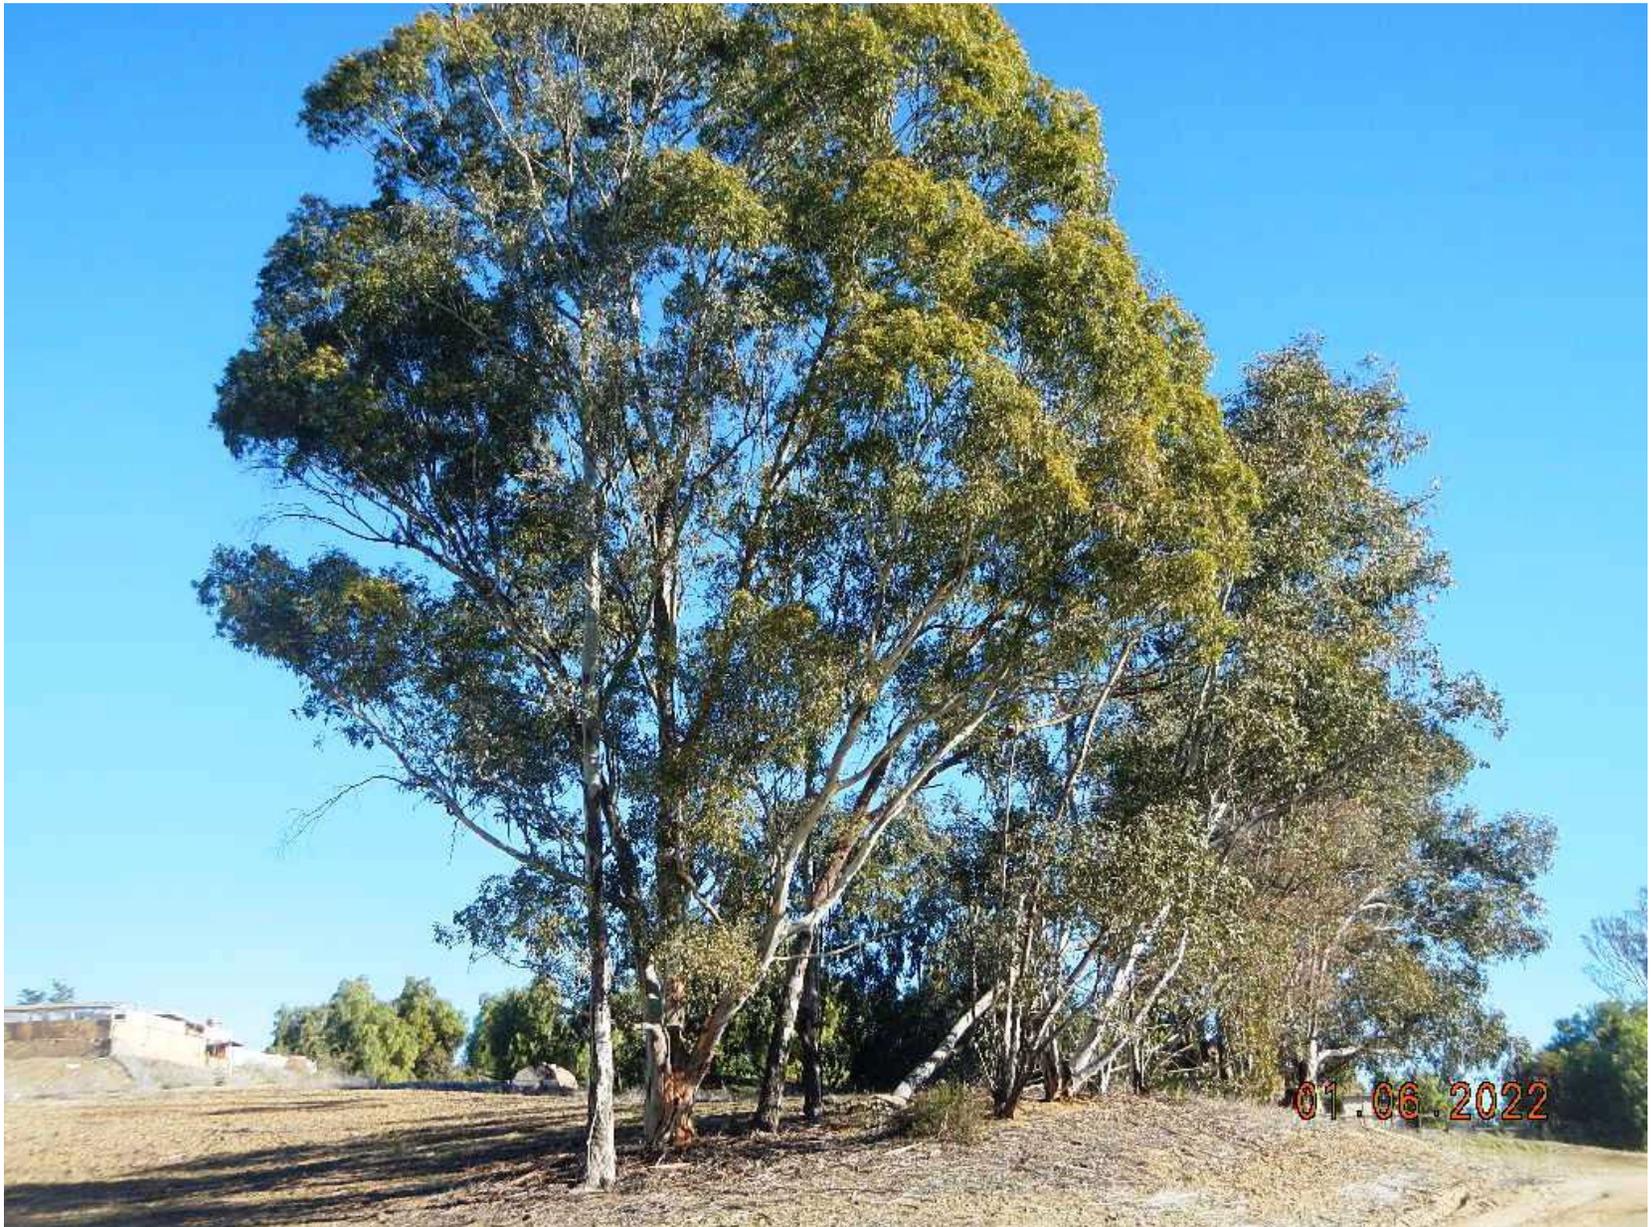
Row of redgums behind the first house at the north corner of the site.

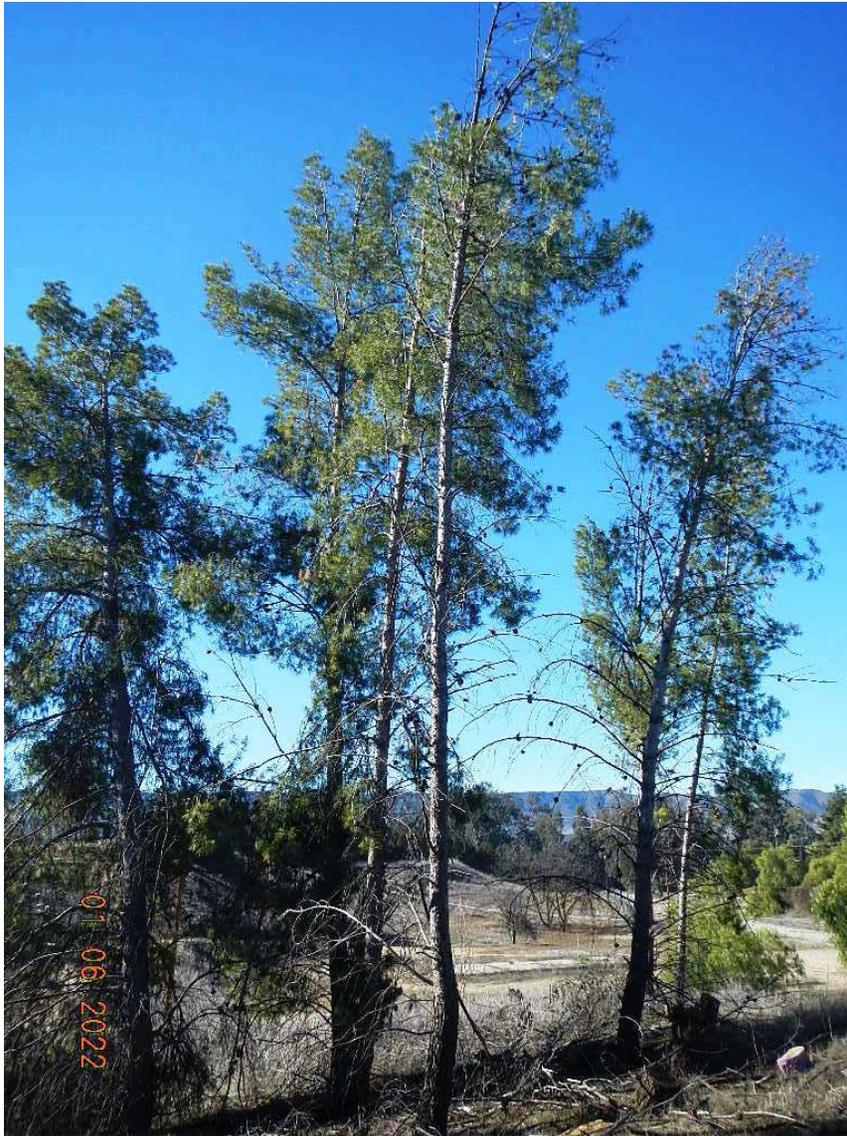
Row of Aleppos behind the first house at the north corner of the site.

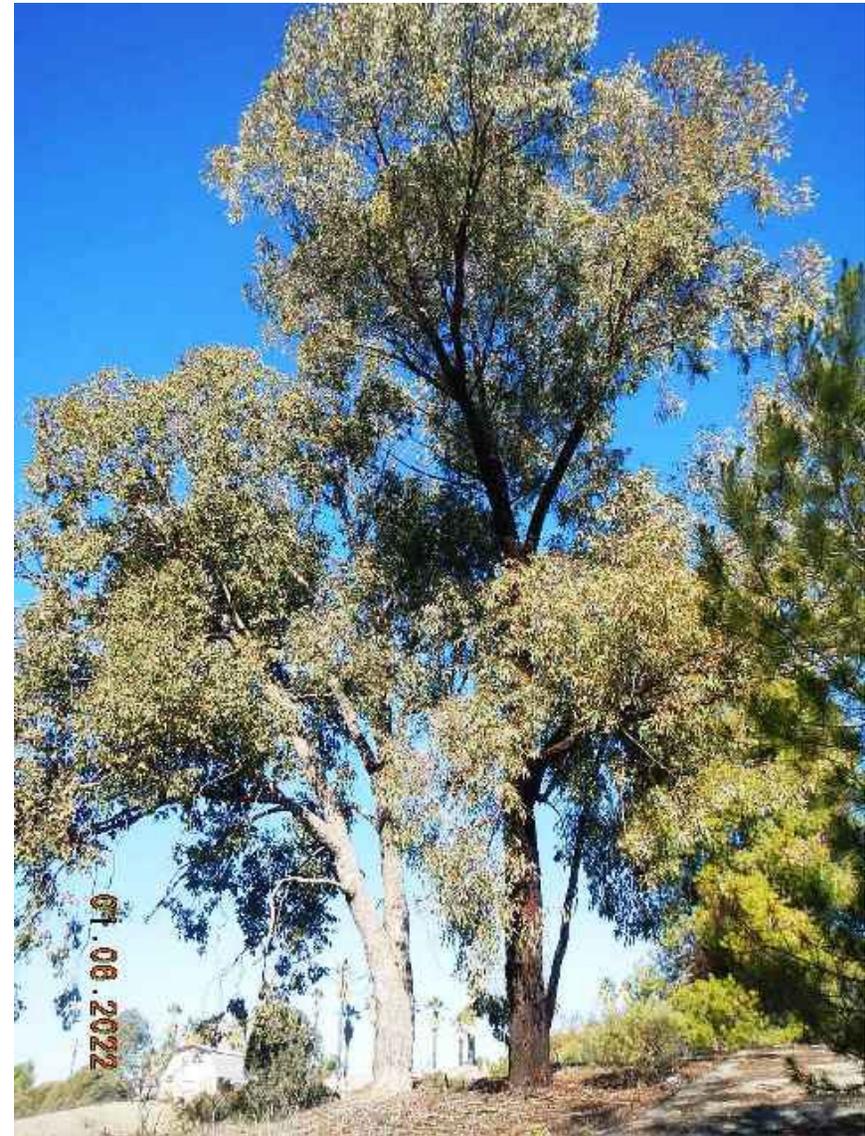
#259 & 260 Red ironbark and red box respectively

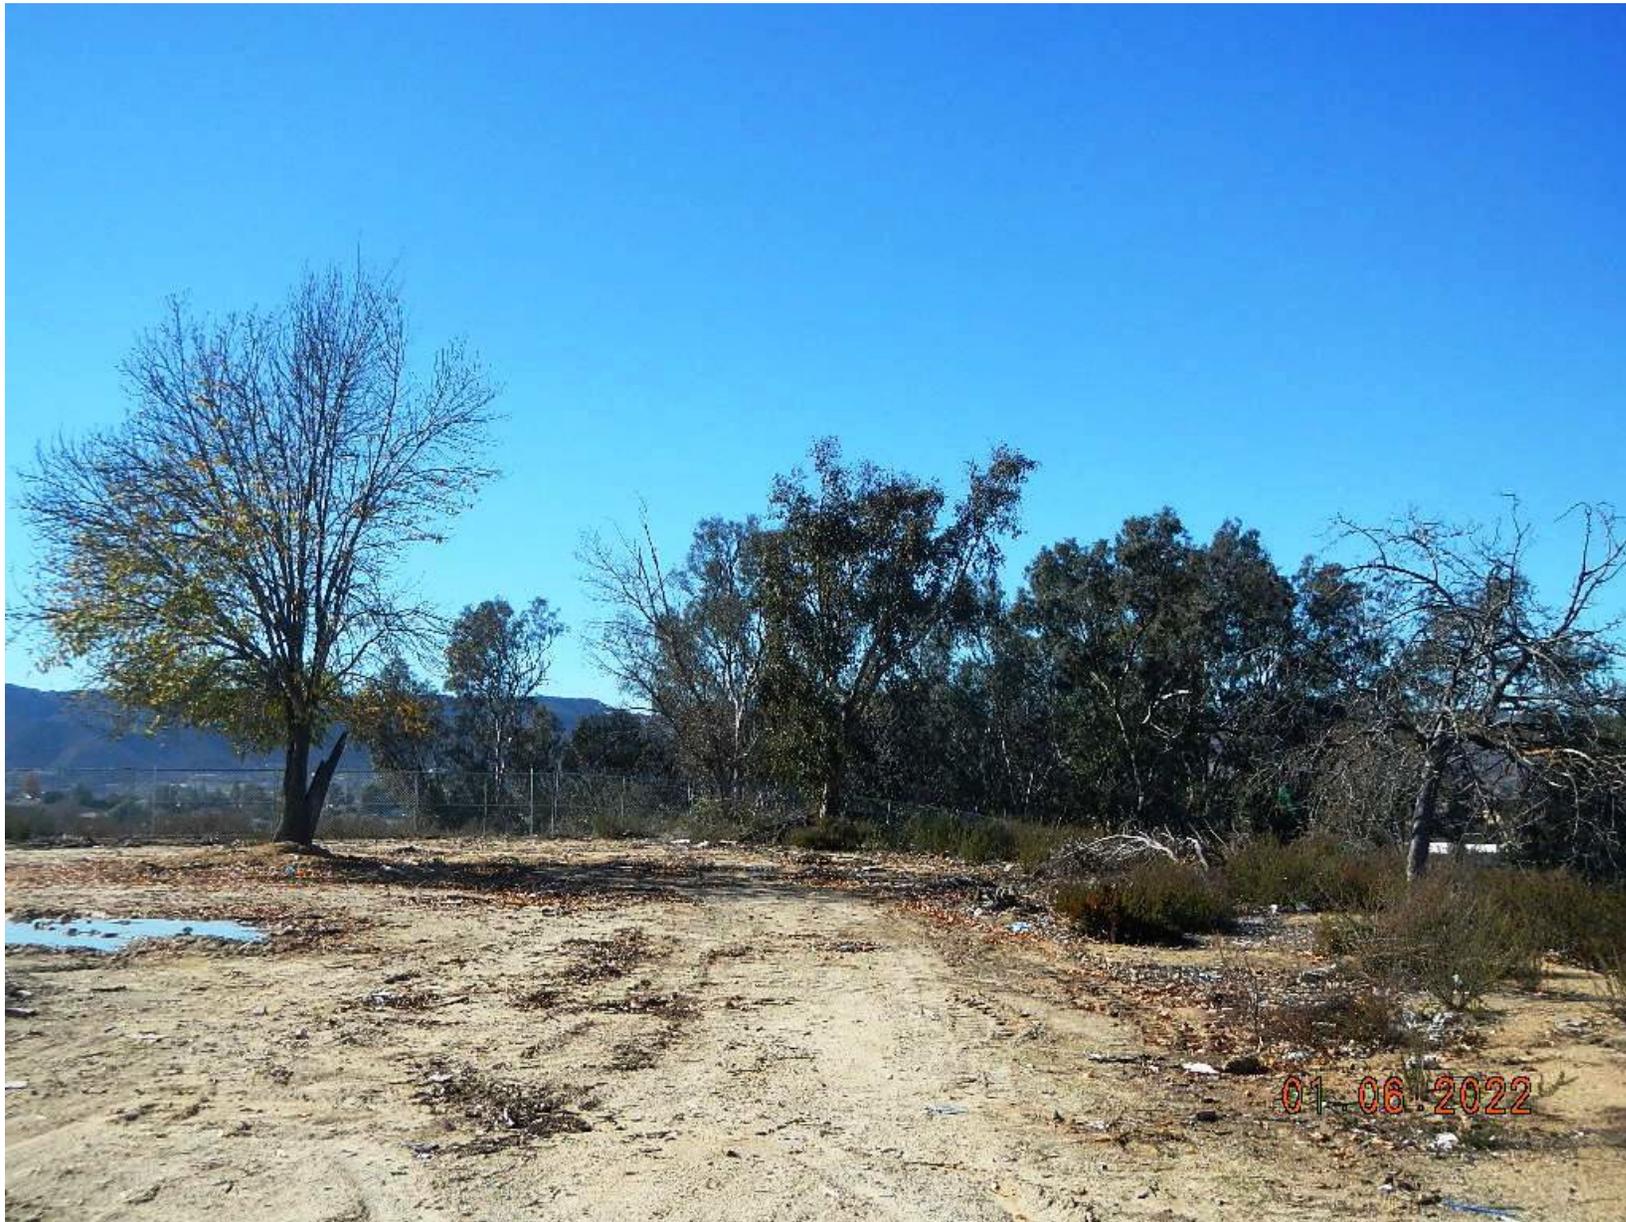
#290 Shamel ash at left, #291 and #292 to the right.

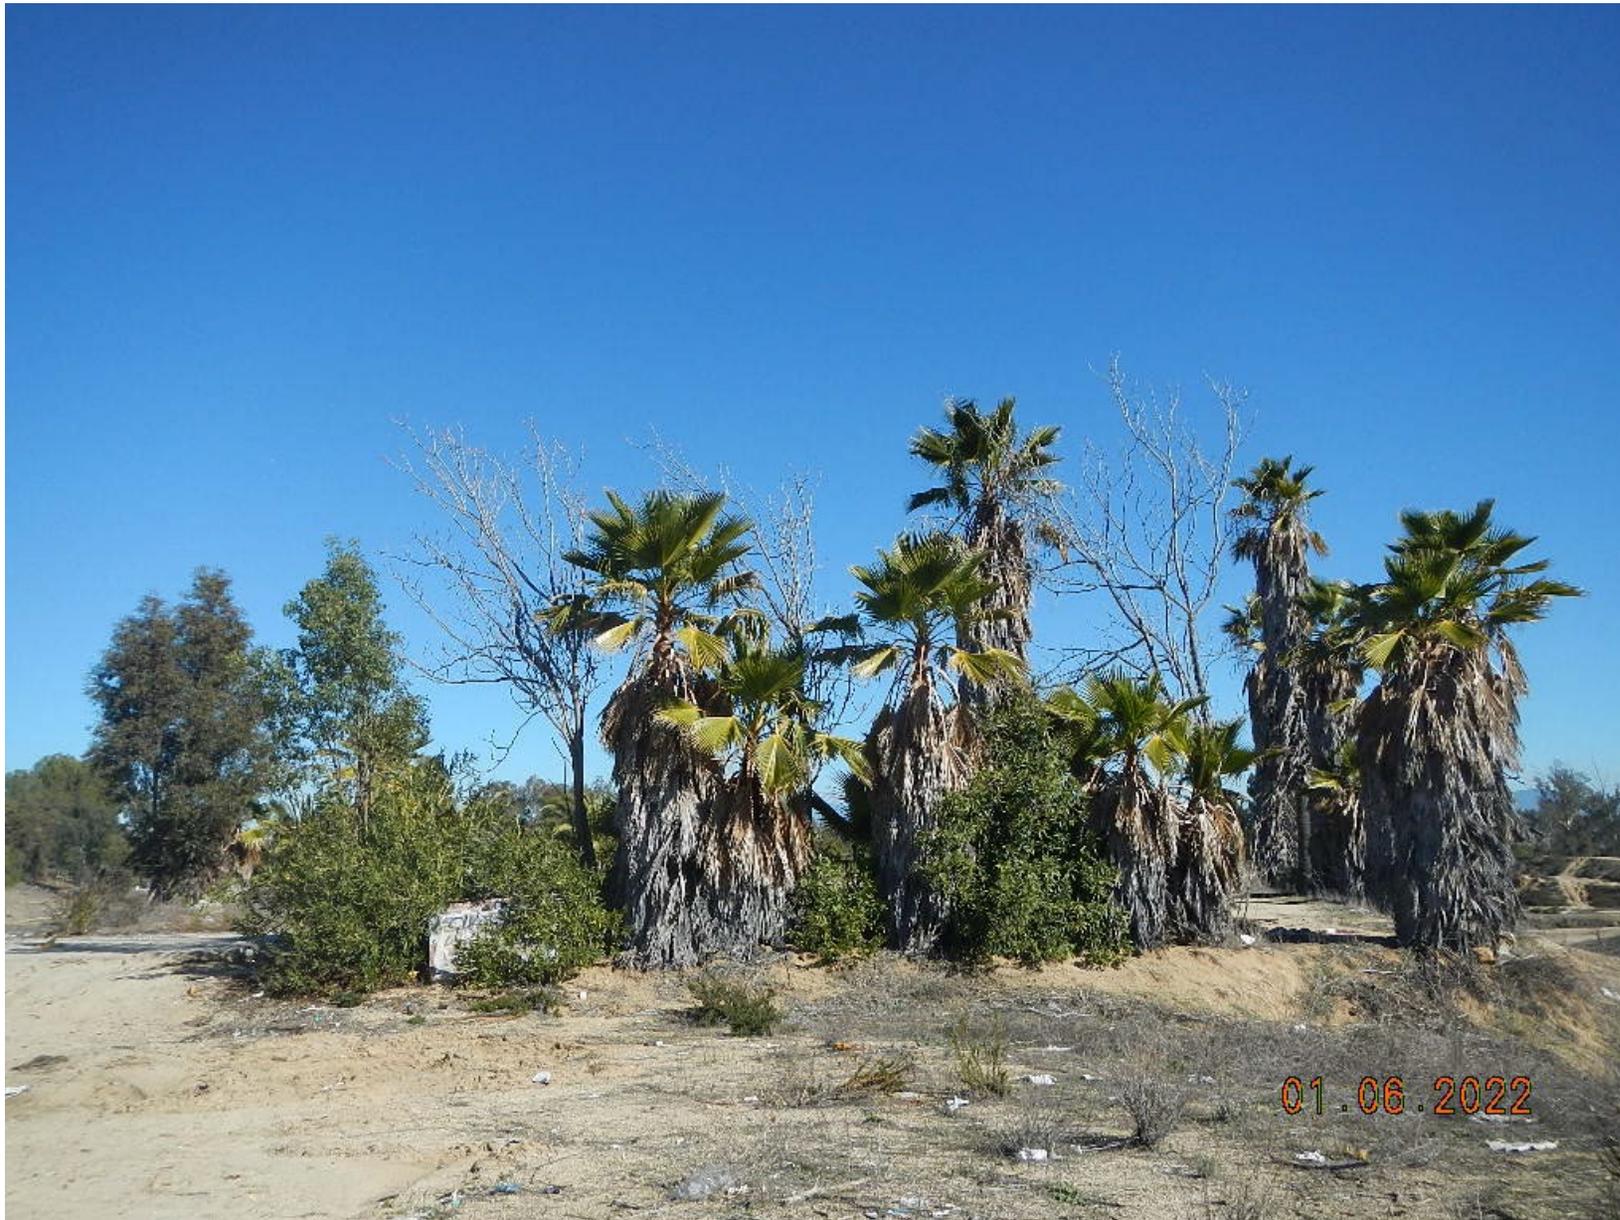
Even the Mexican fan palms have not survived well, the foliage is stunted, yellow, and dead fronds cover the trunks to ground level. The California peppers have a fairly nice canopy of foliage, but their structures are a tangled mess. The Aleppo pines are barely surviving, but most are leaning, codominant with included bark, and dead tops. The row of Afghan pines are very sparse, crowded and one-sided. Some California peppers are attractive, but their low-branching structure would be hard to use in among apartment buildings.

Mexican fan palms are not drought tolerant. These are declining as indicated by the small heads and limited number of fronds.

Mexican fan palms and queen palms can be infected by the new Fusarium wilt, or the small Canary Island date palms can be infected by the old Fusarium wilt. Due to their poor health and condition, they should just be removed.

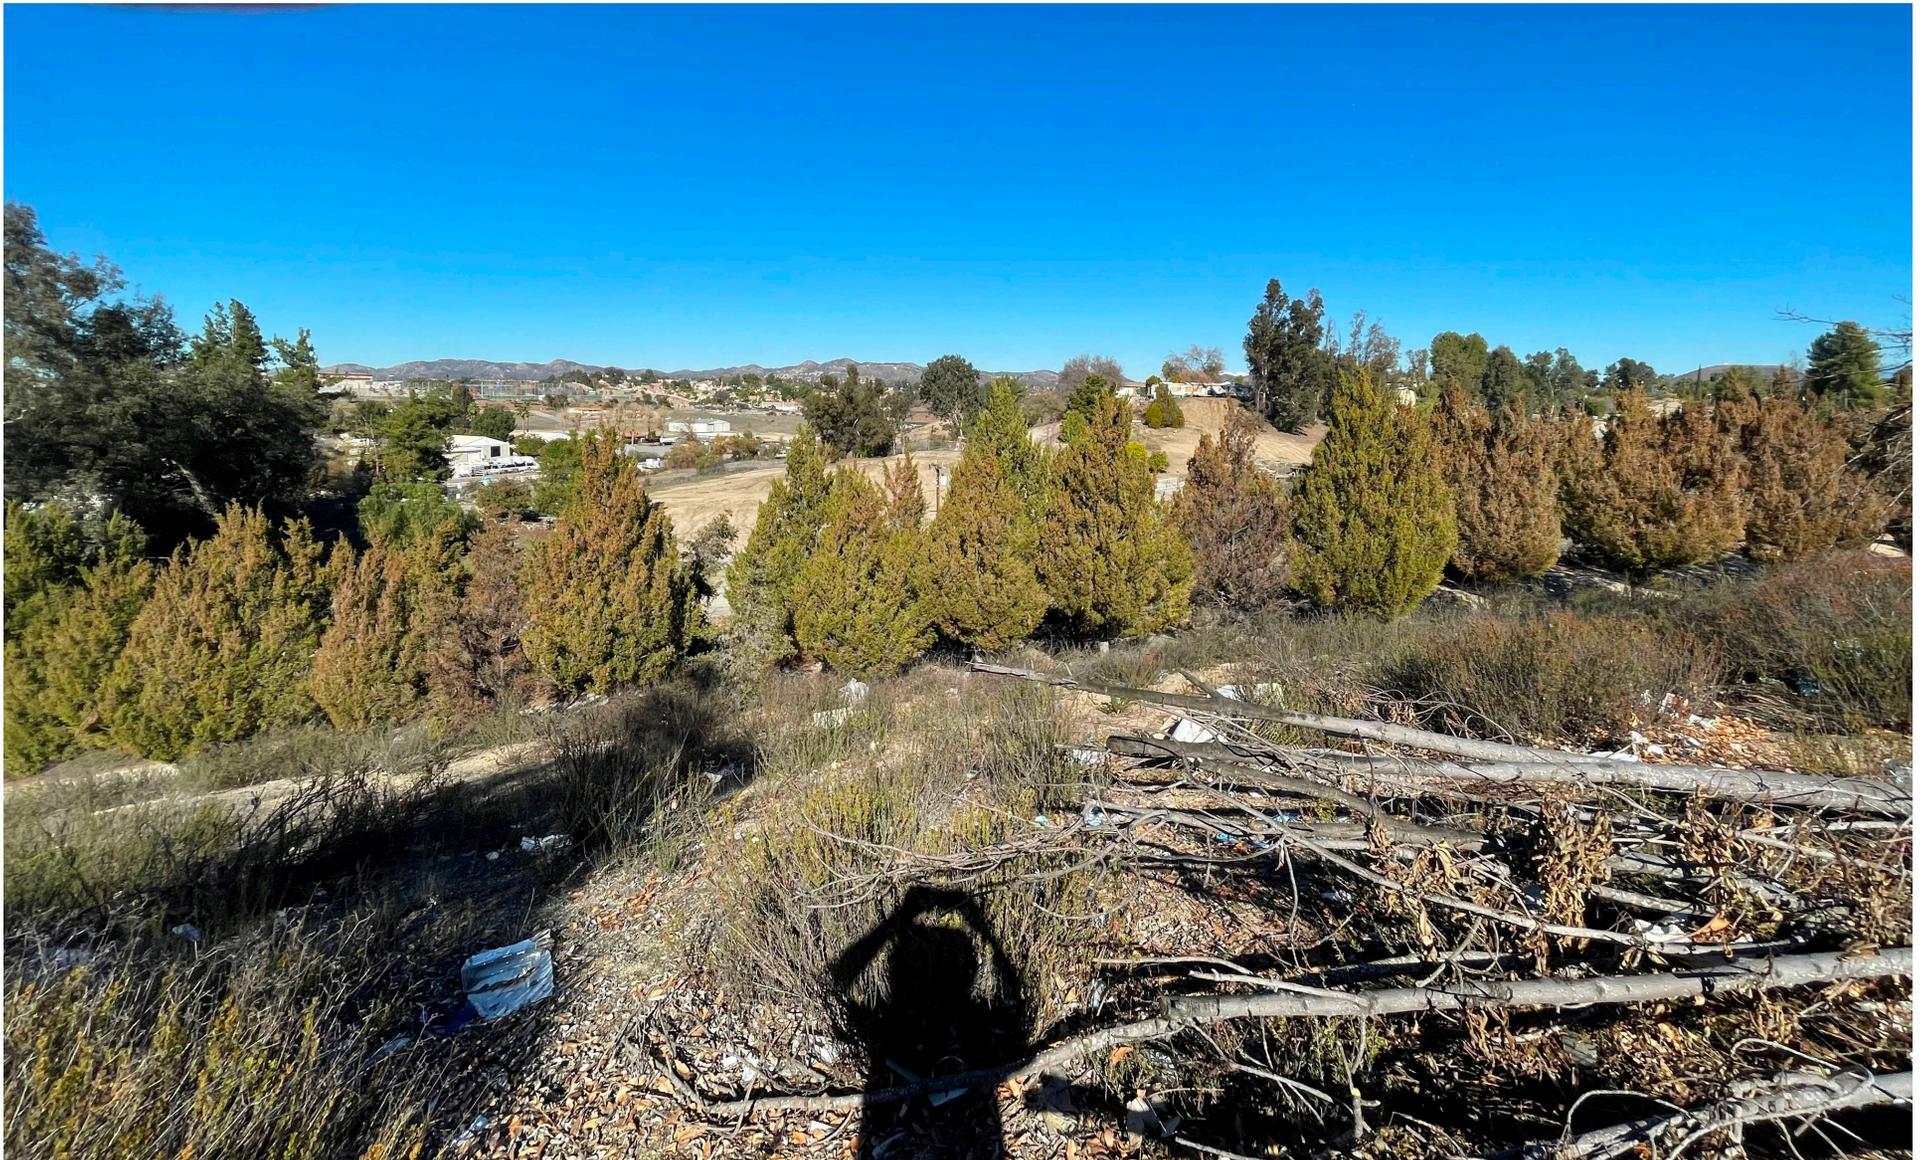
Far west end of Vista Murrieta, viewed from above, note browning.
