Hazardous Materials Assessment

**Morningside High School
10500 S. Yukon Avenue
Inglewood, CA 90303**

**Sampling Date: December 2018 – January 2019
Project No: 18-547**

Prepared for:
*Inglewood Unified School District
401 S. Inglewood Ave., Inglewood, CA 60301*

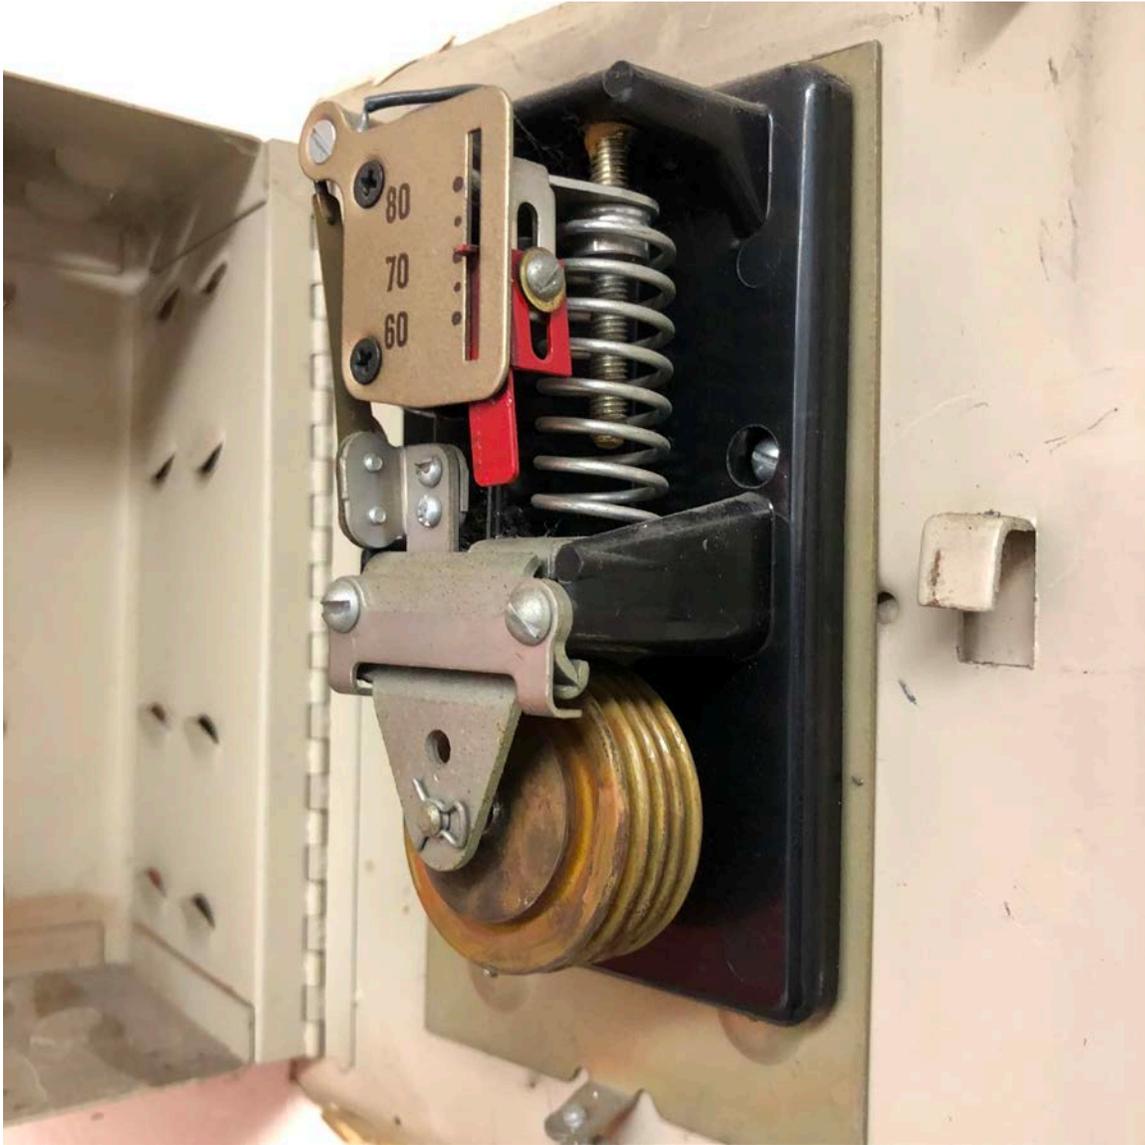
Thermostats in the auditorium were noted to be mechanical contact thermostats with no mercury.

Mechanical contact thermostat.

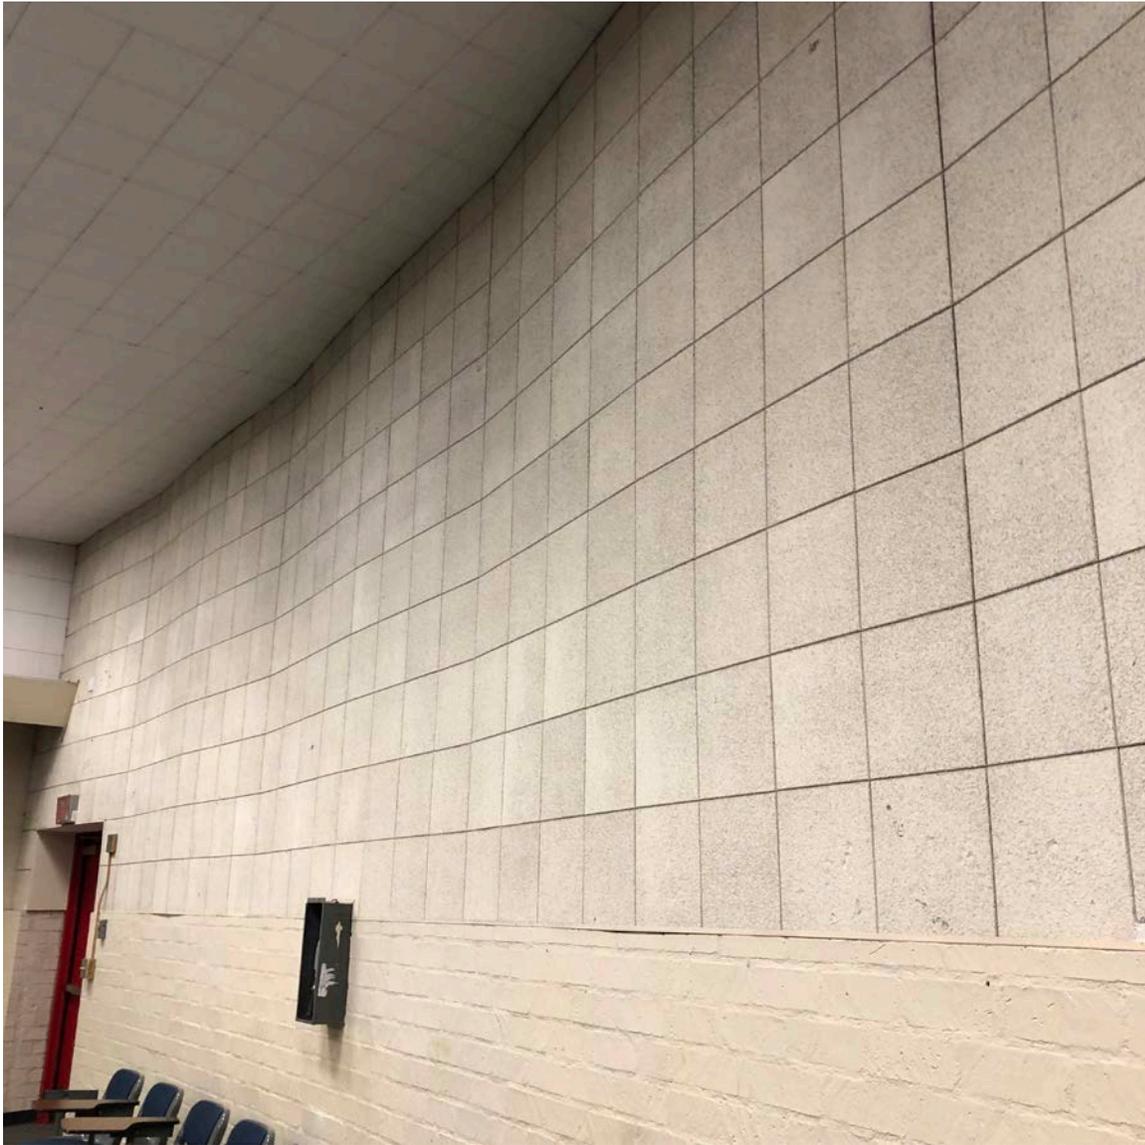
Auditorium wall tiles – no asbestos detected.

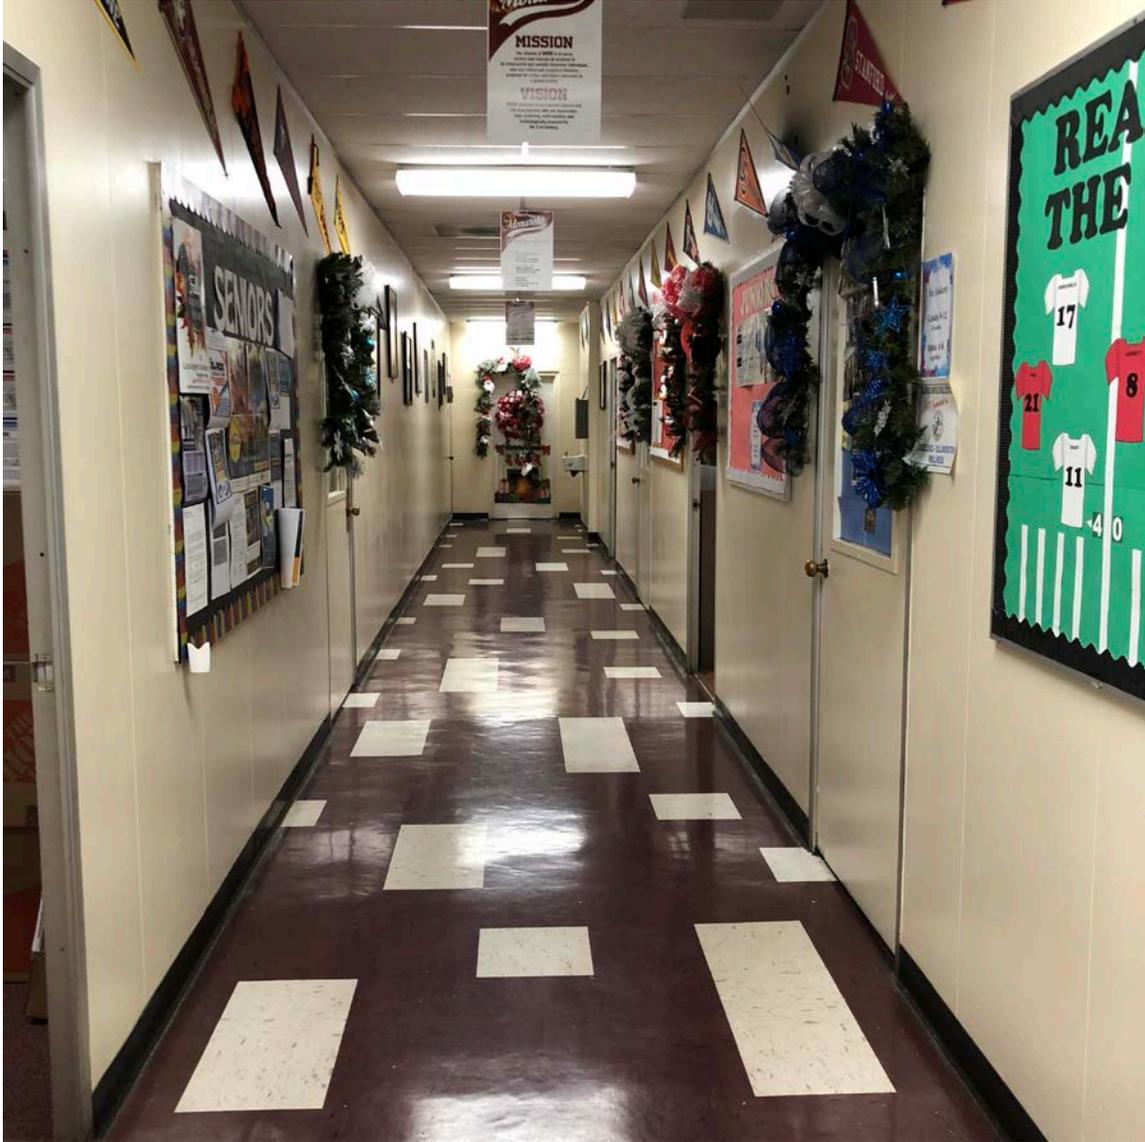
Building A corridor. Floor tile and cove base samples were negative for asbestos.

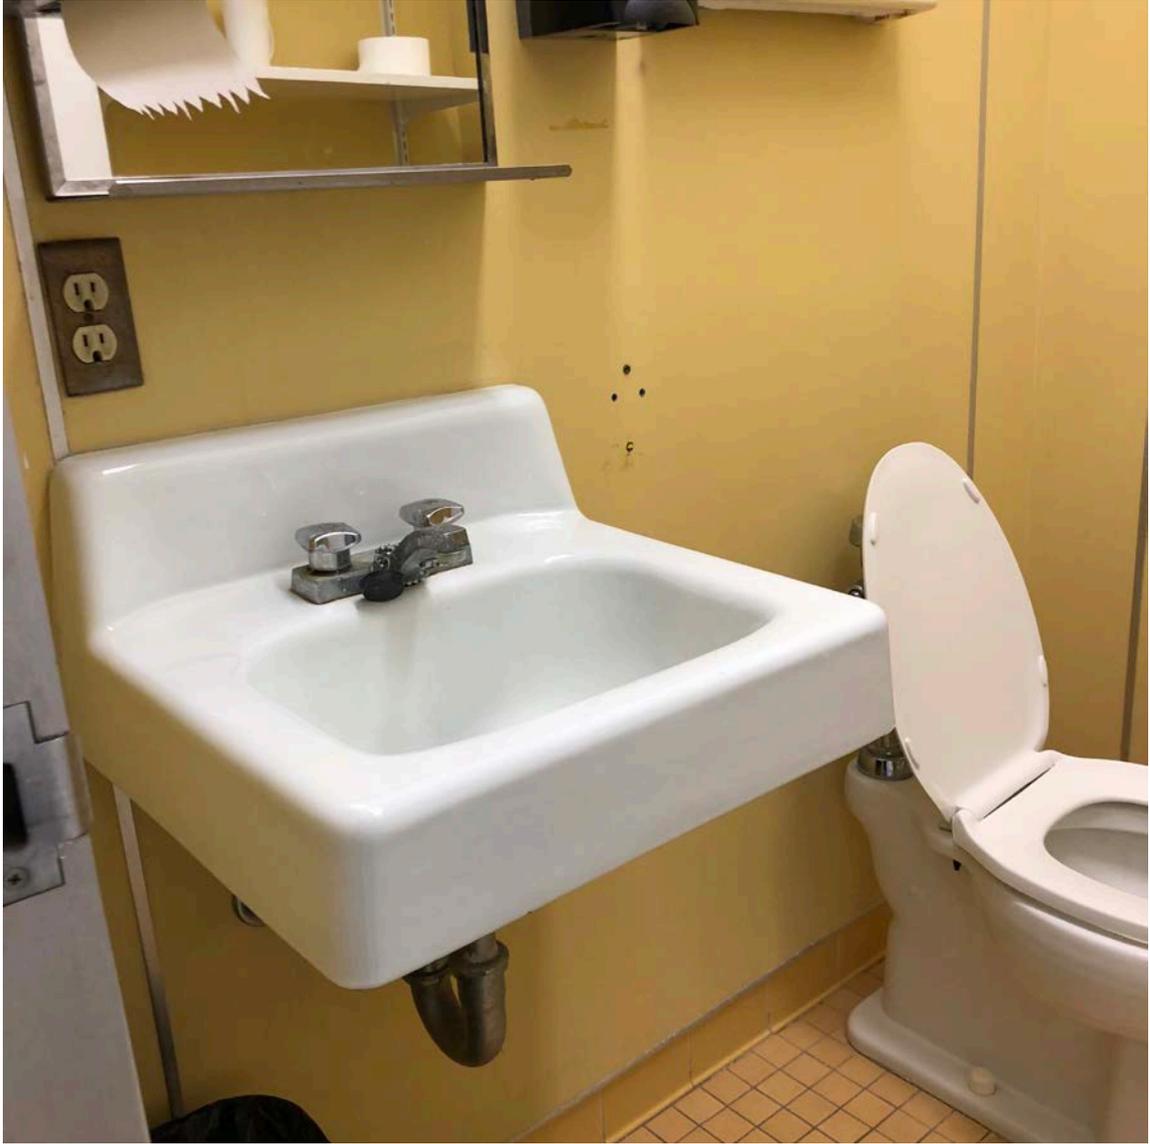
Restroom ceramic cove base contains lead. Yellow ceramic floor tile was found to be negative for lead.

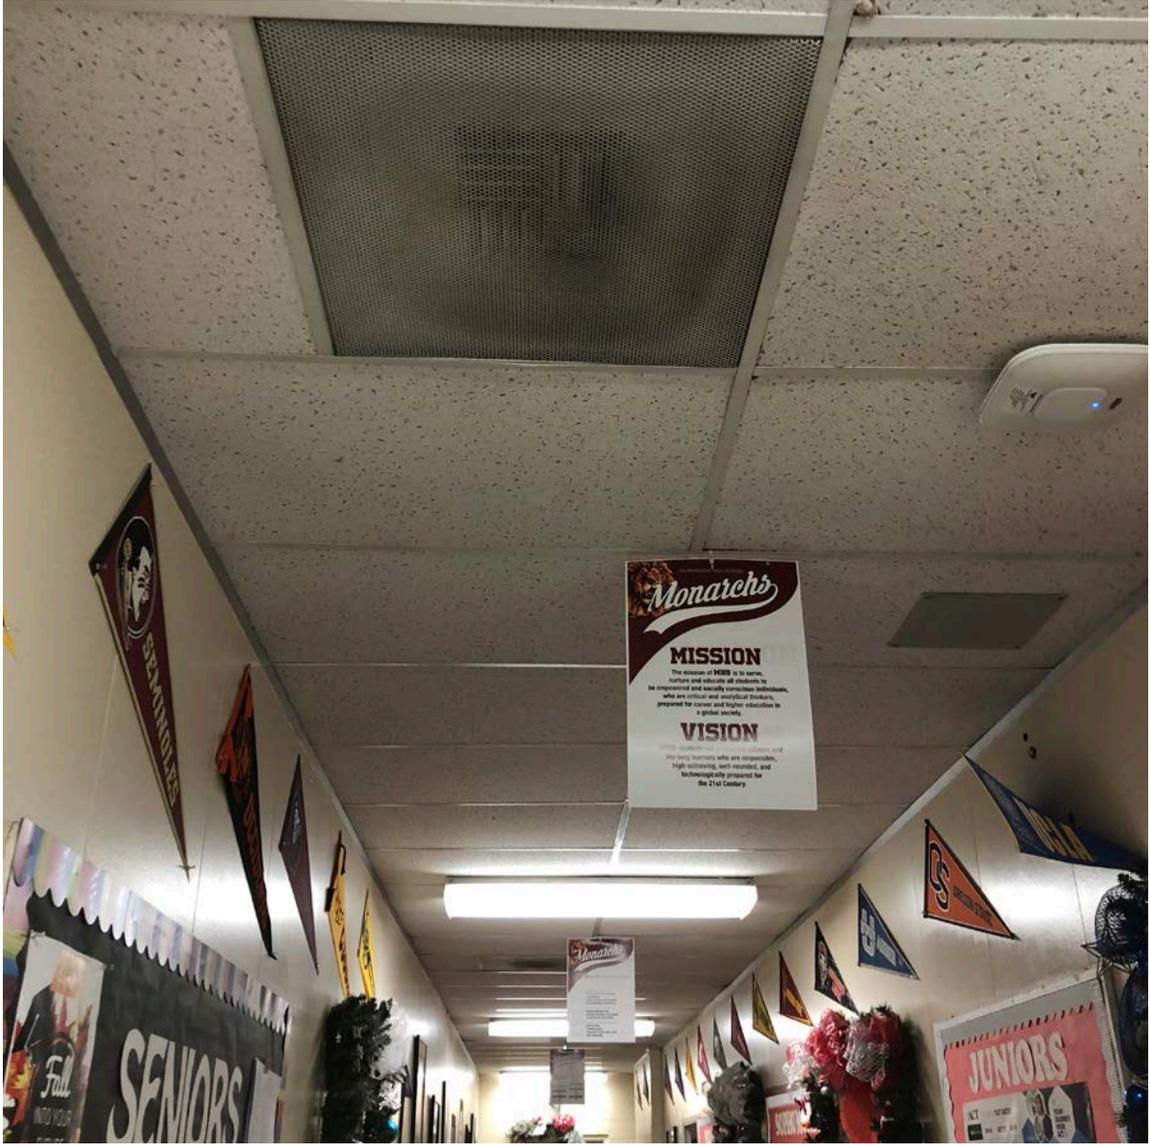
Building A light fixtures contained ballasts labeled “NO PCBs”

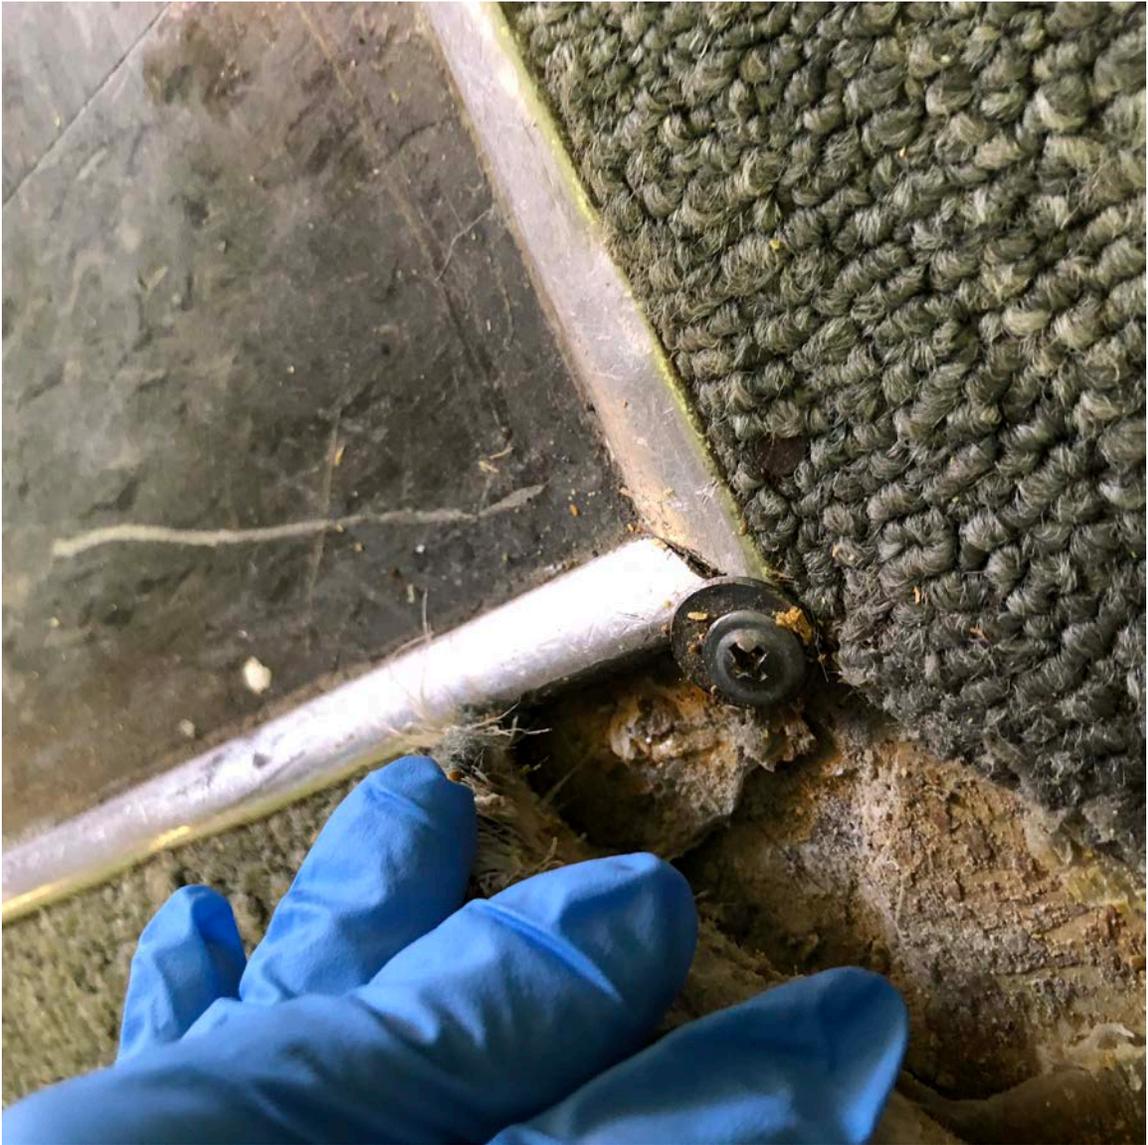
Beige 9-inch floor tile under carpet in Building B.

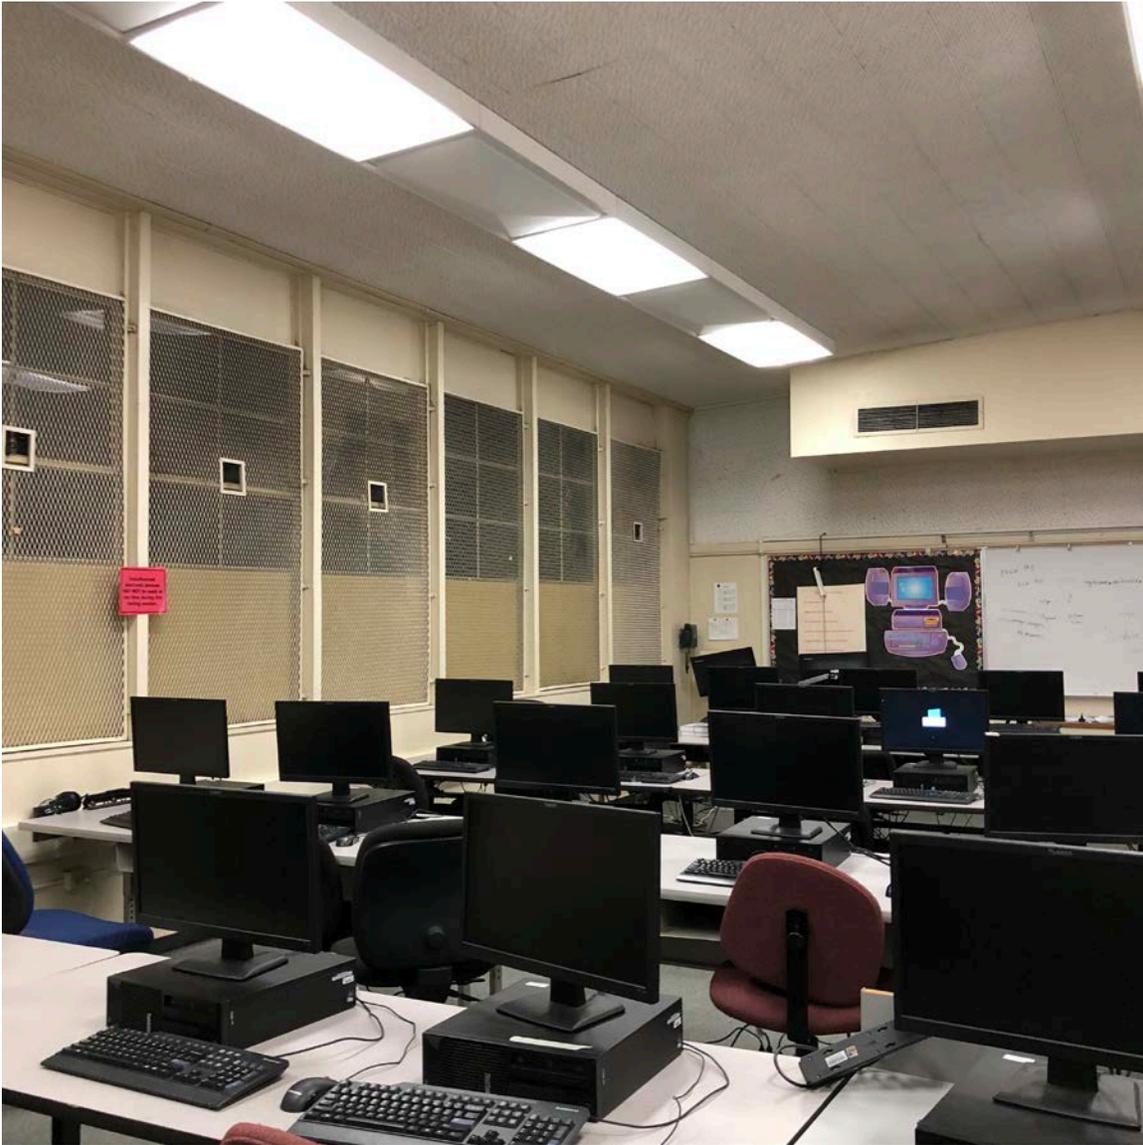
Light fixtures similar to others on campus labeled “No PCBs”

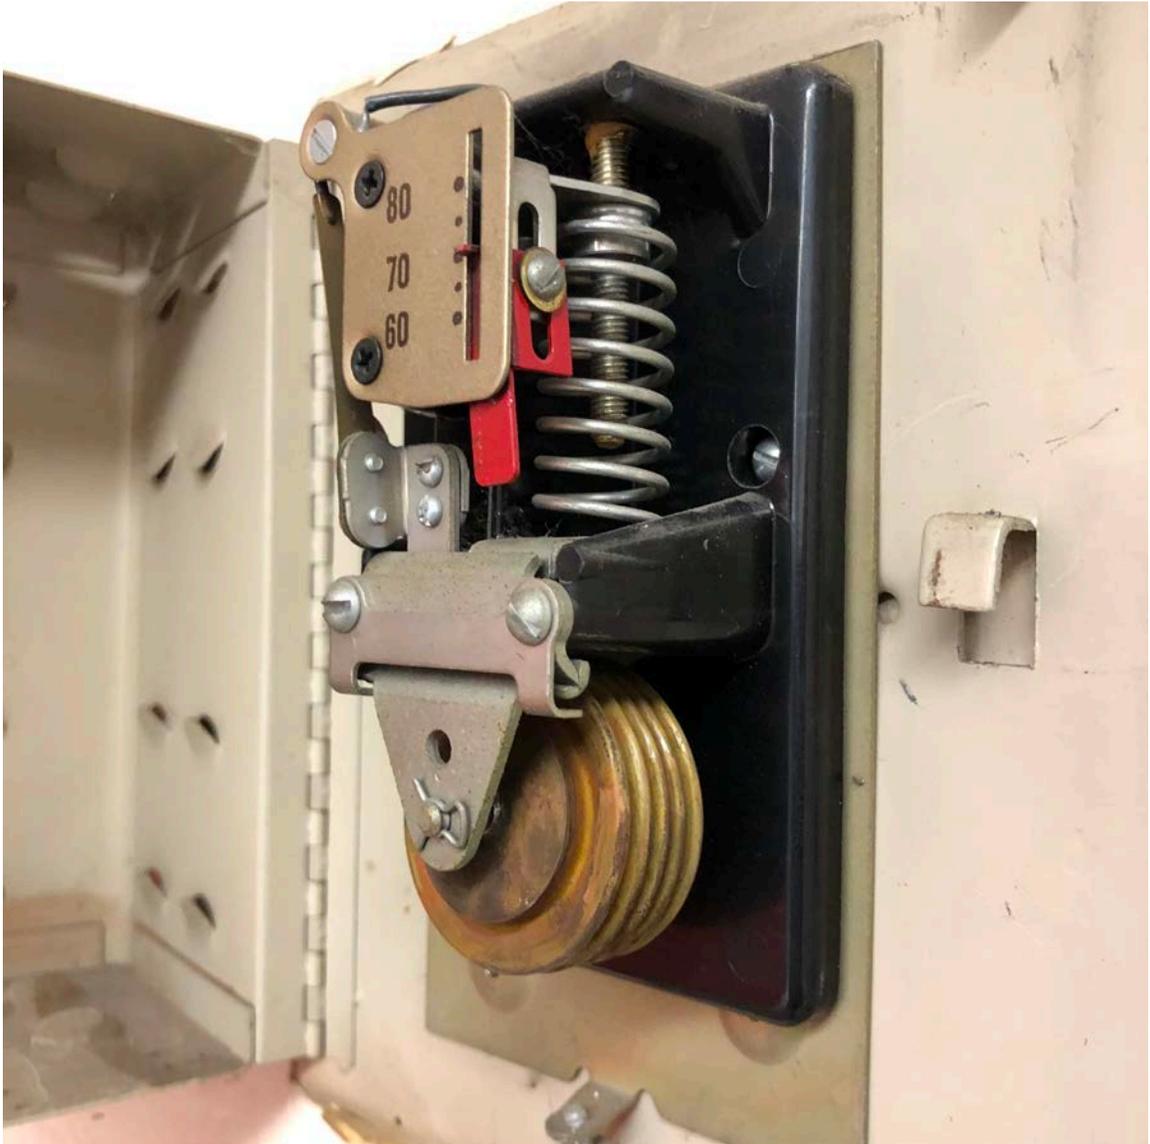
Thermostats in Building F were noted to be mechanical contact thermostats with no mercury. Light switches appeared to contain no mercury. Avoid contact with any silver liquid. Do not break liquid vials. Separate, drum, profile, transport and dispose of thermostats separately from other demolition materials. Provide a copy of profile results to the accepting landfill.

Mechanical contact thermostat.

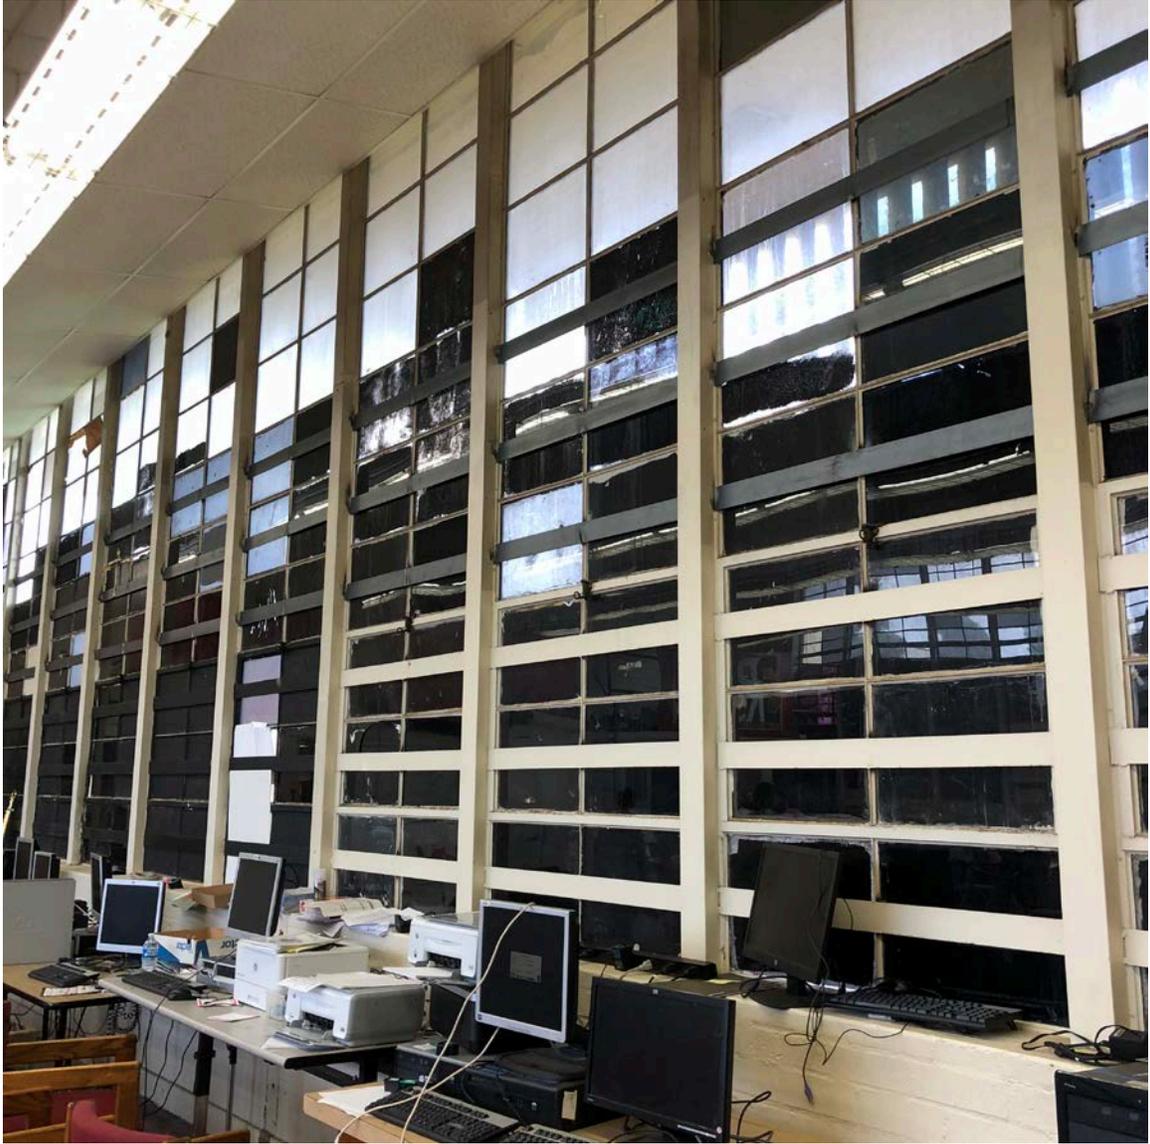
White window and window frame paint is lead based.

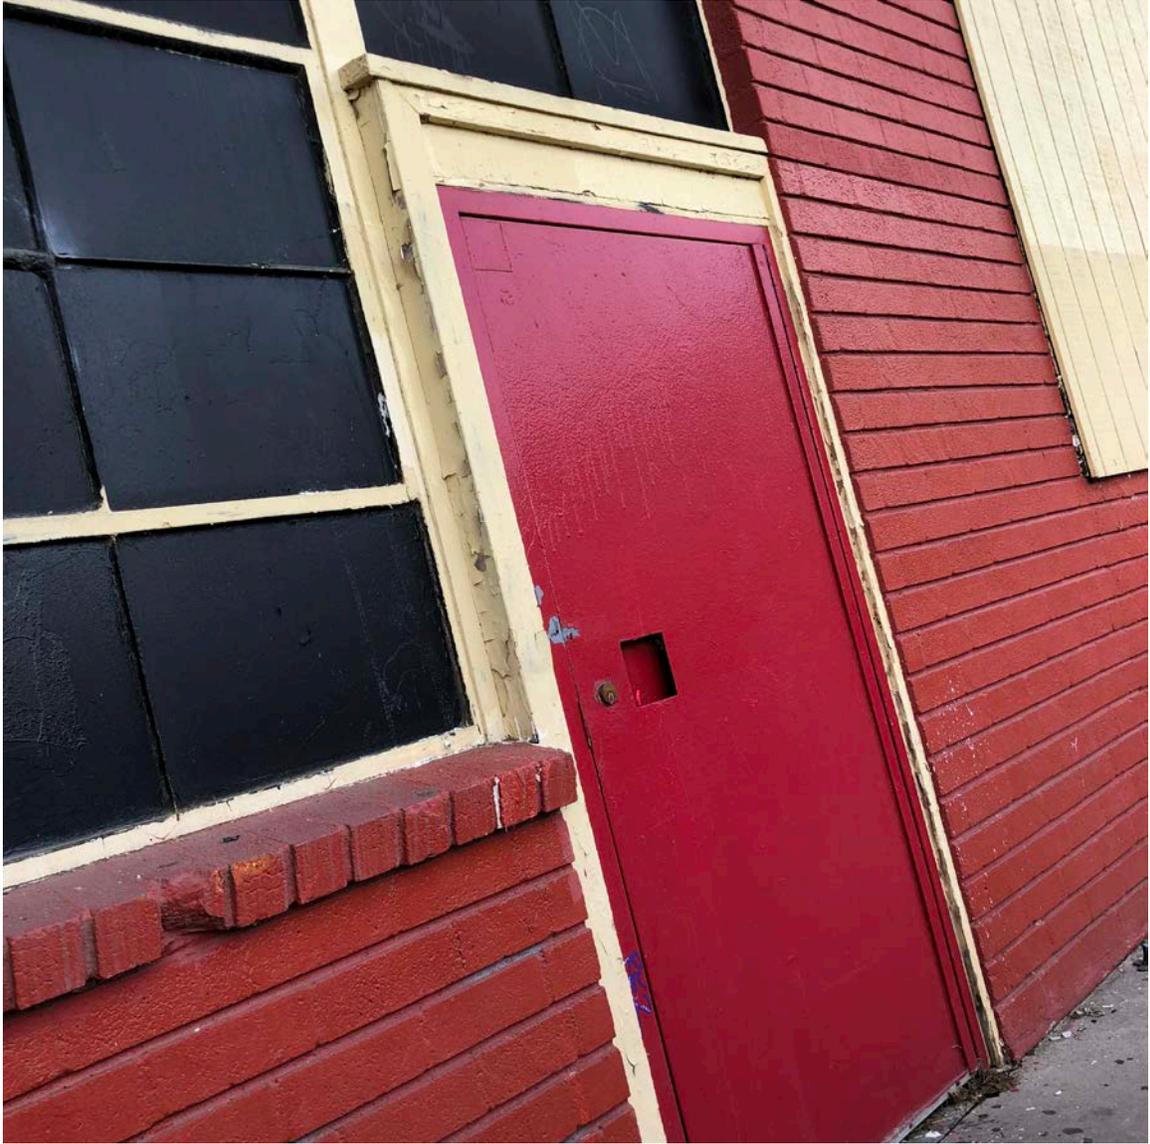
Wooden exterior door frame is coated with yellow lead-based paint.

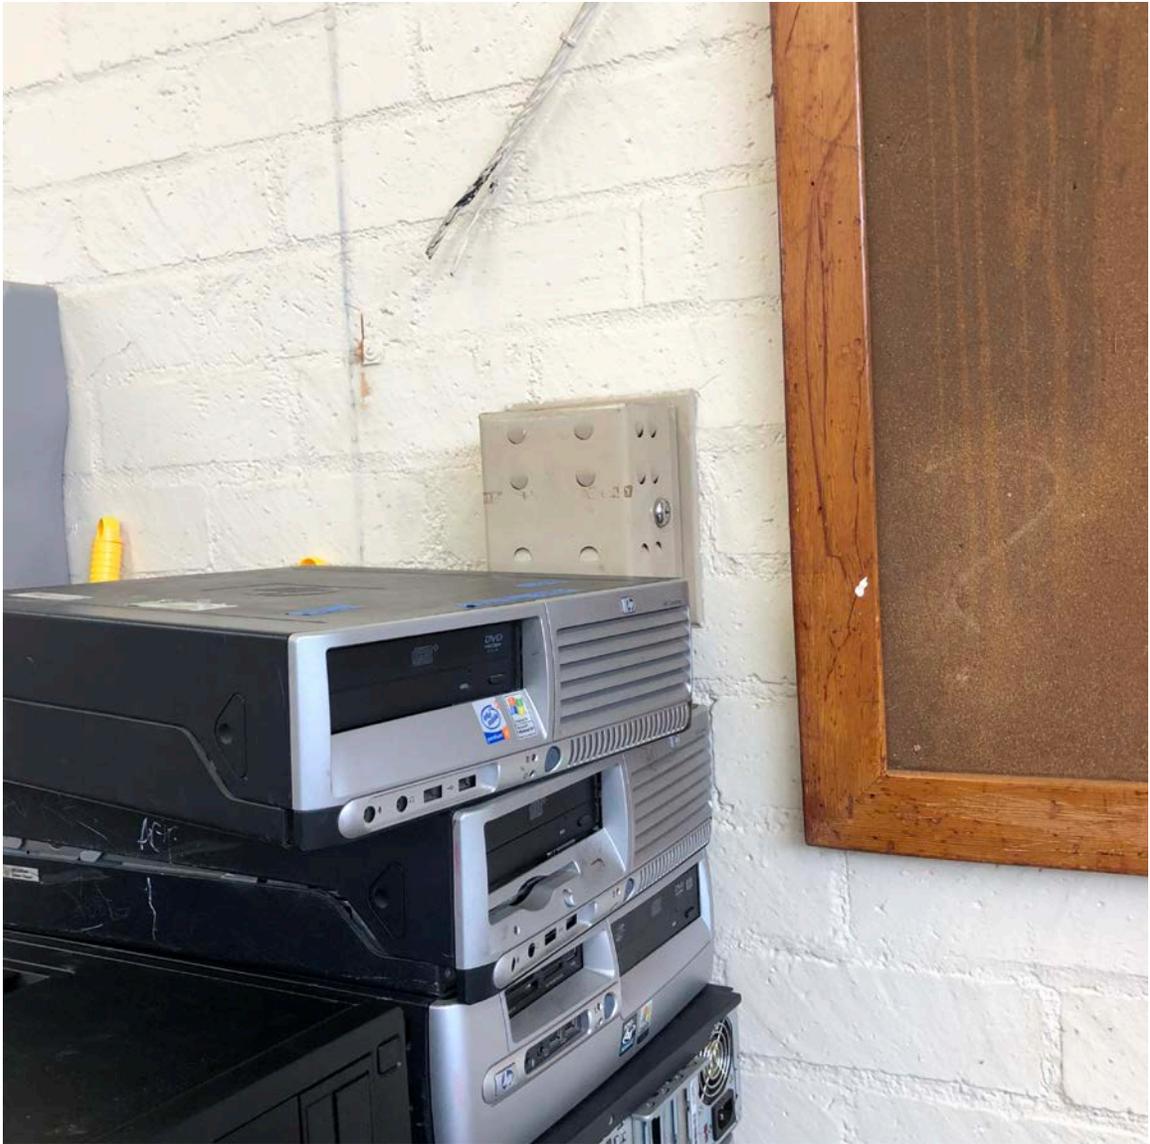
Thermostats in Building H were noted to contain mercury contact switches. Light switches did not appear to contain mercury. Avoid contact with any silver liquid. Do not break liquid vials. Separate, drum, profile, transport and dispose of thermostats separately from other demolition materials. Provide a copy of profile results to the accepting landfill.

Mercury containing thermostat in classroom H3.

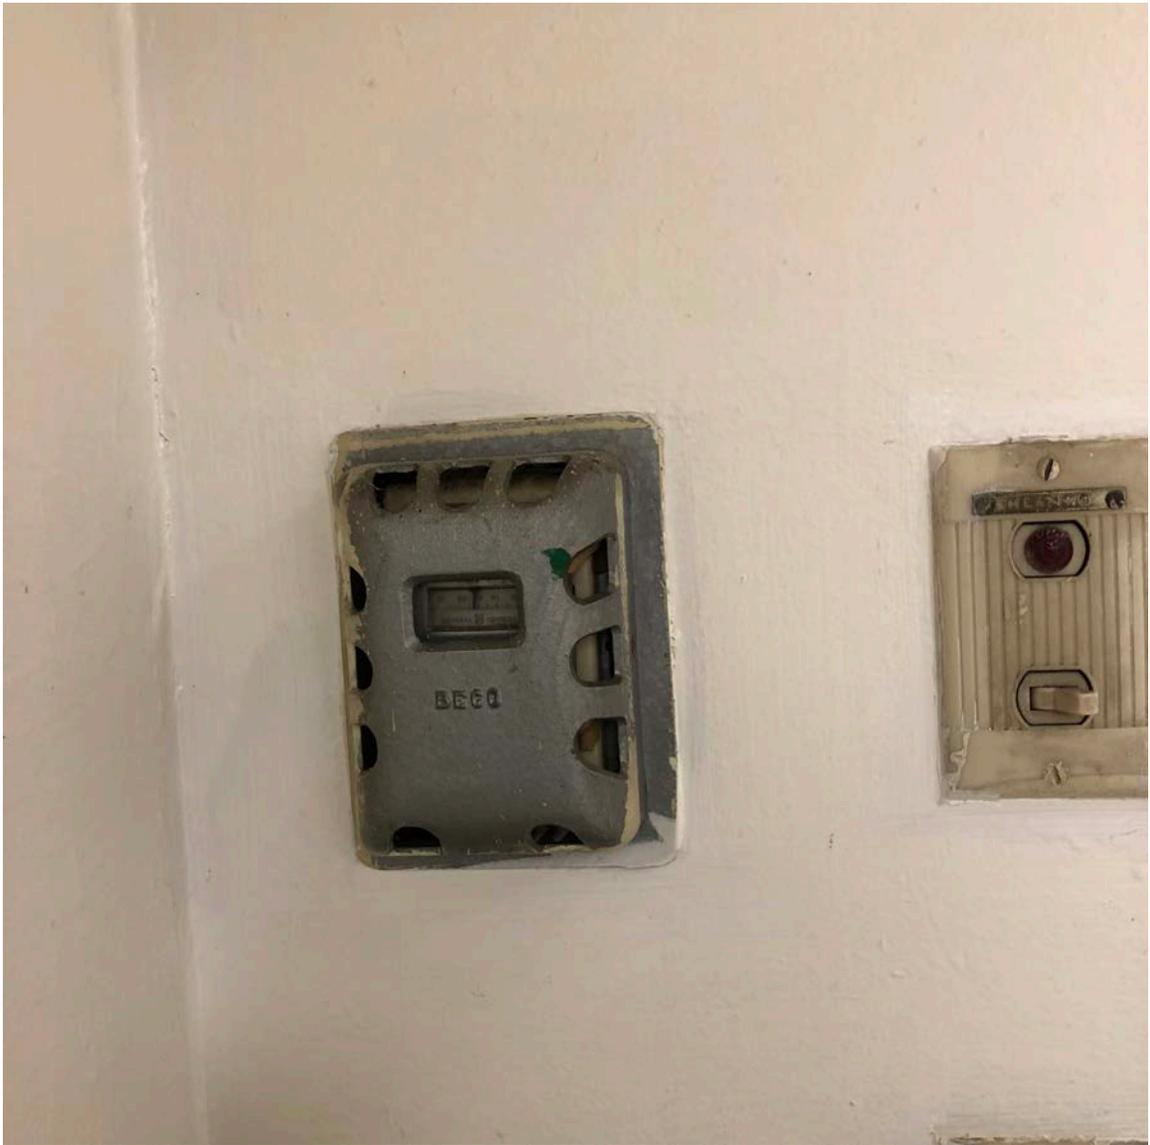
Thermostats in Building I were noted to contain mercury contact switches. Light switches did not appear to contain mercury. Avoid contact with any silver liquid. Do not break liquid vials. Separate, drum, profile, transport and dispose of thermostats separately from other demolition materials. Provide a copy of profile results to the accepting landfill.

Building I thermostat with mercury.

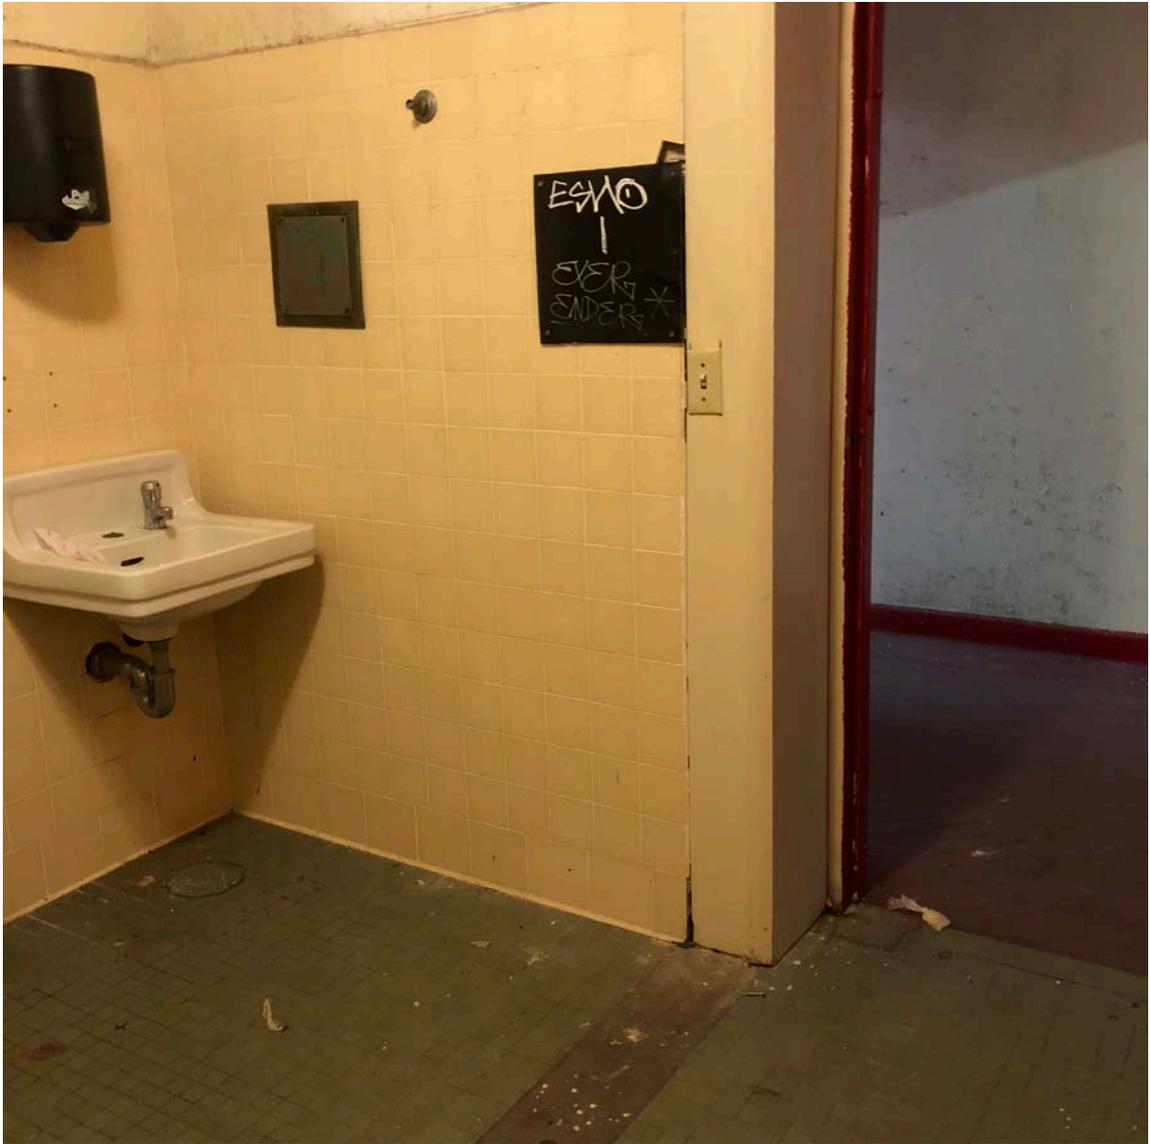
Beige 4-inch wall tile in the restrooms contains lead. Green 1-inch floor tile was negative.

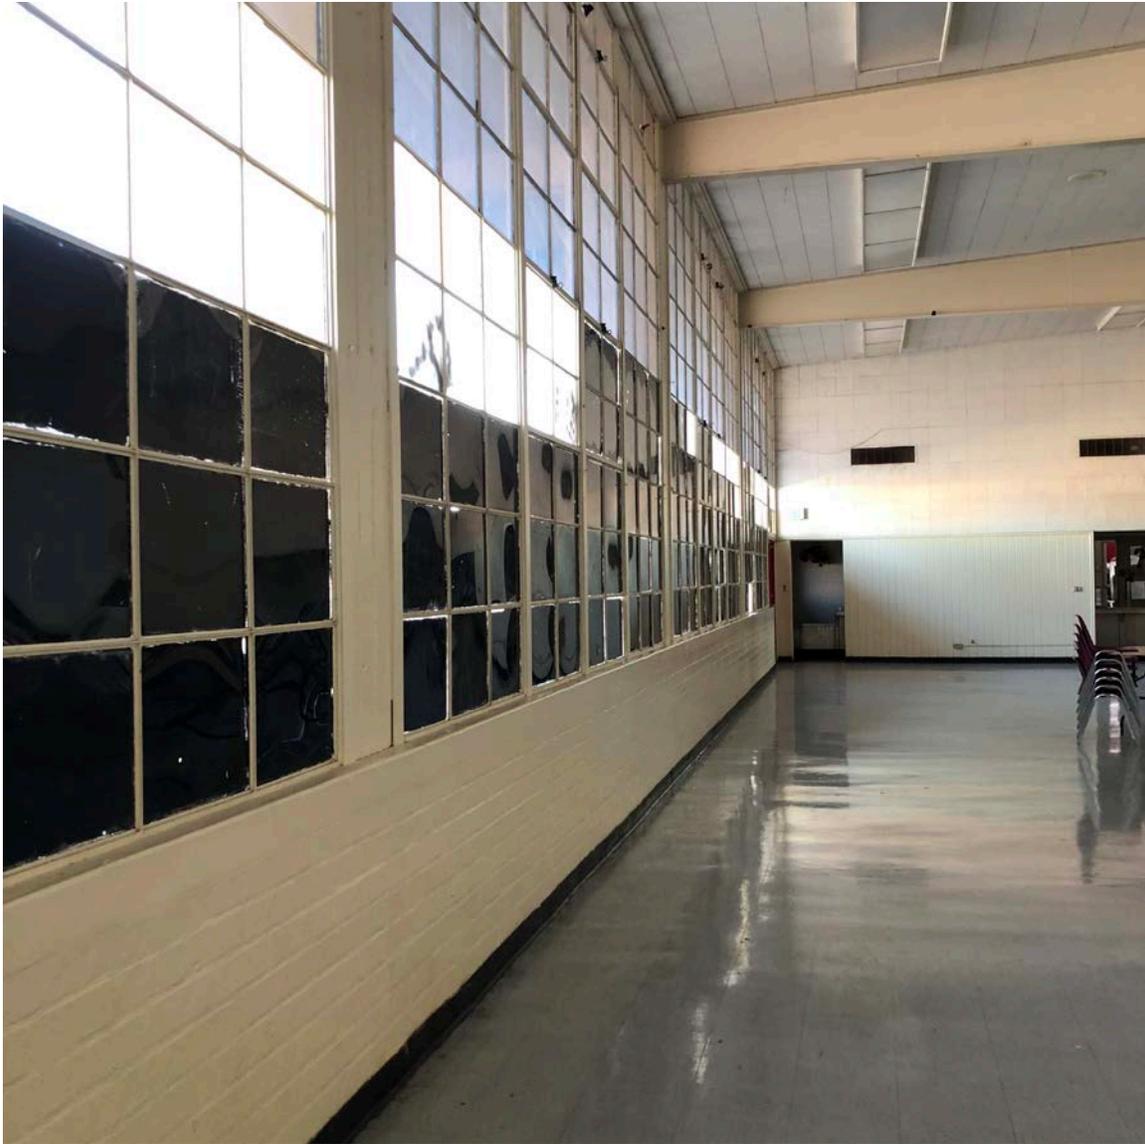
White window paint in Building R is lead-based.

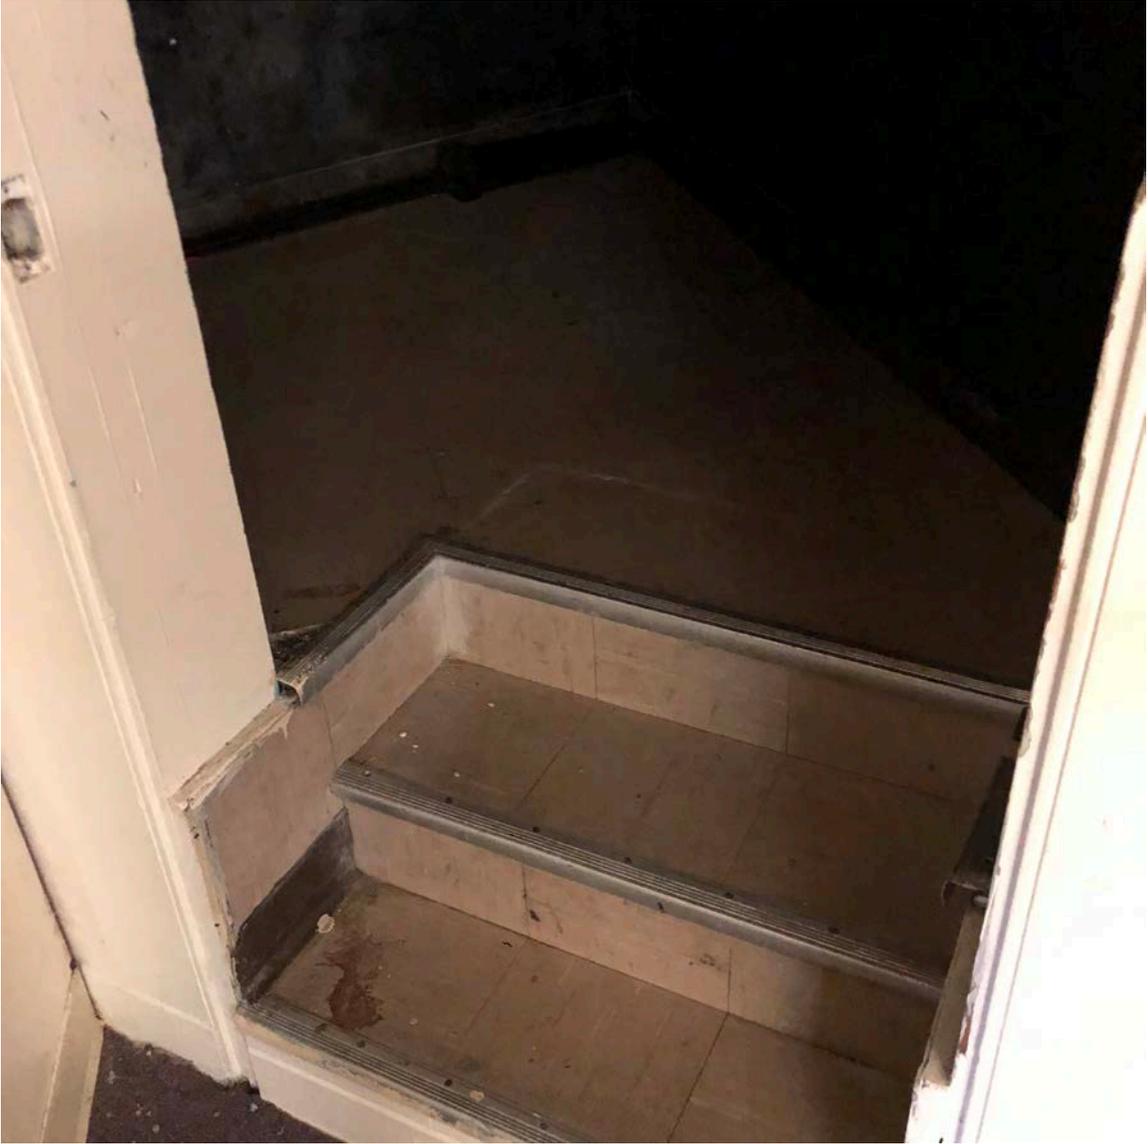
Beige 9-inch floor tile in the student lounge.

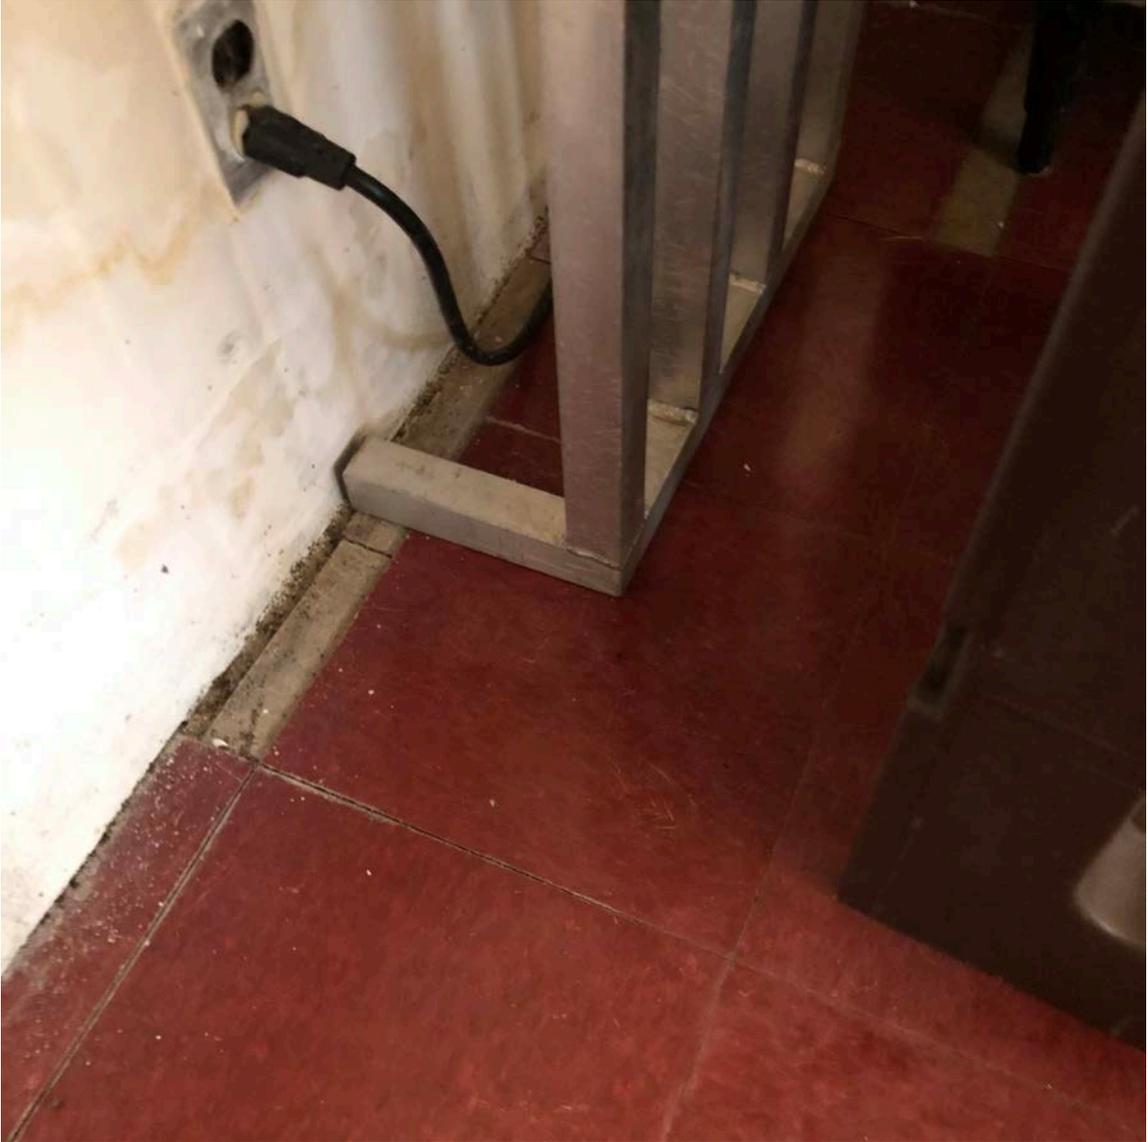
Beige 9-inch floor tile visible under red 12-inch floor tile in the kitchen.
