Hazardous Materials Assessment

**Morningside High School
10500 S. Yukon Avenue
Inglewood, CA 90303**

**Sampling Date: December 2018 – January 2019
Project No: 18-547**

Prepared for:
*Inglewood Unified School District
401 S. Inglewood Ave., Inglewood, CA 60301*

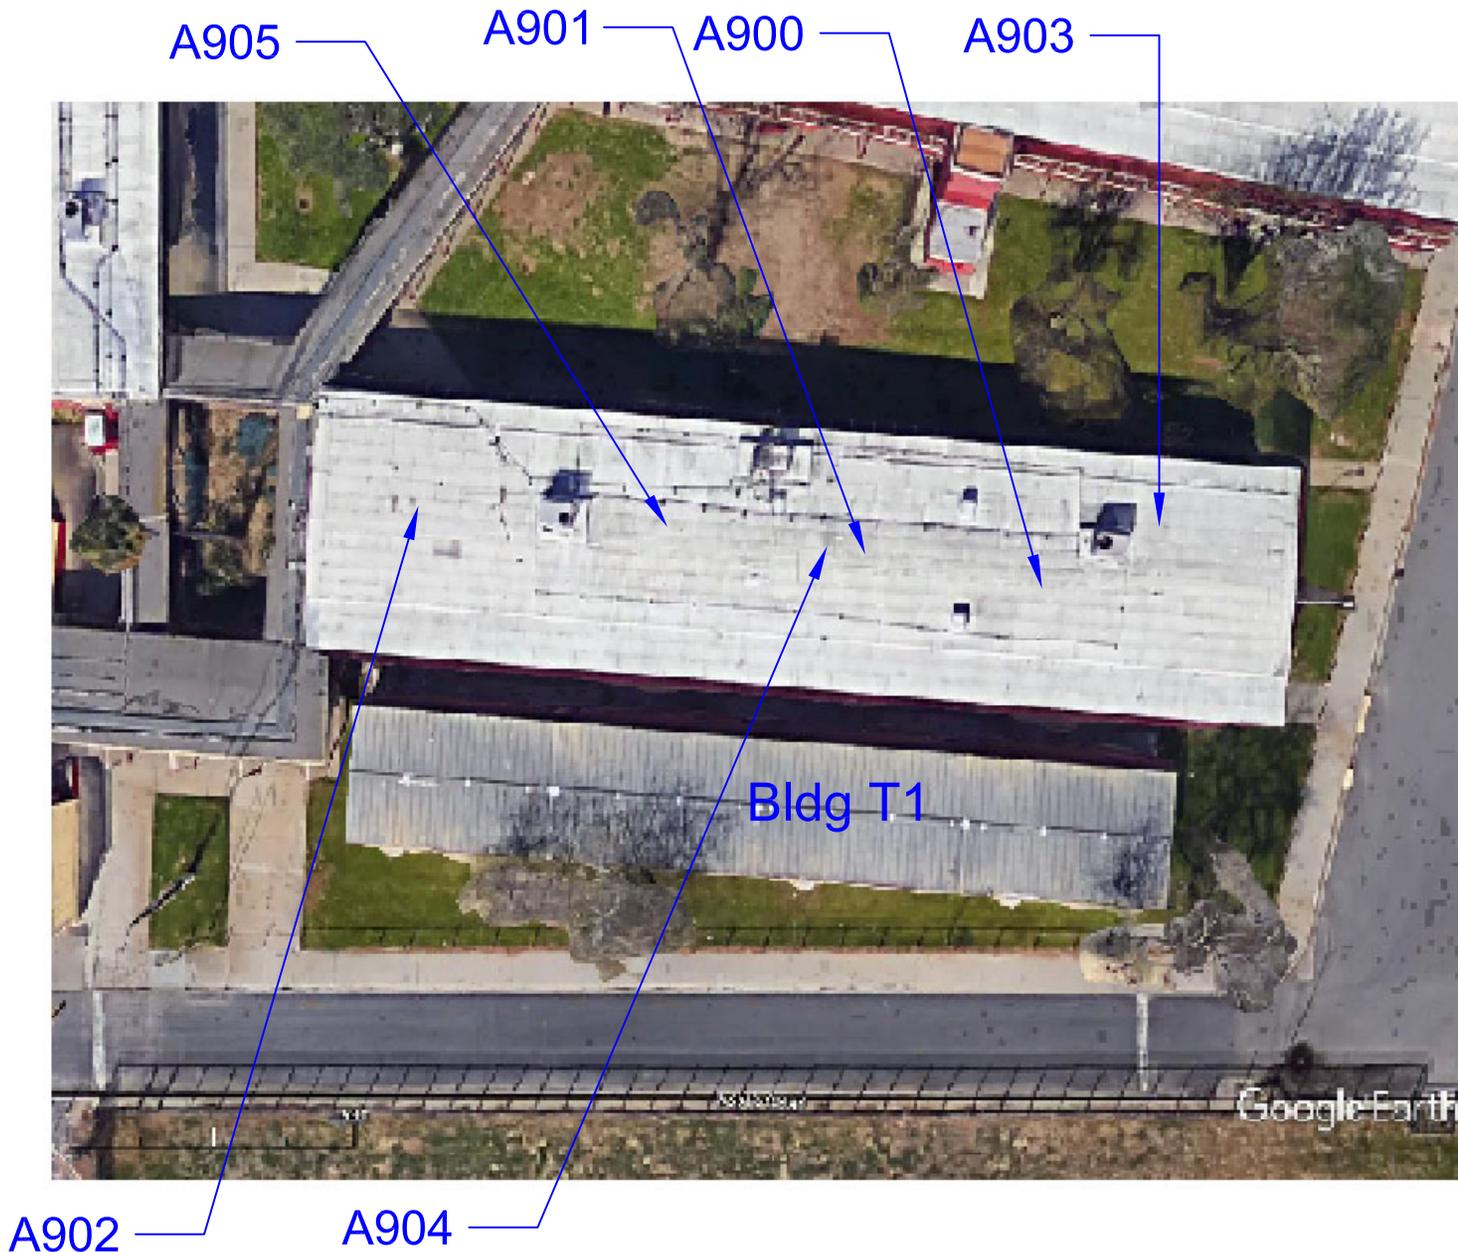
On the date of inspection no suspect material was observed on Building T1 Roof.

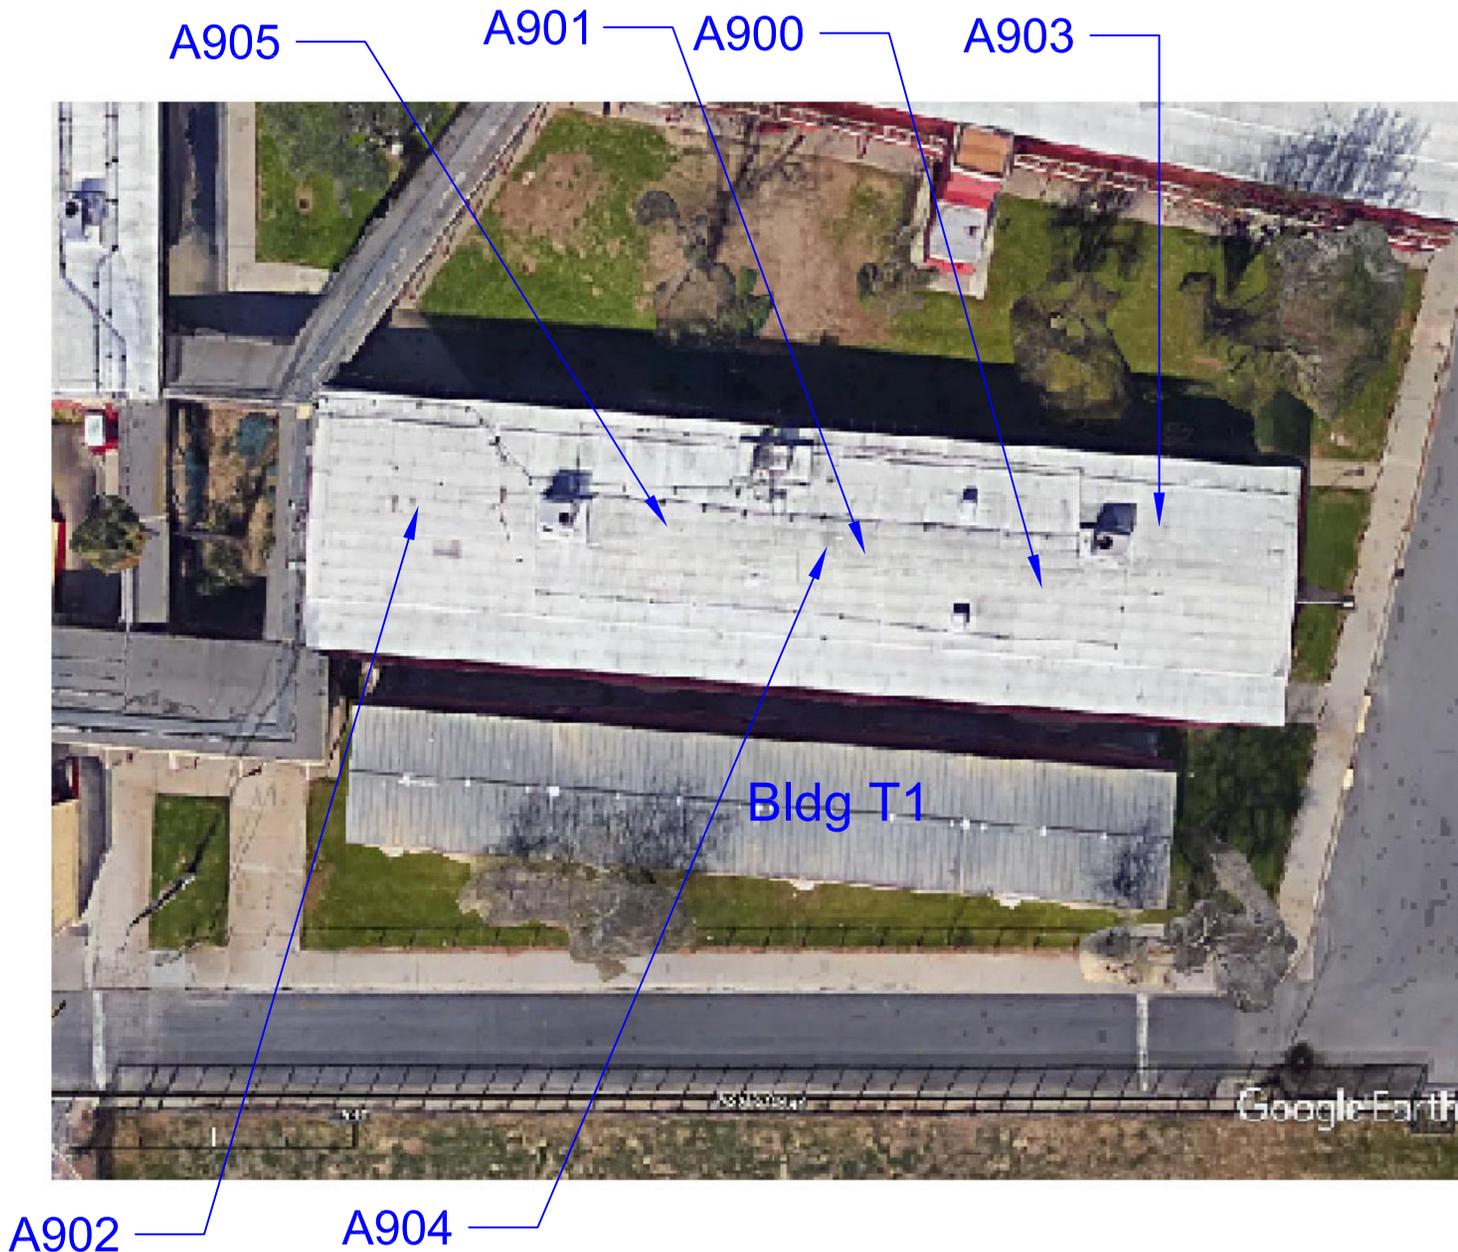
On the date of inspection no suspect material was observed on Building T1 Roof.
