Exhibit D-2

Gilpin Geosciences, Inc
Earthquake & Engineering Geology

January 24, 2020
91650.01

SUBJECT: REVISED
Landslide Investigation: Response to Comments
V. Sattui Hibbard Ranch Vineyard,
Henry Road
Napa, California

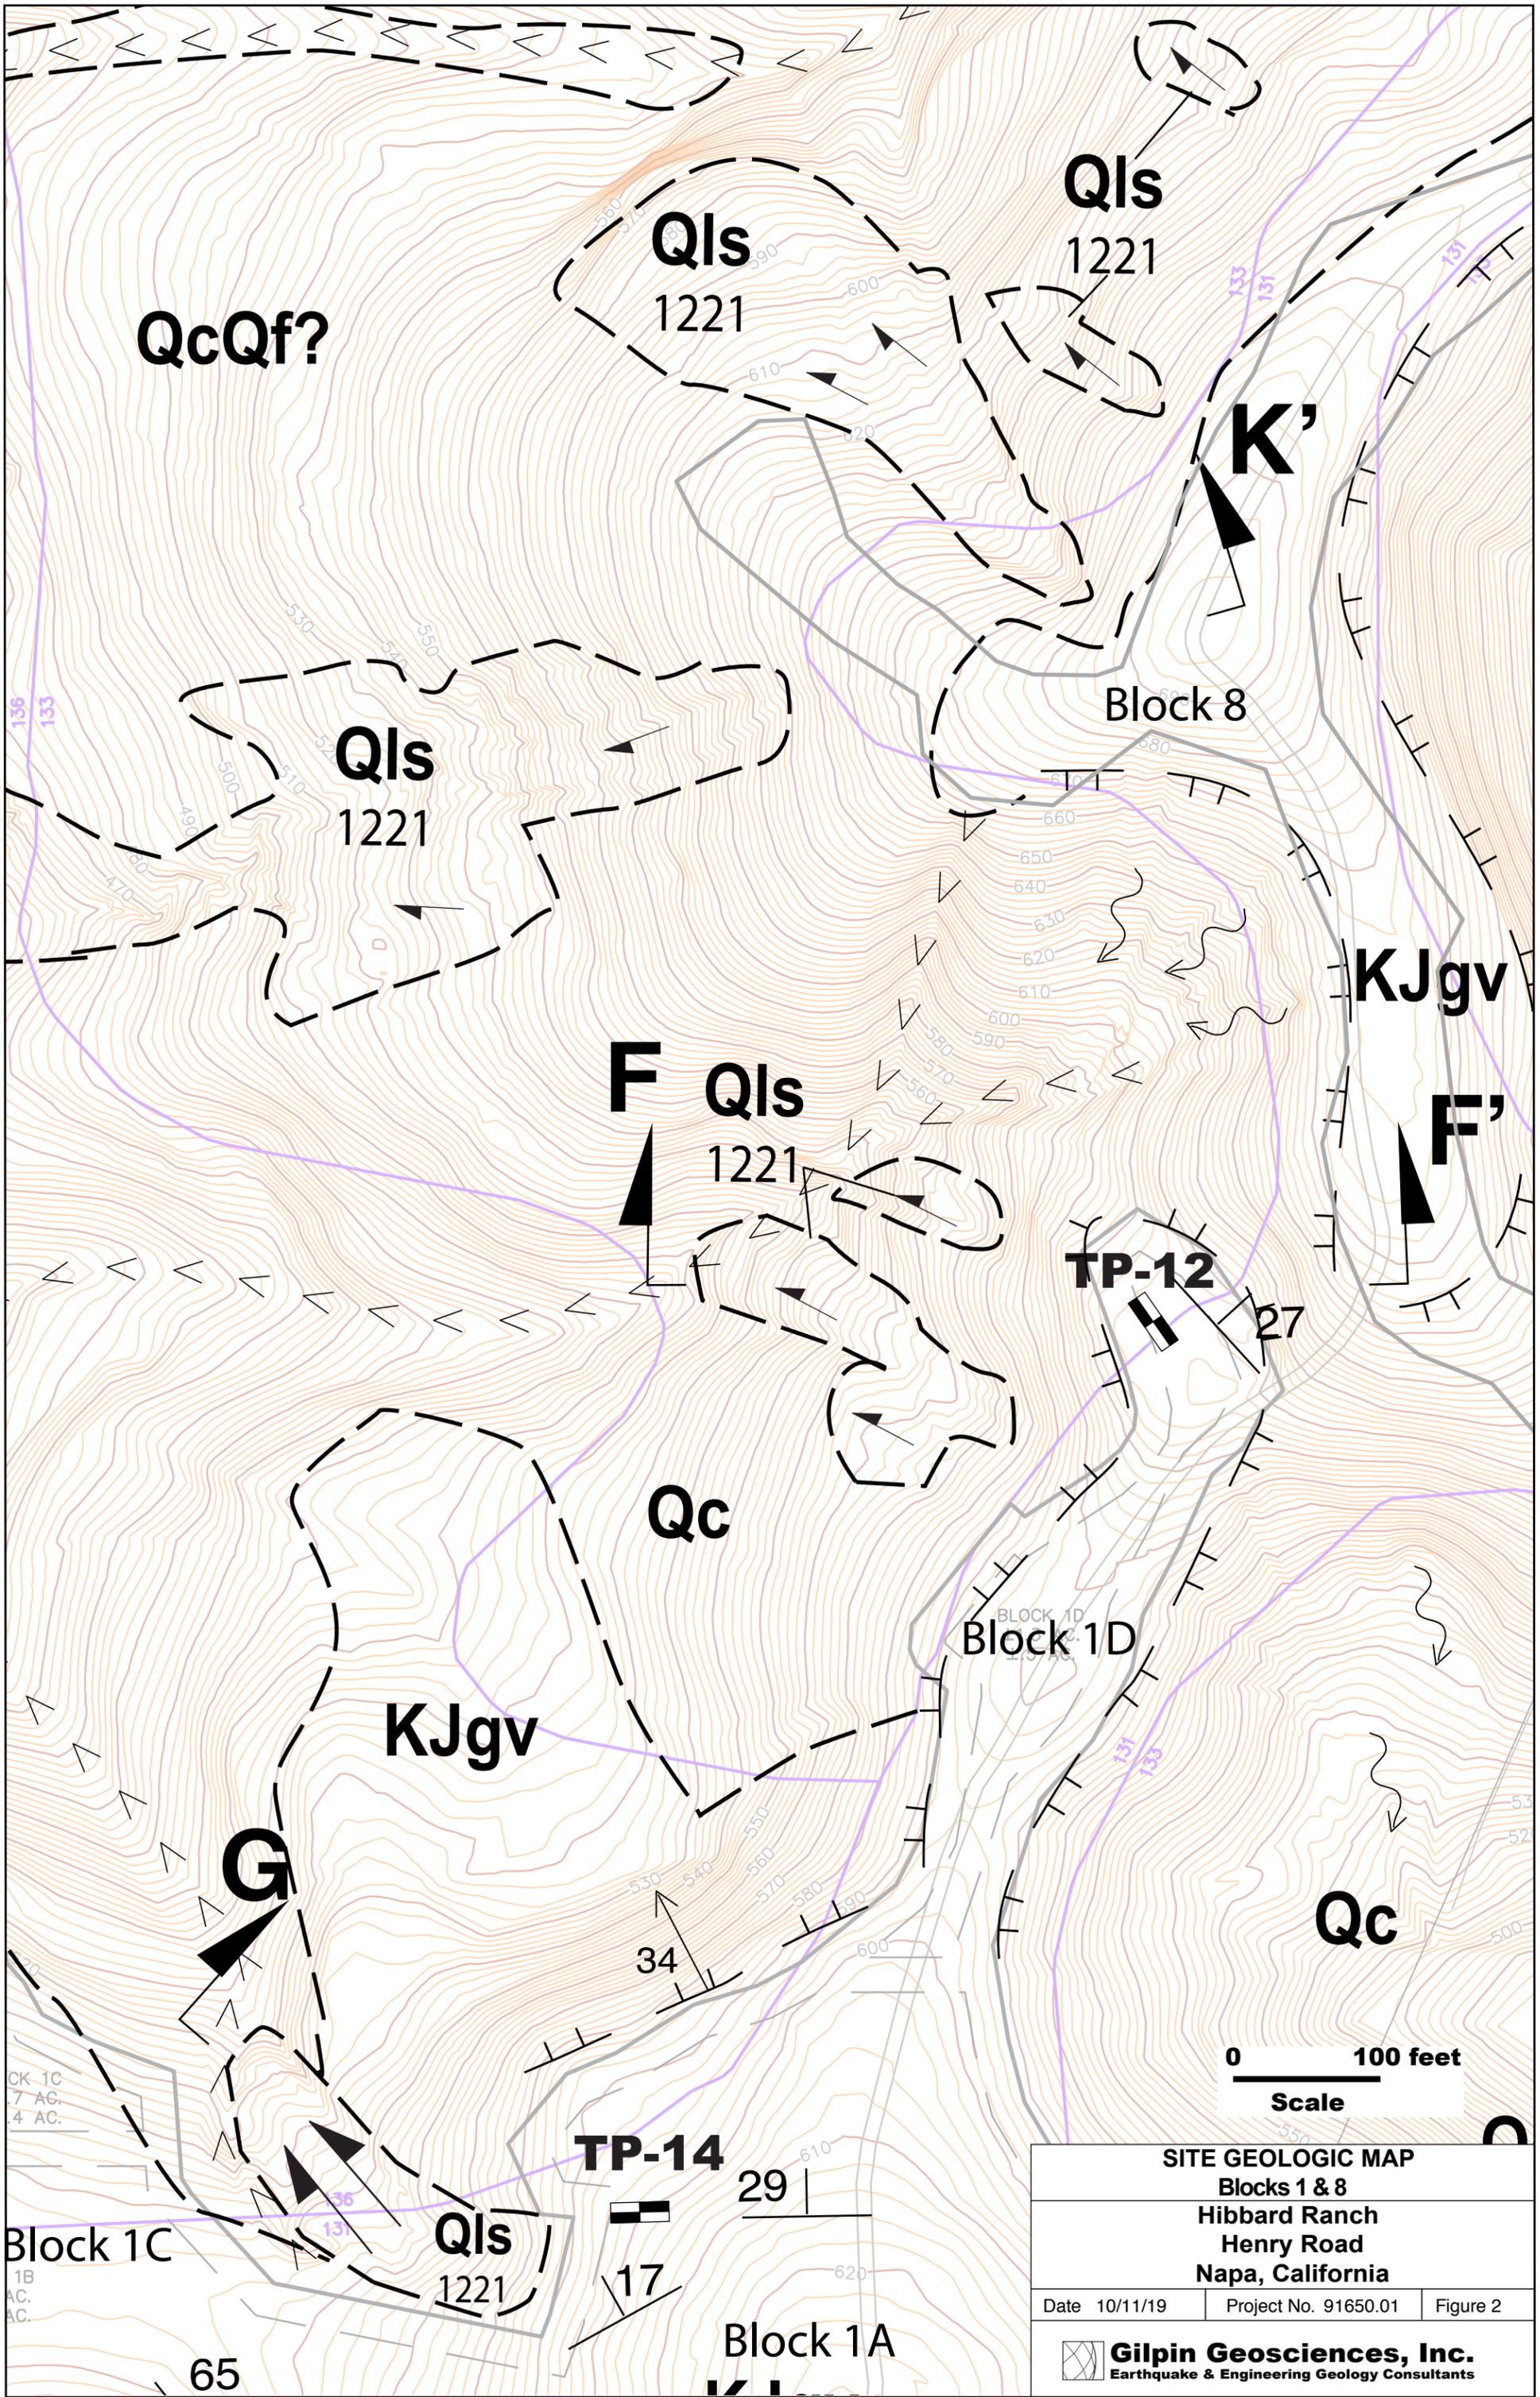
SITE GEOLOGIC MAP		
Blocks 1 & 8		
Hibbard Ranch		
Henry Road		
Napa, California		
Date 10/11/19	Project No. 91650.01	Figure 2

We mapped a 5- to 10-foot-deep earth flow landslide on the northern flank of the ridge crest (Figure 2) on which vineyard Block 1A and 1C are proposed. This slide has developed in a narrow swale drainage that lies between the two blocks. The proposed ridge crest vineyard blocks should be setback from future potential encroachment by this landslide.

Landslides mapped near Block 8 are shown on Figure 2. We also mapped a hillslope that is subject to soil creep on the western flank of the ridgecrest. Vineyard Block 8 is located along the crest of a prominent, roughly north-south trending ridgeline. Three 5- to 10-foot-deep earthflow landslides are mapped on the northwest-facing slope below the northern end of the Block. The two southerly slides appear to be slightly closer than 50 feet horizontal to the local Block boundary. The block boundary should be adjusted to maintain a minimum 50-foot setback from the head scarps of the two landslides.

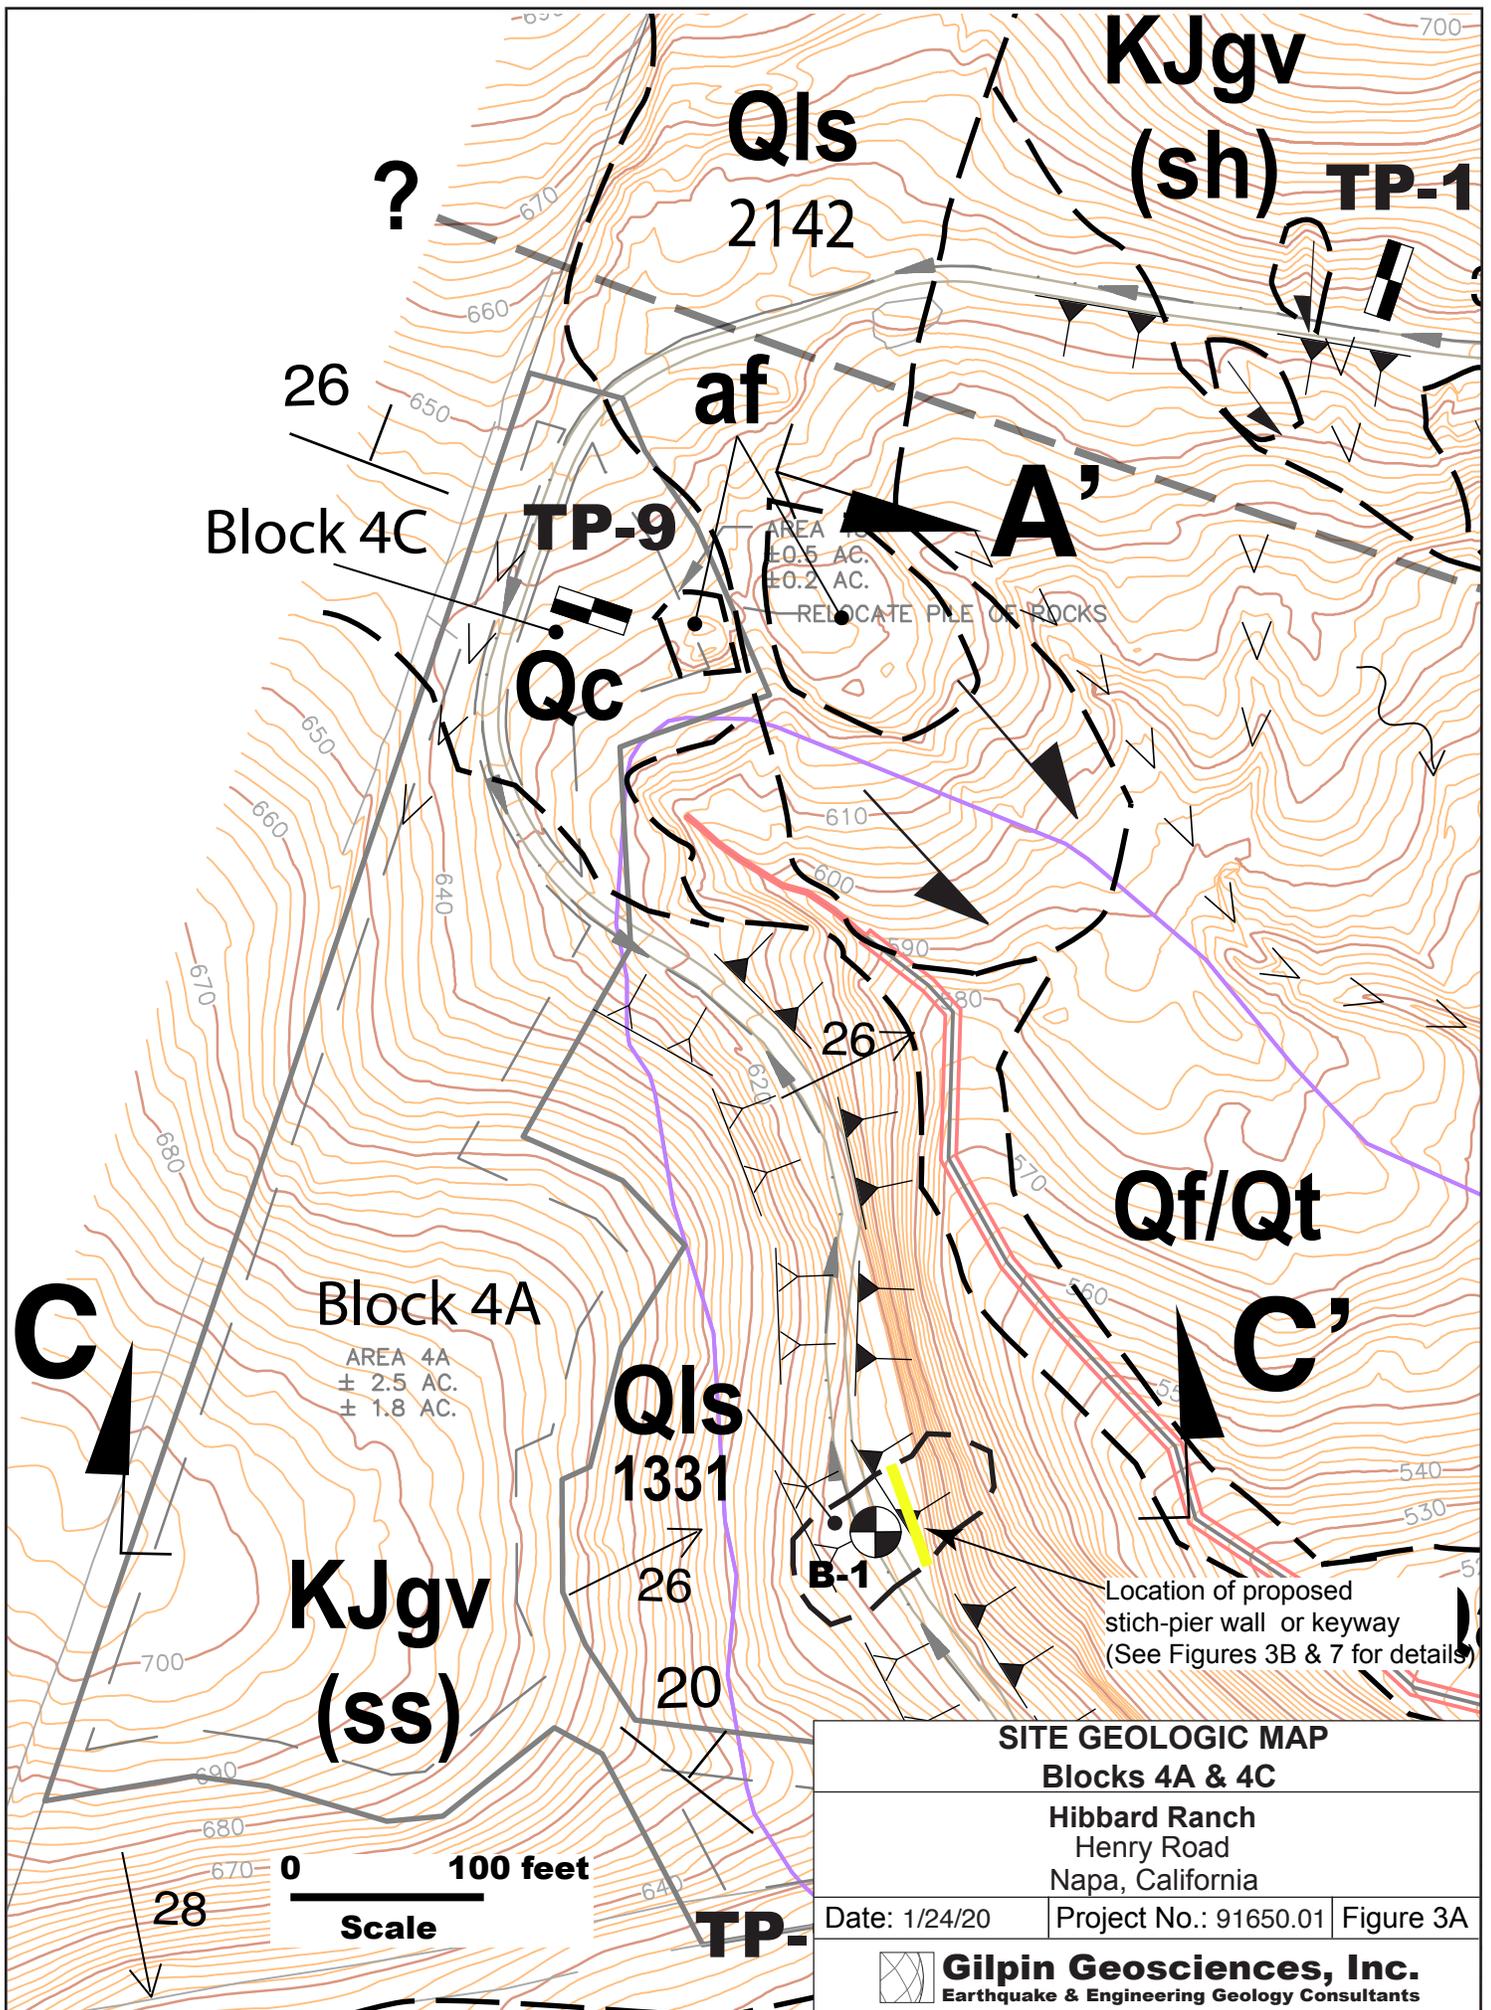
Figure 3A Site Geologic Map Blocks 4A & 4C

We mapped a landslide that failed in an existing access road that traverses the hillside below and east of Block 4A. The Site Geologic Map, Figure 3A, shows the location and approximate dimensions of the landslide that occurred during the winter storms of 2018-19, and Figure 3B shows a cross section with a subsurface geologic interpretation. The landslide is a slump of the shallow bedrock and incorporating the fill placed to construct the roadway. The slide is approximately 45 to 50 feet wide and extends from a head scarp just above the roadway to just below the fill placed for the road construction. We drilled boring B-1 in the roadway. We describe the subsurface conditions in the next section and the log of the boring is included in the Appendix.

We present two mitigation alternatives for the road repair below Block 4A, depending on your needs. The two alternatives are:

1. Install a row of closely spaced drilled piers to act as a stitch-pier wall, to be presented as a design-build package for an independent contractor;
2. Excavate fill and soil to bedrock to construct a drained keyway and reconstruct the slope with an engineered fill slope (discussed above);

Pier holes with a diameter of at least 18 inches should be drilled at three pier diameters, on center, along the downslope edge of the affected roadway. The piers should extend a minimum of 10 feet into the silty bedrock encountered during our subsurface exploration. Steel cages or beams should be placed in the pier holes and backfilled with structural concrete with a minimum 28-day compressive strength of 2,500 pounds per square inch (psi). The pier holes should be clean and free of any water prior to placement of concrete.

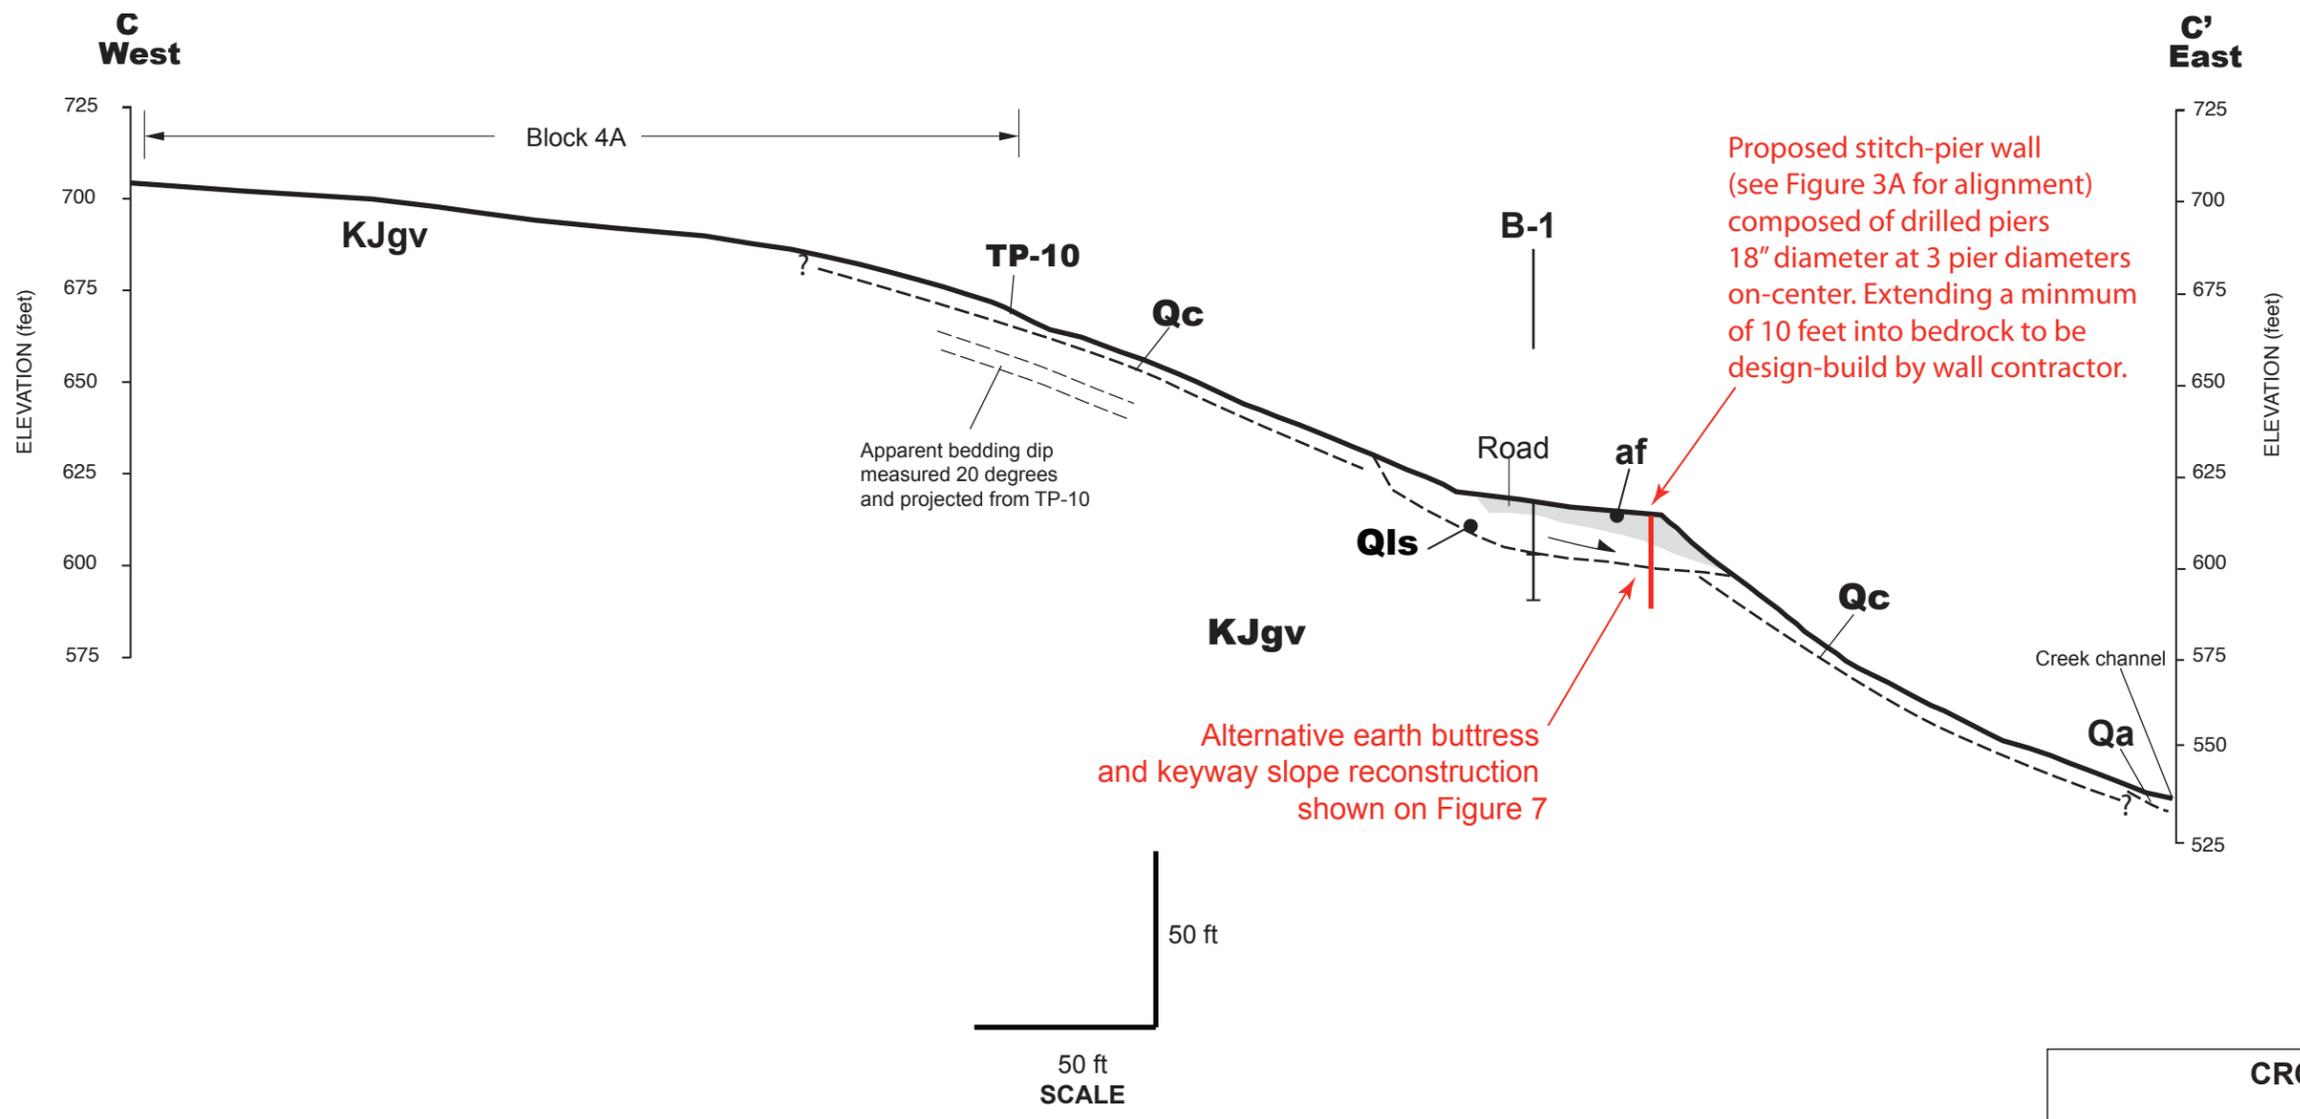
CROSS SECTION C - C' Block 4A		
Hibbard Ranch Henry Road Napa, California		
Date 10/11/19	Project No. 91650.01	Figure 3B

Boring B-1 was drilled in the road below vineyard Block 4A where a landslide slump had occurred during the storms that occurred last winter. We encountered silty to sandy clay and clayey gravel landslide material to a depth of 14 feet below the road surface. The landslide materials were very soft to soft/very loose and moist to wet. We encountered siltstone bedrock below the landslide to the full depth explored 26.5 feet below the road surface. The siltstone is weak to friable locally, of low hardness, and moderately weathered.

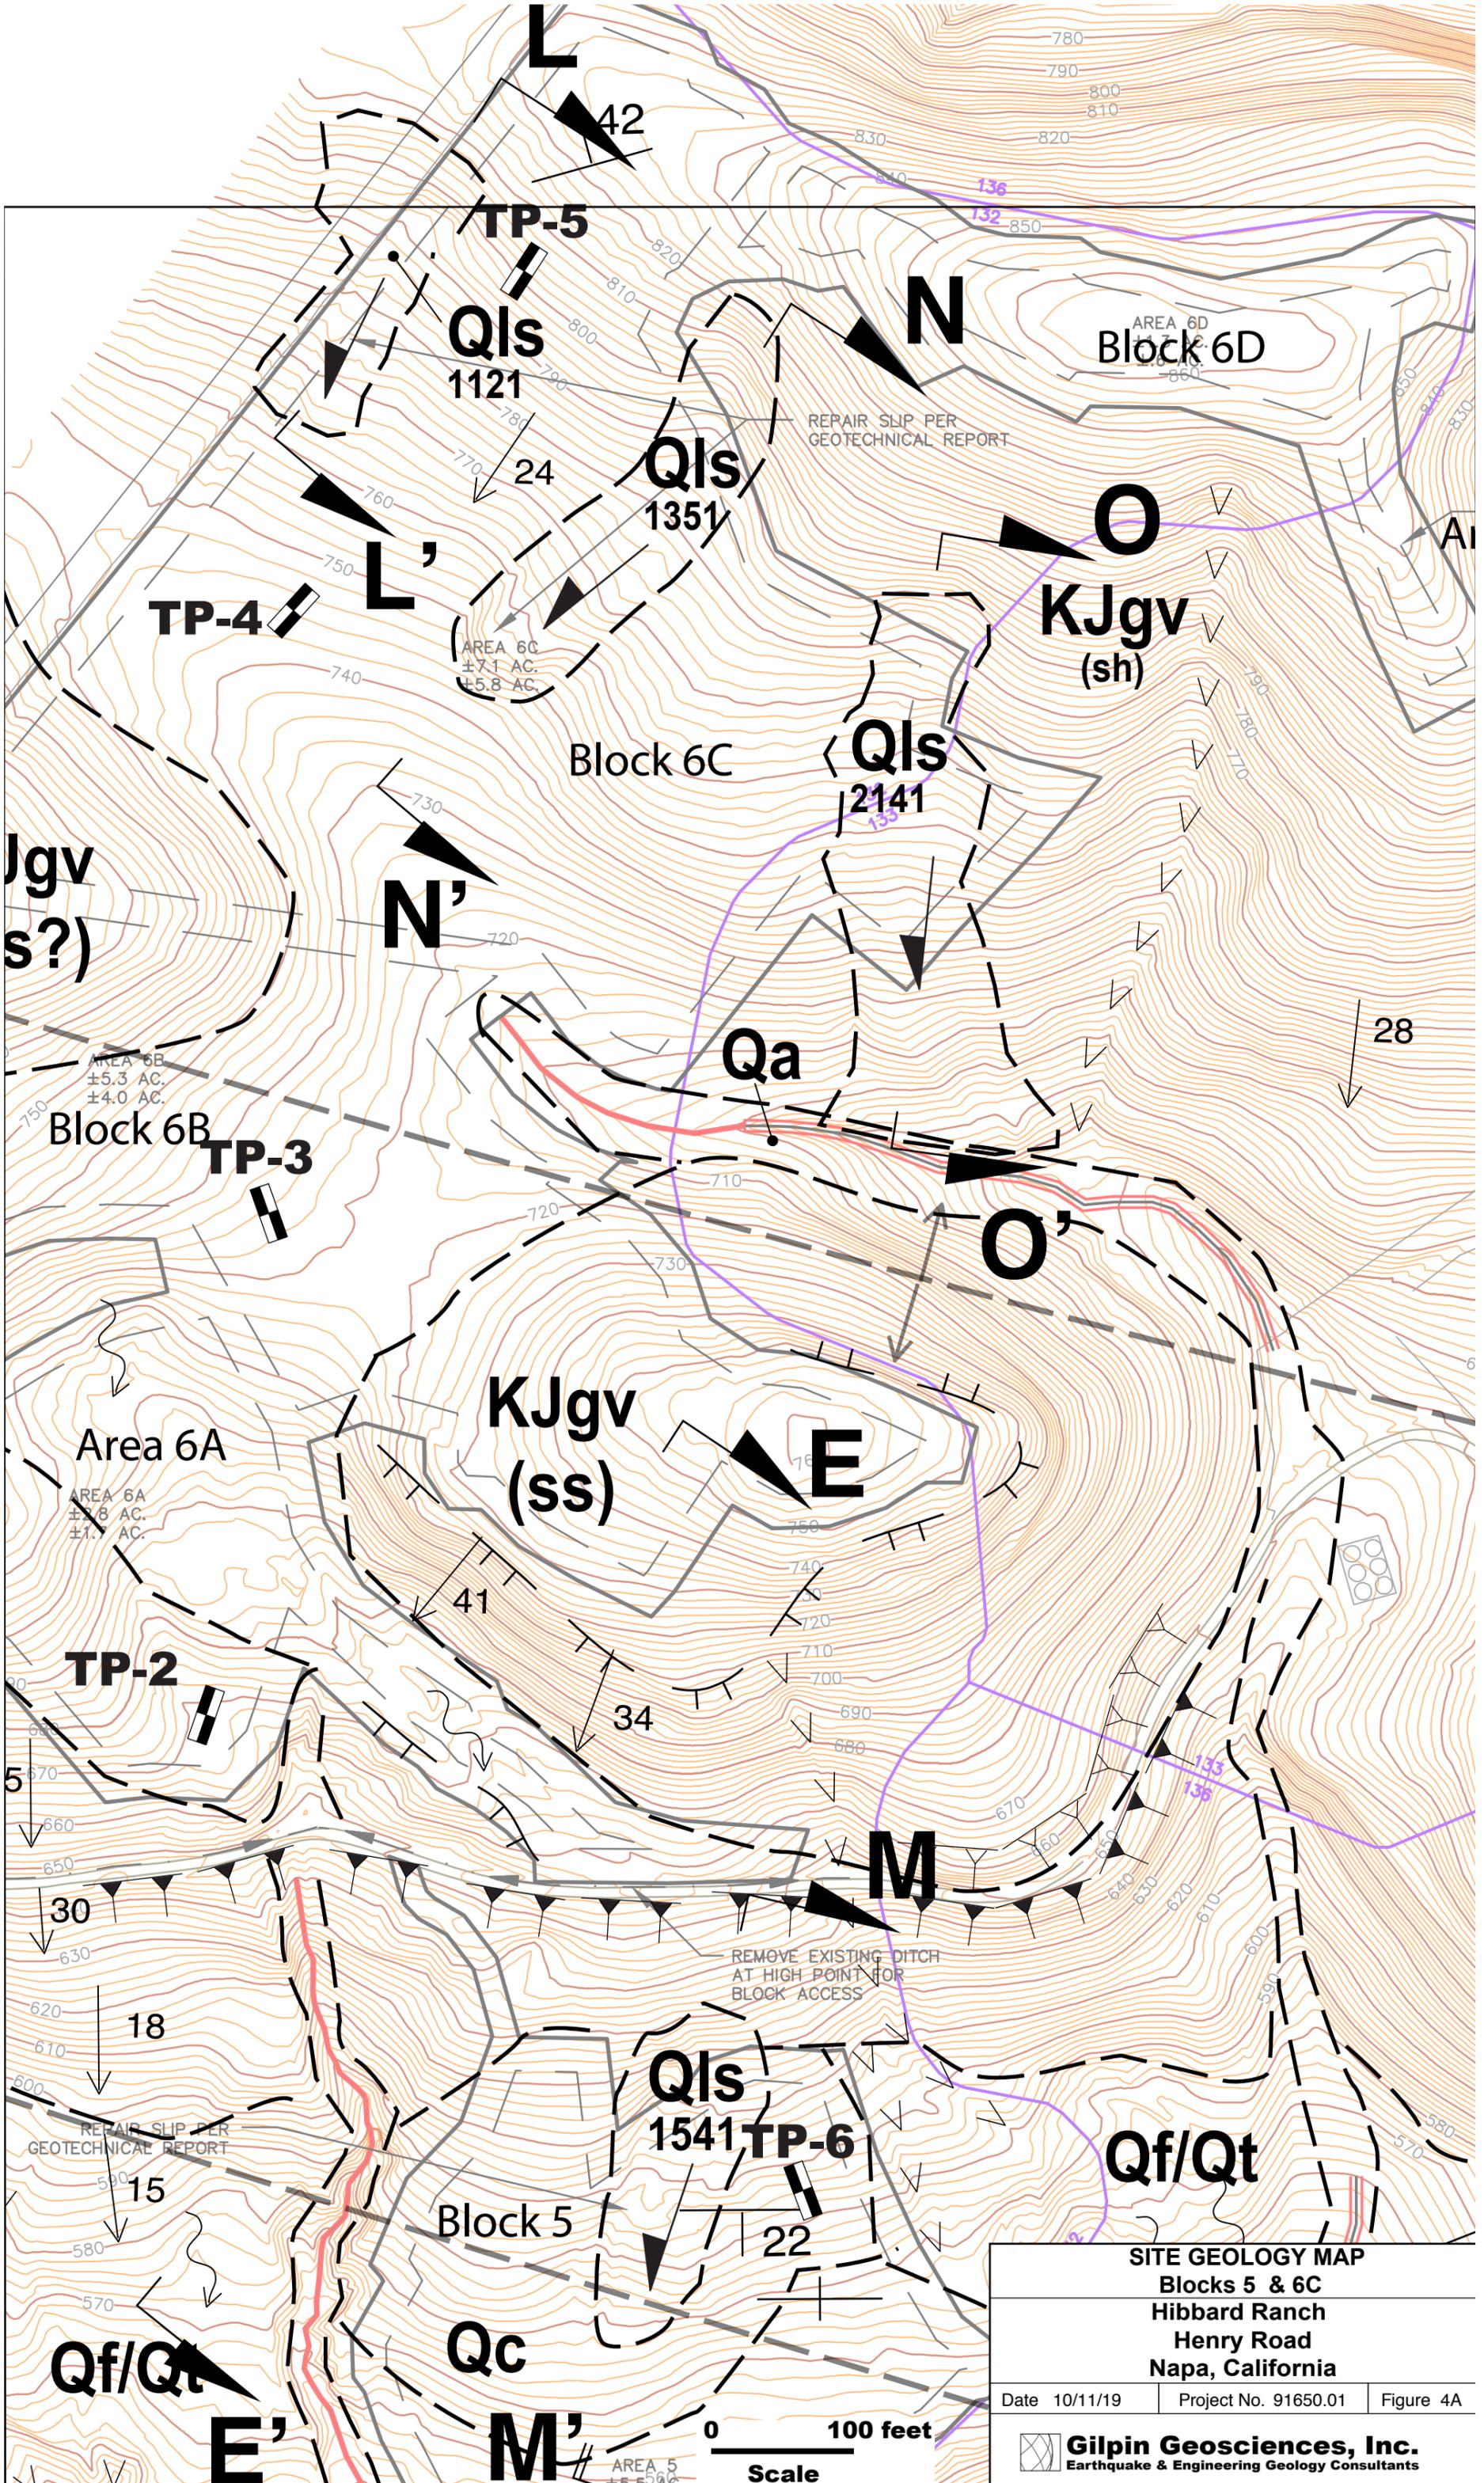
SITE GEOLOGY MAP		
Blocks 5 & 6C		
Hibbard Ranch		
Henry Road		
Napa, California		
Date 10/11/19	Project No. 91650.01	Figure 4A

We mapped a translational landslide that encroaches on Block 5, as shown on Figure 4A. We estimate the landslide to be approximately 20 feet deep as shown on the cross section presented on Figure 4C. In nearby test pit TP-6 (Gilpin Geoscience, 2019), we encountered siltstone bedrock at a depth of 4.5 feet BGS.

We mapped a moderate-size slump landslide (Qls 1351) emanating from the steep ridge at the top of the Block that is approximately 80 feet wide and extends up to 270 feet into the proposed vineyard block (Figure 4A). We estimate the depth of this landslide to be up to 30 feet deep BGS, as shown on the cross section presented on Figure 4B.

We mapped a dormant debris landslide (Qls 2121; Figure 4A) at the easternmost part of Block 6C based on review of infrared aerial photography. The deposit is subdued and poorly defined except in the lower courses of the swale drainage in which it is situated. The slide is approximately 60 to 90 feet wide in the proposed vineyard Block and we estimate it to be approximately 15 to 20 feet deep as shown on the cross section presented on Figure 4B.

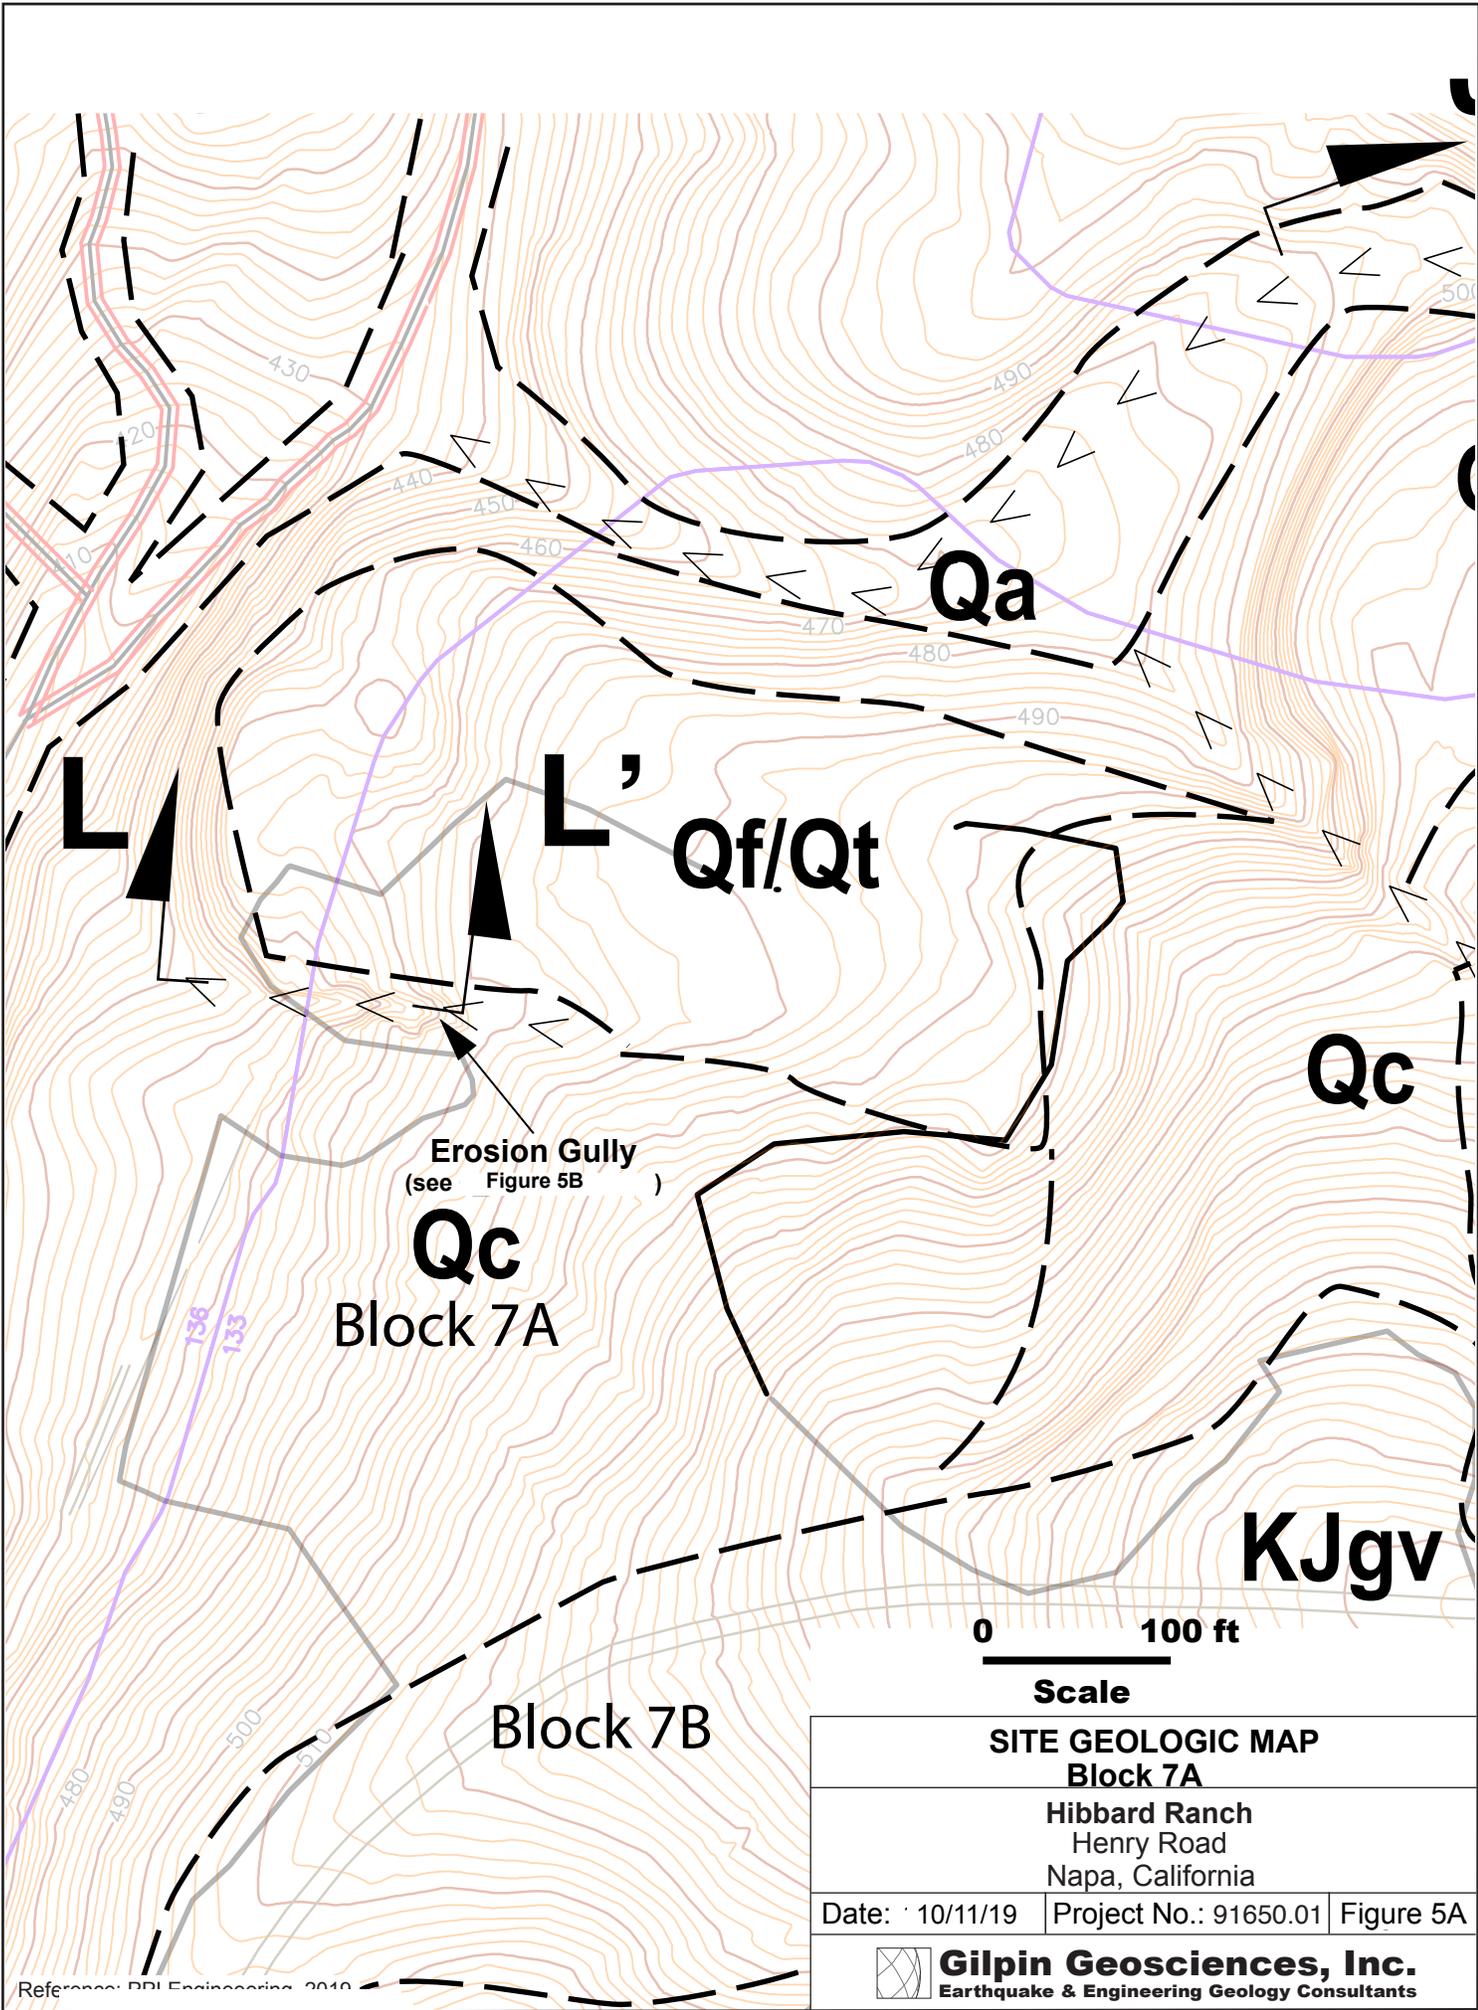
**SITE GEOLOGIC MAP
Block 7A**

We performed site geologic reconnaissance (Figure 5A) and PPI Engineering surveyed a cross section of the erosion gully (Figure 5B) at the lower elevation of Block 7A. The gully is eroded into an uplifted alluvial terrace deposit and drops approximately 30 feet over a length of approximately 120 feet. We show an average top of channel bank with respect to the channel thalweg on the cross section (Figure 5B). The gully has obviously been a hazard in the past as it currently is locally backfilled with concrete pipe and other solid debris in an attempt to arrest its growth.

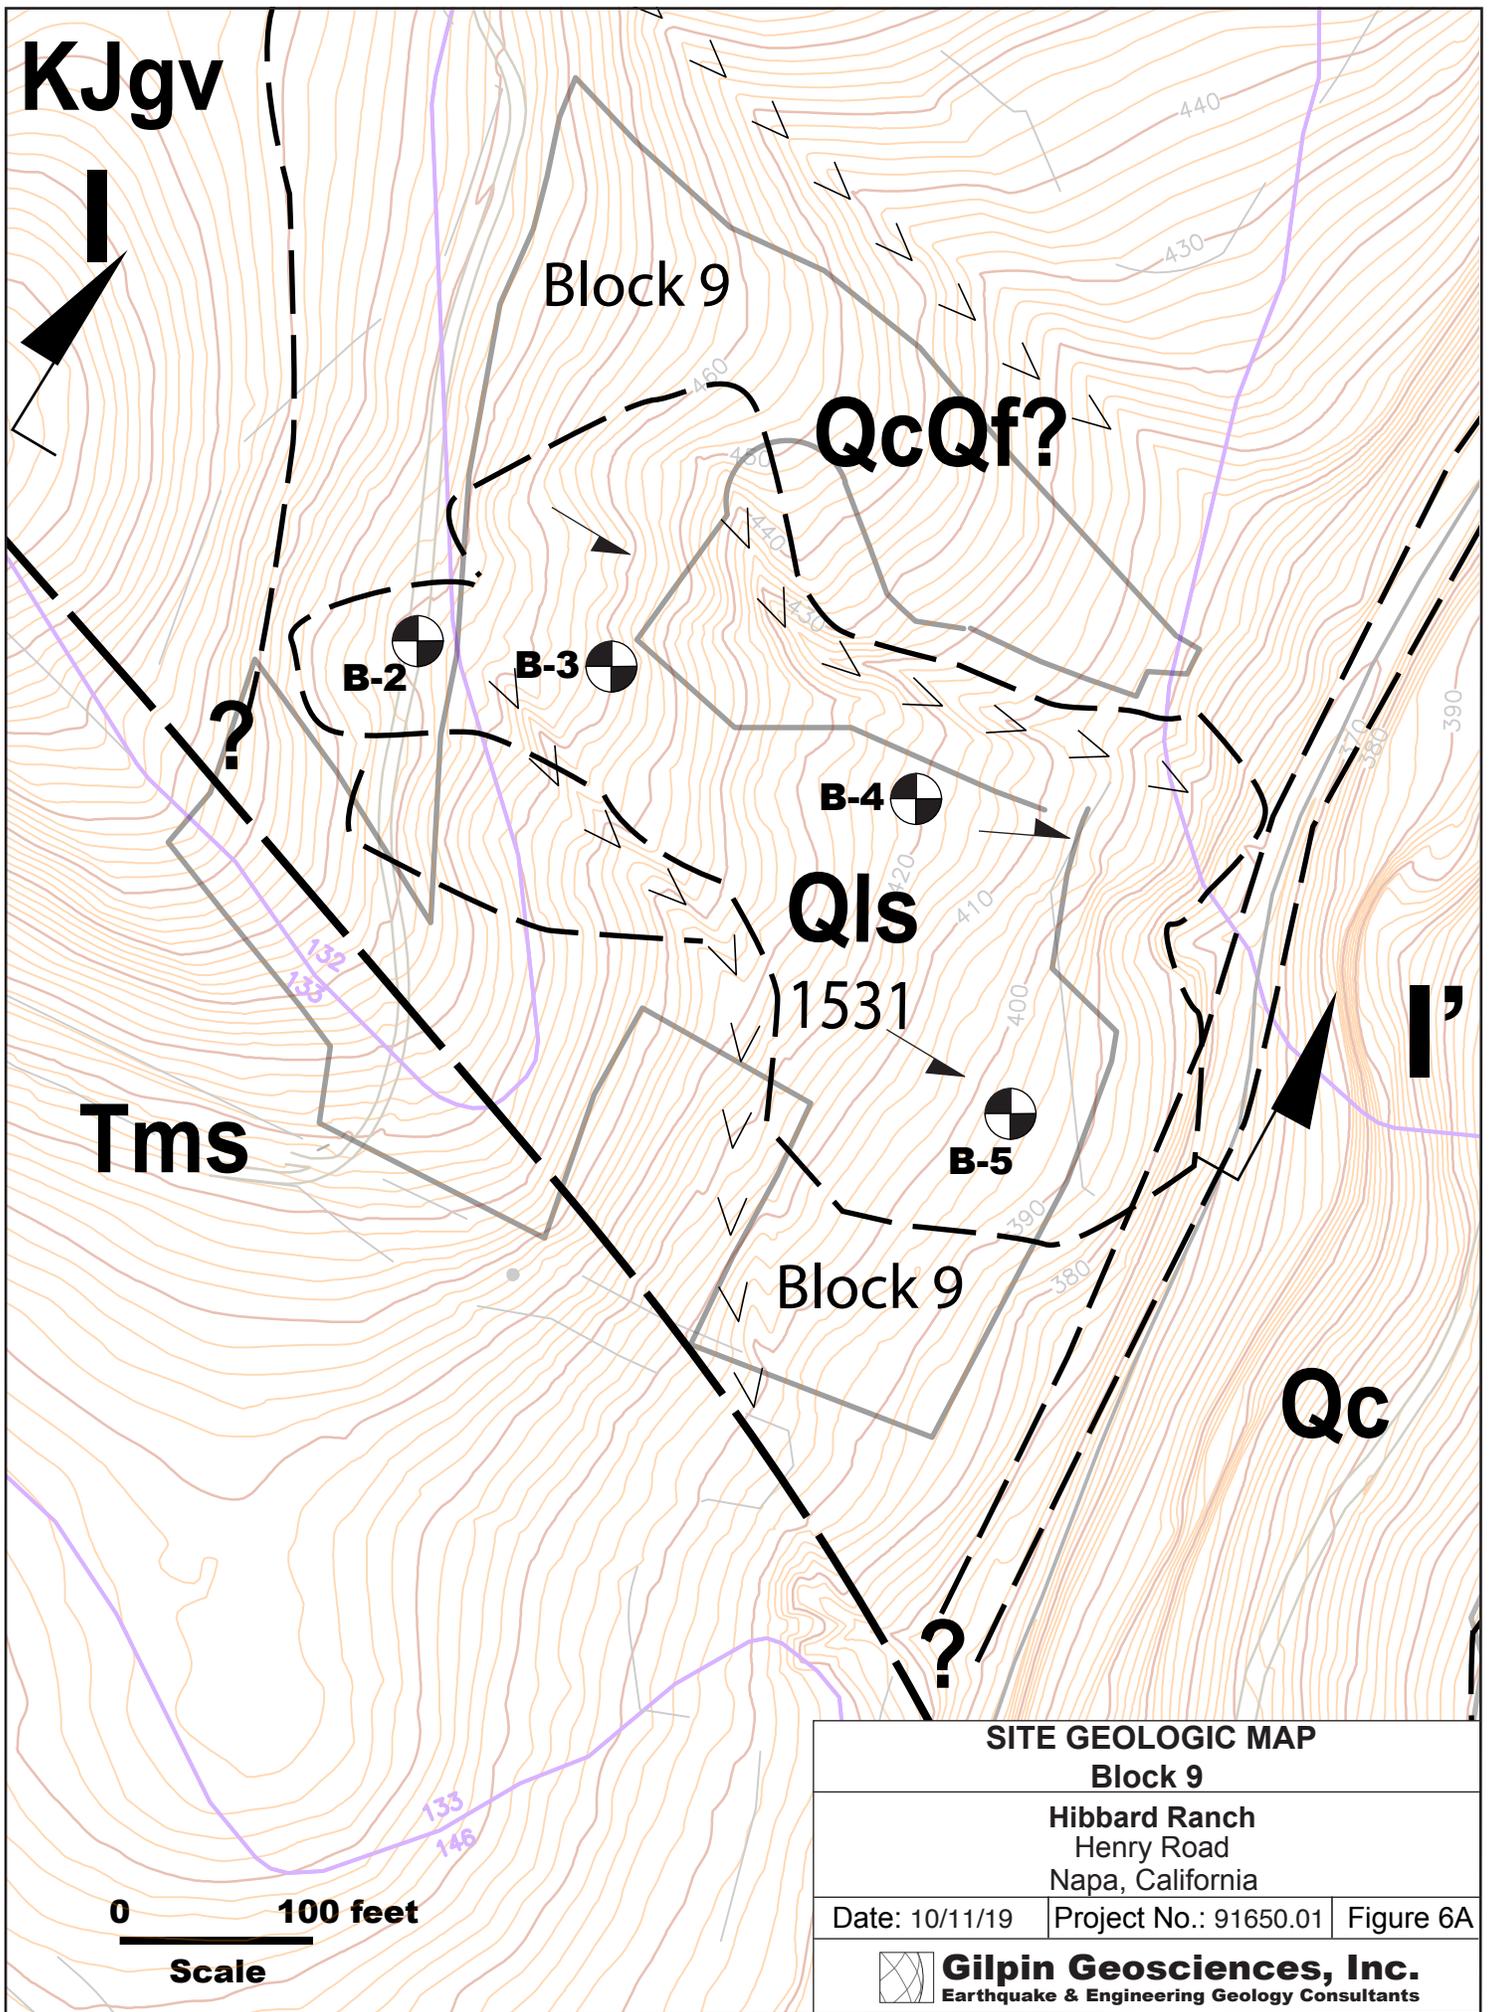
Figure 6A Site Geologic Map 9

Block 9 is located at the southwestern corner of the proposed vineyard improvements and is located on a moderately inclined southwest-facing slope above the prominent southwest drainage that cuts the site. Two irregular tributary drainages cut the proposed vineyard block and characterize the hummocky and irregular drainage on this slope. We mapped a large translational landslide roughly bounded by these two drainages (Figure 6A). We explored the landslide by drilling 4 test borings described in the next section. We estimate the depth of this landslide to be 15 to 26 feet BGS based on the test borings and the cross section shown on Figure 6B.
