Exhibit D-2

Gilpin Geosciences, Inc
Earthquake & Engineering Geology

January 24, 2020
91650.01

SUBJECT: REVISED
Landslide Investigation: Response to Comments
V. Sattui Hibbard Ranch Vineyard,
Henry Road
Napa, California

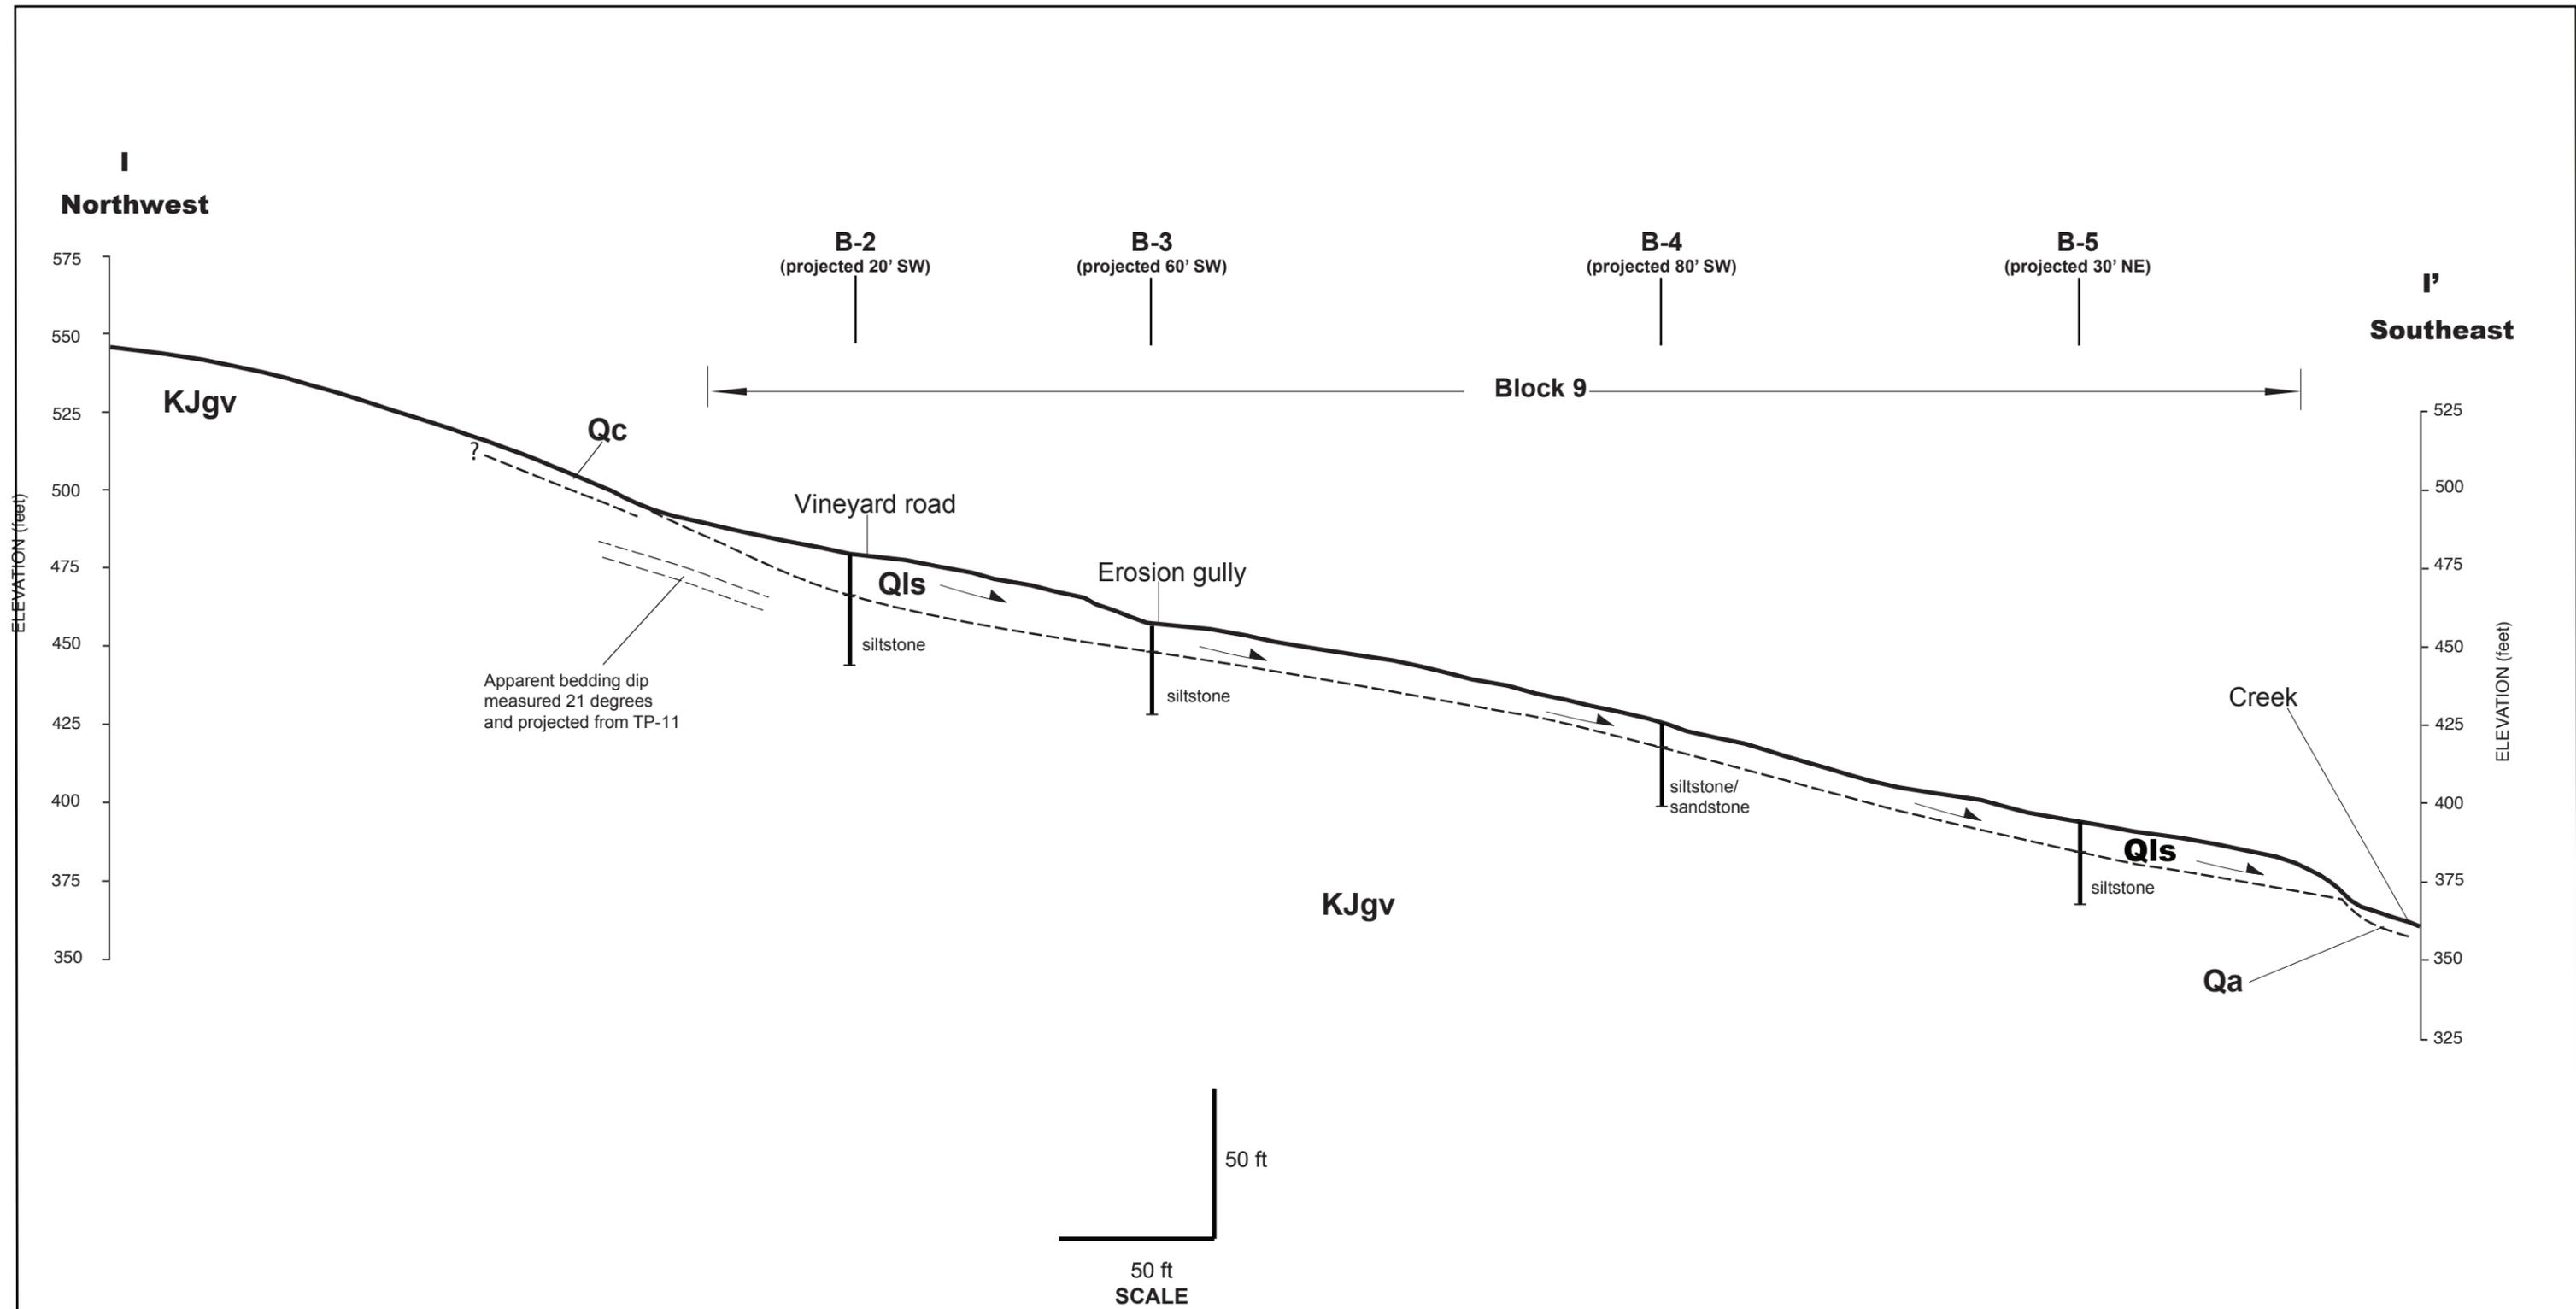
CROSS SECTION I - I' Block 9		
Hibbard Ranch Henry Road Napa, California		
Date 10/11/19	Project No. 91650.01	Figure 6B

Block 9 is located at the southwestern corner of the proposed vineyard improvements and is located on a moderately inclined southwest-facing slope above the prominent southwest drainage that cuts the site. Two irregular tributary drainages cut the proposed vineyard block and characterize the hummocky and irregular drainage on this slope. We mapped a large translational landslide roughly bounded by these two drainages (Figure 6A). We explored the landslide by drilling 4 test borings described in the next section. We estimate the depth of this landslide to be 15 to 26 feet BGS based on the test borings and the cross section shown on Figure 6B.

Borings B-2 through B-5 were drilled in the landslide mapped on vineyard Block 9. We encountered silty to sandy clay and clayey gravel landslide materials to a depth of up to 29.5 feet BGS at the boring B-1 location. The soils encountered are soft to medium stiff/loose and are moist to wet. We encountered a soft and wet landslide slip plane in boring B-2 at a depth of 25 feet BGS. In boring B-4 we encountered silty clay with gravel residual soil that was stiff to very stiff layered between the landslide materials and underlying bedrock.

Siltstone bedrock was encountered below the landslide materials in all the borings on Block 9. We classified the siltstone as friable to weak with low hardness and moderate weathering. We encountered sandstone bedrock underlying the siltstone in boring B-4 at a depth of 26 feet below ground surface (BGS). The sandstone was friable to weak, of low hardness and deeply to completely weathered.
