ARBORIST REPORT AND TREE PROTECTION PLAN

8168 Stevenson Rd, Sacramento County, CA
December 2021

Arborist Report & Tree Protection Plan for
8168 Stevenson Avenue
Sacramento, CA

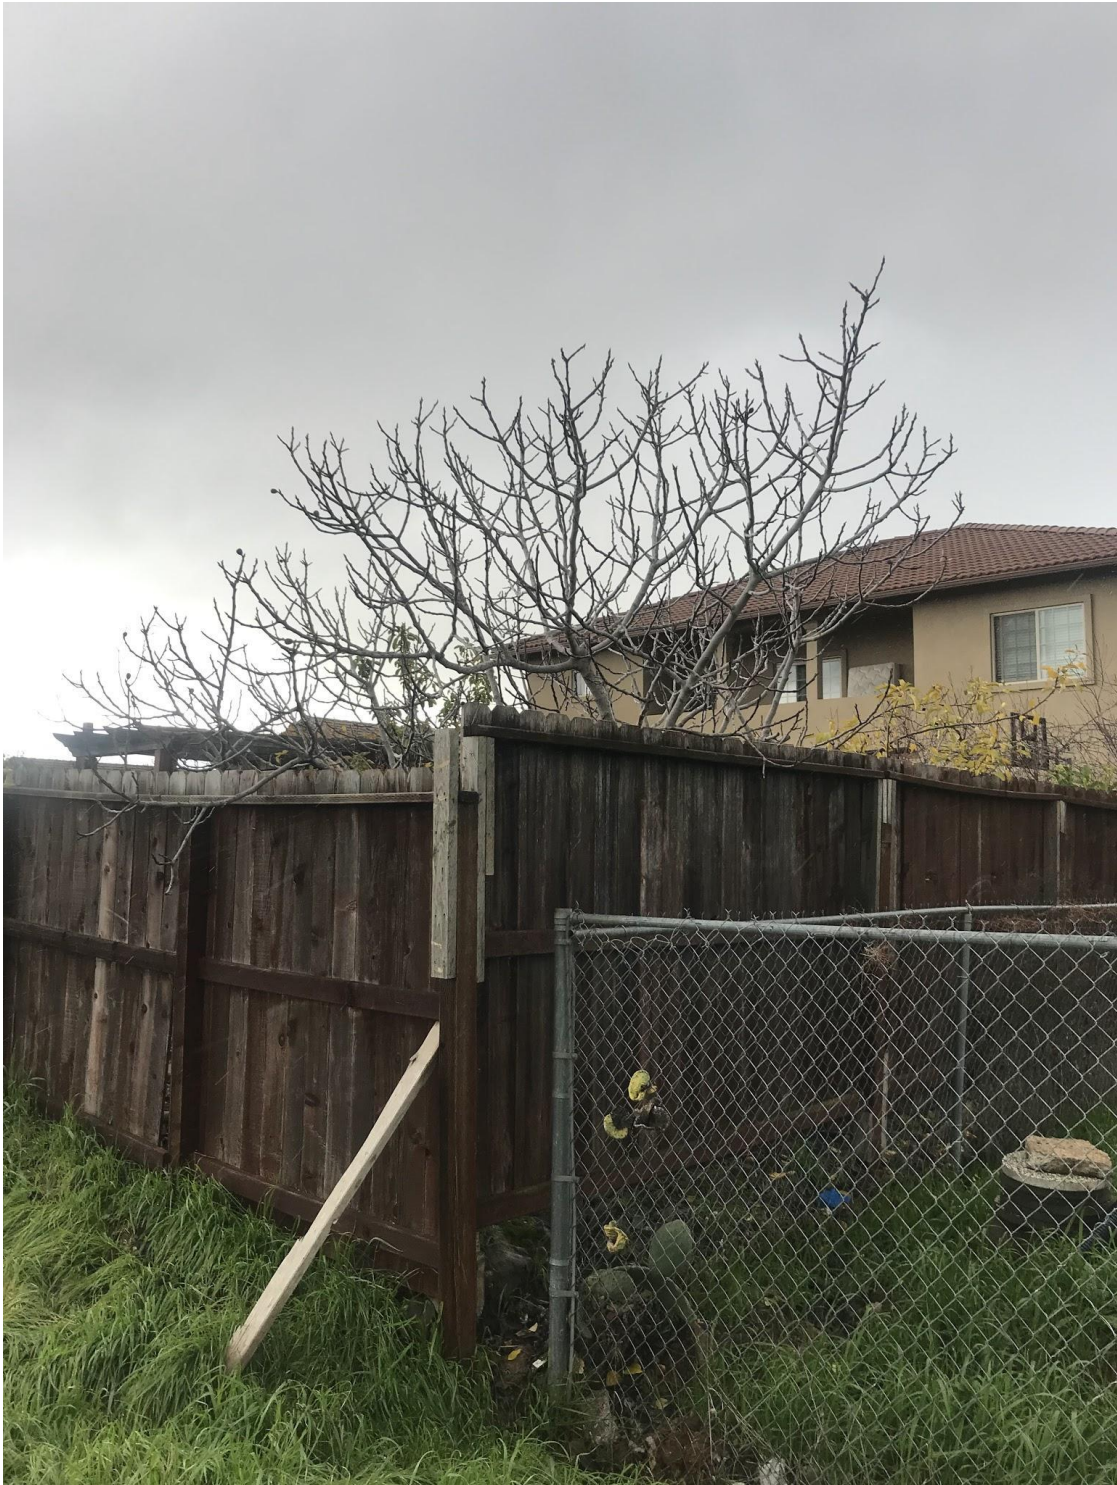
- Tree #1 is a small fig tree with a canopy overhanging the property around 3 feet. No excavation will occur under the canopy and little to no impact is expected. The existing fence should provide sufficient protection.

Photo 1. Tree #1 is located at 873 Abo Zayed Lane and has little foliage overhanging the parcel; little to no impact is expected.

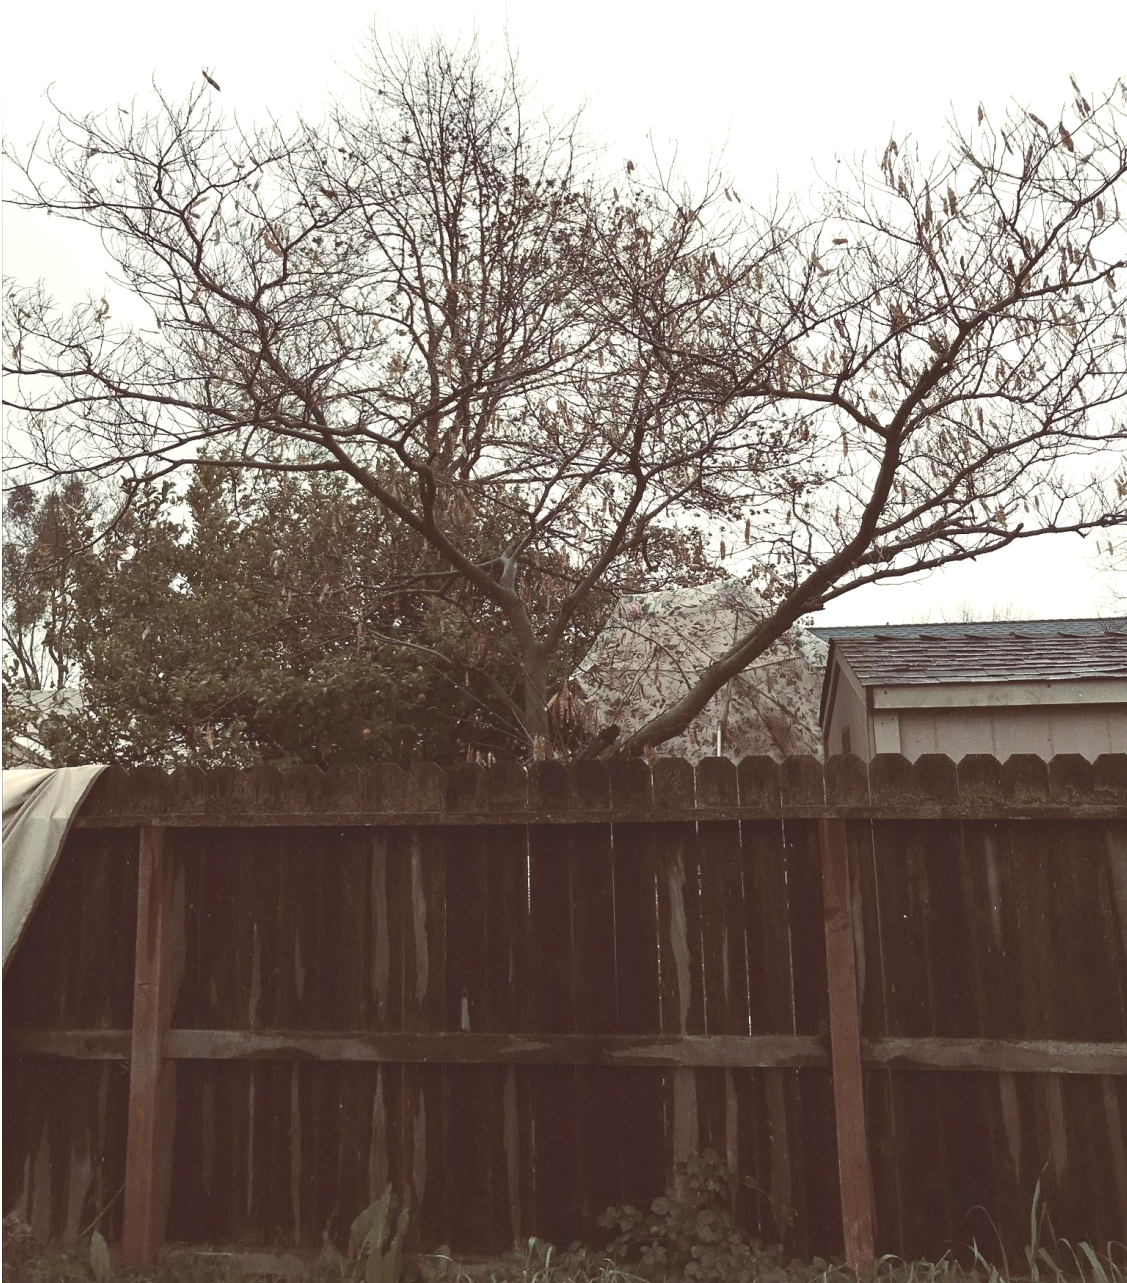
- Tree #2 is a small mimosa tree with a canopy overhanging the property around 6 feet. Excavation may occur under the canopy and moderate to minimal impact is expected. Tree protection fencing is recommended at the edge of CRZ connecting to the existing fence.

Photo 2. Tree #2 is located at 8177 Pine Cove Ct and has some foliage overhanging the parcel; tree protection fencing should be installed at the CRZ and connect to the existing fence.

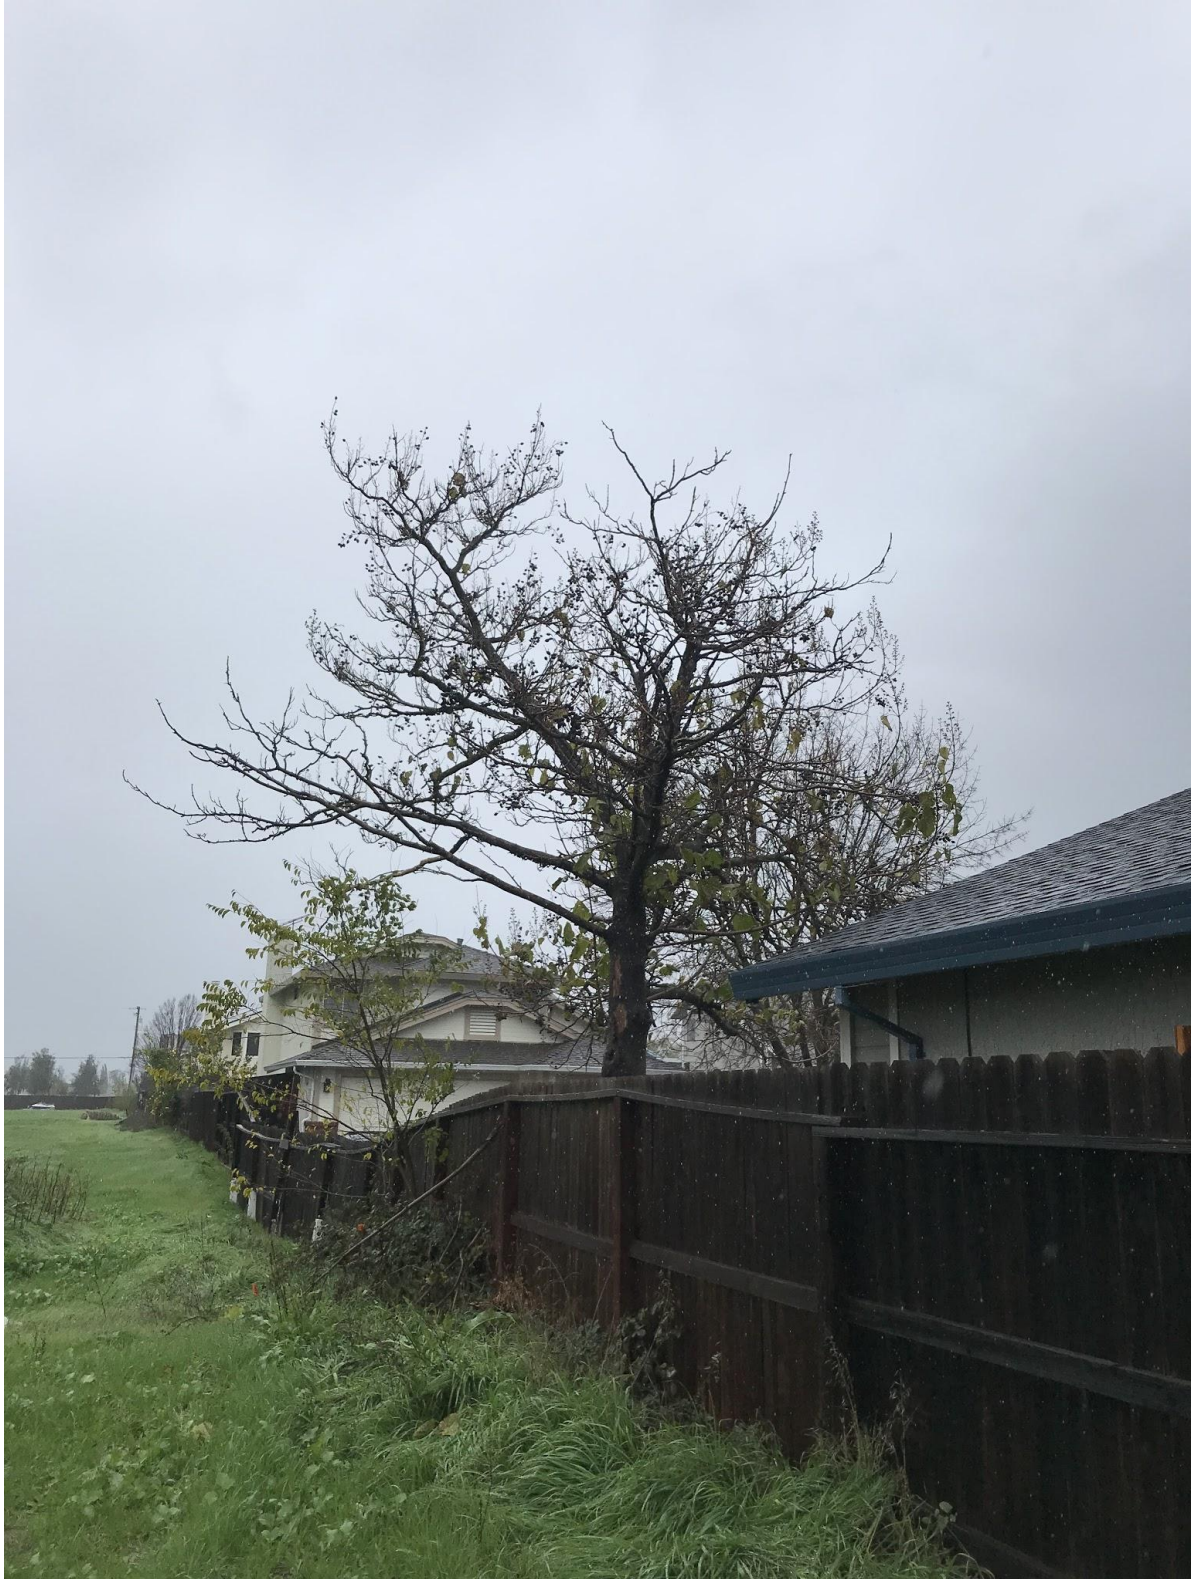
- Tree #3 is a royal paulownia tree in poor condition. The tree should be pruned to remove large deadwood over the project site. Excavation may occur under the canopy and moderate to minimal impact is expected. Tree protection fencing should be installed along the CRZ and connect to the existing fence.

Photo 3. Tree #3 at 8180 Cliffe Way is in poor condition with large deadwood over the parcel; remove deadwood over the parcel and install tree protection fencing along the CRZ to the existing fence.

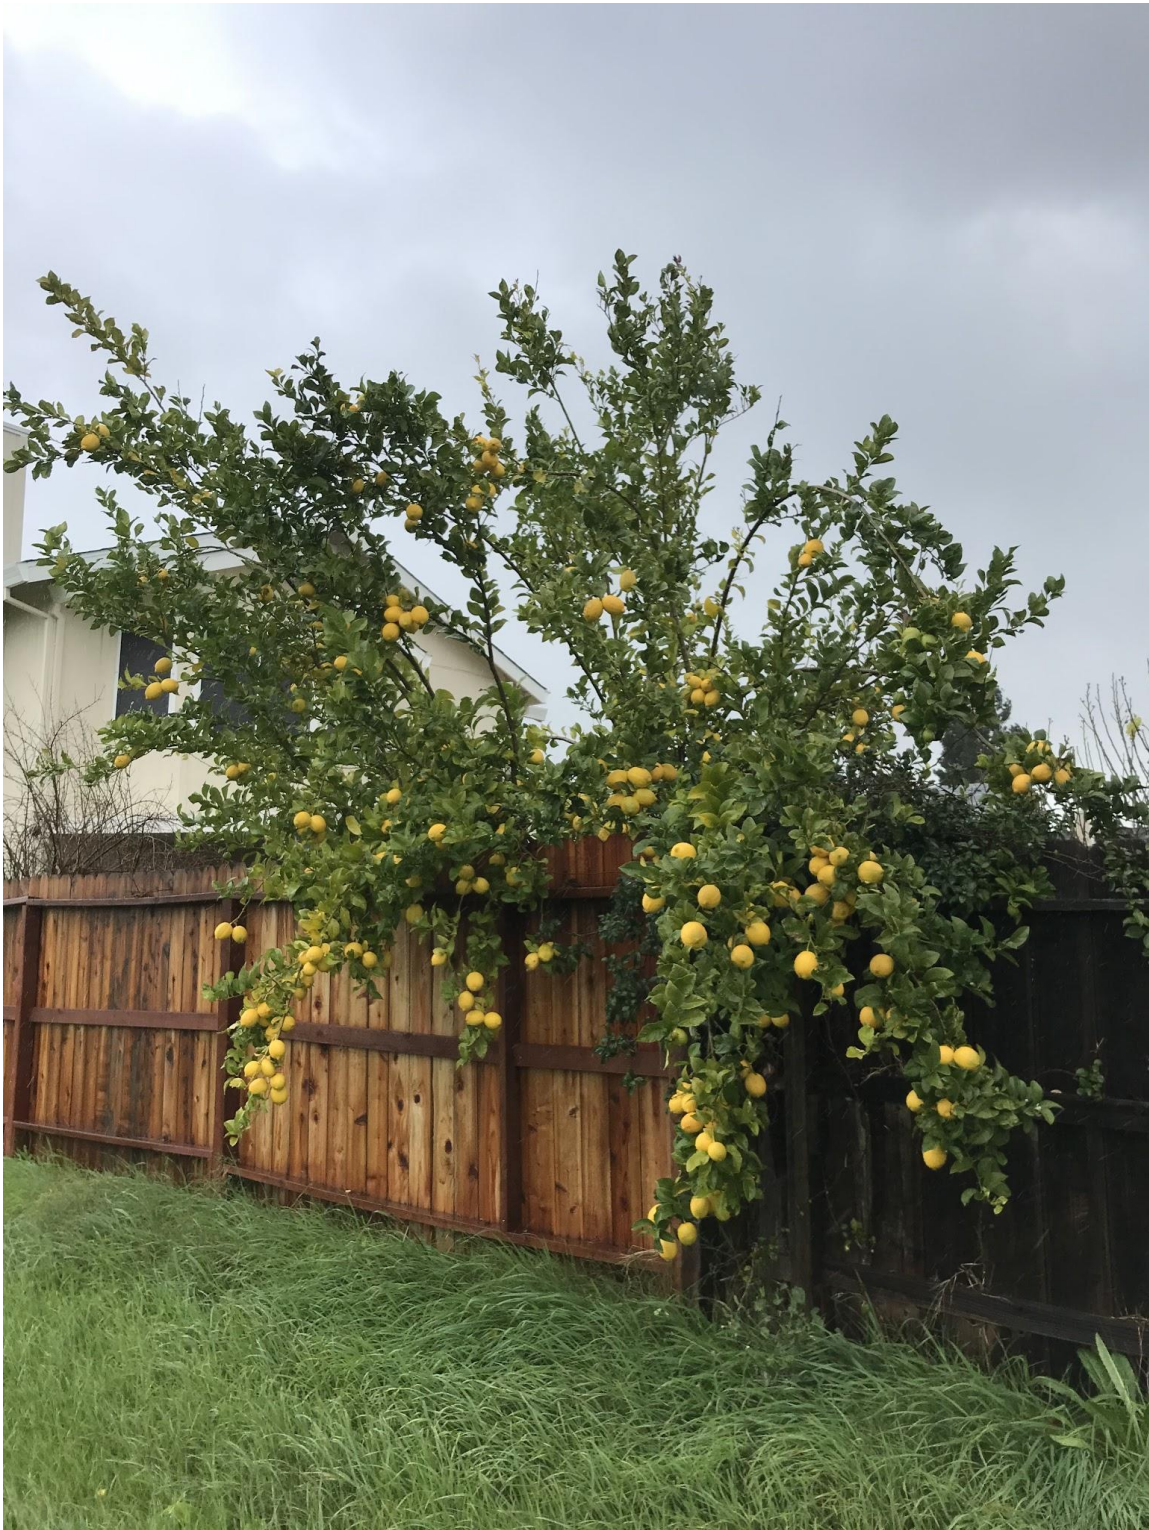
- Tree #4 is a small lemon tree with a canopy overhanging the property around 3 feet. No excavation will occur under the canopy and little to no impact is expected. The existing fence should provide sufficient protection.

Photo 4. Tree #4 is growing at 8180 Aden Way, and minimal impact is expected.

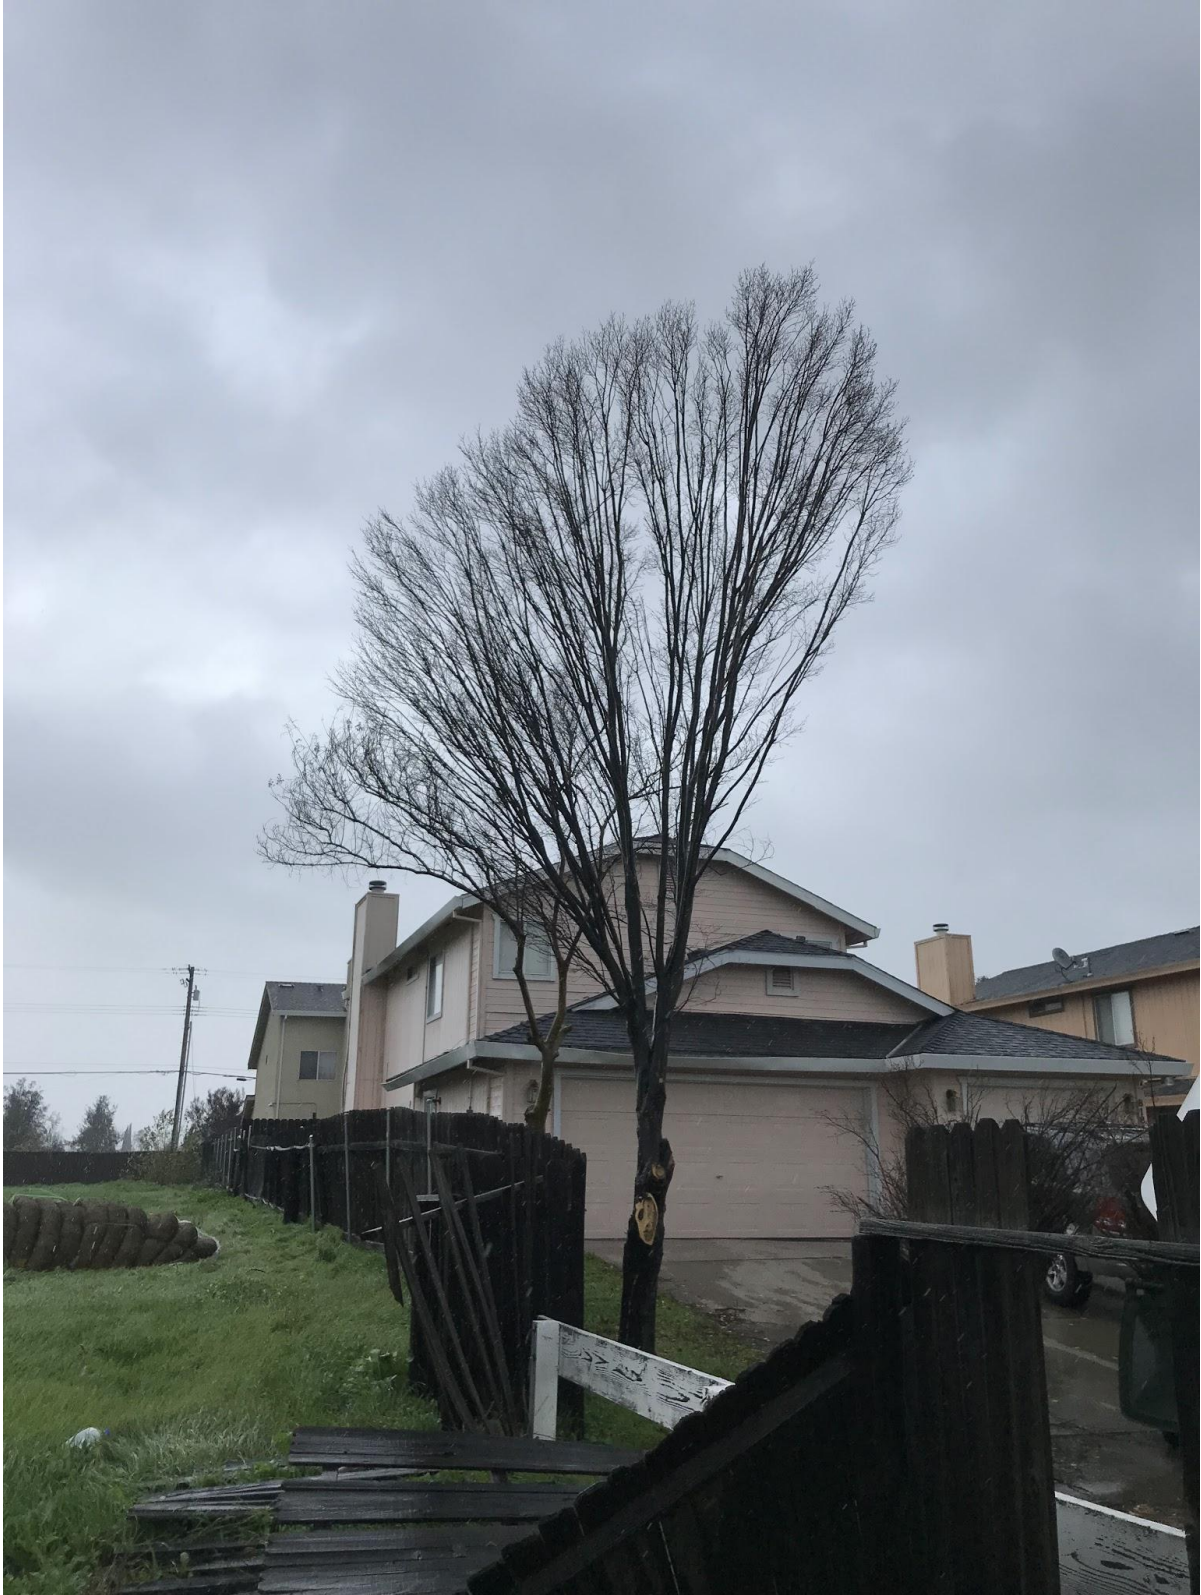
- Tree #5 is a medium-size hornbeam with a canopy overhanging the property around 5 feet. Excavation may occur under the canopy and moderate to minimal impact is expected. The existing fence is unstable and failing and should be repaired. Tree protection fencing should be installed along the CRZ and connect to the existing fence.

Photo 5. Tree #5 (center) and #6 (left) have been poorly pruned; the existing fence is failing and should be repaired. Install tree protection fencing along the CRZ to the existing fence.

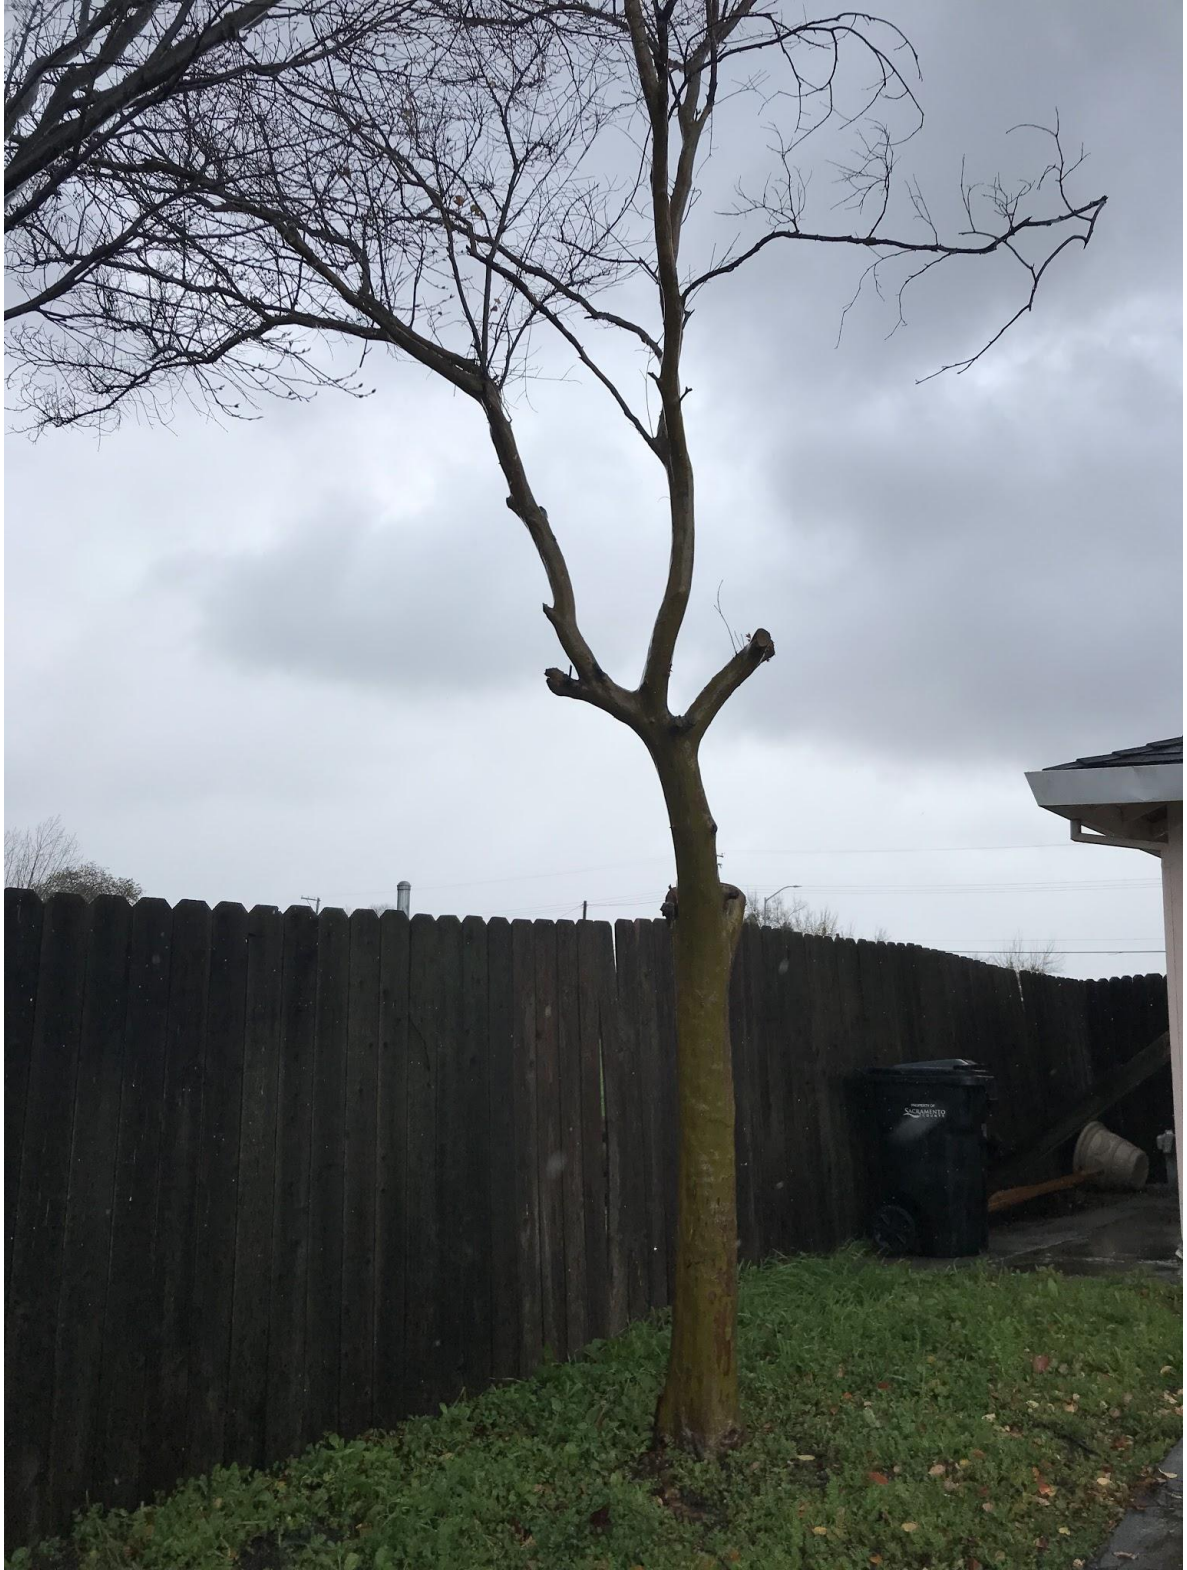
- Tree #6 is a small crape myrtle with a canopy overhanging the property around 4 feet. No excavation will occur under the canopy and little to no impact is expected. The existing fence should provide sufficient protection.

Photo 6. Tree #6 has been improperly pruned and is located at 8181 Aden Way; minimal impact is expected.

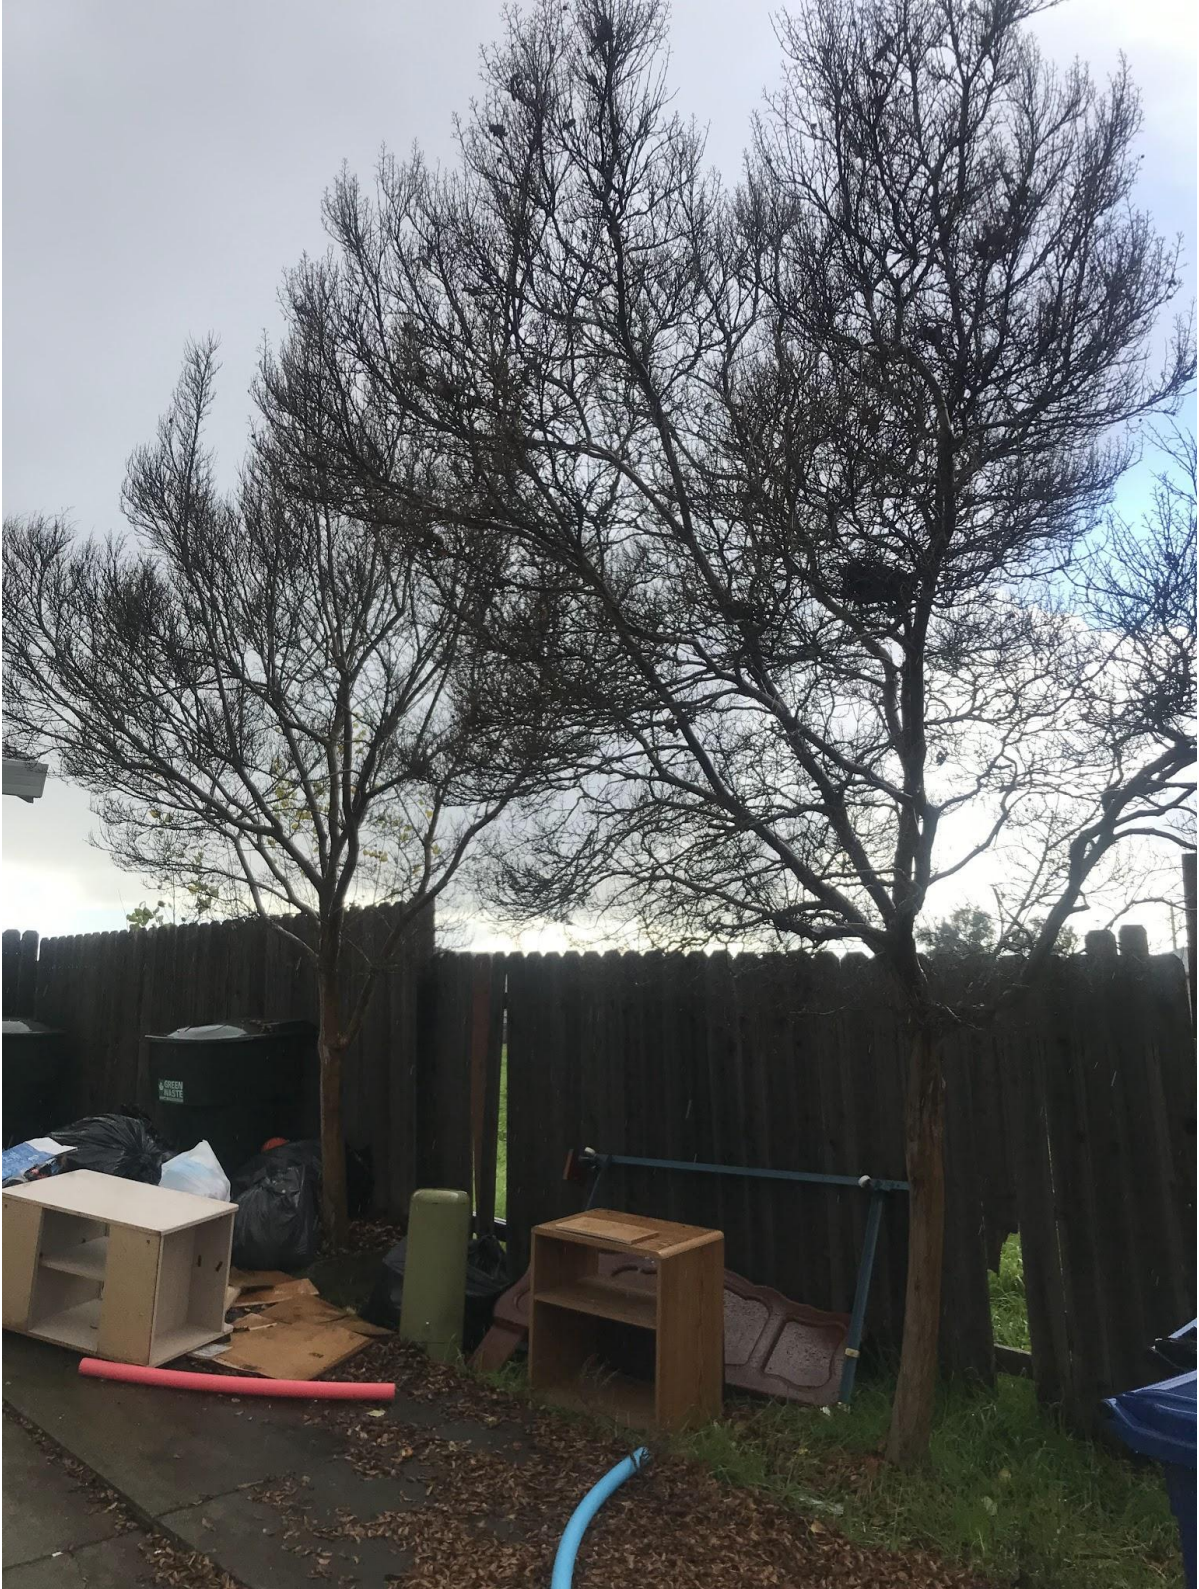
- Tree #7 and 8 are small crape myrtle trees with canopy overhanging the property around 3 feet. No excavation will occur under the canopy and little to no impact is expected. The existing fence should provide sufficient protection.

Photo 7. Trees #7 (left) and 8 (right) are in good condition located along the eastern property line at 8180 Stevenson Ave; minimal to no impact is expected.
