Tree Survey and Arborist Report

*for the Dapplegray Project Site Portion of the PV Peninsula Water Reliability Project)
in the City of Rolling Hills Estate Within the Los Angeles County, California*

Report Date: August 23, 2021

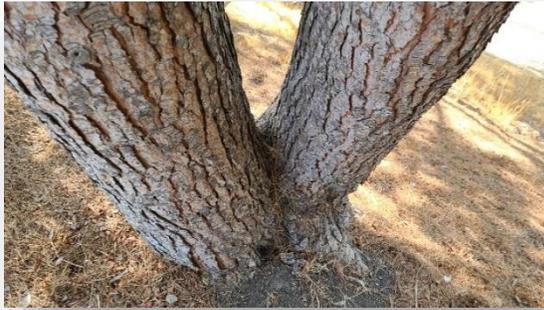
Plate 1. This a view of a co-dominant stem with poor crotch strength (#605).

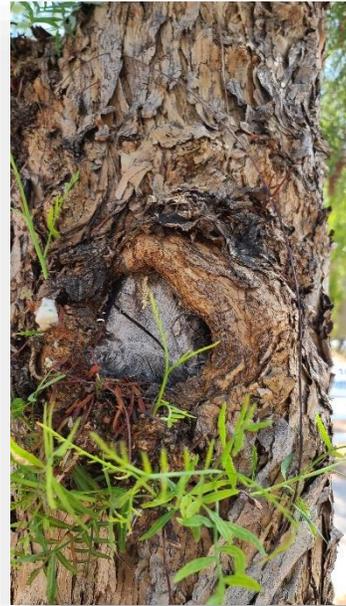
Plate 2. This is a view of internal deadwood within an unclosed branch cut (#611).

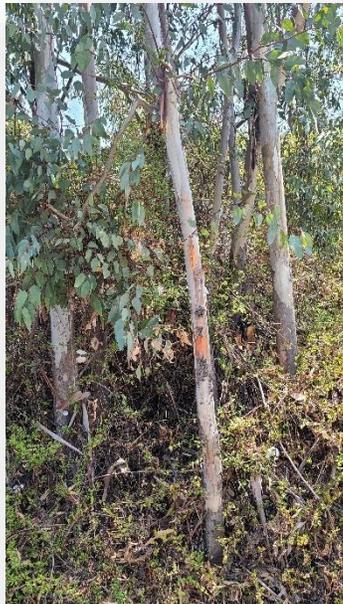
Plate 3. This is a view of a dense tree stand with competing canopies (#615).

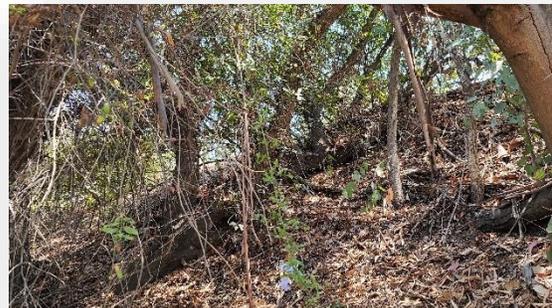
Plate 4. This is a view of a fallen stem that continues to sprout (#617).

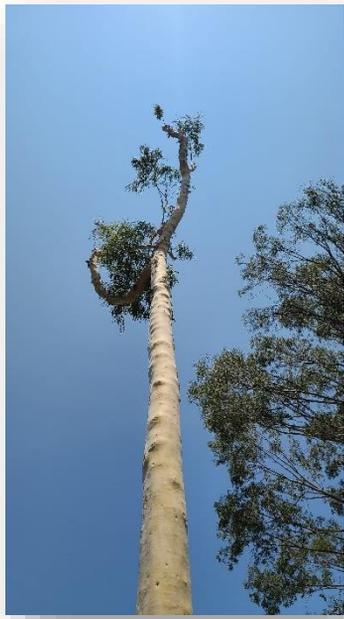
Plate 5. This is a view of a poorly trimmed tree in which limbs were topped and excess canopy had been removed (#618).

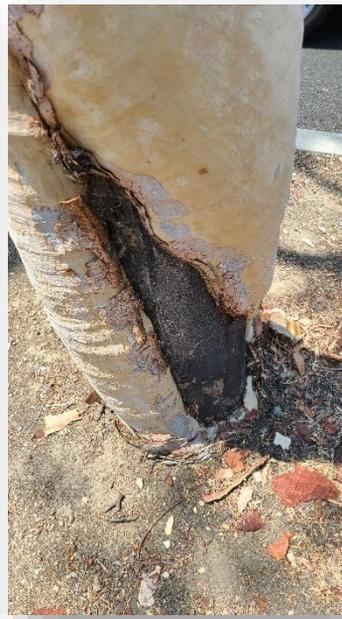
Plate 6. This is a view of decay noted within the lower stem and flare of a tree compromising structural integrity (#620).

Over trimmed														4		6			
619	Lemon Scented Gum	12						12	38	4	5	4	5	4	4	2	3	2-3	Prune
Over trimmed														5		5			
620	Lemon Scented Gum	13						13	28	8	11	10	6	8	8	3	2-3	2-3	Remove
Over trimmed, large area of decay at flare and lower stem														6		11			
621	Lemon Scented Gum	17						17	38	10	6	10	8	10	10	2	2-3	2-3	Prune
Over trimmed														8		6			
622	Shamel Ash	4.5	4.5	4.5	4.5			18	15	10	11	10	12	10	10	3	3	2-3	Remove

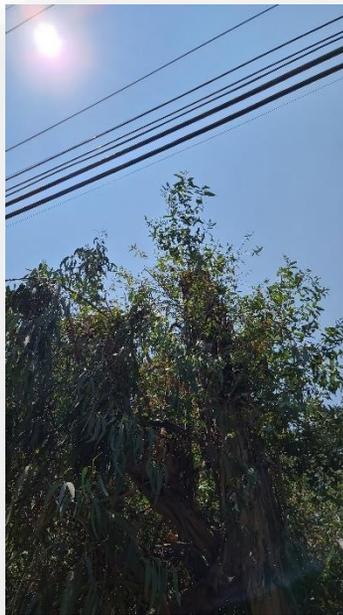
Plate 7. This is a view of a topped tree trimmed to allow for overhead wires, but contributing to water sprouting (#624).

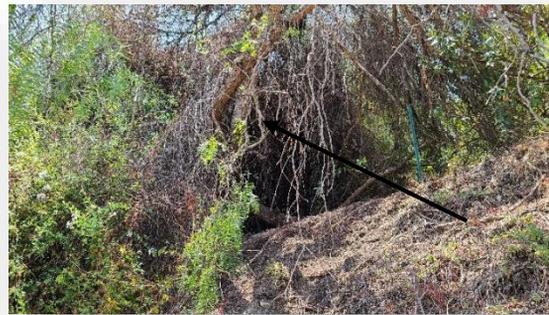
Plate 8. This is a view of a poorly developed canopy and stem of a tree (#NT3).

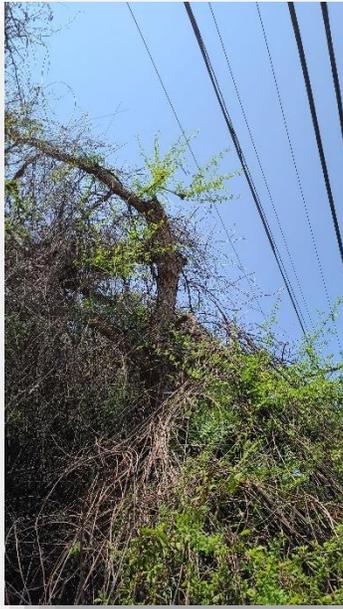
Plate 9. This is a view of a tree that has been severely trimmed to allow for overhead utilities (#NT4).

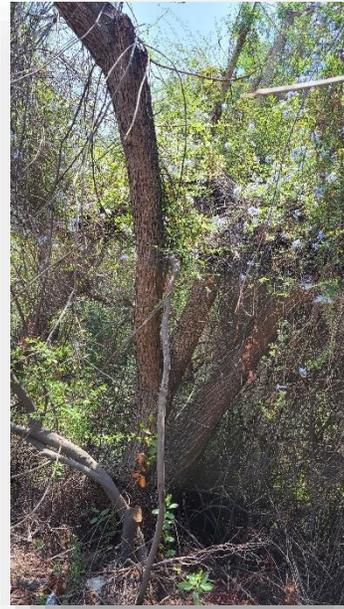
Plate 10. This is a view of a poorly developed canopy (#NT6).

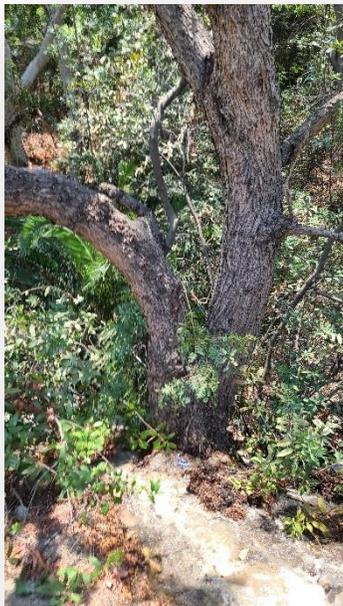
Plate 11. This is a view of a cement base that had been added atop the root crown of a tree following an erosional event due to a ruptured water pipe beneath the street (#NT6).

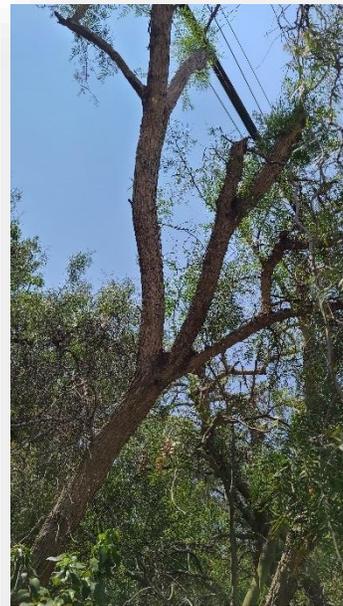
Plate 12. This is a view of utilities running close to branches and foliage within the crown of a tree (#NT10).

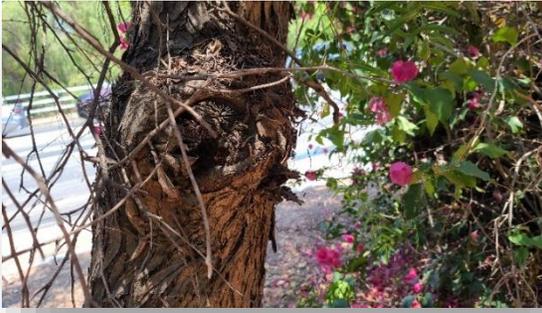
Plate 13. This is a view of a decayed wood within an unclosed branch cut (#629).

628	Peruvian Pepper	36					36	28	4	16	18	18	4	18	16	3	2-3	3-4	Remove
Decay in stem, Senescent																			
629	Peruvian Pepper	10	11				21	18	8	12	12	8	8	8	12	3	3	3	Remove
Co-dominant stem, In decline, Decay mid-stem																			
630	Peruvian Pepper	17	24				41	24	16	20	20	11	11	16	20	2-3	2-3	3	Remove
Upper canopy dead wood, Decline, Senescent, Increased dead wood in stem																			
631	Peruvian Pepper	37					37	23	14	22	20	26	26	14	22	2-3	2-3	2-3	Remove
Internal decay, Poor vigor and form, Topped, Poor prognosis																			
632	Peruvian Pepper	28					28	20	10	26	18	32	32	10	26	2-3	2-3	2-3	Prune
Trimmed for utilities, good vigor, Topped																			
633	Peruvian Pepper	34					34	26	15	10	28	30	30	15	10	2-3	2-3	2-3	Prune
Near utility poles, Some upper canopy dead wood																			
634	Peruvian Pepper	12					12	22	15	12	18	2	2	15	12	3	3	3	Remove
Near utility lines, In decline

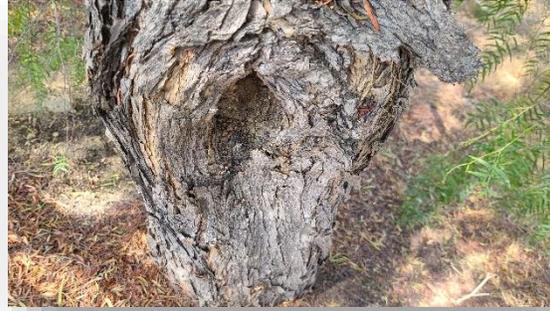
Plate 14. This is a view of a large cavity within the stem of a tree (#639).

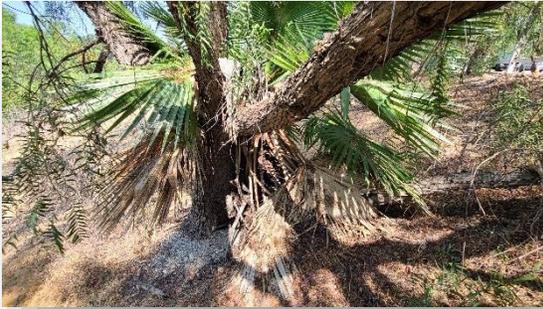
Plate 15. This is a view of a palm growing beneath the canopy of a tree (#643).

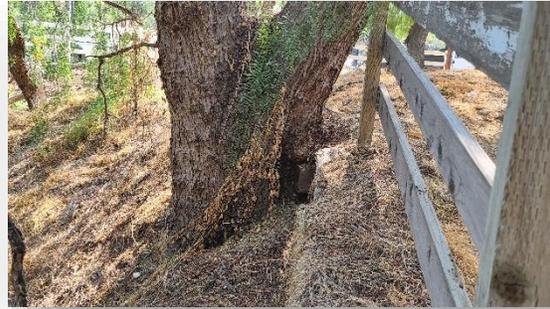
Plate 16. This is a view of a compromised flare of a tree due to an adjacent walkway (#651).

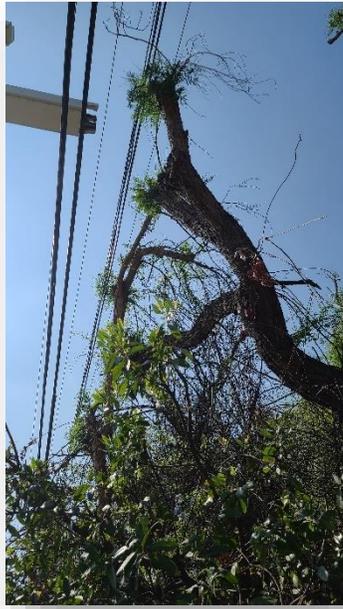
Plate 17. This is a view of a topped tree that has resulted in water sprouting (#NT18).

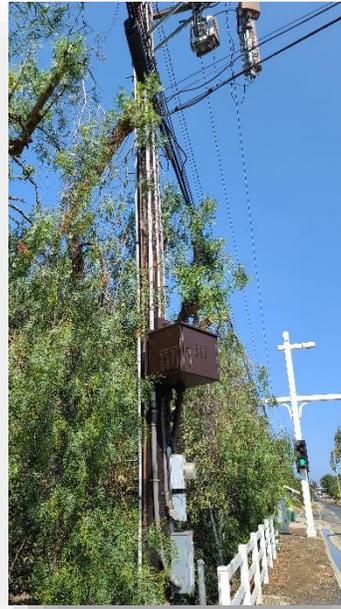
Plate 18. This is a view of a tree canopy currently contacting utilities posing a potentially hazardous condition (#NT22).
