Appendix E: Phase I Environmental Site Assessment

Type of Services	Phase I Environmental Site Assessment and Preliminary Soil Quality Evaluation
Location	2323, 2369, 2389, and 2391 Moorpark Avenue and Assessor's Parcel Numbers 282-01-014, 282-01-015, and 282-01-016 San Jose, California
Client	TTL Management
Client Address	12647 Alcosta Blvd., Suite 470 San Ramon, California 94583
Project Number	648-20-1
Date	December 5, 2019

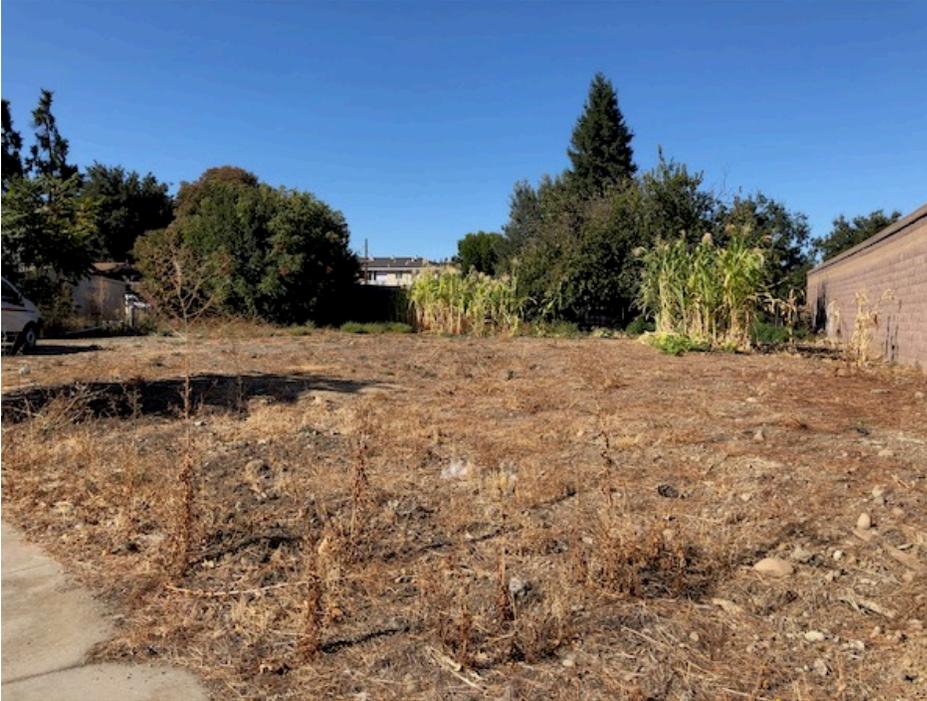
Row Crops or Orchards	Not Observed
Stockpiles of Soil or Debris	Undulating piles of soil with minor debris observed within undeveloped portion of north-northwest portion of Site
Sumps or Clarifiers	Not Observed
Transformers	Pole-mounted, as described above

Photograph 1. View looking west across vacant lot in central-northwest corner of Site, from Central Way.

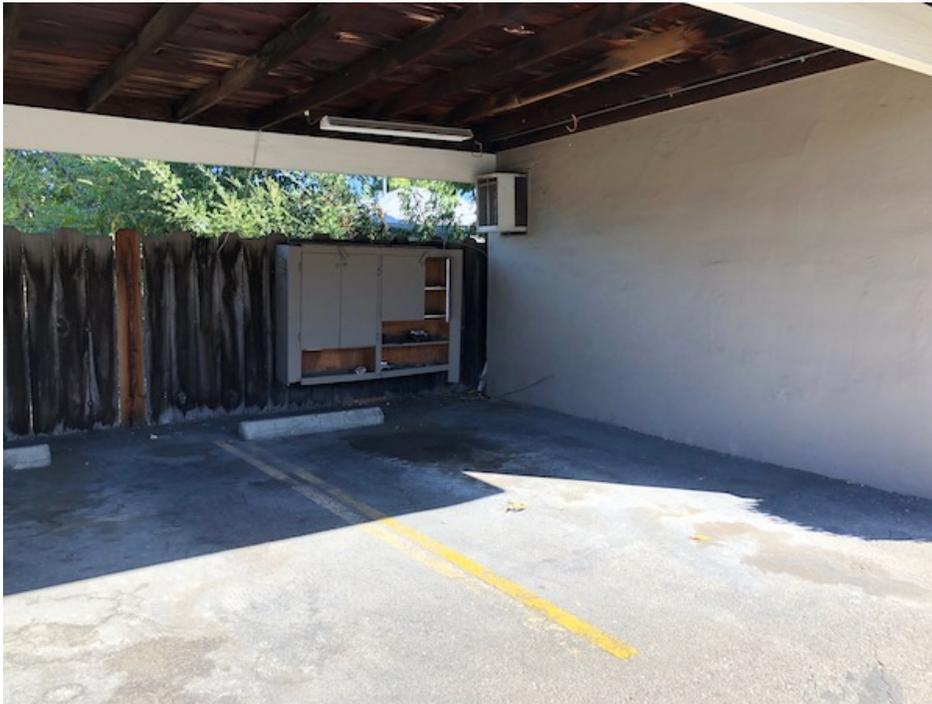
Photograph 7. Tenant storage cabinet within carport.

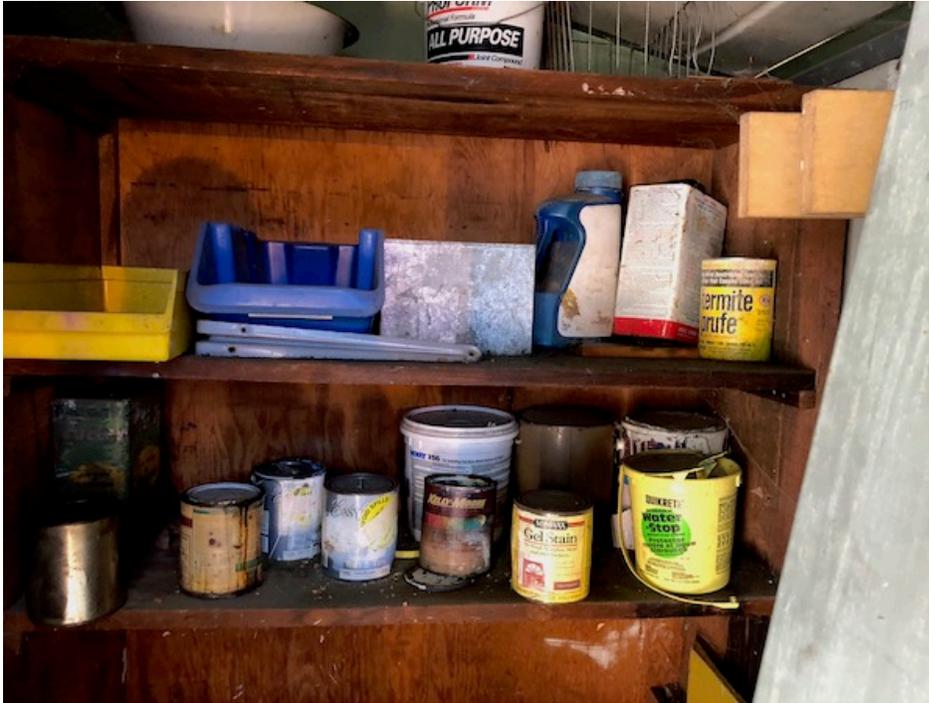
Photograph 10. Typical storage shed interior, note paints and coatings.

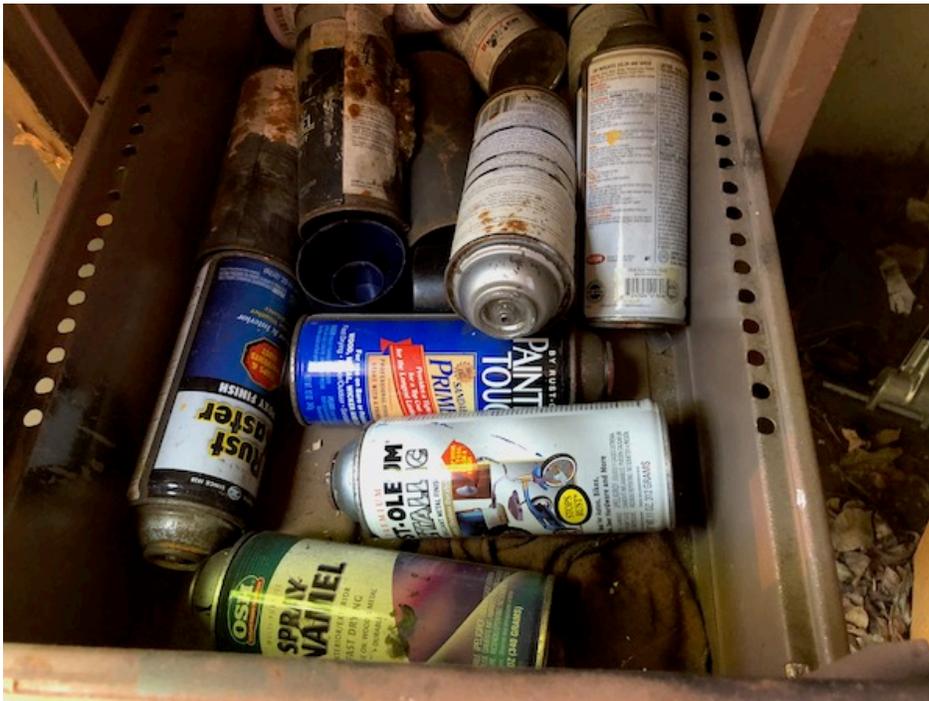
Photograph 11. Typical interior of file cabinet within storage shed. Note multiple spray paint cans.

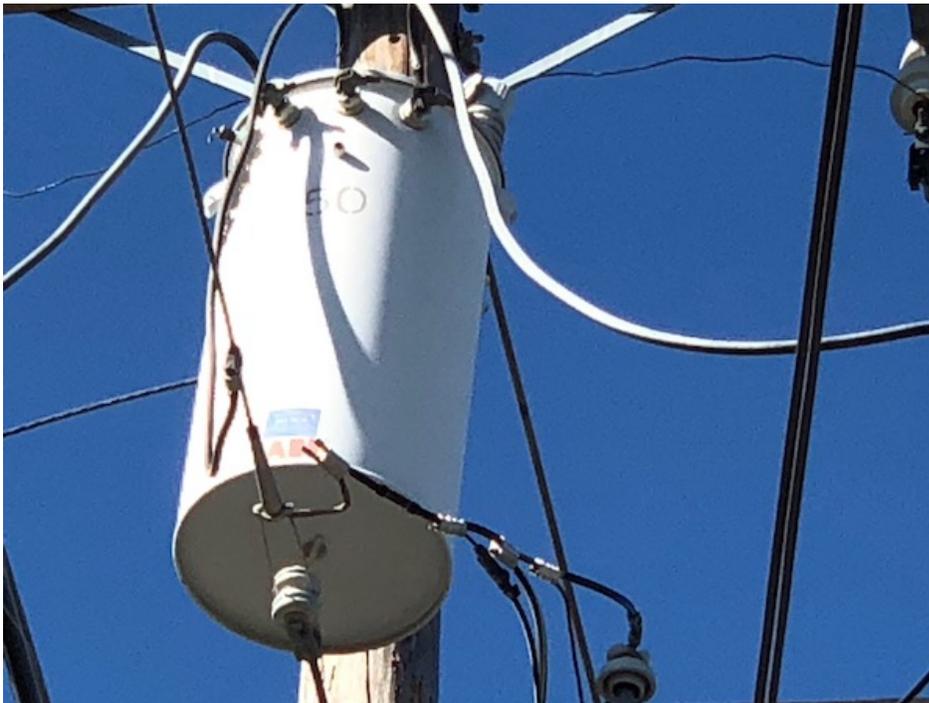
Two pole-mounted transformers were observed along Moorpark Avenue, both appeared to be labeled with “no PCB” blue stickers.

Photograph 13. Pole-mounted transformer labeled non-PCB.

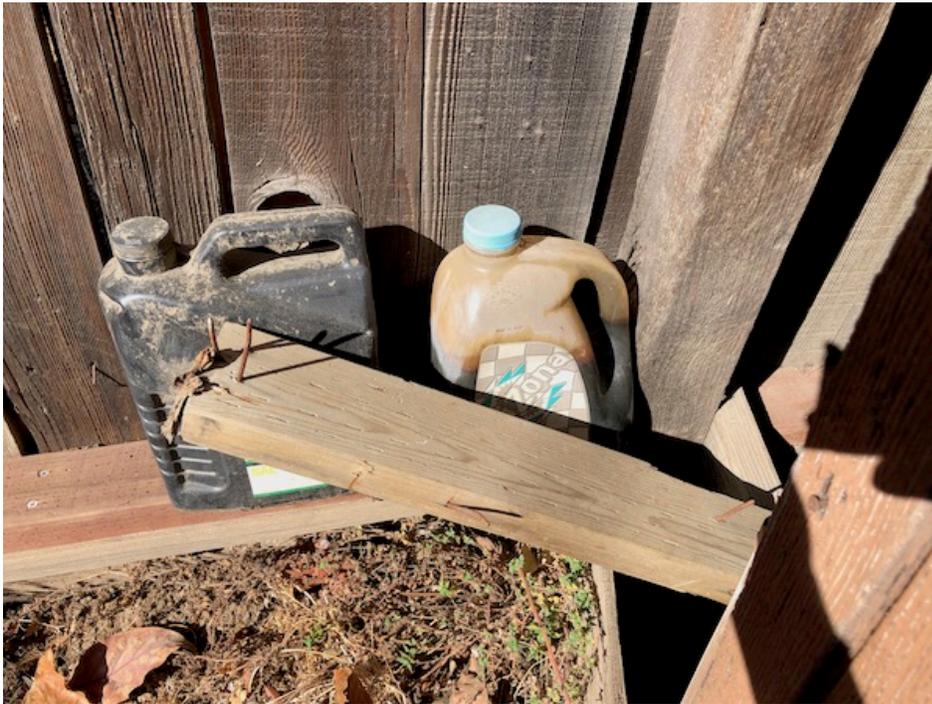
Photograph 21. Two containers of presumed waste oil near carport in northwestern portion of Site.

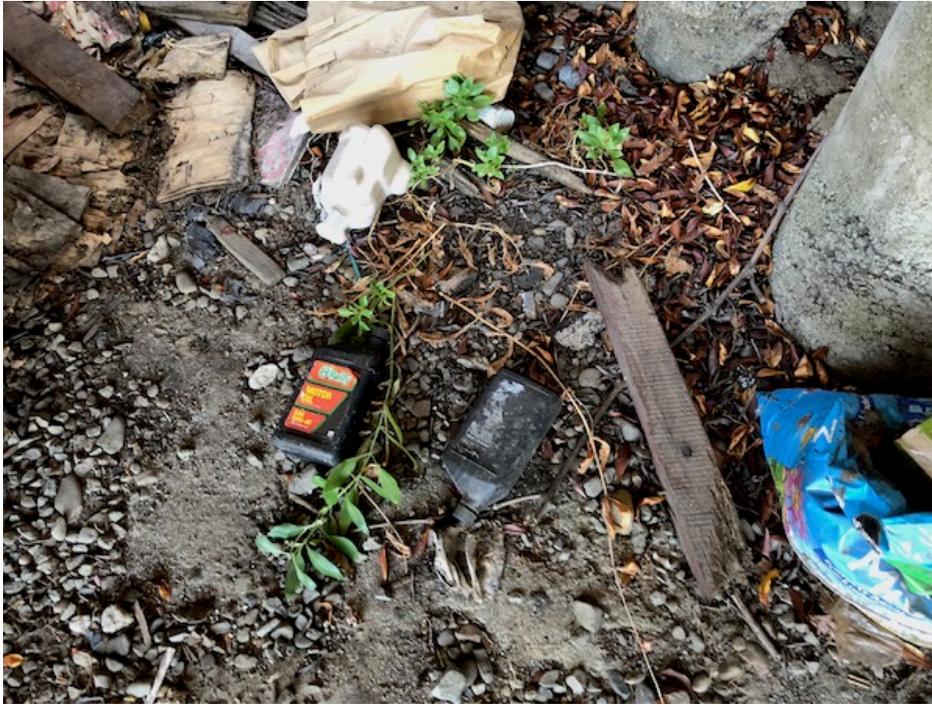
Photograph 24. Motor oil containers observed on ground surface within carport.

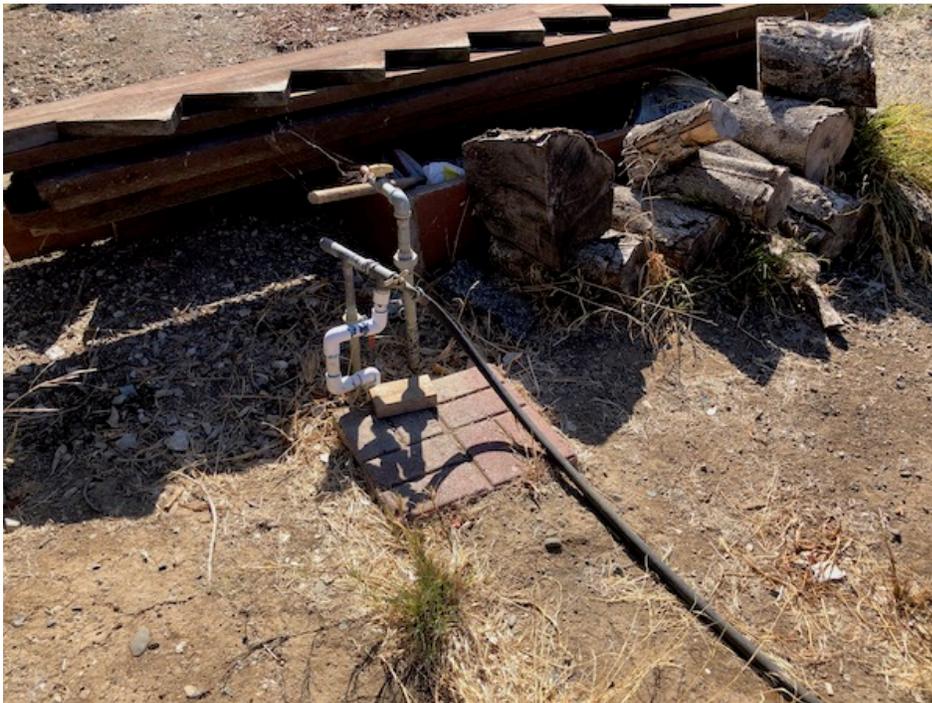
In the northwest corner of the Site, Cornerstone observed several garden sheds, a vegetable garden, and two shipping containers (locked and presumably used for storage). The interiors of several carports contained small containers of motor vehicle maintenance fluids including used motor oil. A possible irrigation well was observed in the garden area, identified by a water

spigot from the ground. No water tanks commonly associated with domestic wells were observed.

Photograph 27. Possible well or remote water spigot located within a garden area in northwest corner of Site.

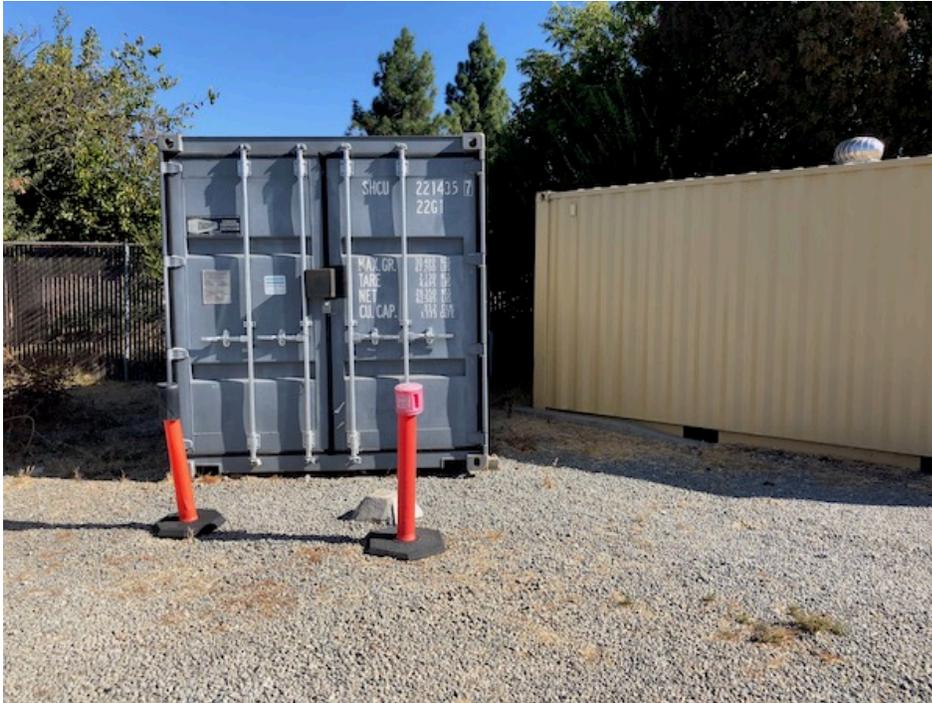
Cornerstone observed the exteriors of two locked storage sheds and two locked steel shipping containers in the northwestern portion of the Site; however, these structures were locked and not accessible during our Site visit.

Photograph 28. Shipping containers in northwest portion of Site.

- Cornerstone was unable to view the interior of the residences on-Site or interiors of locked storage sheds and shipping containers. Additional storage of potentially hazardous materials may be present within these structures. Improper storage of potentially hazardous materials within these locked storage areas increases localized risk of potential surface spills. We recommend requiring that all materials within these structures be removed and properly disposed of off Site prior to acquiring the property.

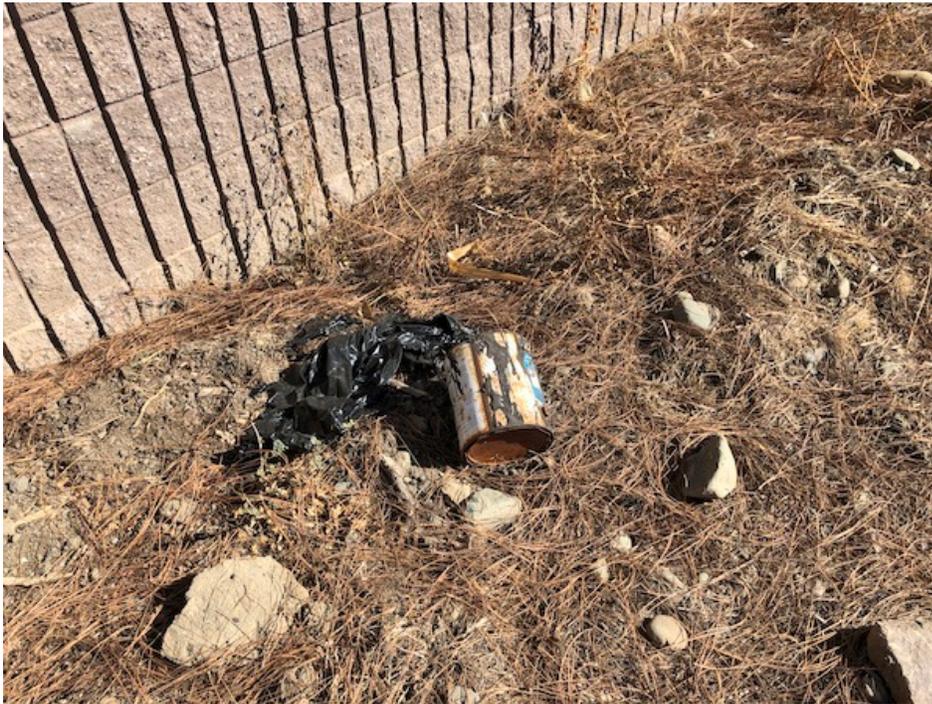
Photograph 47. Paint can and plastic debris within field on northern boundary of Site.

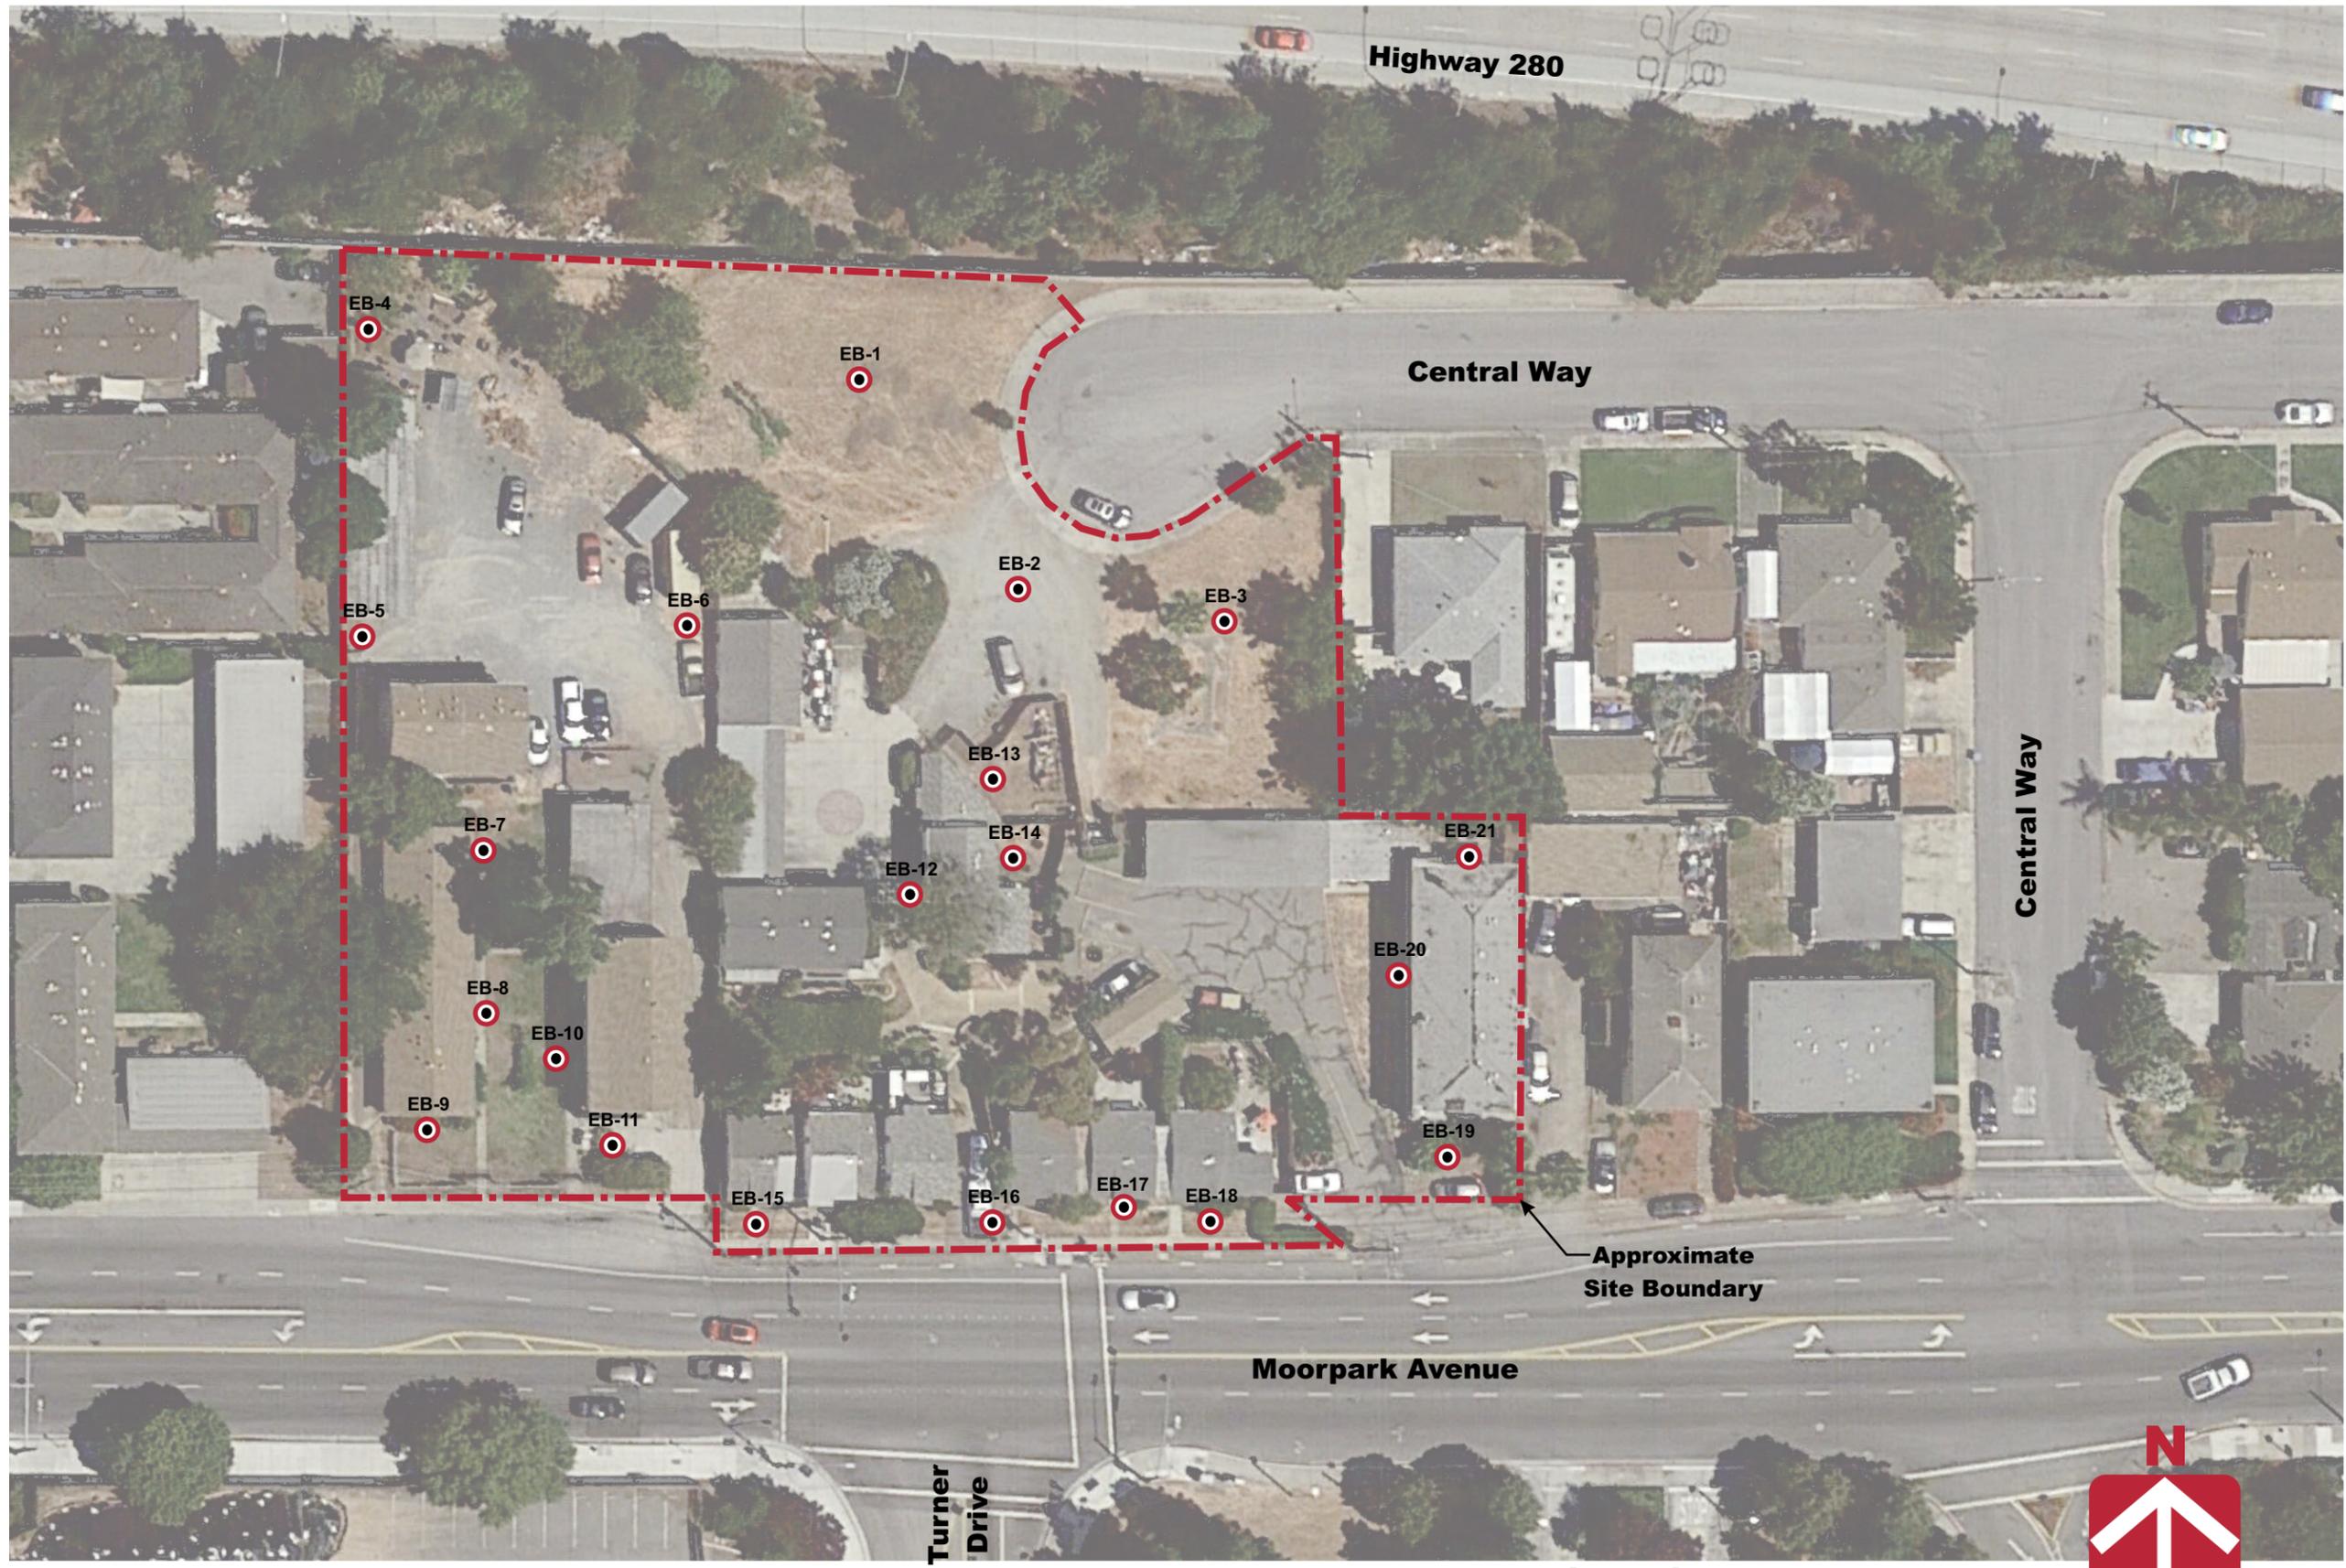
Elevated concentrations of lead were detected in eight samples collected adjacent to existing structures, and likely resulted from weathering/flaking of lead-based paints. Four of these samples (EB-15 through EB-18) were collected from soil adjacent to the six cottages located along Moorpark Avenue and constructed by 1939. The soil adjacent to the foundations of the cottages appears to have been impacted from lead-based paint weathering. The remaining elevated lead concentrations were detected around newer structures and appear to be more sporadic. Soil with total lead exceeding ten times the soluble threshold limit concentration (STLC) of 5 milligrams per liter (mg/L) (i.e. soil with total lead exceeding 50 mg/kg) may fail the STLC California hazardous waste limit. Soluble/STLC lead analyses will be required prior to removal of this soil for off-Site disposal. In our experience, soil with total lead exceeding 100 mg/kg has a high likelihood of exceeding the STLC limit.

Elevated detected concentrations of mercury (one sample), arsenic (four samples), chlordane (two samples), and dieldrin (two samples) likely resulted from past applications of pesticides/termiticides. The two elevated chlordane concentrations were detected two of the four sampling locations adjacent to the cottages, indicating that termiticides may have been used around these structures but in varying amounts and/or frequencies. The detected chlordane concentration in one of these samples exceeded the California hazardous waste (TTLC) threshold, indicating that some of the soil may be considered a hazardous waste if transferred off-Site for disposal. One of the elevated dieldrin concentrations was detected in a sample collected adjacent to one of the storage sheds and the other was detected from an open area of the Site. Based on these data, the chlordane and dieldrin concentrations appear to be laterally limited in lateral extent. Deeper samples were not analyzed for OCPs.

We recommend removal of soil exceeding residential screening criteria prior to Site development. Cornerstone recommends collecting/analyzing additional soil samples to evaluate the lateral and vertical extent of soil with elevated metals and OCPs detected. We additionally recommend preparation of a Soil Management Plan, Site-Specific Health and Safety plan, and Dust Control Plan to establish protocols for managing soil during grading activities.
