Preliminary Arborist Report

749 West El Camino Real

April 22, 2021
Revised April 2022

**Preliminary Arborist Report
749 W El Camino Real
Mountain View, CA**

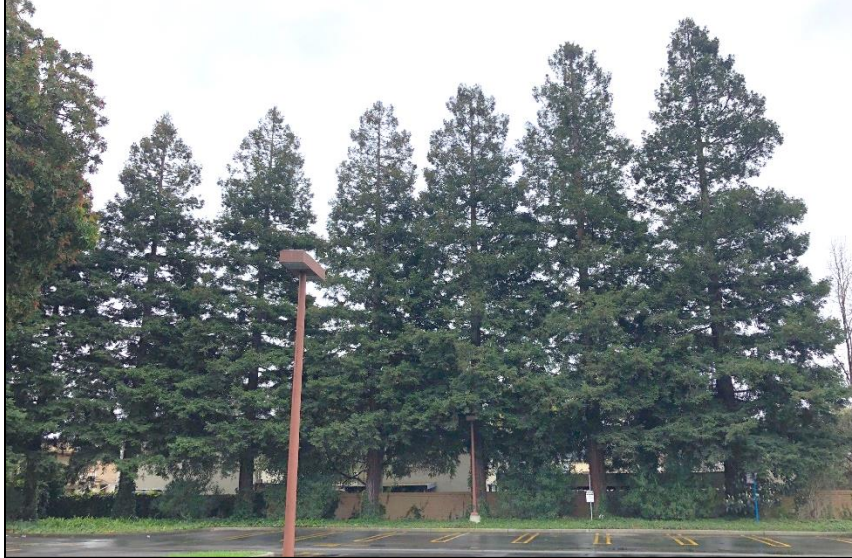
Photo 1 (left):
Coast redwoods
#37-42 along the
eastern parking
lot were in good
condition.

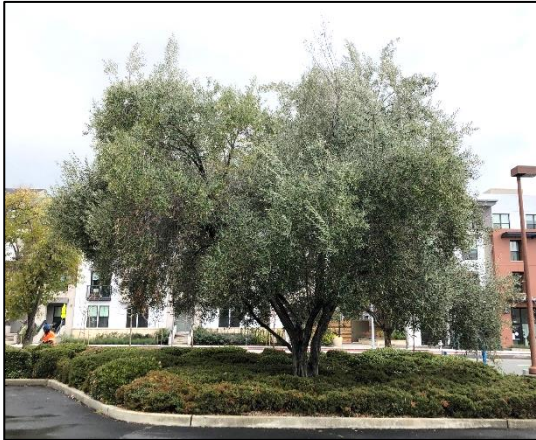
Photo 2 (top): Olive #72 was in good condition.

I recommend evaluating the feasibility of transplanting the olive trees in good condition (#65, 66, and 72). From my review, the current design presents limited opportunity to accommodate relocated trees, unless the landscape plans are revised.

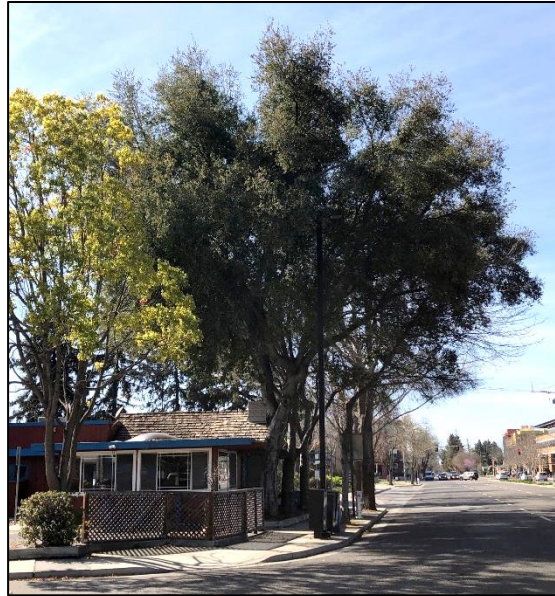
Photo 3 (right): Coast live oak #111 on El Camino Real was in good condition.
