October 20, 2021

Geologic Assessment of Slope Stability
Proposed Babu Vineyard Block C
3300 White Sulphur Springs Road
Saint Helena, CA 94574

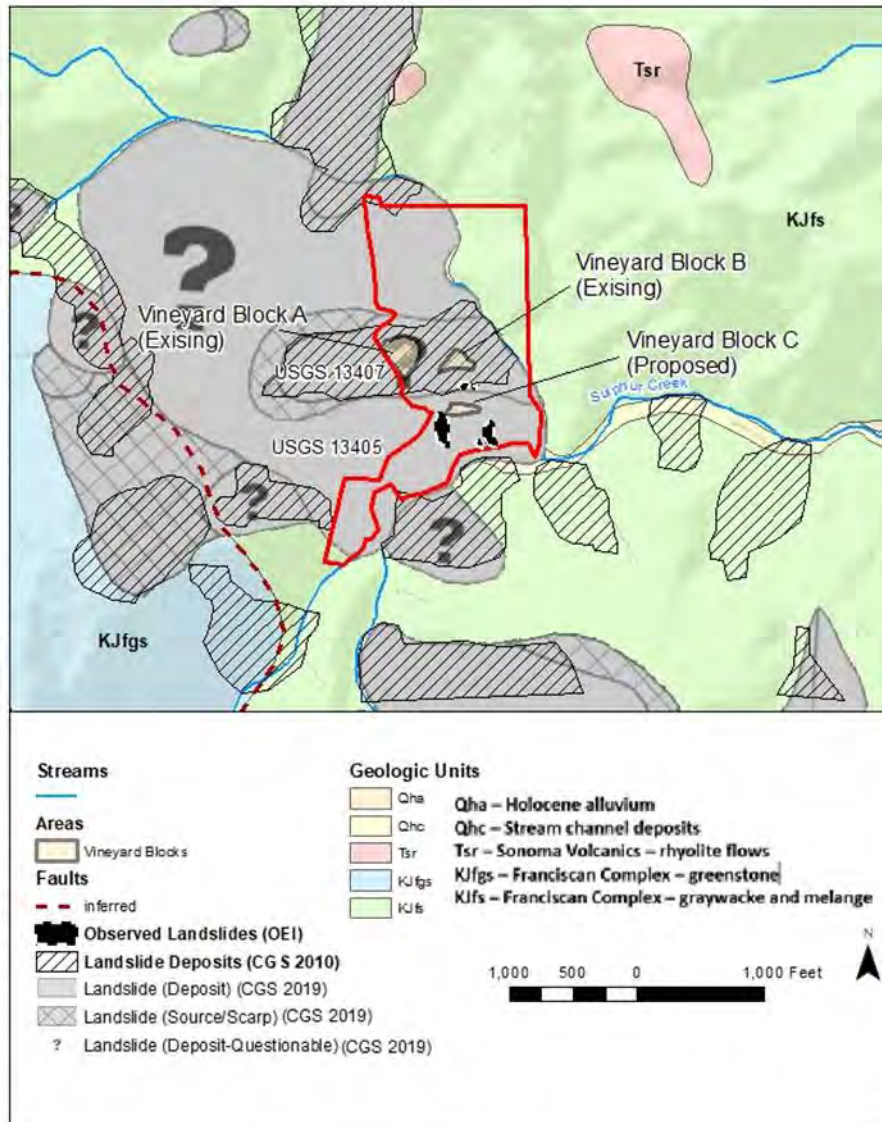
Proposed vineyard Block C is located on the ridge on the southern flank of this rockslide; Block C is not on the rockslide body and is believed to be perched above its remnant lateral scarp.

Figure 1. Local area geology (Graymer et al. USGS , 2007), landslide deposits (Wagner and Gutierrez CGS 2010, CGS Landslide Inventory 2019, and OEI field observations 2021) and subject parcel outlined in red.

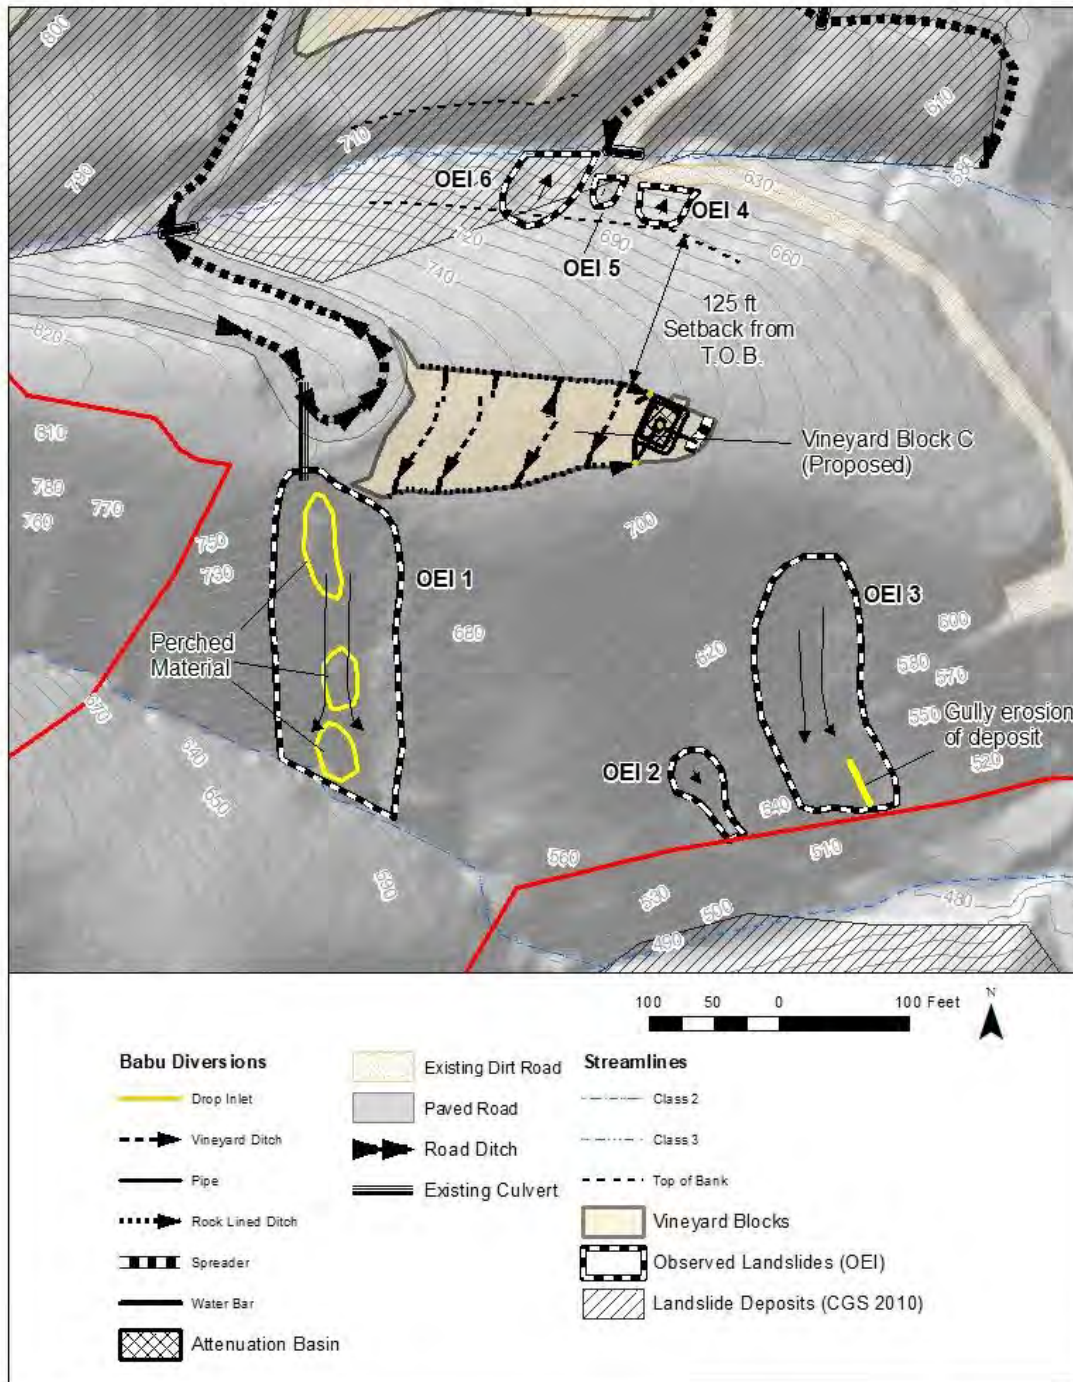
Potential geologic hazards observed in my site reconnaissance include six debris slides of varying scales located along the southern and northeast edges of proposed vineyard Block C. Within the area reviewed, one feature was observed to be active: Landslide OEI 1. The remaining landslide features (Landslides OEI 2-6) were observed to be historically active.

Figure 2. Observed landslides in the vicinity of proposed vineyard Block C. Topographic contours and hillshade derived from 2018 USGS Lidar.

Within the landslide body of OEI 1 there are three distinct lobes of perched, potentially unstable material (shown as yellow polygons in Figure 2). Although runoff from the proposed project will not arrive to these areas concentrated runoff from a road cross drain culvert does drain to the top of OEI 1. Damage to the culvert during the Glass Fire required this culvert to be replaced. Presently the culvert does not have a downspout to direct flows downslope away from the upper lobes of sediment. To avoid future destabilization of the landslide body from water diverted through the cross drain a downspout of an appropriate length should be installed. The specific length of this downspout has not been determined however it is expected to be between 100 and 200 feet. As stated in the ECP, coordination in the field is required between the contractor and a representative of OEI to determine the length and specific layout of the downspout.

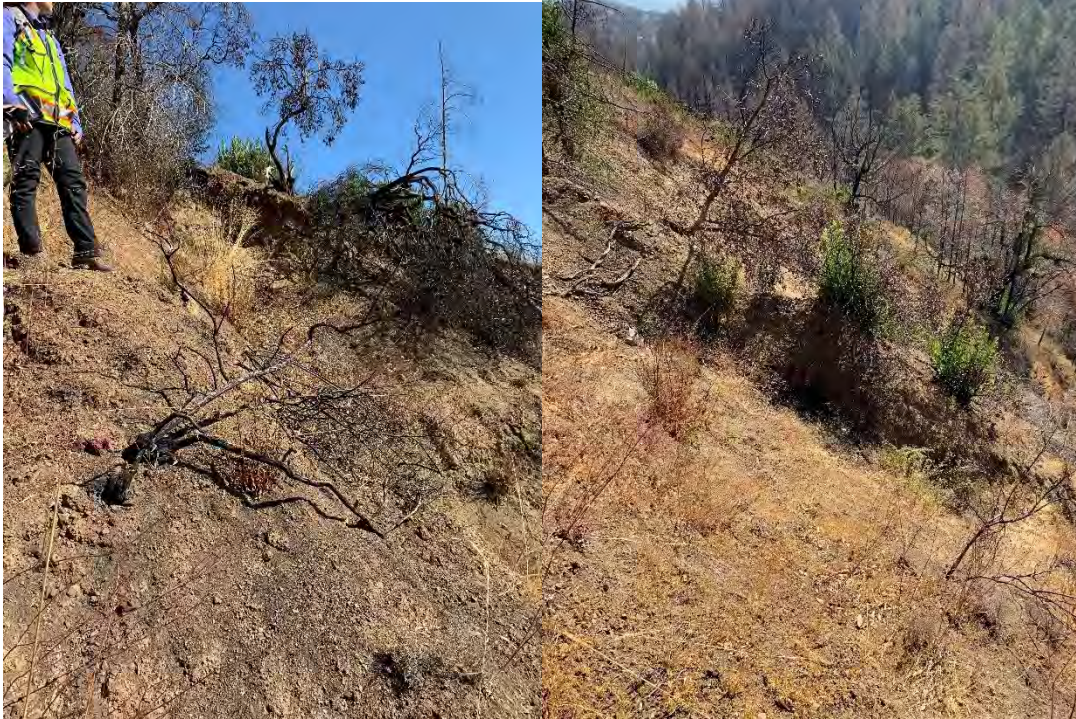
Landslide OEI 1 is an active debris slide located near the southwest corner of proposed vineyard Block C. This landslide has evidence of intermittent shallow erosion in the form of fresh soil exposures on portions of its scarp, margins and throughout the landslide body. Figure 3 shows photos of the scarp and a portion of the main body of the landslide. Review of aerial imagery available through Google Earth indicate that OEI 1 is greater than 30 years old. No tension cracks or evidence of recent significant movement was observed along the margins or within the body

of the landslide. Landslide OEI 1 is considered low hazard with respect to the proposed project as runoff from the vineyard will not flow to the landslide area. All runoff from the proposed vineyard area will be collected in a rock-lined ditch located along the southern vineyard block boundary and diverted to an attenuation basin at the eastern edge of the block (Figure 2 and ECP). This water will be released from the attenuation basin on to the divergent slope below via a level spreader.

Figure 3. Landslide OEI 1 view upslope to the main scarp and downslope of the main body.

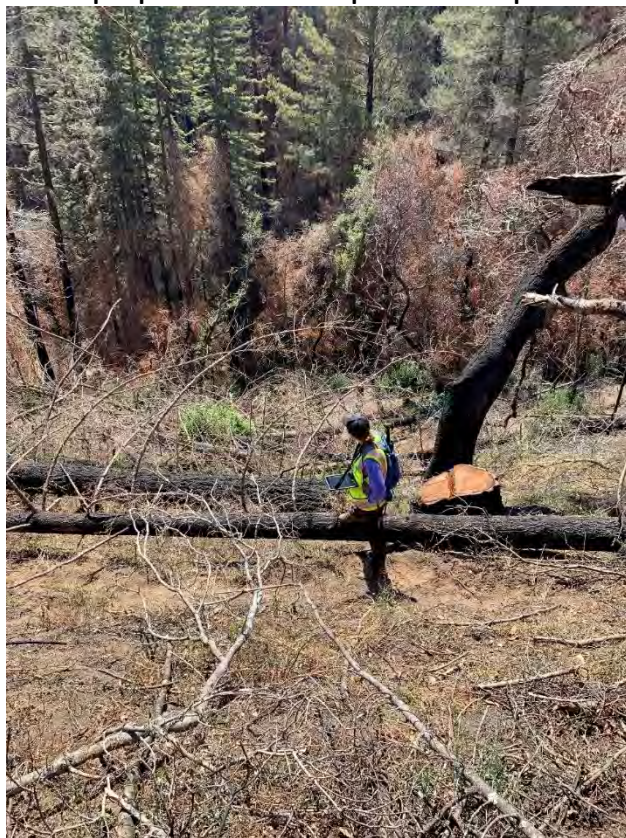
Landslide OEI 2 is an historically active debris slide located approximately 200 feet east of OEI 1 and 240 feet south of Block C near the base of the slope (Figure 2). OEI 2 appears to be at least five years old as evidenced by a small maple growing in the body of the landslide. Landslide OEI 3 is also an historic debris slide located 50 feet east of OEI 2 and 108 feet southeast of the Block C boundary (Figure 2 and Figure 4). This landslide appears to be older than OEI 2 (possibly greater than 40 years) as larger diameter fir stumps were observed in the landslide body. Topographic features across OEI 2 and 3 are mildly to greatly subdued and no evidence of recent movement (within the last year) was observed; however, some gully erosion of the main deposit of OEI 3 was observed

Landslides OEI 2 and OEI 3 have been determined to be low hazard with respect to project effects owing to the relatively large distance from the proposed vineyard boundary and fact that runoff from the project will be collected in the proposed rock-lined ditch and diverted to an attenuation basin at the eastern edge of the block. All collected runoff will be released from the attenuation basin onto the divergent slope below via a level spreader and no concentrated flows are expected to arrive to either landslide.

Figure 4. Landslide OEI 3 view from top of mapped area.
