Appendix B – Arborist Report

# Kielty Arborist Services LLC

April 20<sup>th</sup>, 2021

Site: 150 Grant Avenue, 123 Sherman Avenue, & 2501 Park Boulevard, Palo Alto

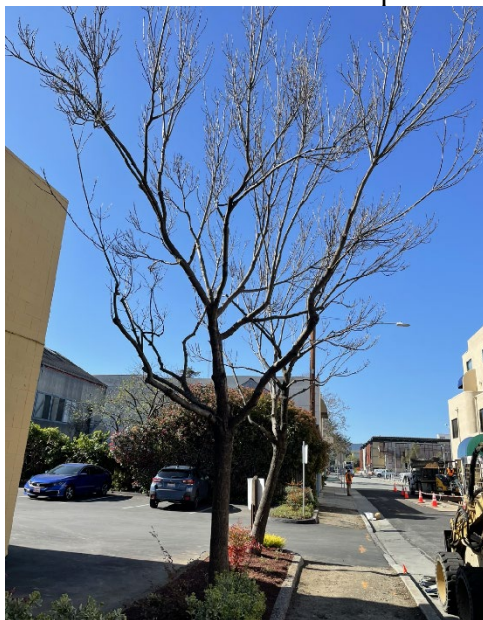
Raywood ash trees #3, #4, magnolia tree #5, and photina tree #6 are proposed for removal to facilitate construction. These trees are not protected in the city of Palo Alto. Magnolia tree #5 is in poor condition as heartwood rot was observed on the trunk as well as an overall decline in the canopy. This tree is not expected to survive much longer regardless of the proposed construction. These trees will need to be replaced on site per the tree canopy replacement standard.

Showing ash trees #3 and #4

**Raywood ash tree #3**= 15-foot-wide canopy

Replacement trees= Three 24" box trees or two 36" box trees.

**Raywood ash tree #4**= 15-foot-wide canopy

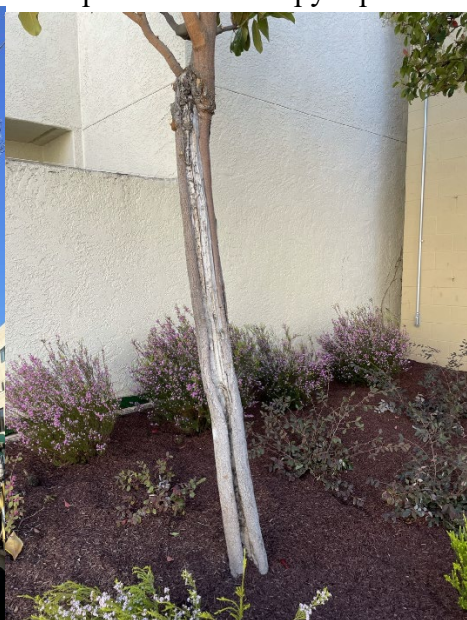
Showing heartwood rot on magnolia #5

**Magnolia tree #5**= 12-foot-wide canopy

Replacement trees= Three 24" box trees or two 36" box trees.

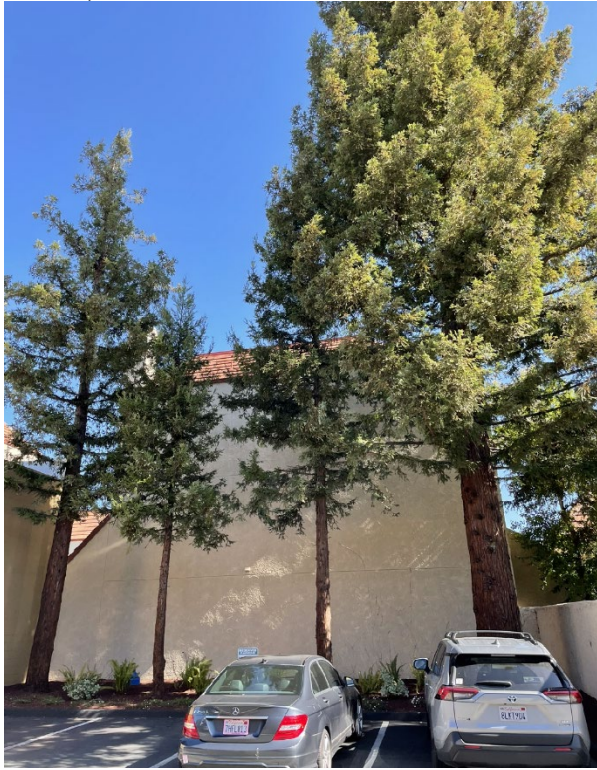
Redwood trees #8 and #9 are proposed for removal. These trees are under the protected size for redwood trees in the city of Palo Alto. Removal is needed to facilitate construction. These trees will need to be replaced per tree canopy replacement standards.

**Showing redwood trees #7-10**

**Redwood tree #8**= 15-foot-wide canopy

Replacement trees= Three 24" box trees or two 36" box trees.

**Redwood tree #9**= 12-foot-wide canopy

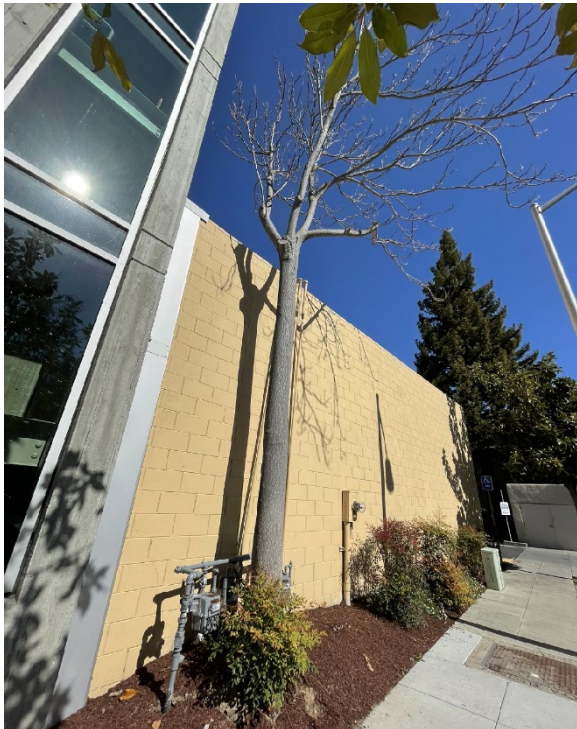
Tree of heaven tree #13 is proposed for removal. This species is highly invasive and encouraged for removal. The tree is located up against an existing building foundation. Removal is needed before demolition of the building as demolition could destabilize the tree. This tree will need to be replaced per tree canopy replacement standards.

**Showing tree of heaven #13**

**Tree of heaven #13**= 25-foot-wide canopy

Replacement trees= Three 24" box trees or two 36" box trees.
