Preliminary Arborist Report

469 Piercy Road
San Jose, CA

July 2022

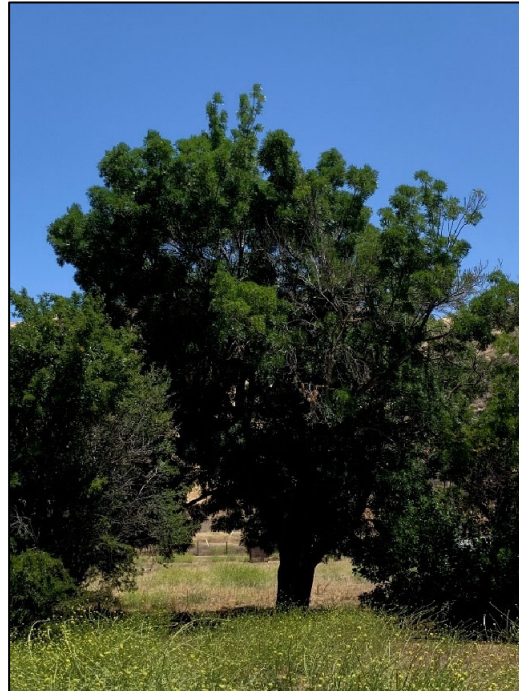
Raywood ash #152 and 153 were both in poor condition. Tree #152 had pervasive twig dieback and was heavily suppressed by tree #153. Tree #153 had multiple attachments arising from 4 feet with a seam extending from the attachment point to the ground.

Photo 1: Raywood ash #153 had a vigorous crown, but poor form and structure with multiple attachments arising from a single point and a seam running from the attachment point to the ground.

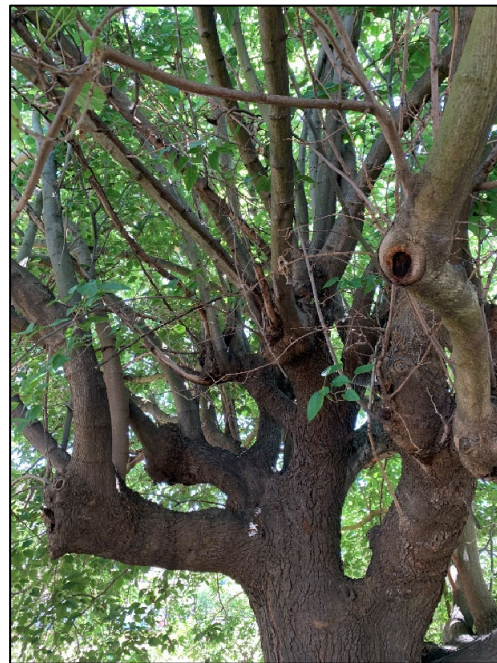
Photo 2: Mulberry #164 had been repeatedly topped. The crown consisted of weakly attached branches.
