*Re: Serramonte Del Rey Campus Redevelopment, City of Daly City
Federal and State Wetlands Jurisdiction Assessment*

**Subject: Hydrologic reconnaissance, Jefferson Union High School District,
699 Serramonte Blvd., Daly City, CA**

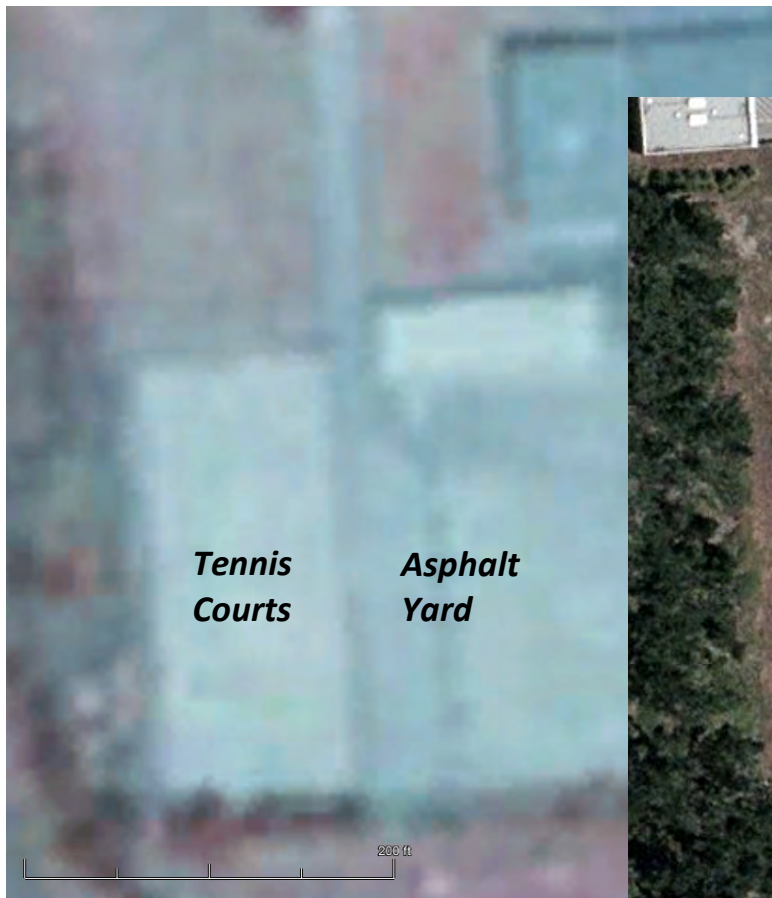
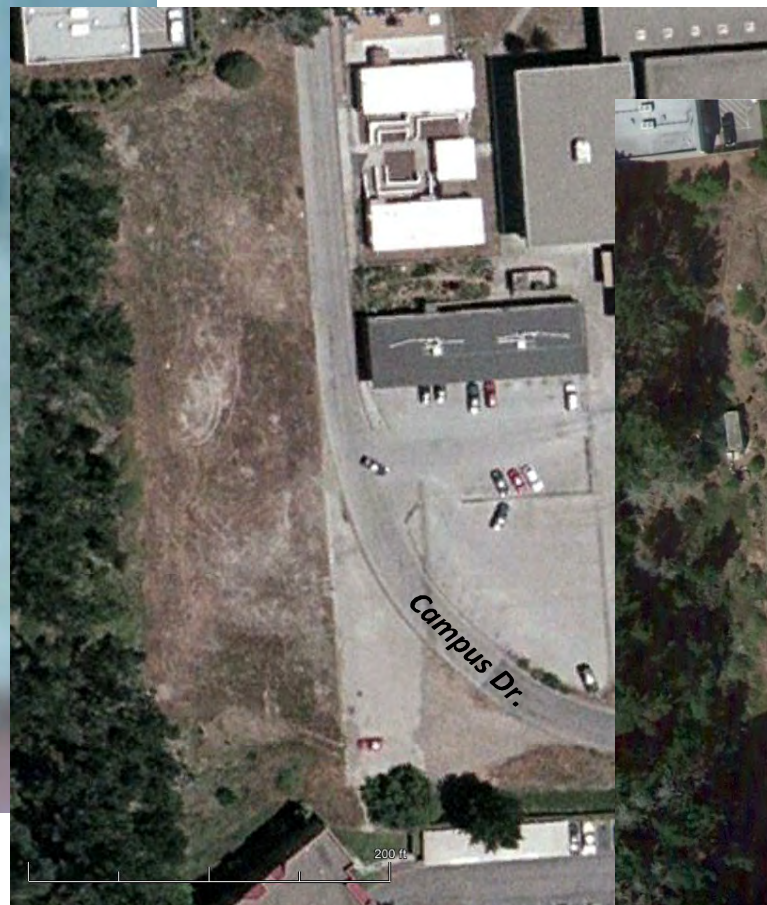
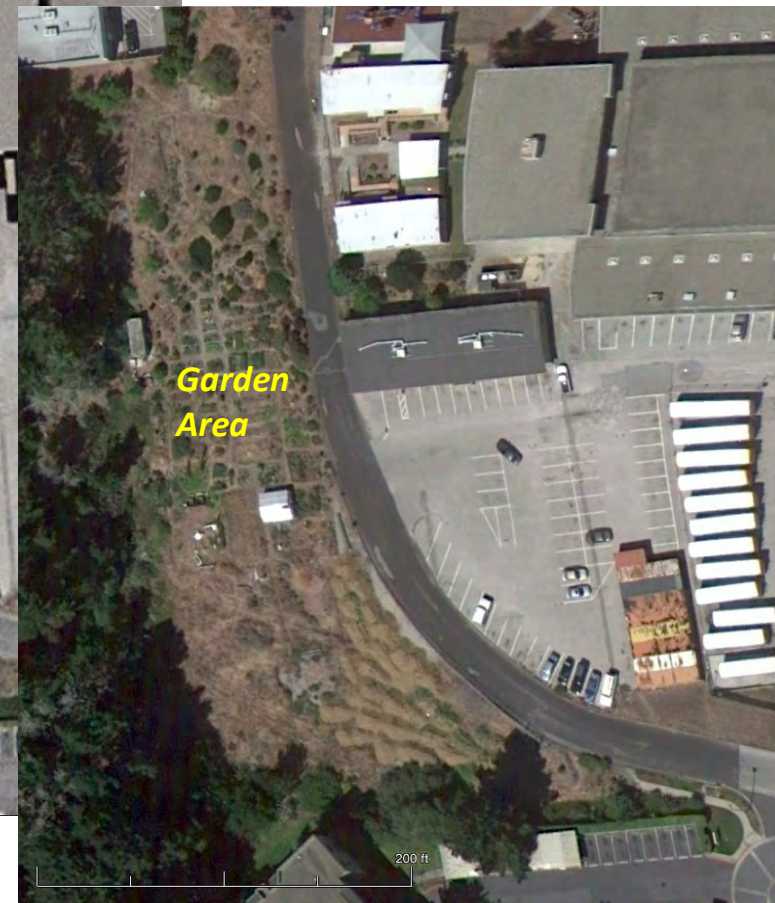
1982
 (drainage system functioning prior to the addition of fill material)

2003
 (some fill material add on the tennis court area, construction of Campus Dr. and housing to the south)

2010
 (more fill material add and expanding onto the asphalt yard area)

Figure 2. Historical aerial photos showing the blocking of storm drainage and inlets by progressively adding fill material for expansion of the garden area, Jefferson Union High School District, 699 Serramonte Boulevard, Daly City, CA. Fill material is primarily dune sand and wood-chip mulch. Rainfall accumulates within the fill material (perched on asphalt) and settles at the south end of the fill area, rather than as runoff to the storm-drain system.

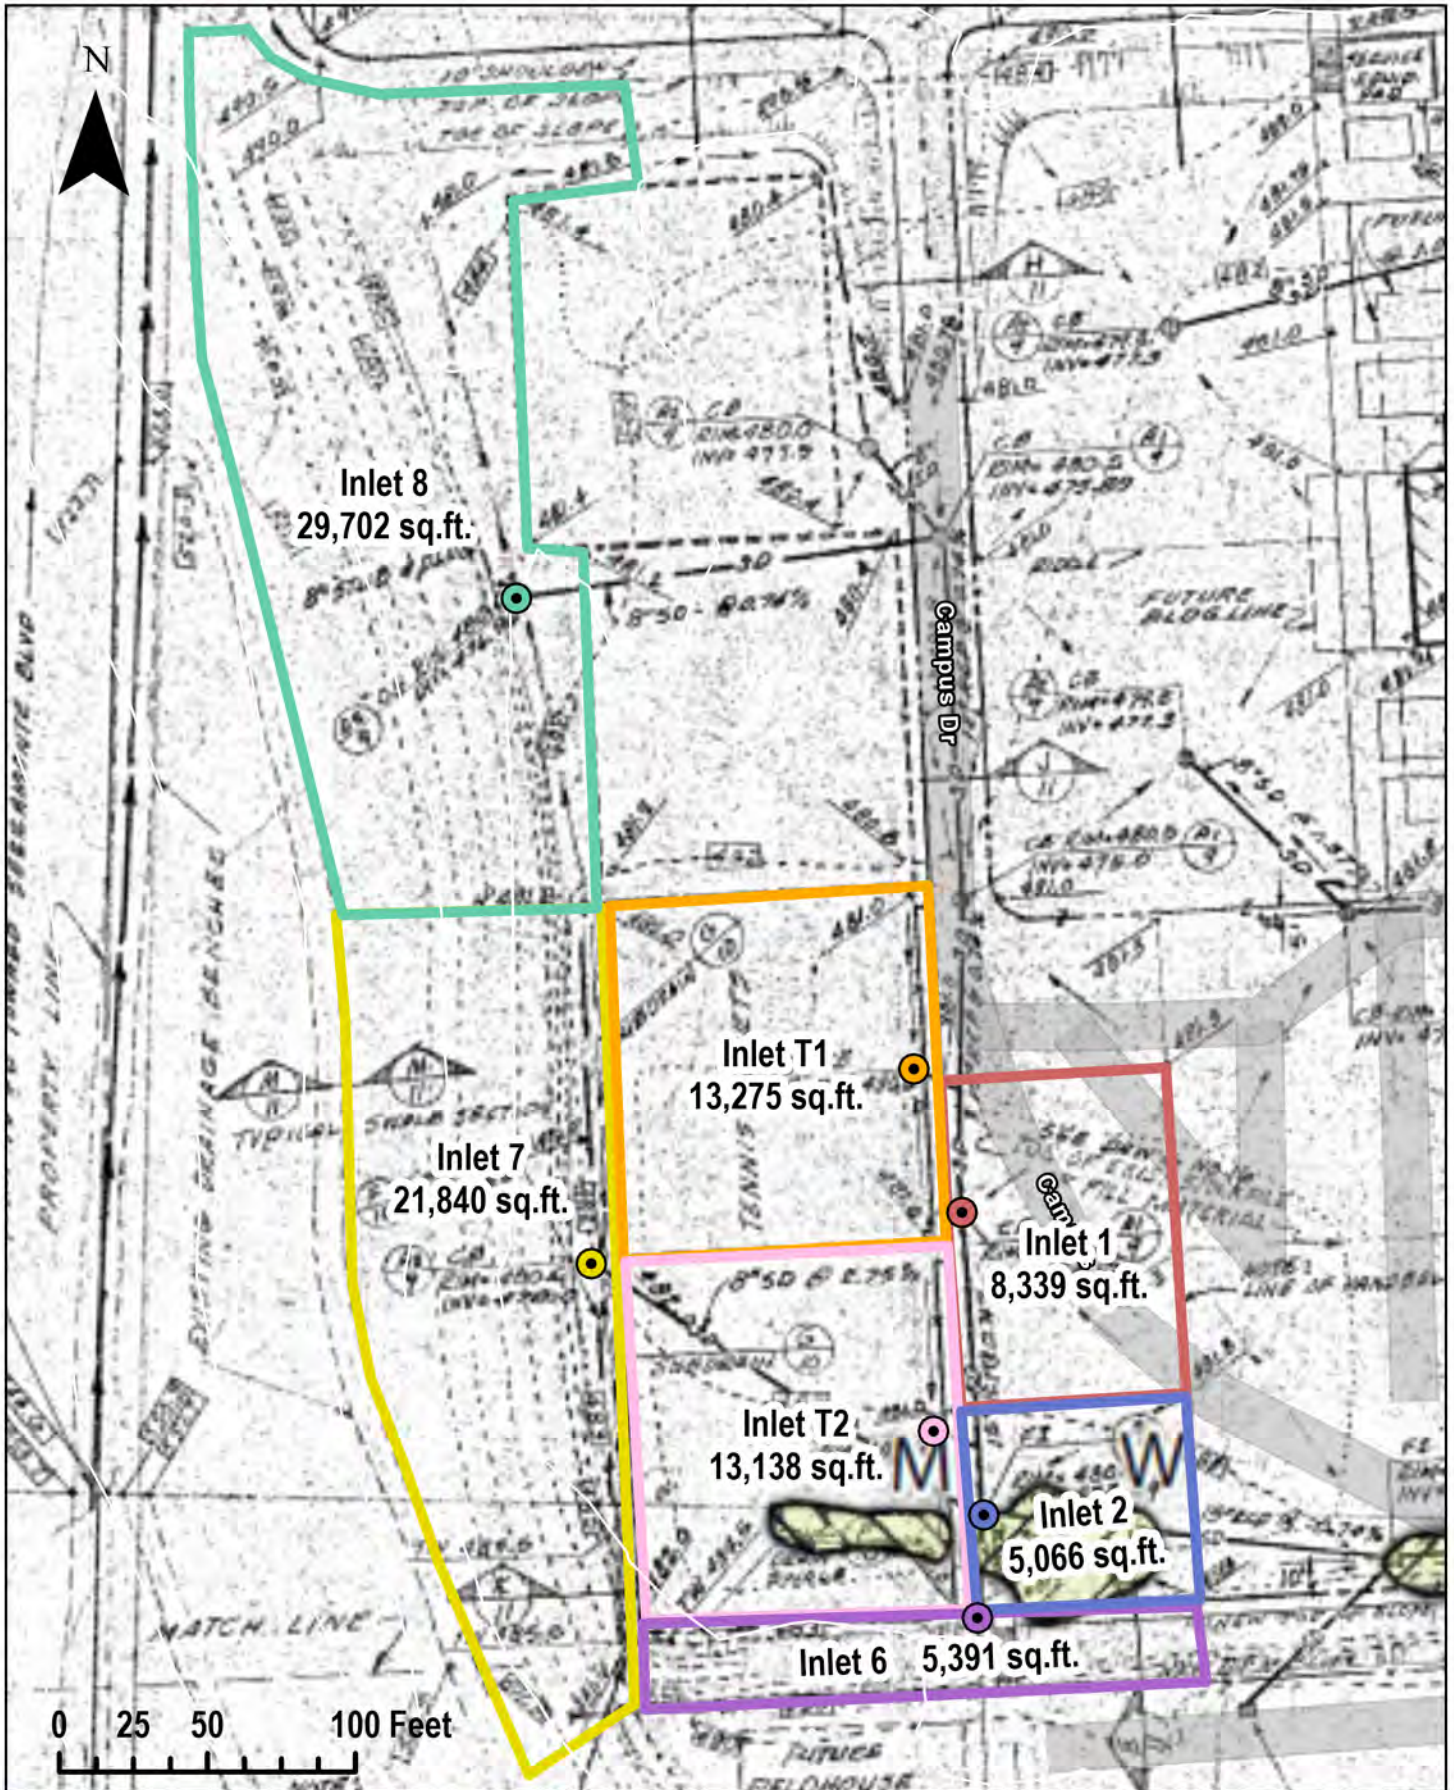
Figure 3. As-built drainage areas of inlets, Jefferson Union High School District, 699 Serramonte Blvd., Daly City, CA

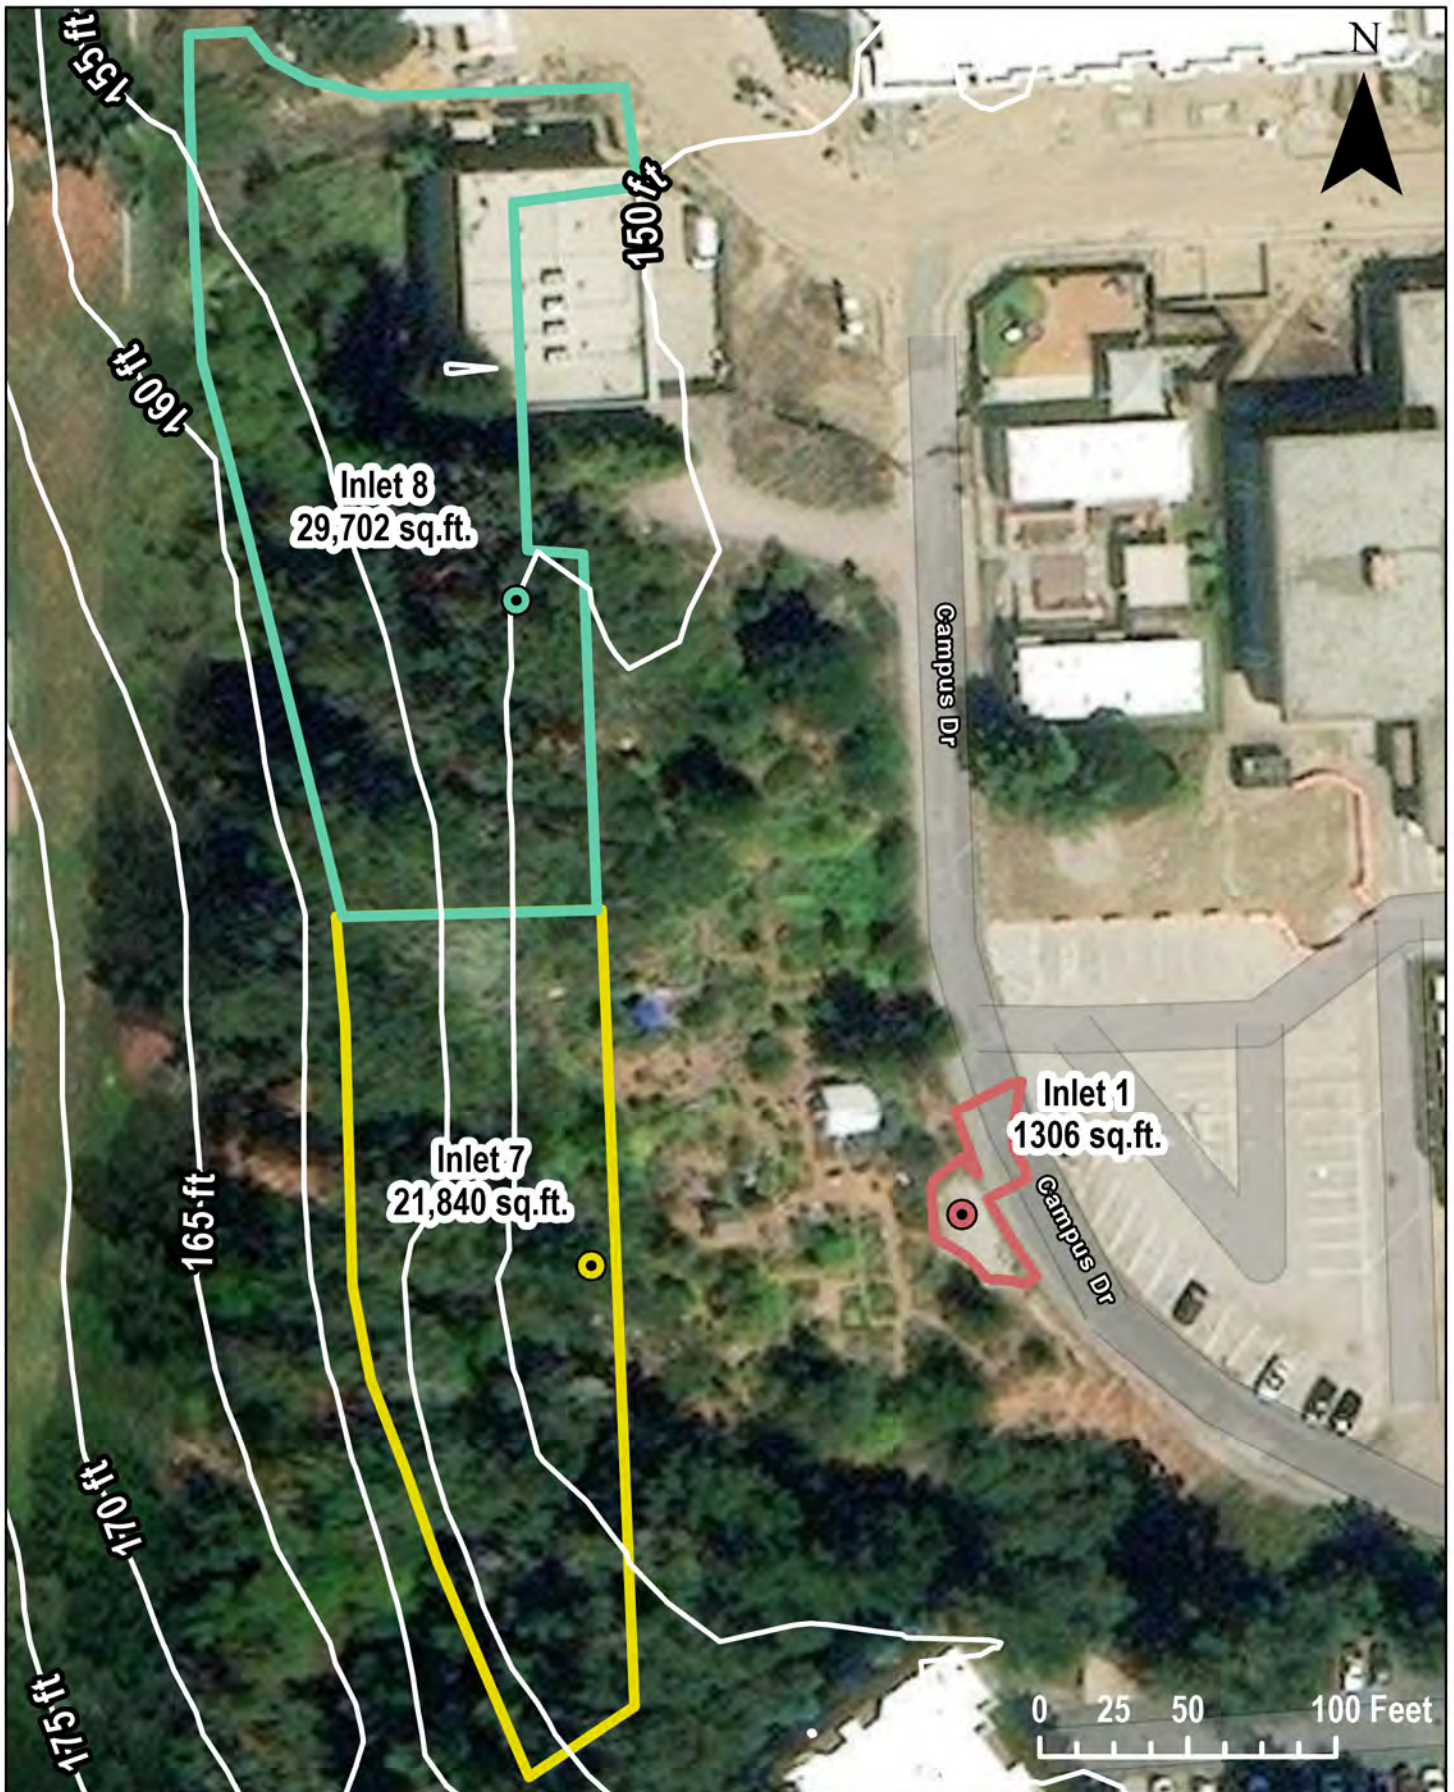
The mounds of fill shown on aerial photos are currently present at the tennis court and asphalt yard area and used as a demonstration garden and irrigated with potable water supplied by the public water system. Rainfall on the fill material currently does not “freely” runoff to the inlets as designed, but rather, infiltrates into the fill and mostly perches on the tennis court and asphalt, and spreads laterally. Seepage was observed to percolate below grade into the storm drain system at Inlet #2 (as described below). The drainage area to the inlets have been greatly truncated by the fill as shown in **Figure 4** and summarized in **Table 1**.

Figure 4. Current drainage areas of inlets, Jefferson Union High School District, 699 Serramonte Blvd., Daly City, CA

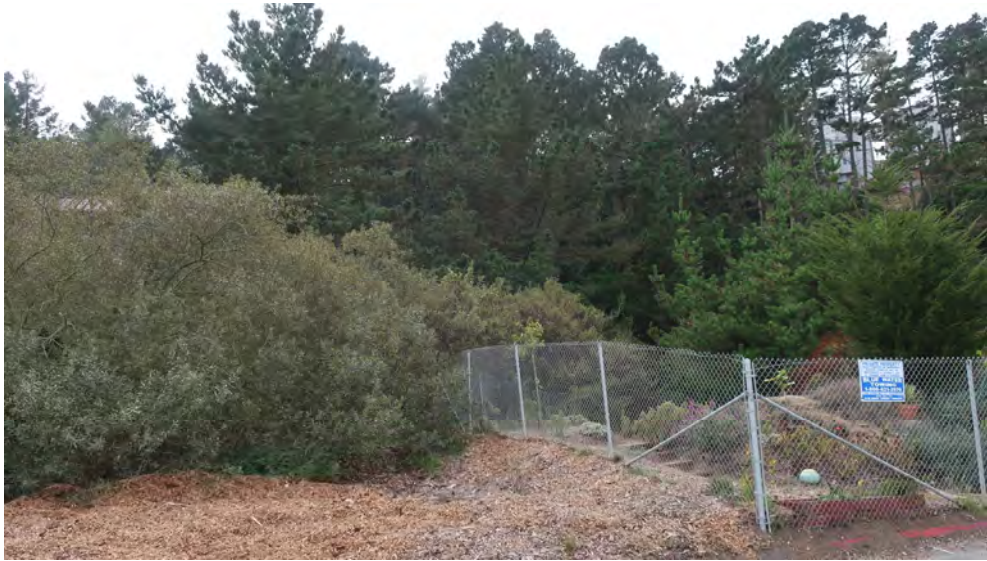
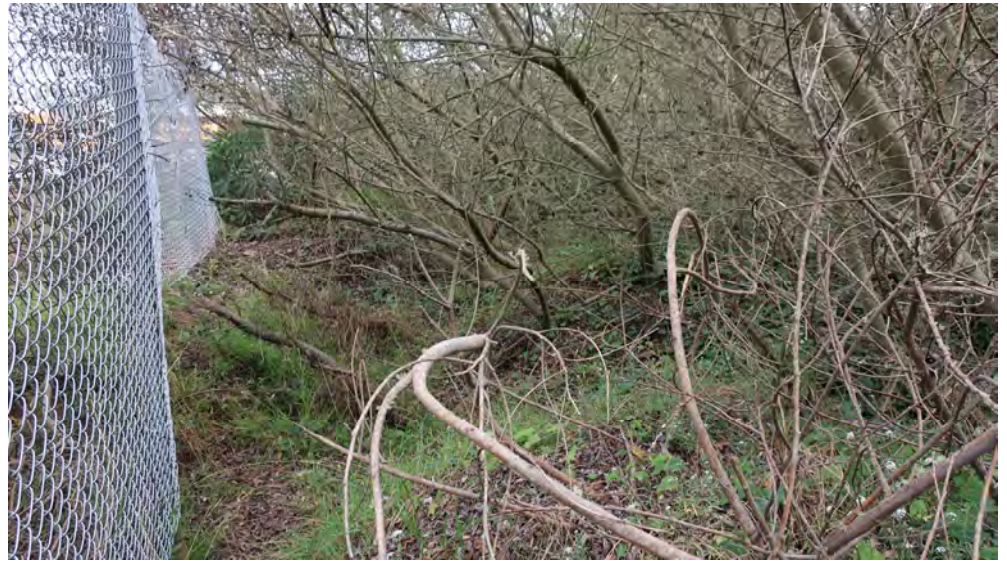
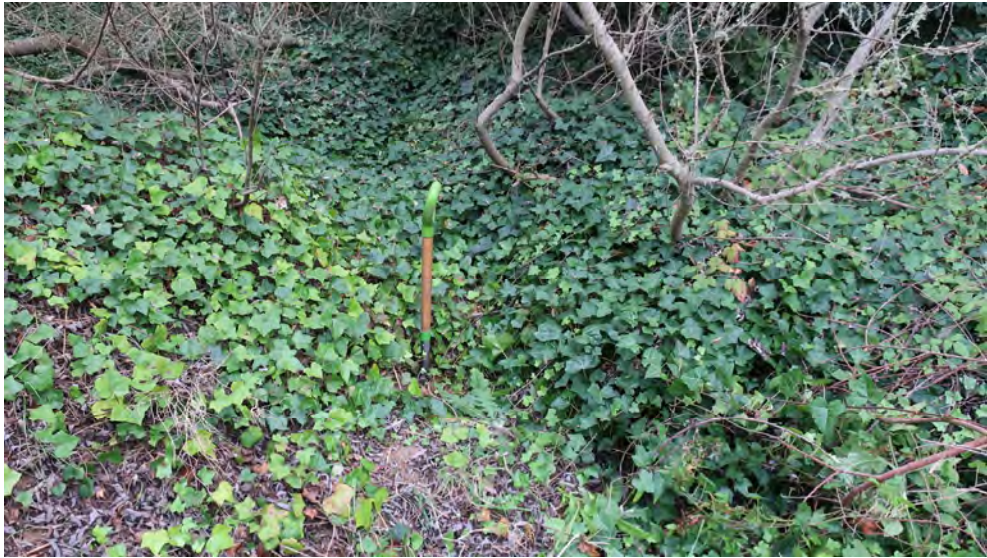
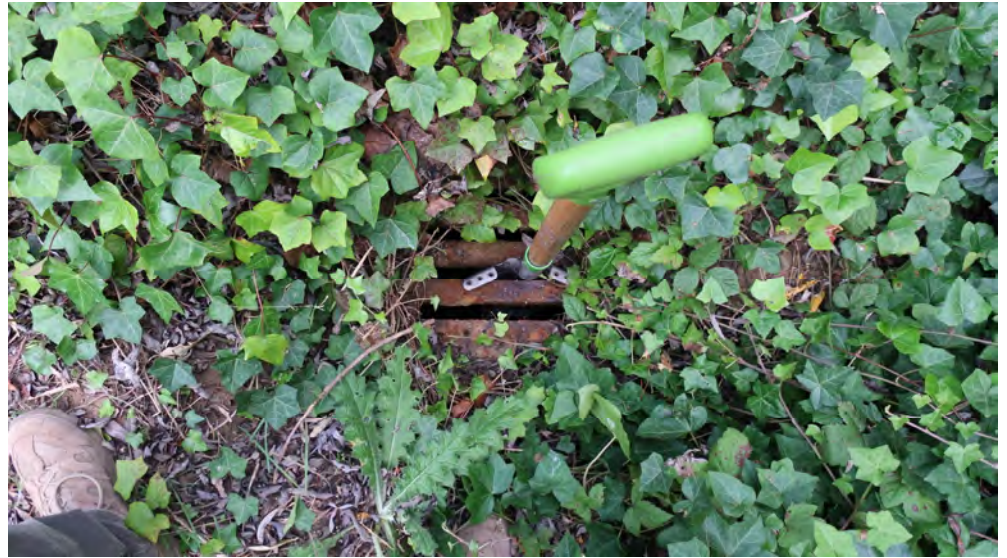
Figure 5. Site photos showing fill piles and blocked storm drainage at Inlet #2, Jefferson Union High School District, 699 Serramonte Boulevard, Daly City, CA. A sample of subdrain seepage of less than 1 gpm into the storm drain was collected on October 27, 2022. Surface soils were dry.

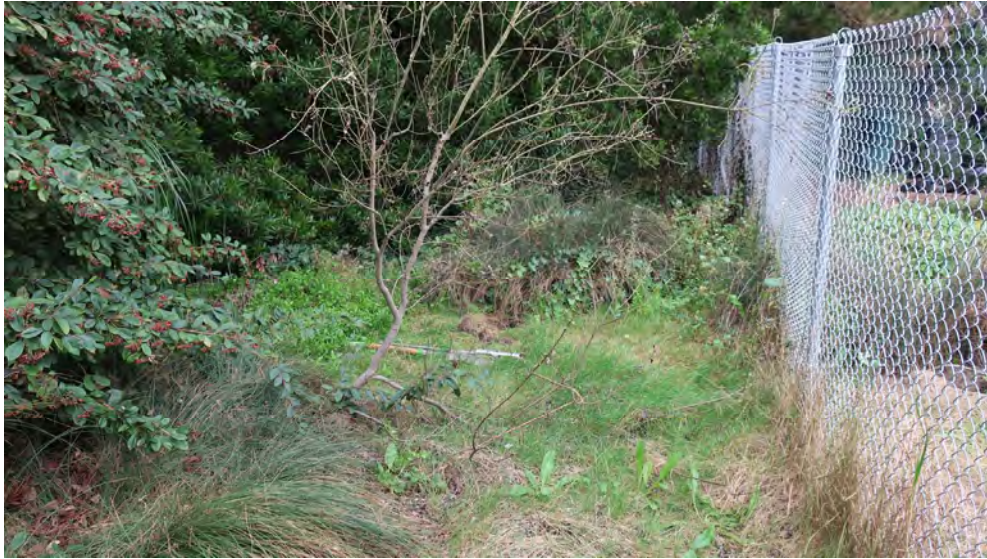
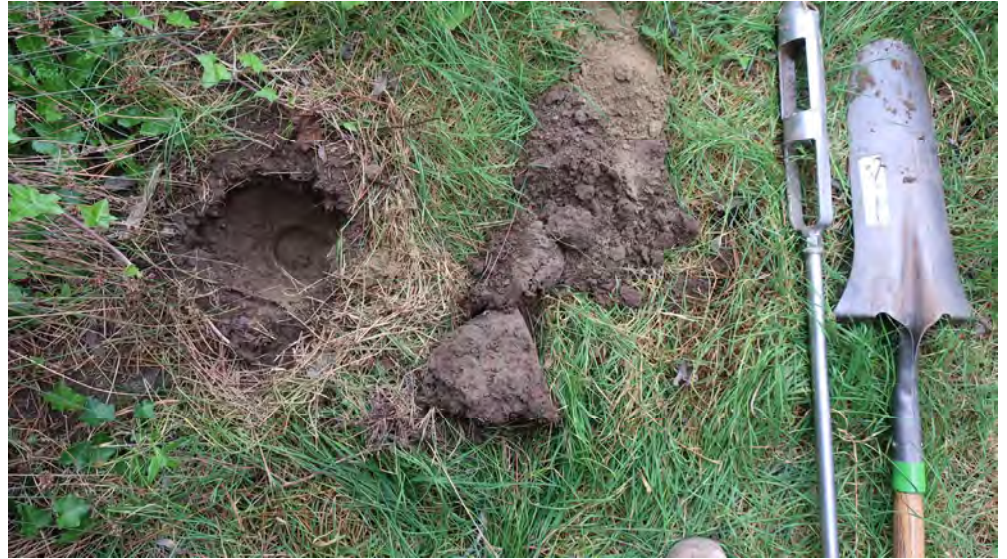
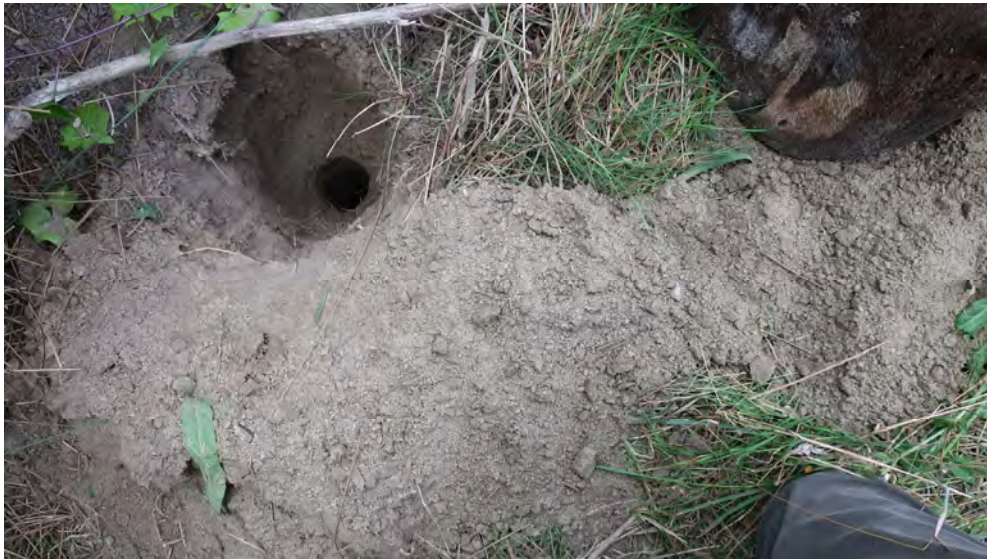
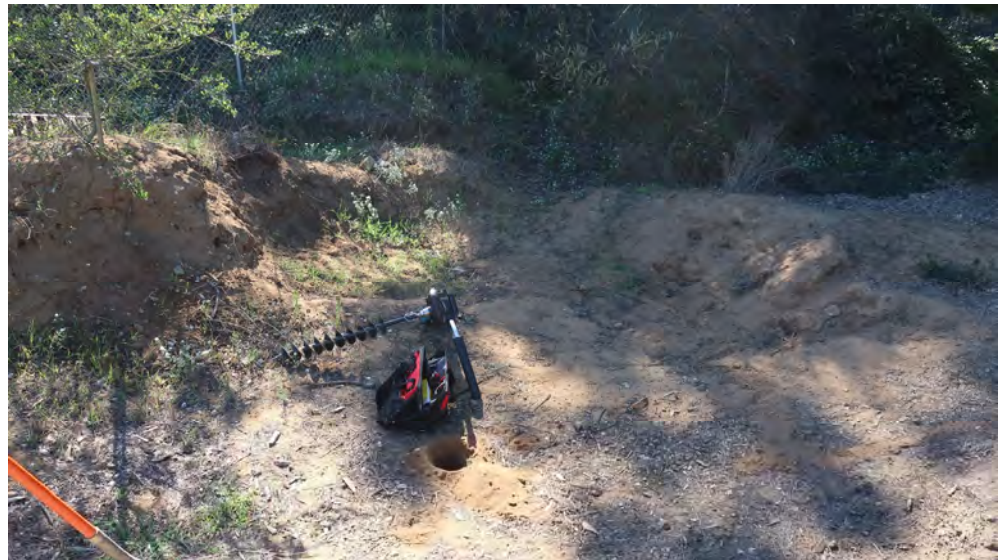
- We hand cored to a depth of two feet in the area where rushes (*Juncus spp*) are found, a 15 ft x 25 ft depression at the south end of the former tennis-court area (**Figure 6**). The soils were a dry brown sandy clay loam with fine lenses of red mottles. The soil mottles indicate periods of saturated soil. At a depth two feet, soils were hard and seemed mechanically compacted. Drainage from this area was blocked by piles of placed fill, as well as vegetation growing on the fill. Upslope erosion to this area was not apparent.

Figure 6. Site photos of fill material, Jefferson Union High School District, 699 Serramonte Boulevard, Daly City, CA. Fill material is primarily dune sand and wood-chip mulch. Underlying the fill mounds was either asphalt or compacted soil. Soil was dry with fine lenses of red mottles in the area of the *Juncus*. Photos taken in late October 20, 2022.

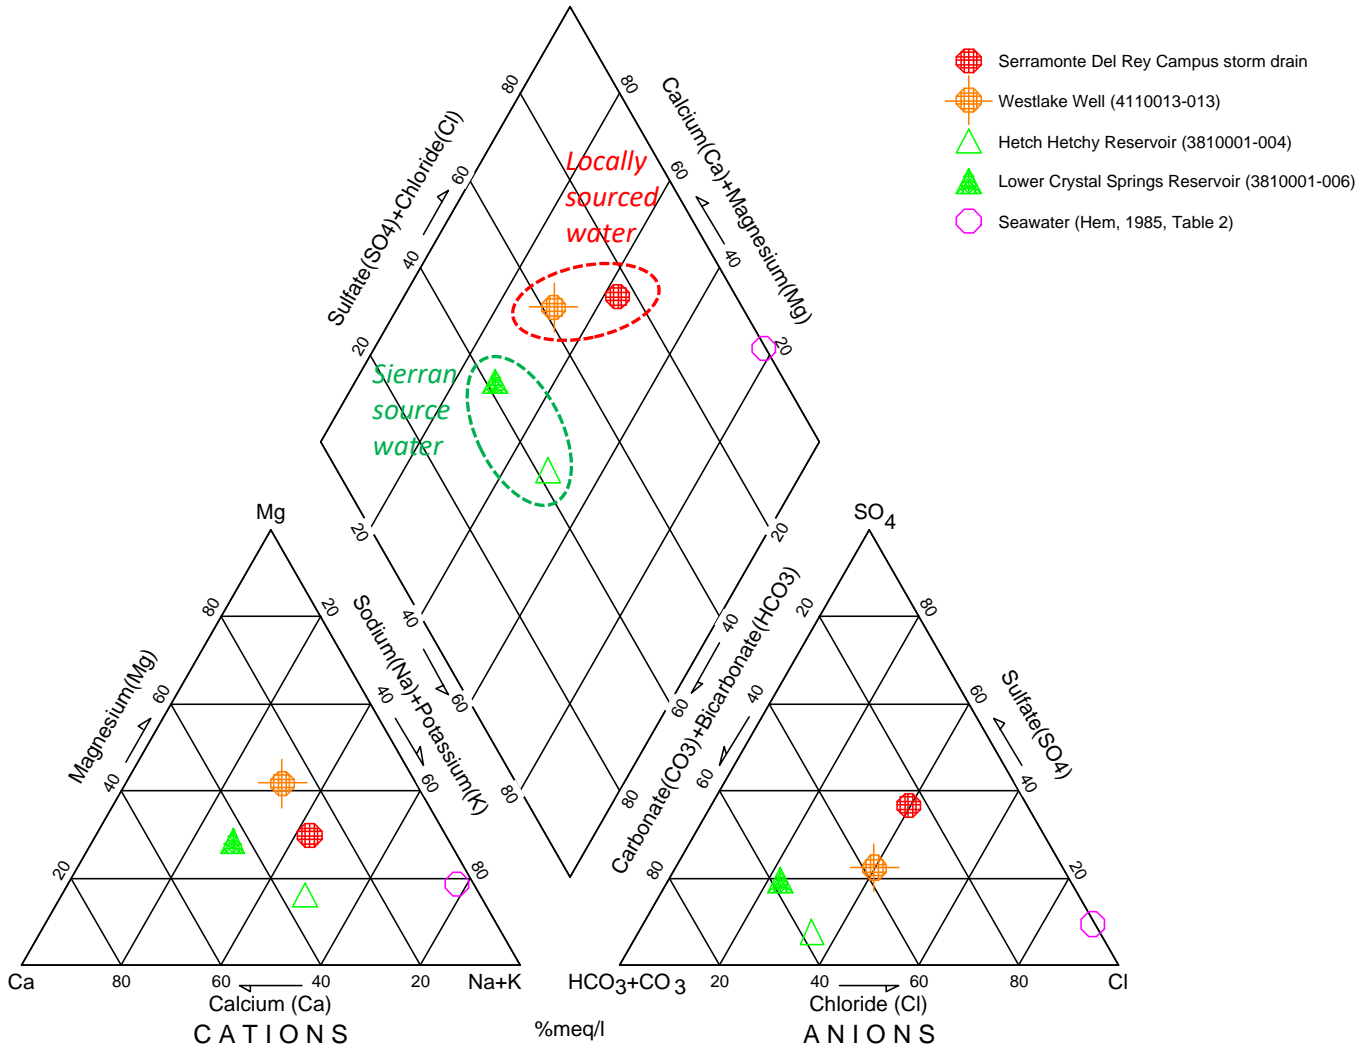
- The general mineral (major ion) composition is plotted in a Piper diagram to illustrate the charge balance of the dissolved ions (**Figure 8**). This plot can be interpreted as showing an ionic fingerprint of water sources. Though groundwater chemistry may change along a flow path, the Inlet #2 seepage is grouped with local groundwater suggesting its source may not be leaks from water or sewer lines (imported water from the Sierra Nevada). Crystal Spring Reservoir, Hetch Hetchy Reservoir, seawater, and regional groundwater data are also plotted for reference.

Figure 8. Piper diagram illustrating ionic signatures of water samples collected at the Serramonte Del Rey Campus relative to Sierran source water and local groundwater, San Mateo County, California. On-site subdrain seepage at inlet DI-01 is grouped similar to local groundwater suggesting its source may not be leaks from water or sewer lines (imported water from the Sierra Nevada) though groundwater chemistry may change along a flow path.

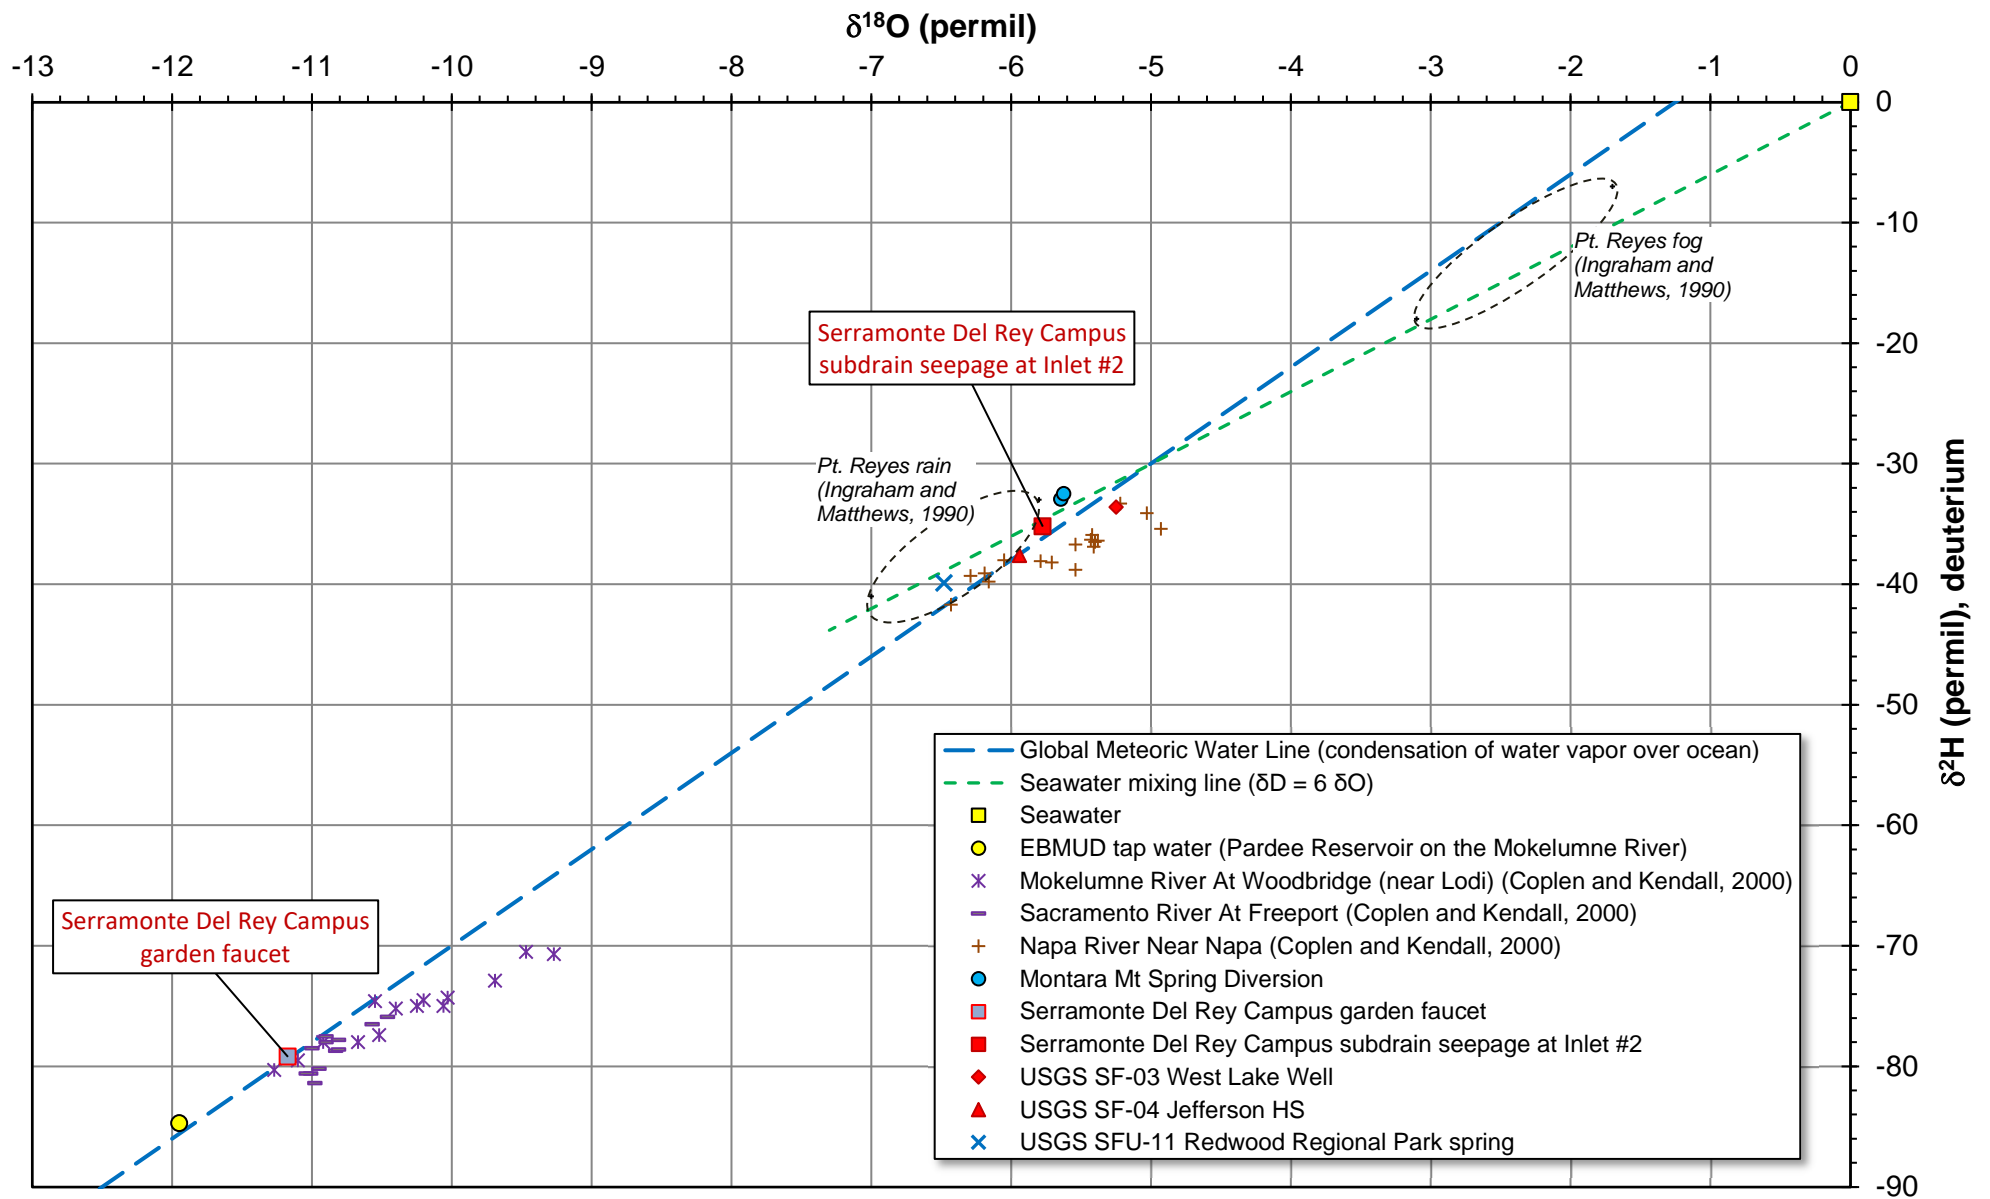
- MBAS (surfactants) were not detected in Inlet #2 seepage sample, suggesting any leakage sewer pipes is negligible.
- Isotopic results (**Figure 9**) of the Inlet #2 seepage sample grouped with published results of coastal rain and groundwater (such as local Westlake Well water). Results indicate the Inlet #2 seepage water is not imported Sierran water (Crystal Springs Reservoir) and not fog drip.

Figure 9. Stable isotopes of oxygen and hydrogen in samples collected at Serramonte Del Rey Campus relative to published results from coastal and inland waters. Water with a higher deuterium content is generally found near the coast, at low elevations, in warm rains, and in water which has undergone partial evaporation. The variation of oxygen-18 content generally follow those of deuterium. The subdrain seep sample plots within the range of coastal waters while the garden faucet municipal water plots as Sierran source water. Fog drip does not appear significant as a source of the seepage.

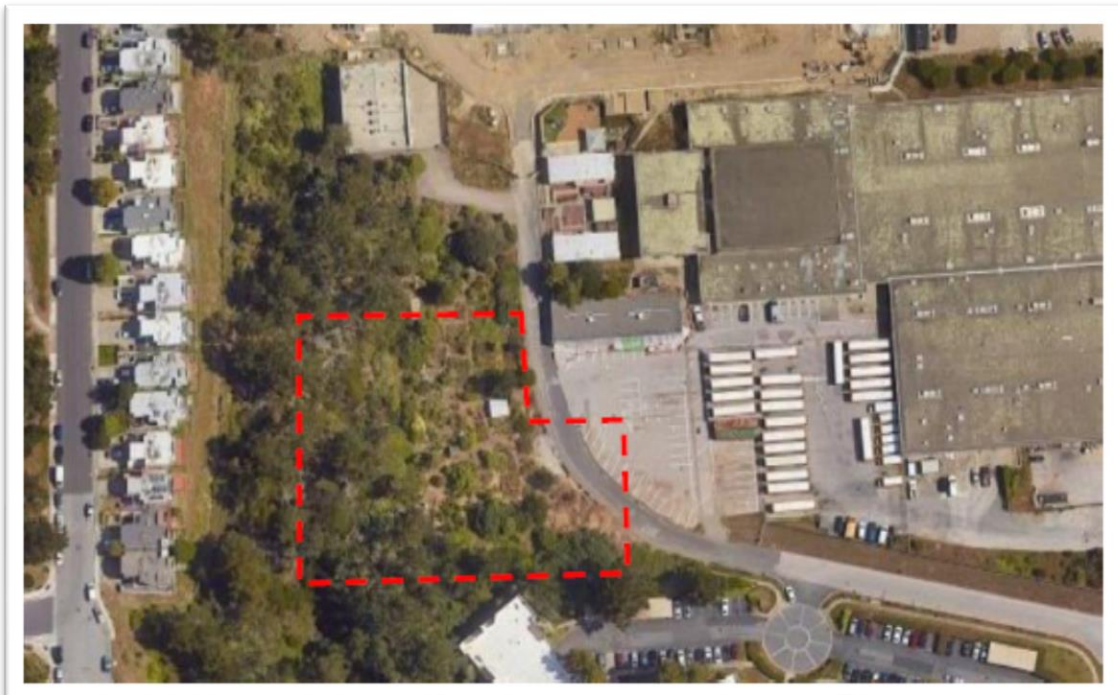
The drainage area we investigated is located at the southwest portion of the site and west of Campus Drive. The drainage area (shown below, outlined in red) generally includes the slope down from the existing apartment buildings to the south, the "garden area," the slope to the west of the "garden area," and a portion of existing Campus Drive (original tennis court and play yard area).

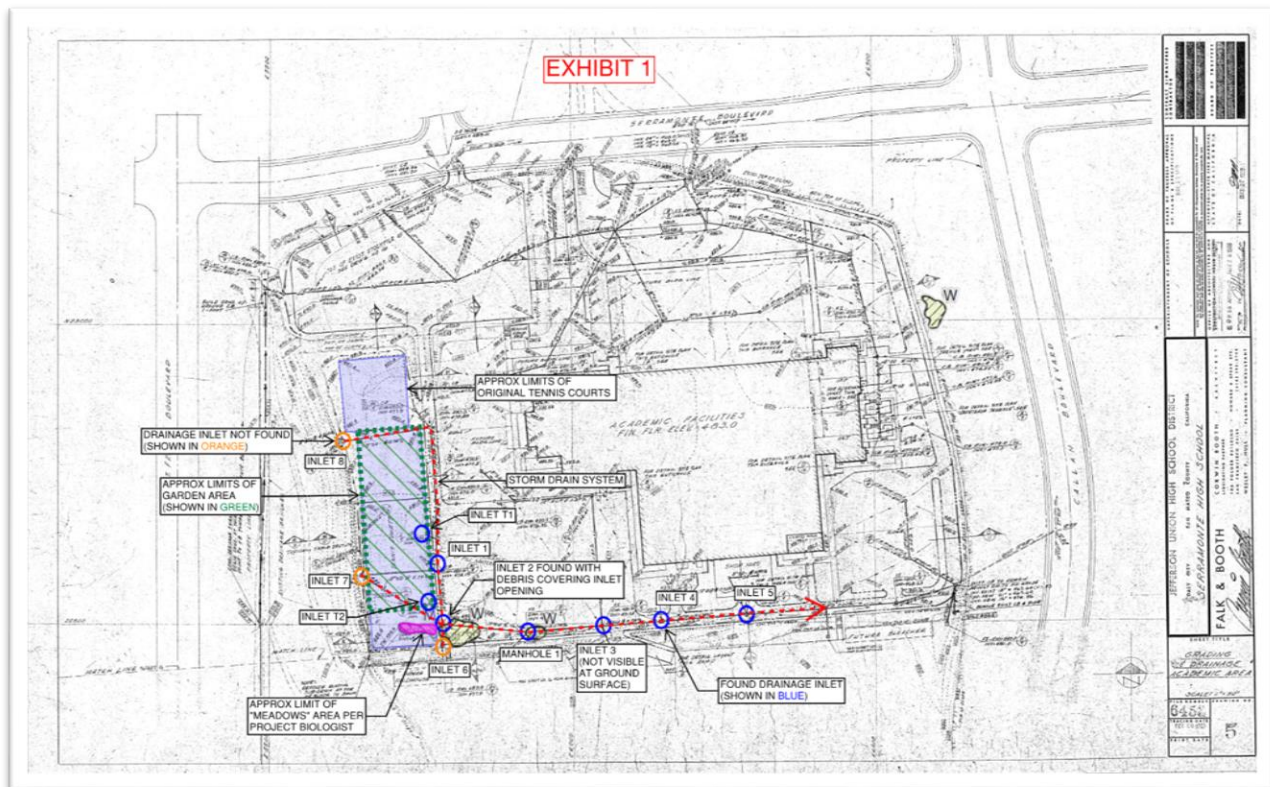
The current "garden area" as shown on Exhibit 1 is located approximately where the original tennis courts and play yard were located. A field investigation by Balance Hydrologics, Inc. found that a portion of the play yard pavement is below soil. The edge of the buried asphalt pavement appears to align with the eastern edge of the tennis courts.

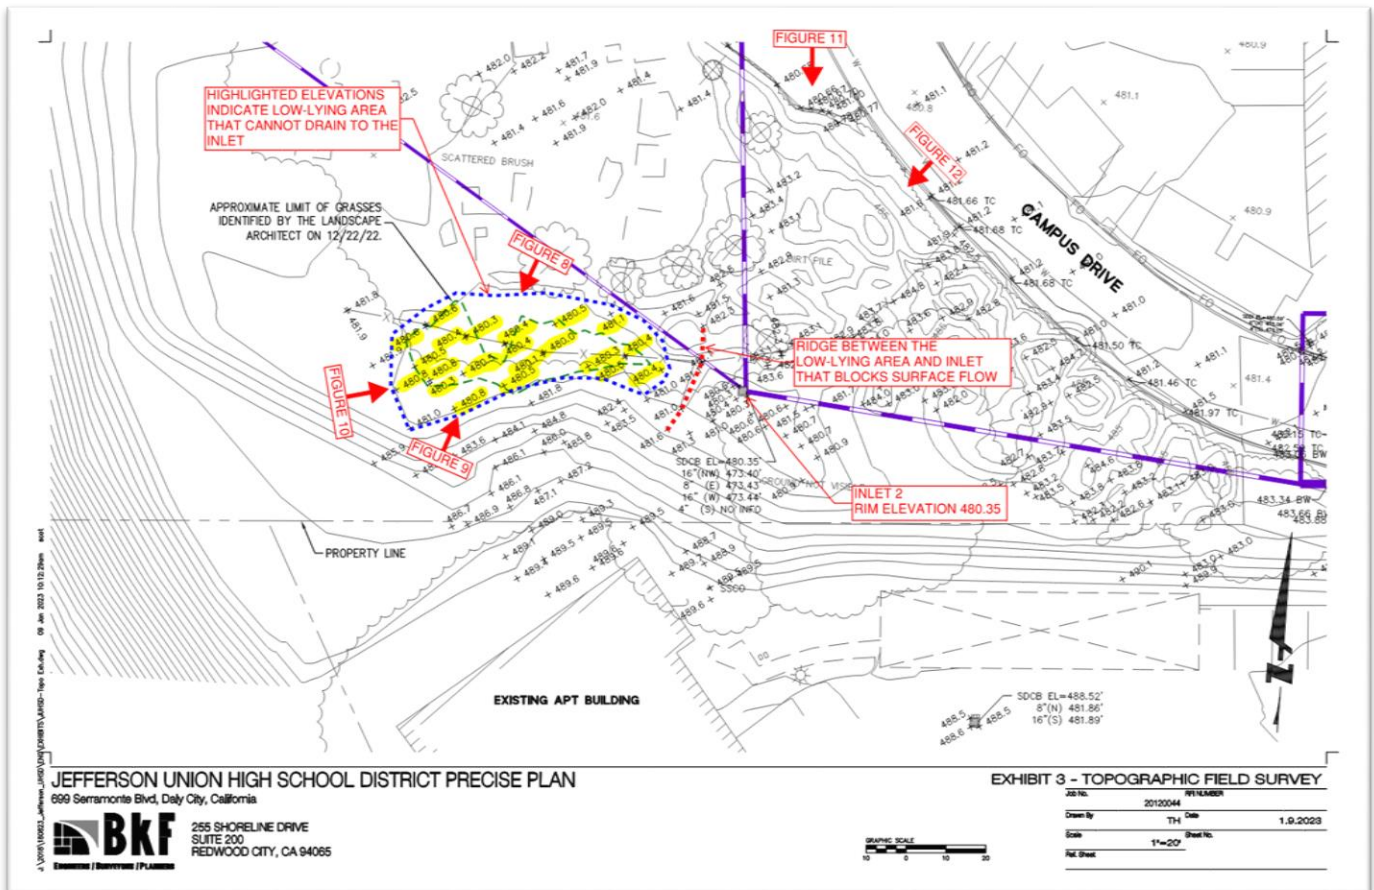
Exhibit 3 shows the approximate limits of the grasses identified in the “meadows area.” The detailed survey also located a low-lying area that does not have a positive drainage path to the existing drainage system. For example, Figures 8, 9, and 10 show standing water in the area of the grasses. A mound of soil between this low-lying area and drainage inlet 2 blocks a positive drainage path from the low-lying area to the inlet. Based on interviews with Dean DeVolder (District Office Maintenance staff) and John Shultz (former Director Operations between 2003 and 2017), soils were brought in and periodically placed in and removed from this area depending on off-site needs, and which have accumulated over time into the current mound.

Further, we observed mounds of vegetation, shredded wood, and other debris at the south and southeast of the garden area, on the eastern edge of the “meadows area.” The source and purpose of the mounds are unclear, but based on a review of historical Google Earth aerial photos, their configurations appear to change over the years. (See figures 11 and 12.) These mounds are not part of the natural topography when the drainage system was designed and implemented, and is further impeding the drainage path of stormwater through the grass and “meadow area” to drainage inlet 2.

Because the above observed mounding blocks the positive drainage path from the “meadow area” to drainage inlet 2, a lack of routine maintenance has created the current ponding water in the low-lying area. If this mounding is

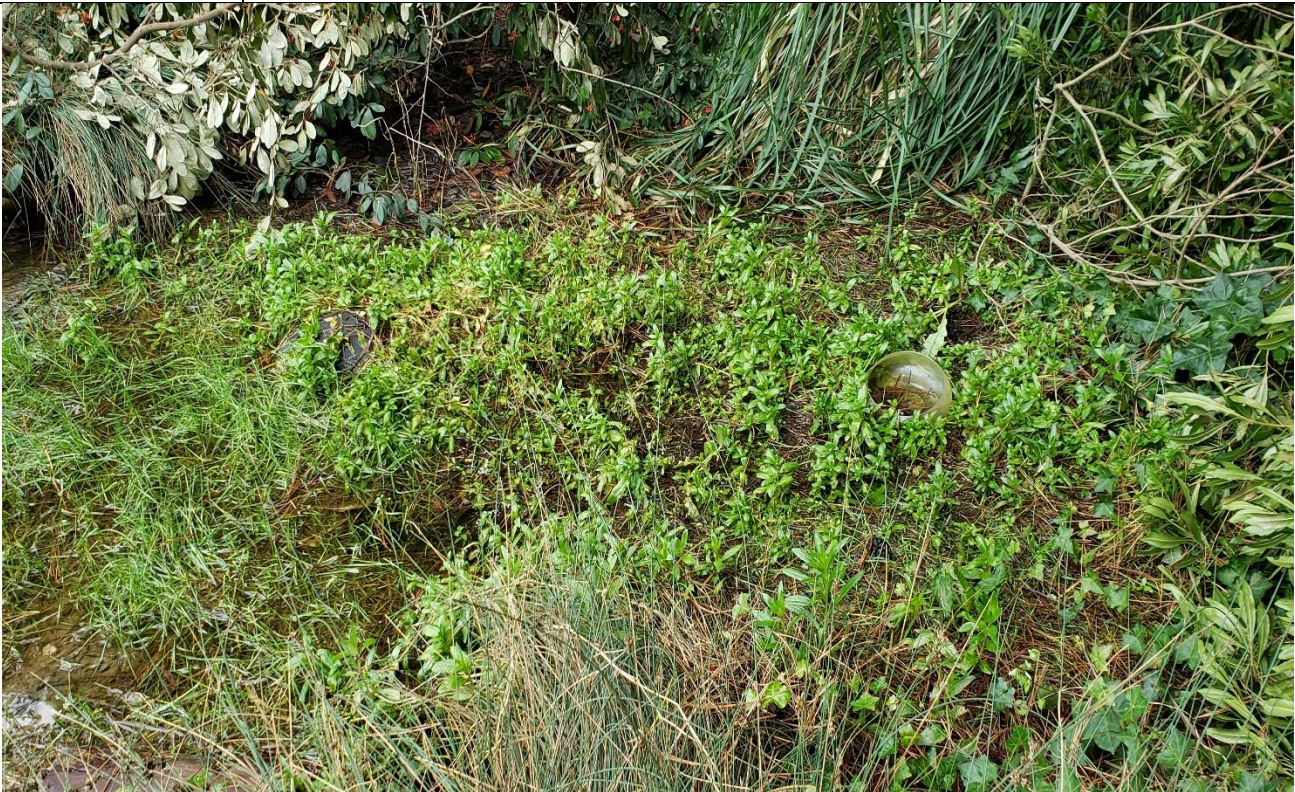
FIGURE 8

STANDING WATER

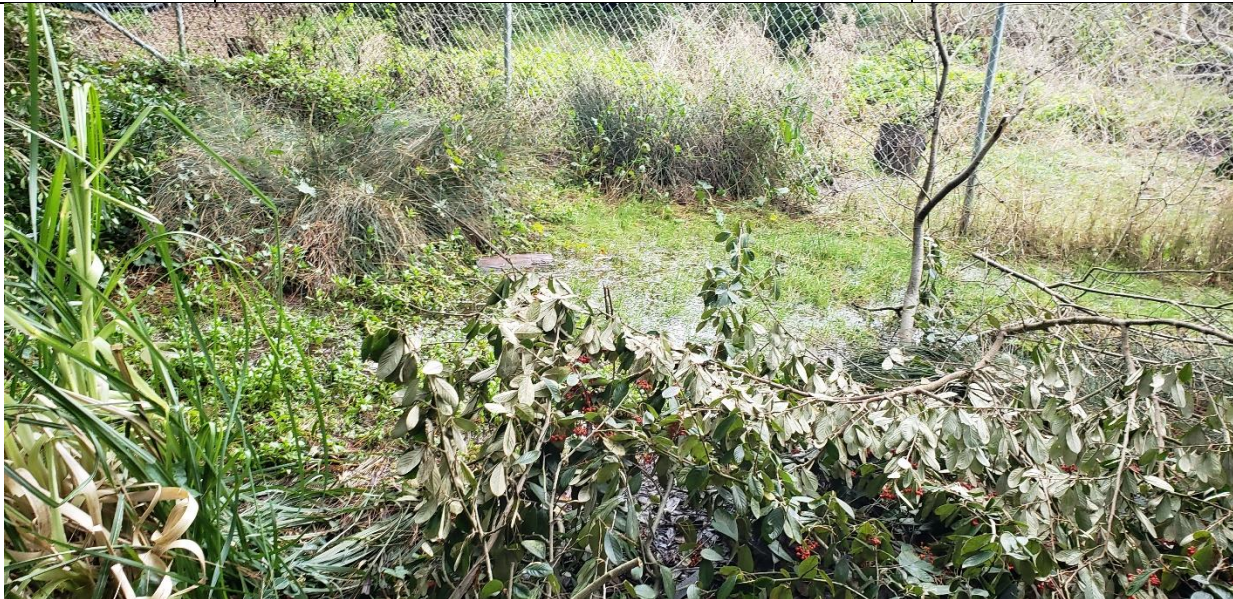
FIGURE 9

STANDING WATER
