*Re: Serramonte Del Rey Campus Redevelopment, City of Daly City
Federal and State Wetlands Jurisdiction Assessment*

**Subject: Hydrologic reconnaissance, Jefferson Union High School District,
699 Serramonte Blvd., Daly City, CA**

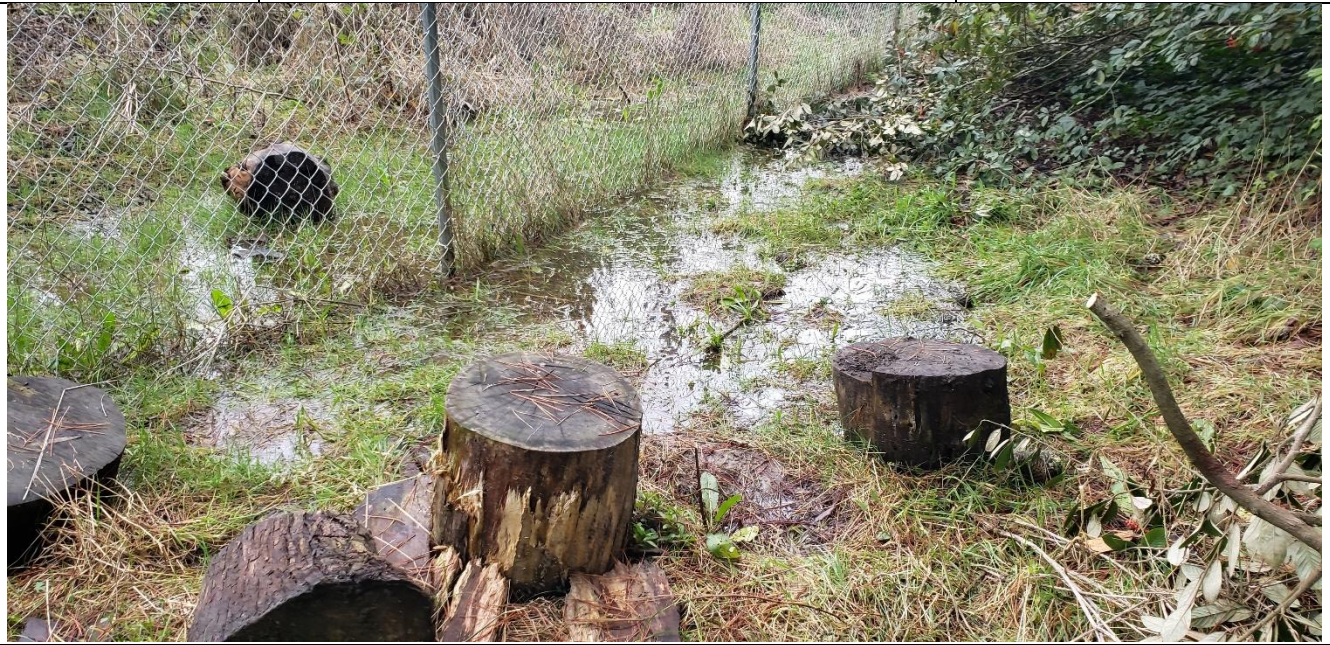
FIGURE 10

STANDING WATER

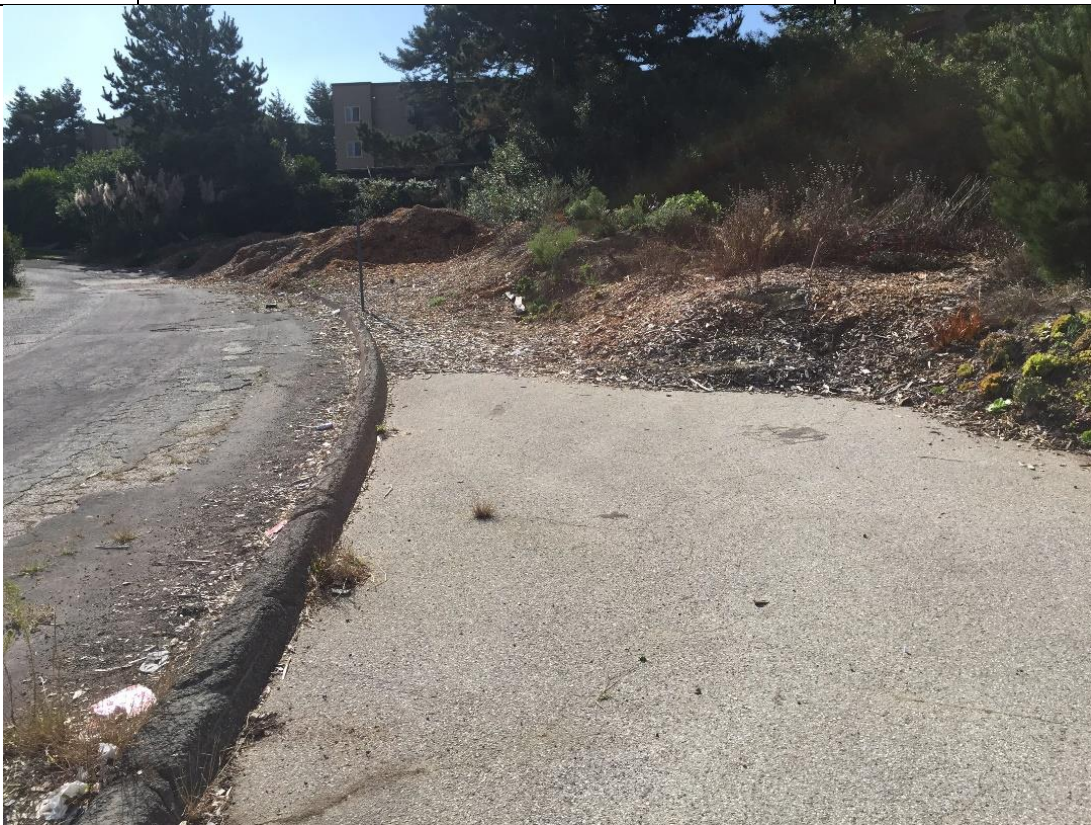
FIGURE 11

STOCKPILED MATERIAL

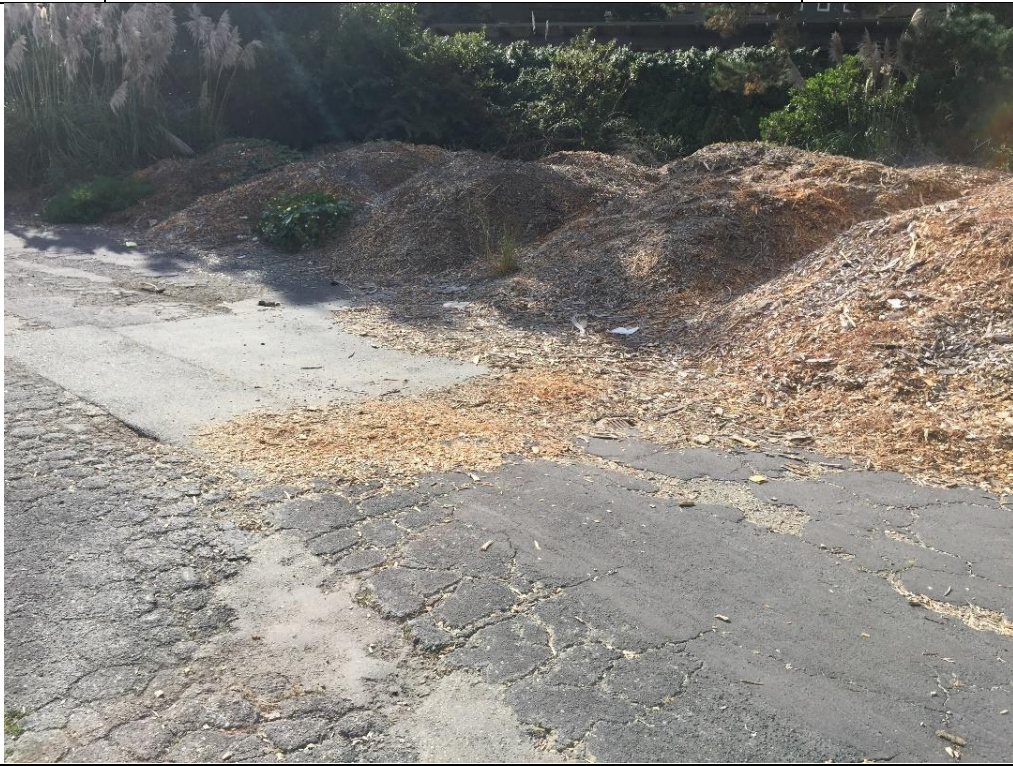
FIGURE 12

STOCKPILED MATERIAL
