Re: Preliminary Arborist Report for 3378-3386 El Camino Real, Santa Clara

PRELIMINARY TREE PROTECTION PLAN for 3378-3386 El Camino Real

By: Maija Wigoda-Mikkila
 Certified Arborist # WE-12986A
 Traverso Tree Service, Inc.
 August 19, 2022
 (drawn on Preliminary Site Plan by BKF Engineers dated 8-19-22)

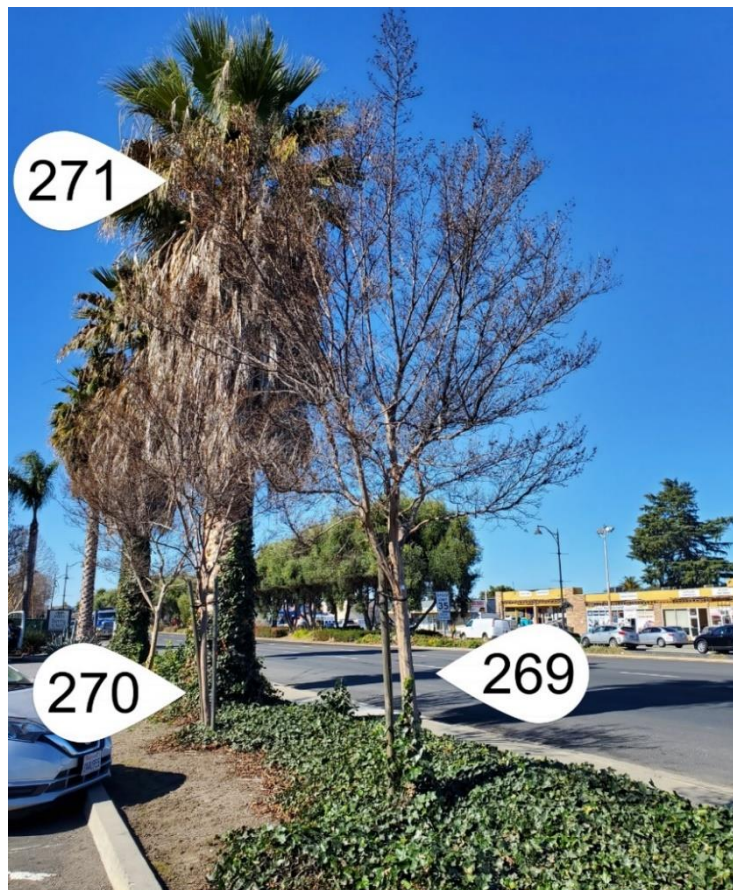
Figure 1. Trees along El Camino Real consist of stunted crape myrtles and Mexican fan palms (select trees are numbered). All trees on the subject site are proposed to be removed.

All the on-site trees are located in existing planting areas on the north side of the property and will need to be removed (figure 1). Proposed improvements are either in direct conflict with their trunks or will result in excessive root loss.

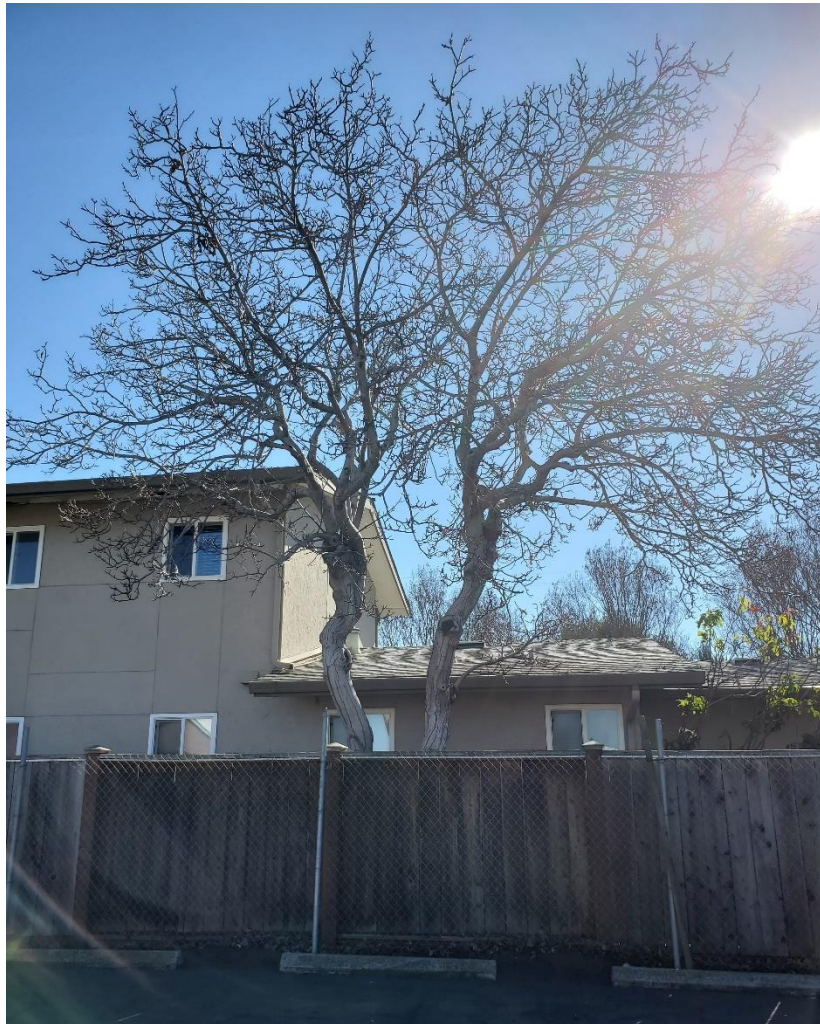
Figure 2. Tree #279, the neighbor's English walnut, is especially intolerant of root damage. The extent of root encroachment will need to be determined after the asphalt has been removed by digging an exploratory trench along the proposed walkways. After the project arborist has reviewed the exposed roots, they shall provide additional design & protection recommendations.

#	Species	DBH	Health	Structure	Dripline				Age	DE	CI	Comments	Recommendations
					N	E	S	W					
279	English Walnut (<i>Juglans regia</i>)	12, 10	F	F	15	10	10	20	M	X	M +/-	Neighbor's tree. DBH estimated. No tag. Old big pruning wounds with decay, nice visible wound wood. Somewhat stunted shoots. Codominant stems 1' from grade. <i>10' from proposed walkway, 17' from proposed foundation & 16' from proposed trash enclosure.</i>	PA on-site to monitor asphalt demolition within 15' of P/L fence. After demolition, dig exploratory trench with an air spade along proposed walkways & trash enclosures to locate roots. PA will review roots & provide recommendations for design adjustment. PA may provide additional tree protection measures. PA to approve & monitor all work within TPZ.
280	Lombardy Poplar (<i>Populus nigra</i> 'Italica')	14	G	G-F	5	5	5	10	M	X	M +/-	Neighbor's tree. Trunk location & DBH estimated by arborist. Tag on fence. <i>3' from proposed trash enclosure.</i>	After demolition, install 6' chain-link protection fencing as close to proposed foundation as feasible (#279) & 5' from P/L fence (#280-291). Apply a 4" thick layer of mulch over exposed soil within the TPZ. Tree #279: Lay 6" of mulch with 3/4" plywood on top OR place steel plates between proposed foundation & protection fencing. During landscape phase, tilling of soil or irrigation trenching in the TPZ shall be done with an air spade. Amend soil with compost & cover with a 4" thick layer of mulch. If root encroachment is high & design adjustments cannot be made, some trees may need to be removed (will require neighbor's permission).

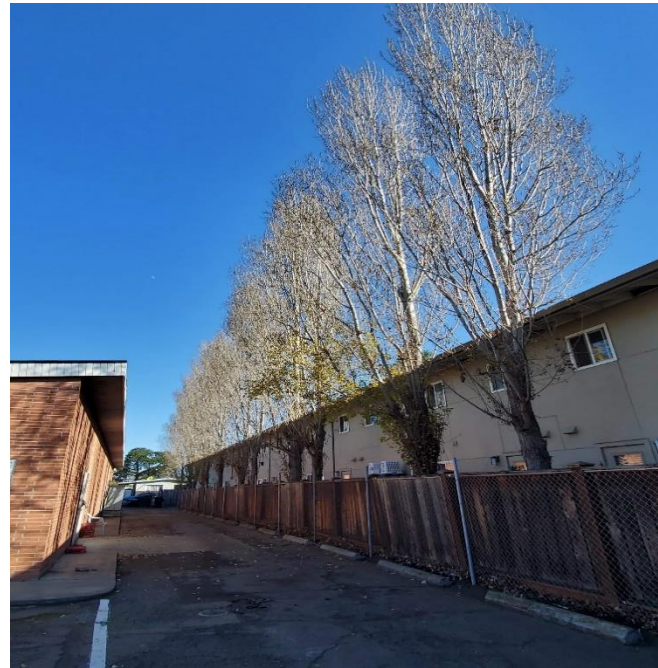
The poplars and English walnut are located in the backyards of multi-family homes south of the project site (figures 2-3). The trunks are within 2'-3' of the existing fence. Based on this distance, I would expect that large structural roots are growing into the subject property. These roots found closest to the trunk are responsible for anchoring the tree in the soil. Notably, Lombardy poplars are especially susceptible to uprooting if primary structural roots are damaged. English walnuts are intolerant of root damage and even minor construction impacts can cause them to decline in health.

Figure 3. The neighbor's Lombardy poplars, #280-291 are 2'-3' from the property line. It is likely that large structural roots are growing into the subject site. The extent of root encroachment will need to be determined after the asphalt has been removed by digging an exploratory trench along the proposed walkways & trash enclosures. After the project arborist has reviewed the exposed roots, they shall provide additional design & protection recommendations.

On the subject site, the soil has been paved over with asphalt up to the south property line. Soil compaction during standard asphalt preparation decreases the pore space available for water, air, and root growth. Assuming the backyards on the property to the south are not as compacted, I would expect to find more roots on the neighboring property than on the subject site.

Typically, I would recommend excavating an exploratory trench to determine the extent of root encroachment prior to finalizing design plans. However, the existing asphalt on the subject property prevents exploratory work at this time. Thus, my recommendations are preliminary and will need to be reevaluated once the asphalt has been demolished. After the removal of the existing pavement, an exploratory trench shall be dug along the proposed walkways and trash enclosures with an air spade, a tool which uses compressed air to dislodge soil without harming a tree's roots. The PA shall review the uncovered tree roots and provide design guidance for the proposed walkways and trash enclosures. In general, avoiding grading, soil compaction, excavation, and fill within the Tree Protection Zone (TPZ) will minimize root loss. Plans should be flexible enough to accommodate roots within this area. If root encroachment is high and adjustments cannot be made, some trees may need to be removed. As these trees are located off-site, their removals must be approved by the neighboring property owner.

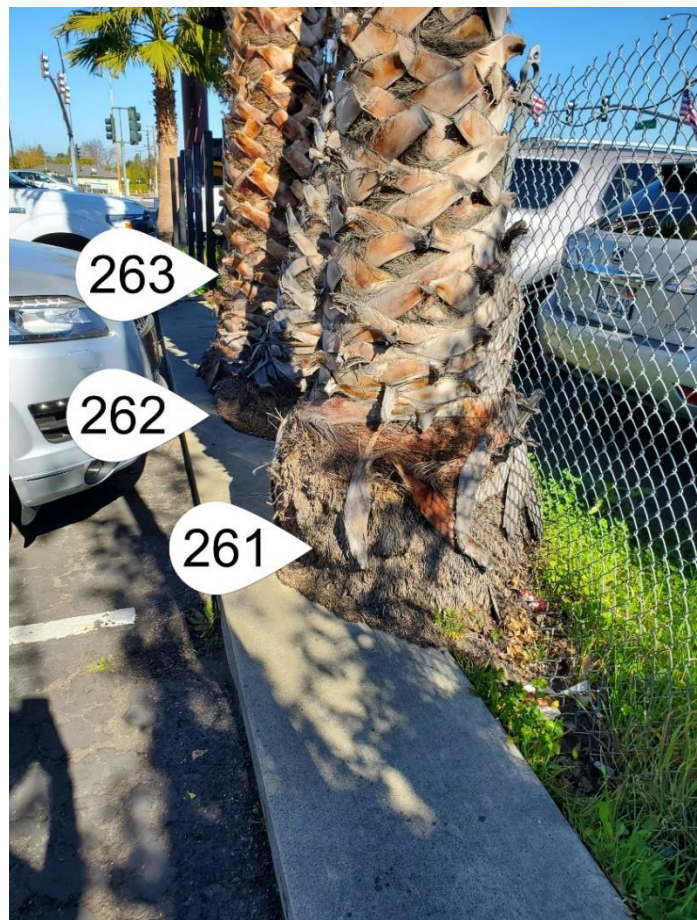
Approximately 1/3-1/2 of the root systems of these palms have grown over the existing concrete curb, preventing them from properly anchoring into the soil (figure 4). As the trees grow in height and mass, this increases stress on their compromised root systems. Although the trees appear to be in good health, high winds or rains could put them past their holding capacity and cause them to fail. *Regardless of construction, I recommend these palms be removed due to their increased susceptibility to failure.* Removal will require approval from the neighboring property owner.

Figure 4. These co-owned palms are growing over the existing concrete curb, preventing them from properly anchoring into the soil. These palms should be removed due to their hazardous condition. Removal will require the neighbor's permission.

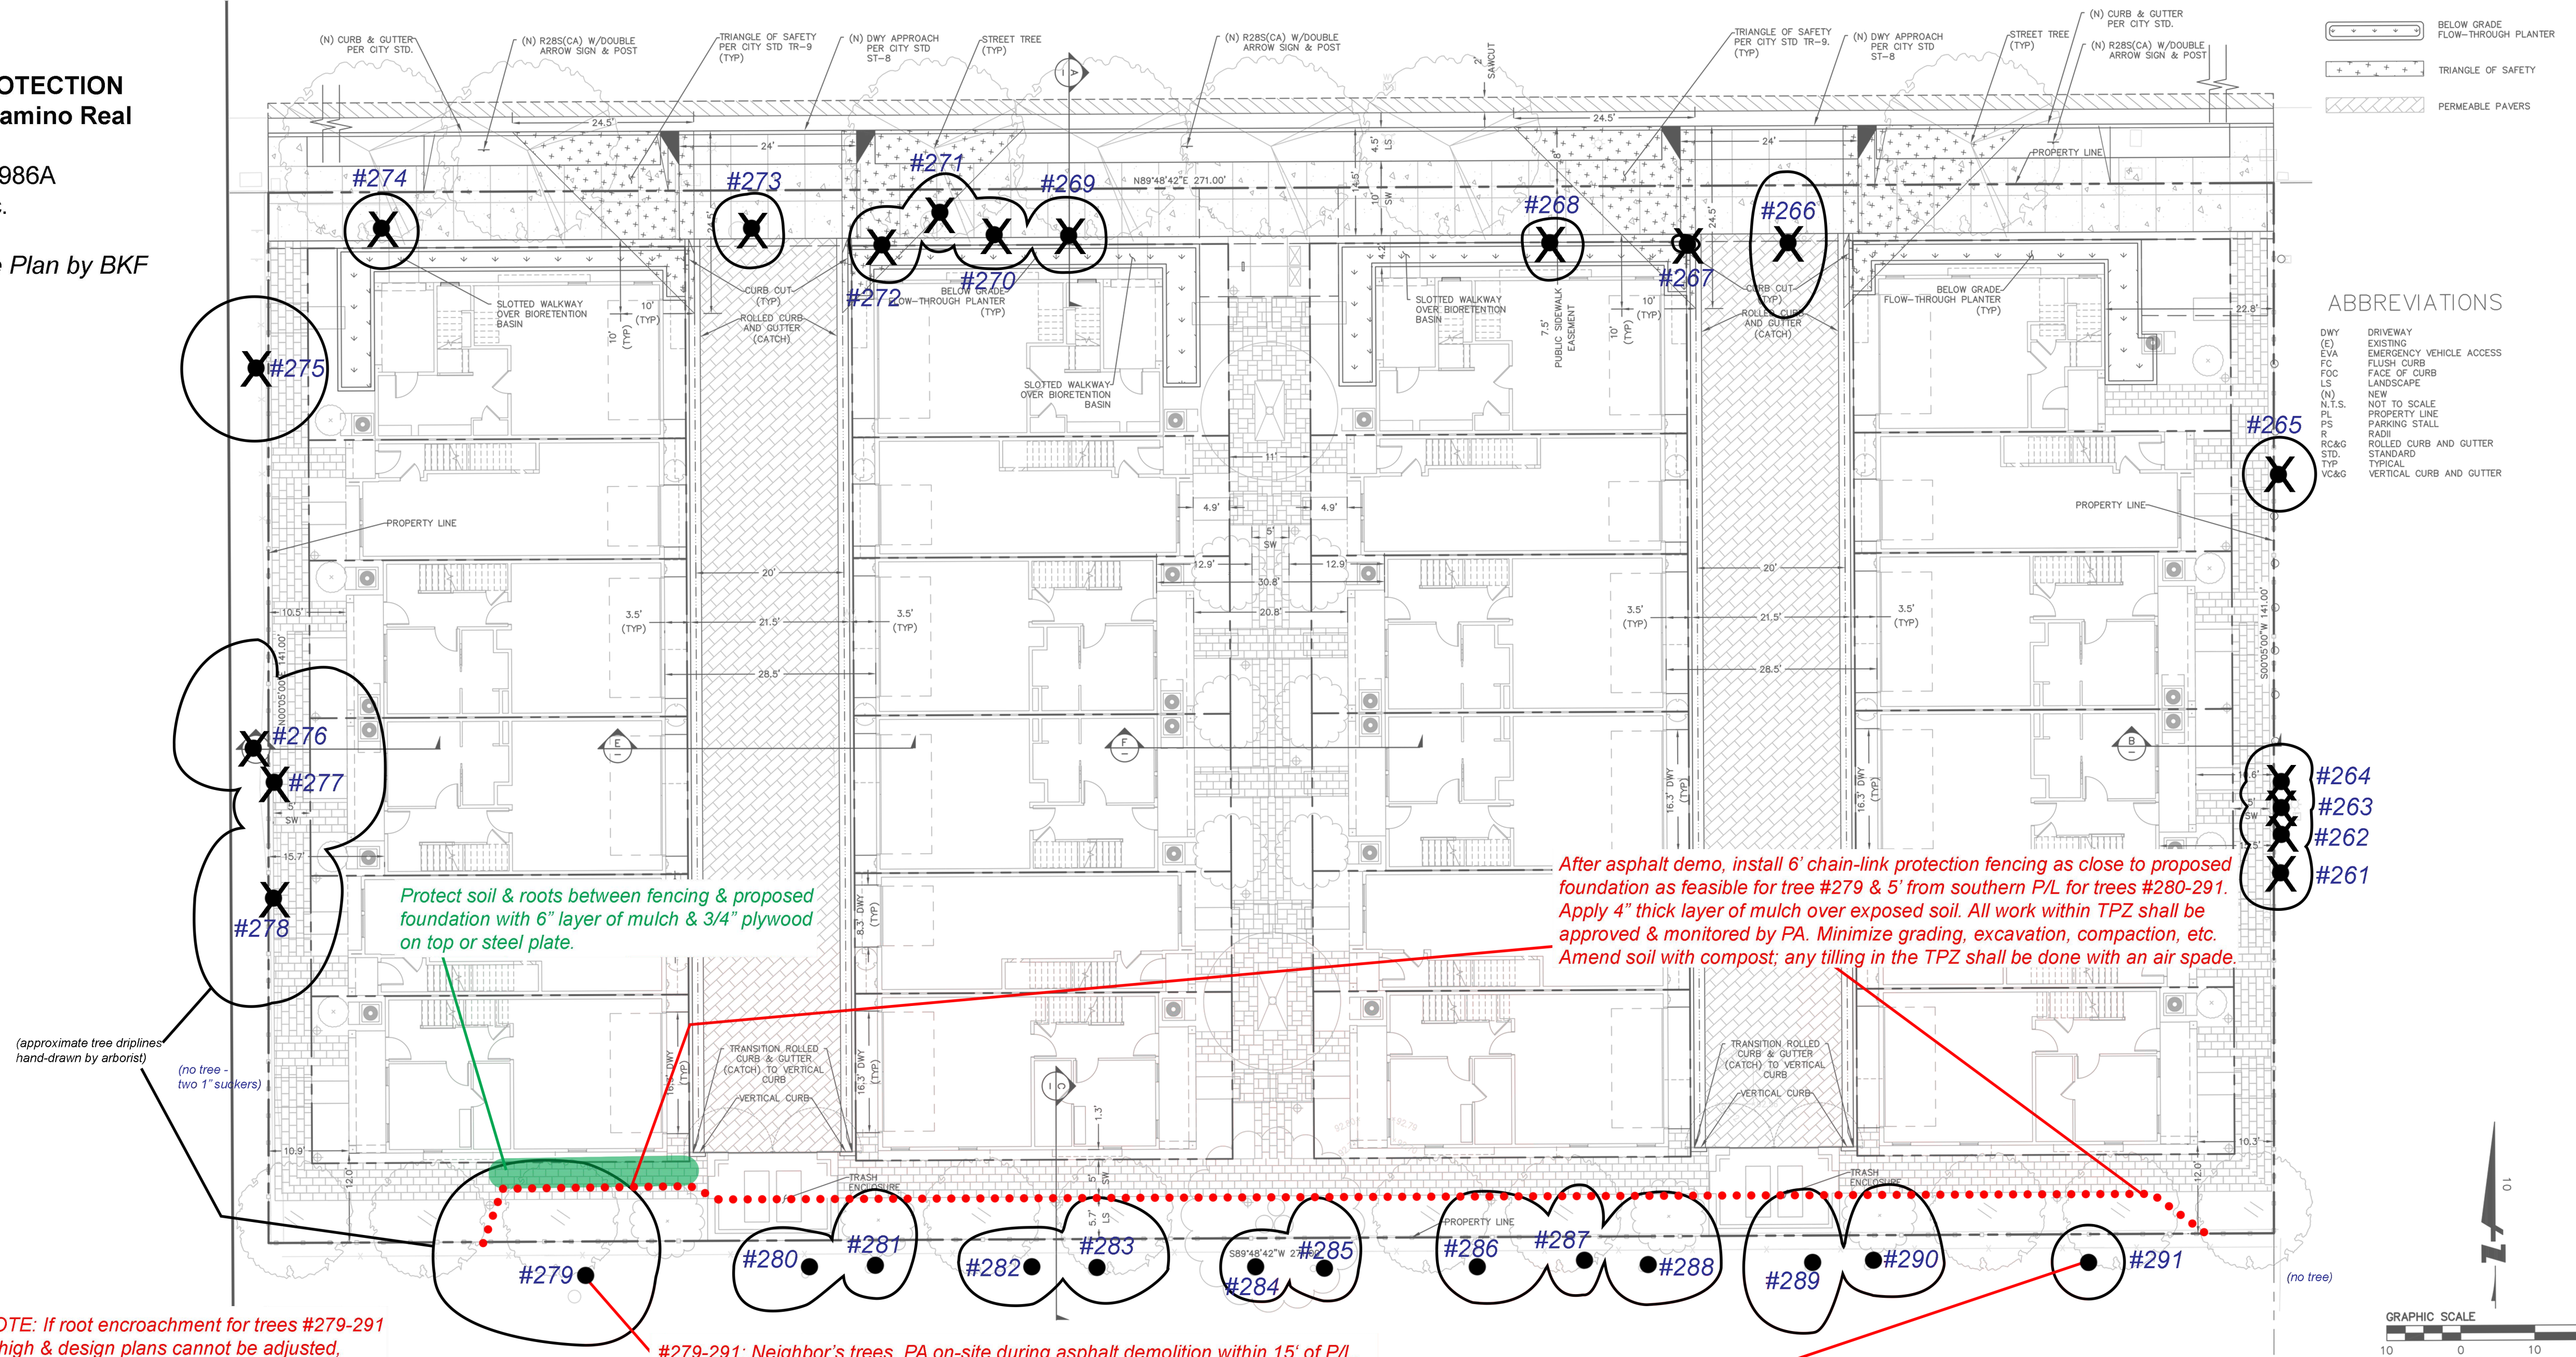
#279-291: Neighbor's trees. PA on-site during asphalt demolition within 15' of P/L. After demo, dig exploratory trench with air spade along proposed walkways & trash enclosures. PA shall review roots & provide recommendations for design guidance for walkways & trash enclosures. PA may provide additional tree protection recommendations.

NOTE: If root encroachment for trees #279-291 is high & design plans cannot be adjusted, some trees may need to be removed (will require permission from property owner).

After asphalt demo, install 6' chain-link protection fencing as close to proposed foundation as feasible for tree #279 & 5' from southern P/L for trees #280-291. Apply 4" thick layer of mulch over exposed soil. All work within TPZ shall be approved & monitored by PA. Minimize grading, excavation, compaction, etc. Amend soil with compost; any tilling in the TPZ shall be done with an air spade.
