**Sunset Canyon Recreation Replacement Building Project
Environmentally-Regulated Materials Survey Report
Citadel Environmental Services, Inc.**

Environmentally-Regulated Materials (ERMs) Survey Report - REVISED

Sunset Canyon Recreation Center (CAAN 4205A)
111 Easton Avenue
Los Angeles, California 90095

Citadel Project Number 3002.1165.0

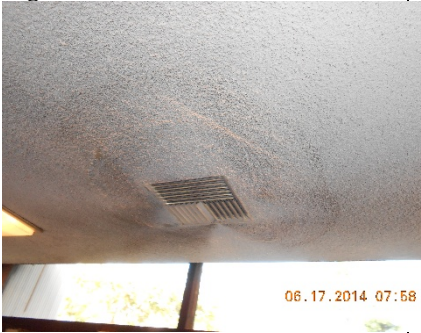
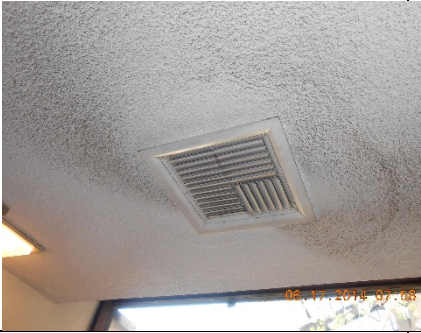
Location	Moisture (%)	Observations	Recommendations
Santa Fe Room – Ceiling	Plaster: 0.1-0.2 (dry/ acceptable) Wood: 8.0-8.3% (dry/ acceptable)	<ul style="list-style-type: none"> Note – there have been no recent rain events and conditions were very dry at the site at the time of the inspection. No signs of suspect microbial growth (SMG) were observed. Visible water staining and discoloration (yellow/brown) was observed on spray applied acoustical ceiling (SAAC) surrounding three (3) supply air registers.

<ul style="list-style-type: none"> Remove ceiling materials (plaster, button board and SAAC) from the supply air registers (x3) out two (2) feet on all sides of the air register. Clean ceiling cavity, wood framing and plywood roof, with an approved anti-microbial cleaning agent. Check the backside of button board for SMG and remove two (2) feet past last visible signs if observed. Contact Citadel for final visual inspection.

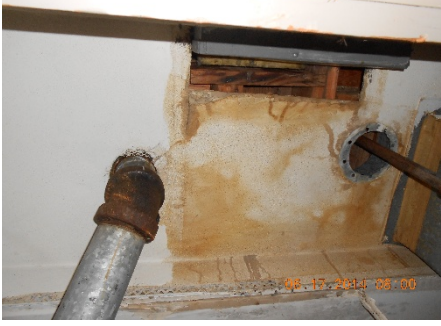
Santa Fe Room – Closet Ceiling	Plaster: 0.1 – 0.2%	<ul style="list-style-type: none"> Visible water staining and discoloration (yellow/brown) was observed on the ceiling plaster materials which had deteriorated, exposing the plywood roof, as a result. 	<ul style="list-style-type: none"> Remove ceiling materials (plaster and button board) from the entire closet ceiling. Clean ceiling cavity, wood framing and plywood roof, with an approved anti-microbial cleaning agent. Check the backside of button board for SMG and remove two (2) feet past last visible signs if observed. Contact Citadel for final visual inspection

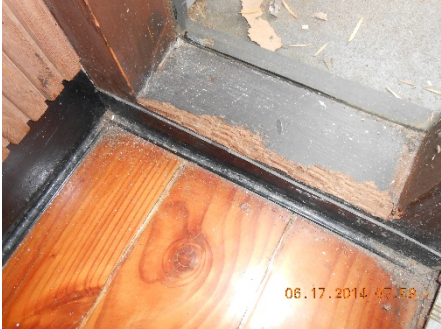
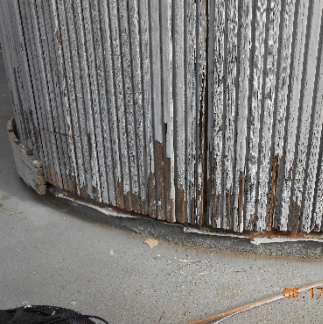
Santa Fe Room – Exterior and Door Thresholds	Wood: 8.0-8.3% (dry/ acceptable)	<ul style="list-style-type: none"> The exterior wood siding, door frames, doors and thresholds were all observed to be visibly damaged (i.e. warped, swollen, hollow in areas) and exhibiting signs of wood rot/dry rot.

<ul style="list-style-type: none"> Remove all exterior siding, door frames and thresholds. Contact Citadel for final visual inspection.
