Job No. 210820  
September 14, 2021

**Subject: Geotechnical Evaluation of Fill Conditions  
Site Located on West Side of Taberna Vista Way About 650 Feet  
North of Tavern Road, APN 403-380-6400  
Alpine, CA 91901**

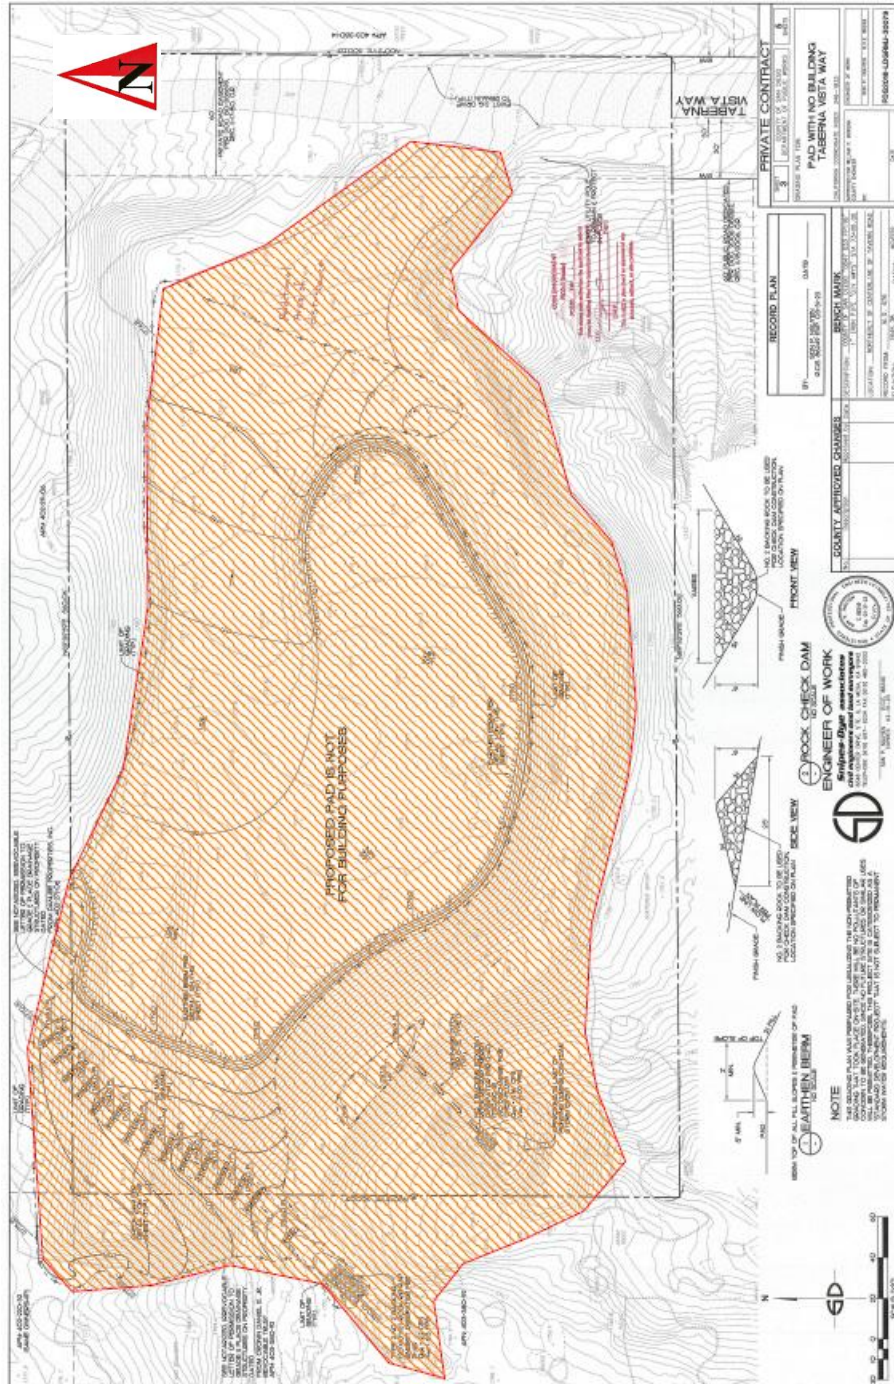
## FIGURE 2 GRADING PLAN

As shown on the attached grading plan there is a central, flat, slightly sloping fill area. There are descending fill slopes in the south to southwest portions of the lot with individual heights of about 15 feet and a combined height of about 30 feet, and lesser fill slopes with heights of about 5 to 10 feet in the north and northwest portions of the lot. The fill slopes are inclined at about 2:1 (horizontal to vertical).

As shown on the grading plan the fill limits extend slightly outside the property boundary on the west side of the site.
