March 31, 2020 (Revised April 17, 2020)

Landslide Hazard Evaluation
Prichard Hill Properties Vineyard Development
92 and 95 Long Ranch Road
St. Helena, California

Project Number: 7382.01.09.2

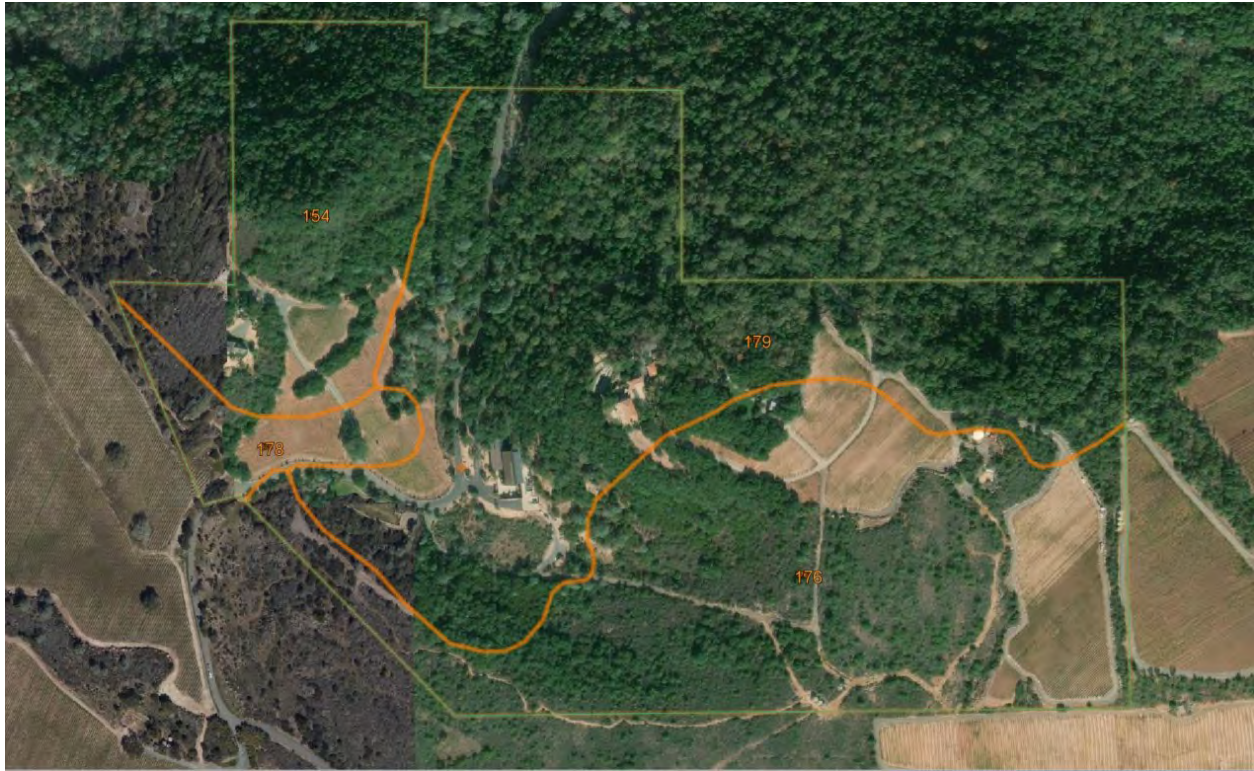
Based on our geologic review we compiled the image and table below indicating the soil types and depth of materials. This information was collected from the NRCS Web Soil Survey listed above.
