TREE INVENTORY AND ASSESSMENT

TREE INVENTORY AND ASSESSMENT
LMC APARTMENTS-SOUTHEAST OF JEFFERSON BLVD
AND MURRIETA HOT SPRINGS RD.
MURRIETA, CALIFORNIA

6/1/2022

Dane S. Shota Certified Arborist WE 3436A
Arborist and Nursery Services
16835 Algonquin Street # 172
Huntington Beach, CA 92649-3825
Office (714) 377-1181, Cell (714) 653-4627
arbordane@yahoo.com
Certified Water Auditor # MWDOC-1321
"Qualified Water Efficient Landscaper"

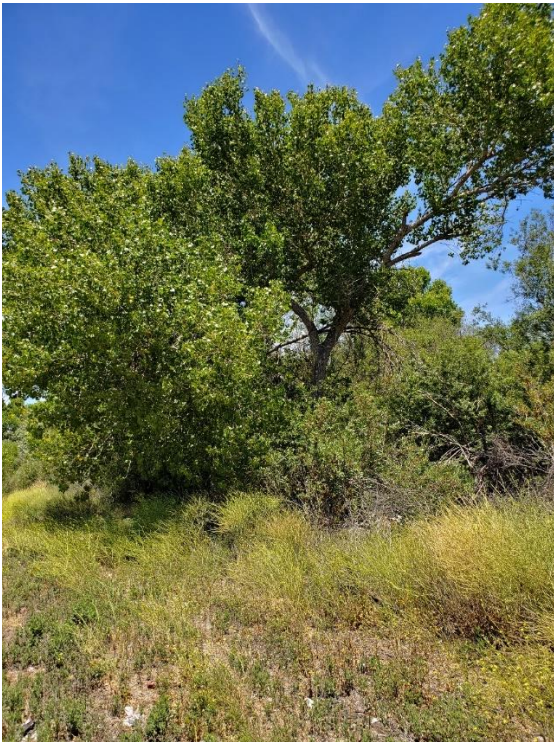
Western Cottonwood; *Populus fremontii*

This tree requires a lot of water.

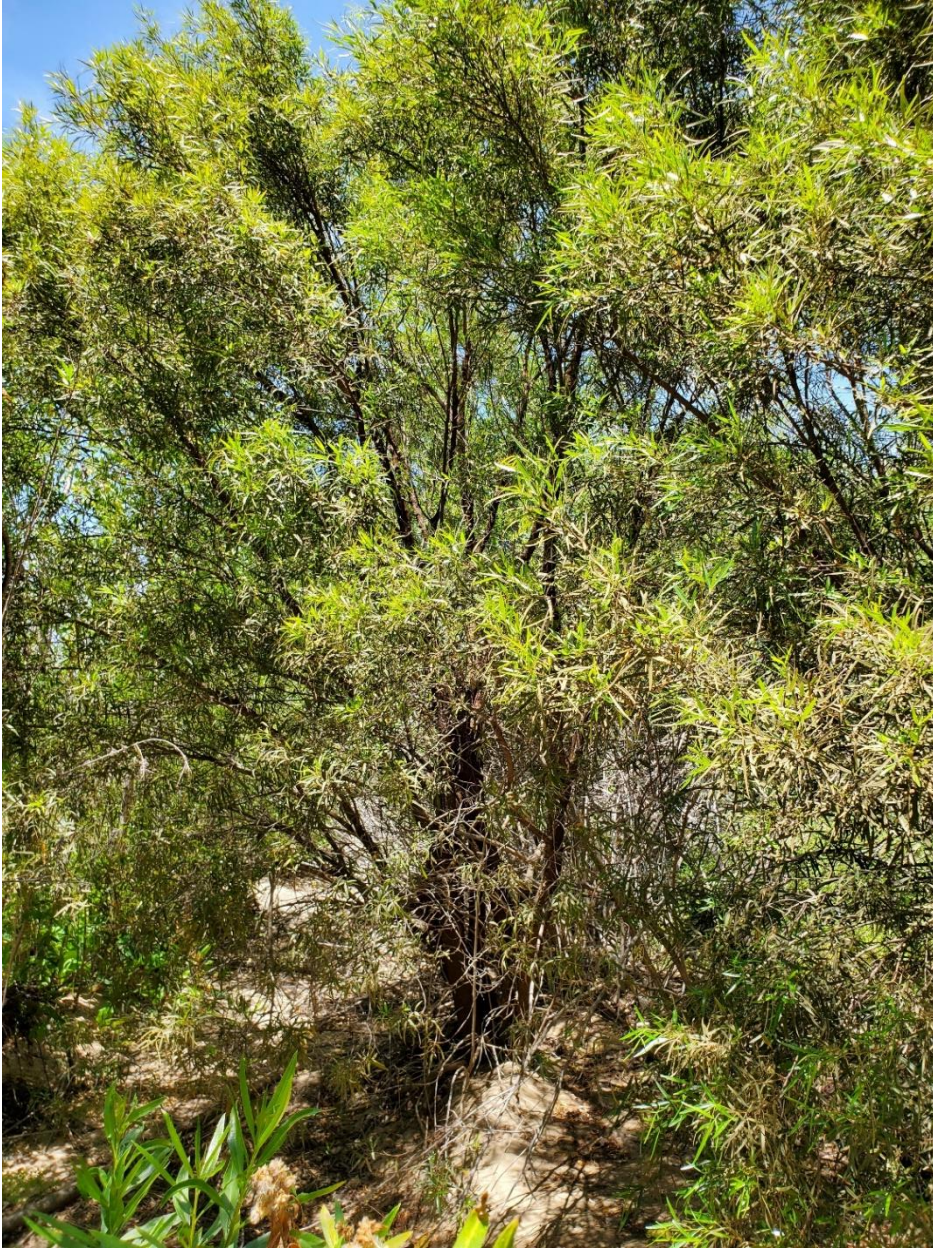
African Sumac; *Rhus lancea*

This is a non-native tree that is drought tolerant

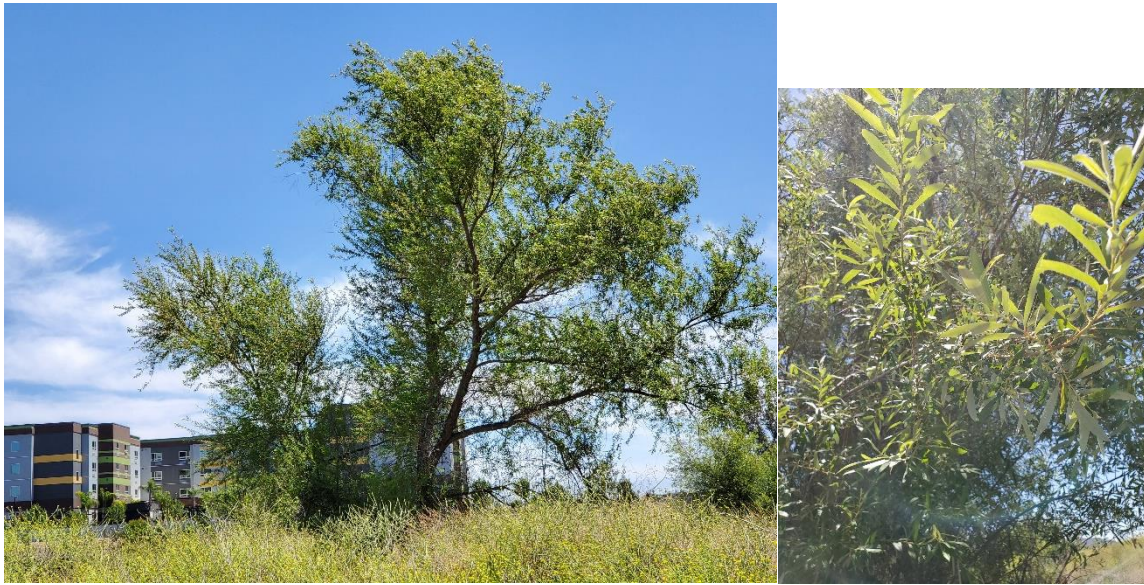
Most of the tree inventory consists of Goodding's willow; *Salix gooddingii*. These trees are stressed due to the lack of soil moisture and it requires a lot of water. There was a lot of caterpillars eating the leaves of these trees. Caterpillars were seen crawling in the commercial building parking lot next to where I took this tree inventory.

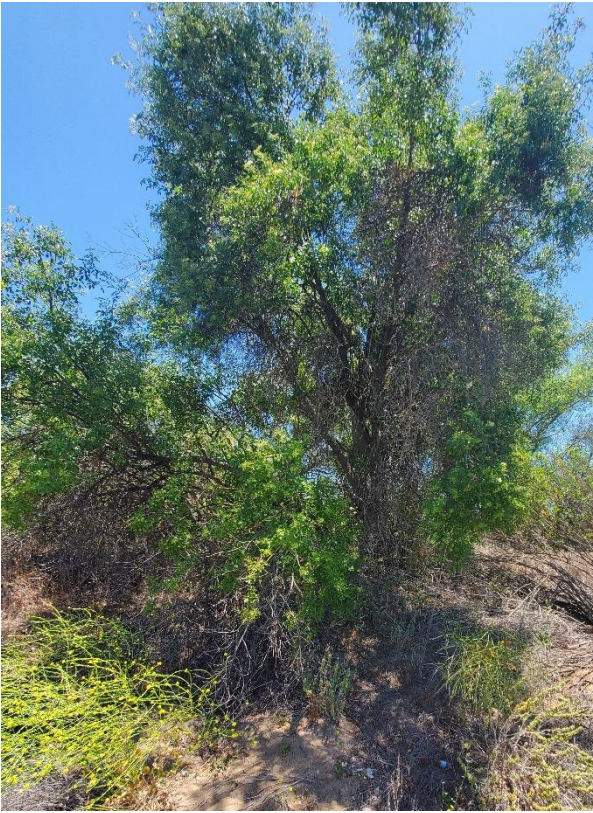
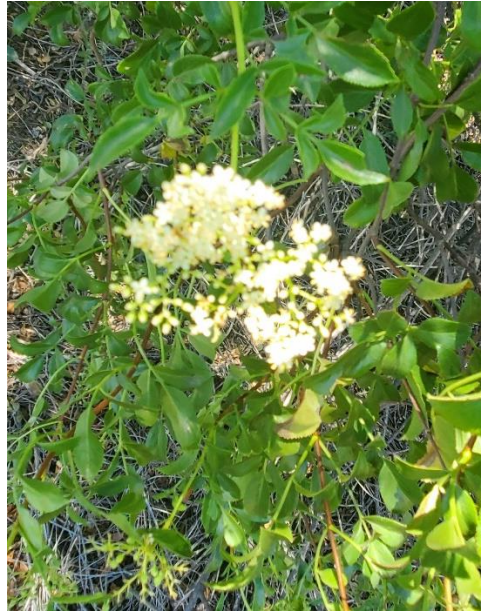
Elderberry; *Sambucus species*. The species can be identified when the berries are present.

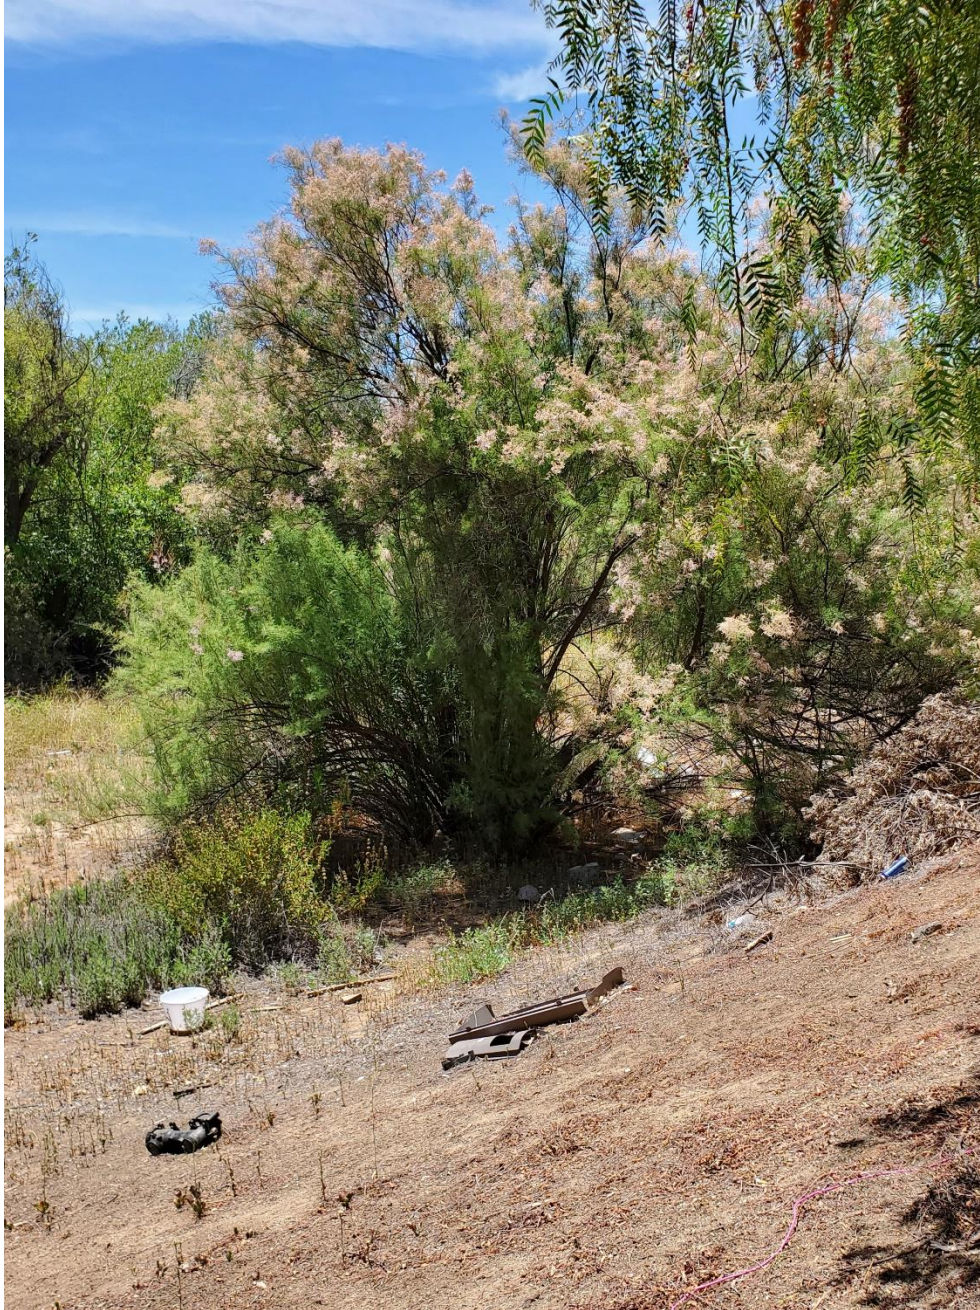
Tamarix; Tamarix species. This tree is listed as a fire hazard and invasive on the Murrieta Fire Rescue Wildland Urban Interface Undesirable Plants & Trees list.

| Tree # | Common Name | Botanical Name | Diameter at 4.5 feet (dbh) in inches | Condition Rating | Structure Rating | Comments |
|---|---|---|---|---|---|---|
| 54 | Tamarix | Tamarix species | 20x20x5,4,5 | 3 | 2 | Considered flammable and invasive |

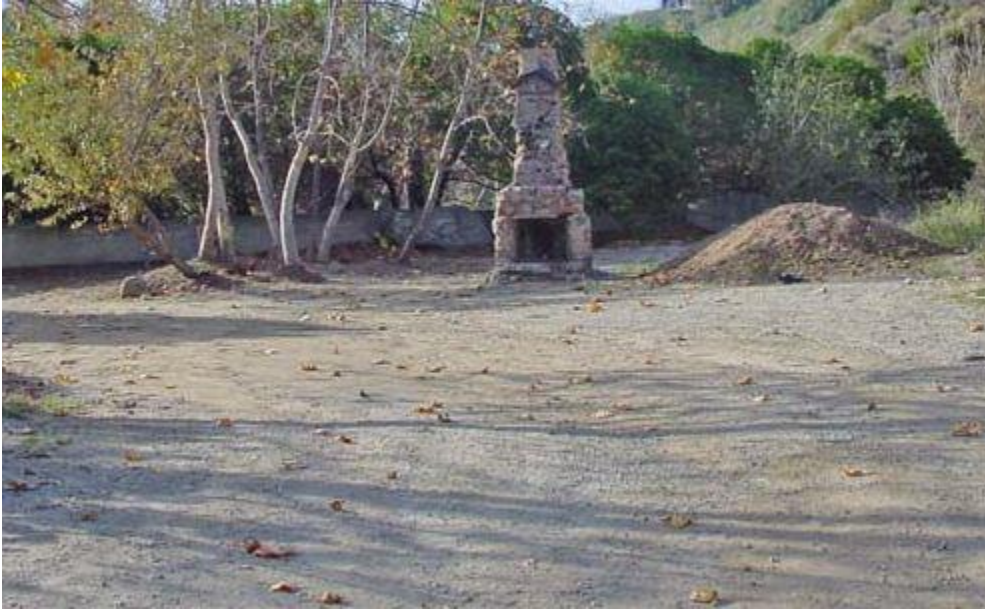
MALIBU FIRE 1993

Although some of these Eucalyptuses seem to be eligible to keep, you may want to consider on removing these Eucalyptuses due to the high fuel content in them. There were loud explosions heard due to Eucalyptus blowing up in this Malibu fire.

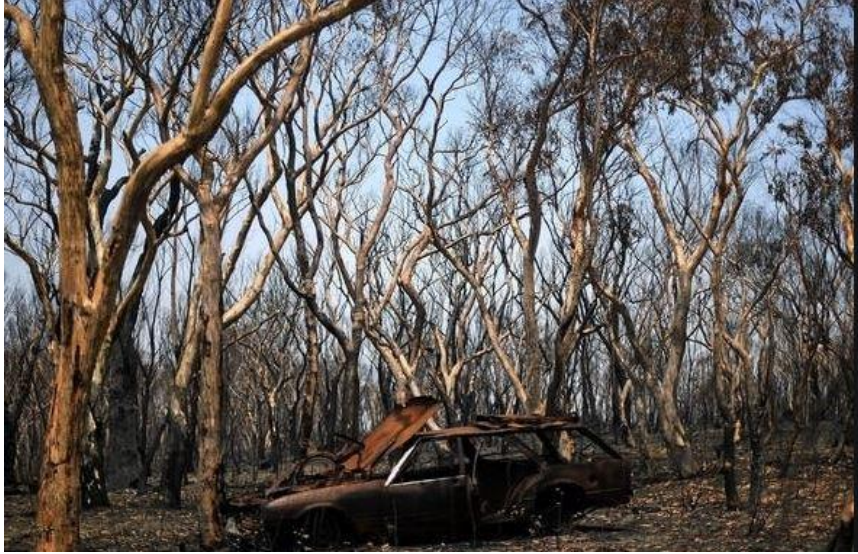
Australia Fire 2019/2020

A lot of Australia's forests were burning in this fire. See the Eucalyptus trees in the picture above. Eucalyptus trees are considered flammable dead or alive.
