# Tree Survey and Arborist Report

*for an approximate 1.6-acre Site  
On the NE C/O of Glendora and Whitcomb Avenues  
In the City of Glendora, County of Los Angeles, California*

George J Wirtes, MS, RCA #738

*Report Date: June 11, 2021*

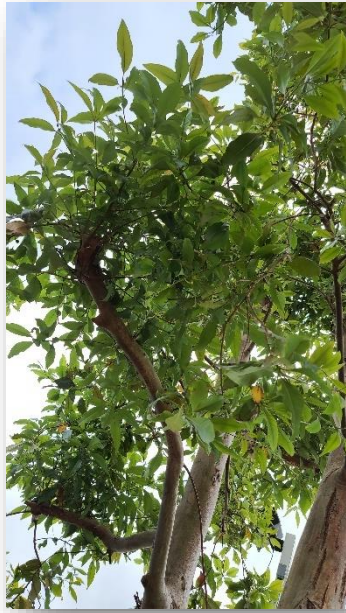
Plate 1. This is a view of water sprouting on a tree that had its branches topped (#406).

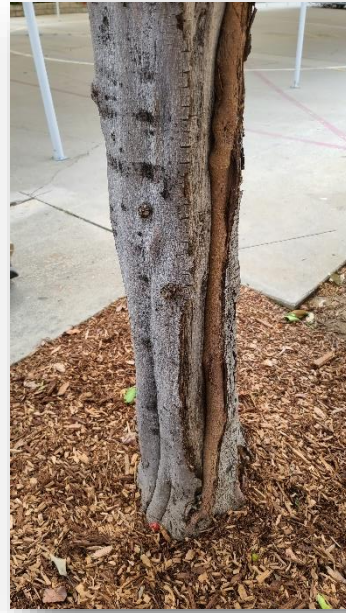
Plate 2. This is a view of a large canker running the length of a stem on a tree (#407).

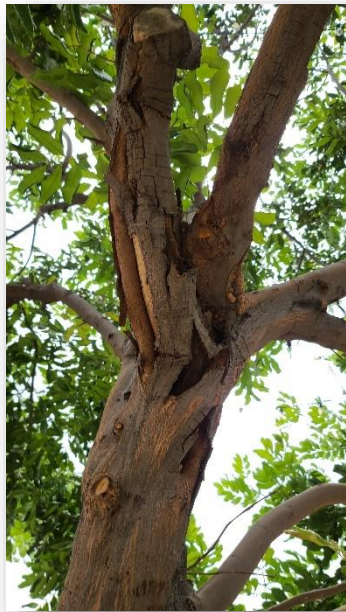
Plate 3. This is a view of a diseased limb within the canopy of a tree (#407).

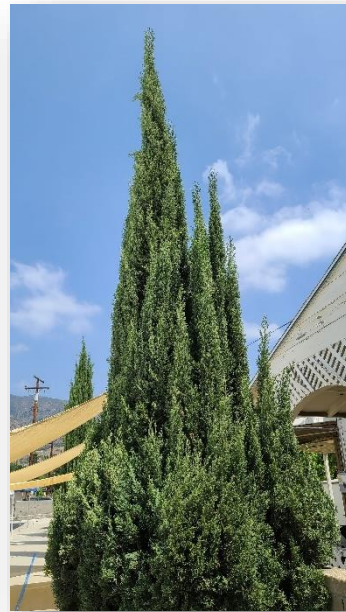
Plate 4. This is a view of a mal-formed canopy due to a topped central stem (#414).

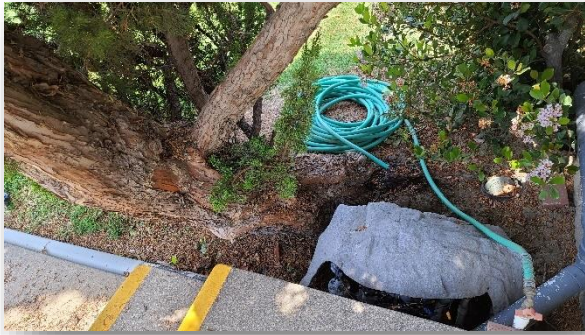
Plate 5. This is a view of a tree with a significant lean and a poorly developed stem flare (#415).

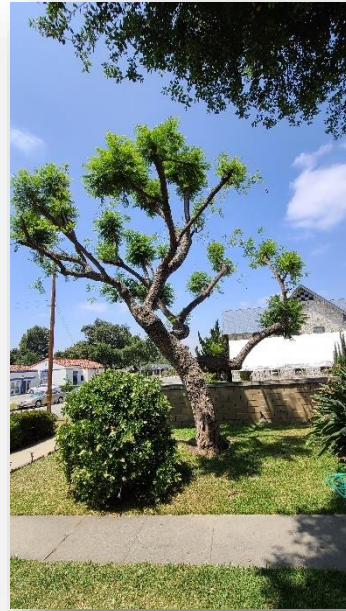
Plate 6. This is a view of a poorly trimmed tree (topped) where water sprouting has resulted (#416).

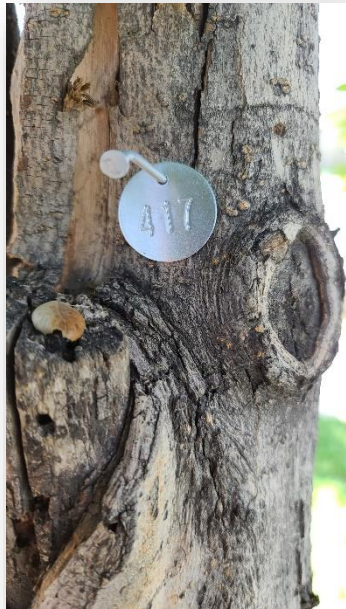
Plate 7. This is a view of deadwood with boreholes stemming from an unclosed branch cut (#417).

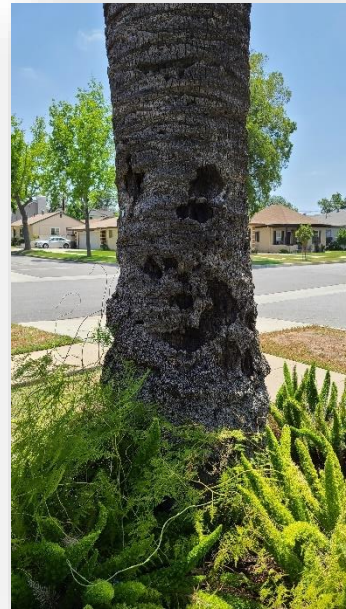
Plate 8. This is a view of possible trunk rot on the stem of a palm tree (#419).

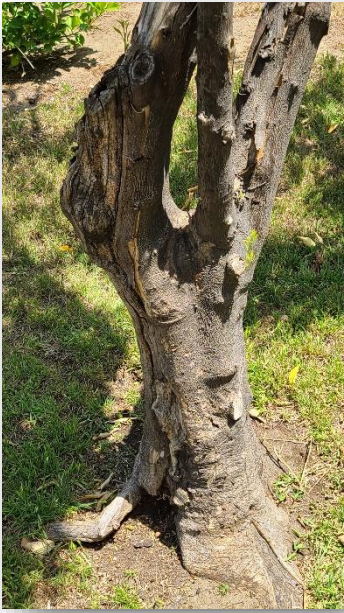
Plate 9. This is a view of severe decay on a stem (#420).

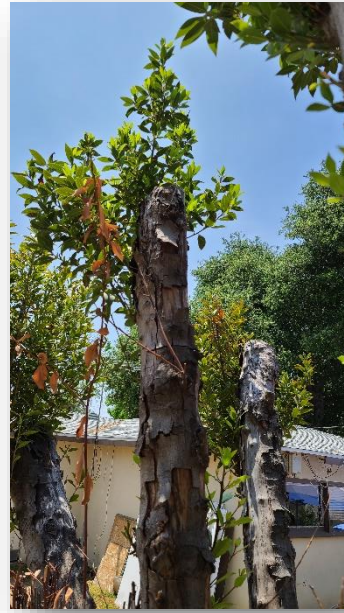
Plate 10. This is a view of a diseased tree in significant decline that has been topped (#423).

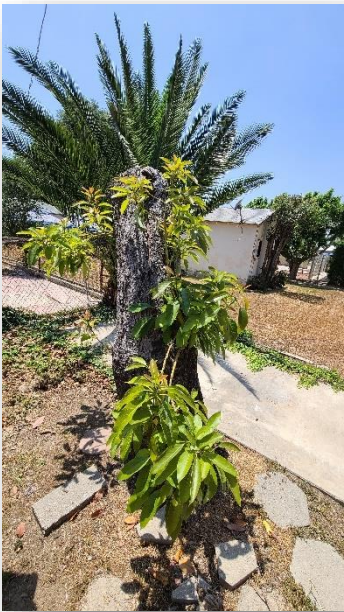
Plate 10. This is a view of topped tree with numerous emergent sprouts (#430).

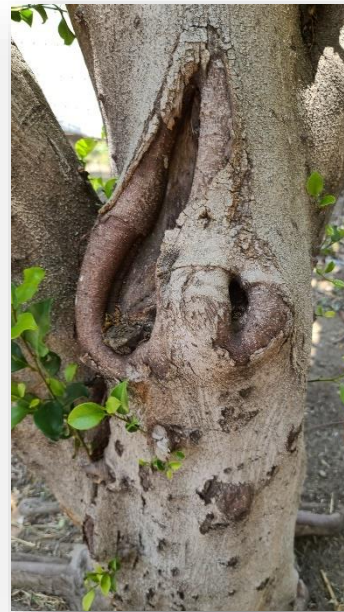
Plate 10. This is a view of an unclosed branch cut (#427).
