MACNAIR  
&  
ASSOCIATES  
CONSULTING ARBORISTS AND HORTICULTURISTS

RE: Kortum Canyon Arborist Report

According to your request, I have evaluated trees impacted by the proposed road improvements on the Kortum Canyon project site in Calistoga, CA. This evaluation identifies the trees within the roadway grading limits and assesses their health and structural condition. Also provided is an overview of general tree health on the project site.

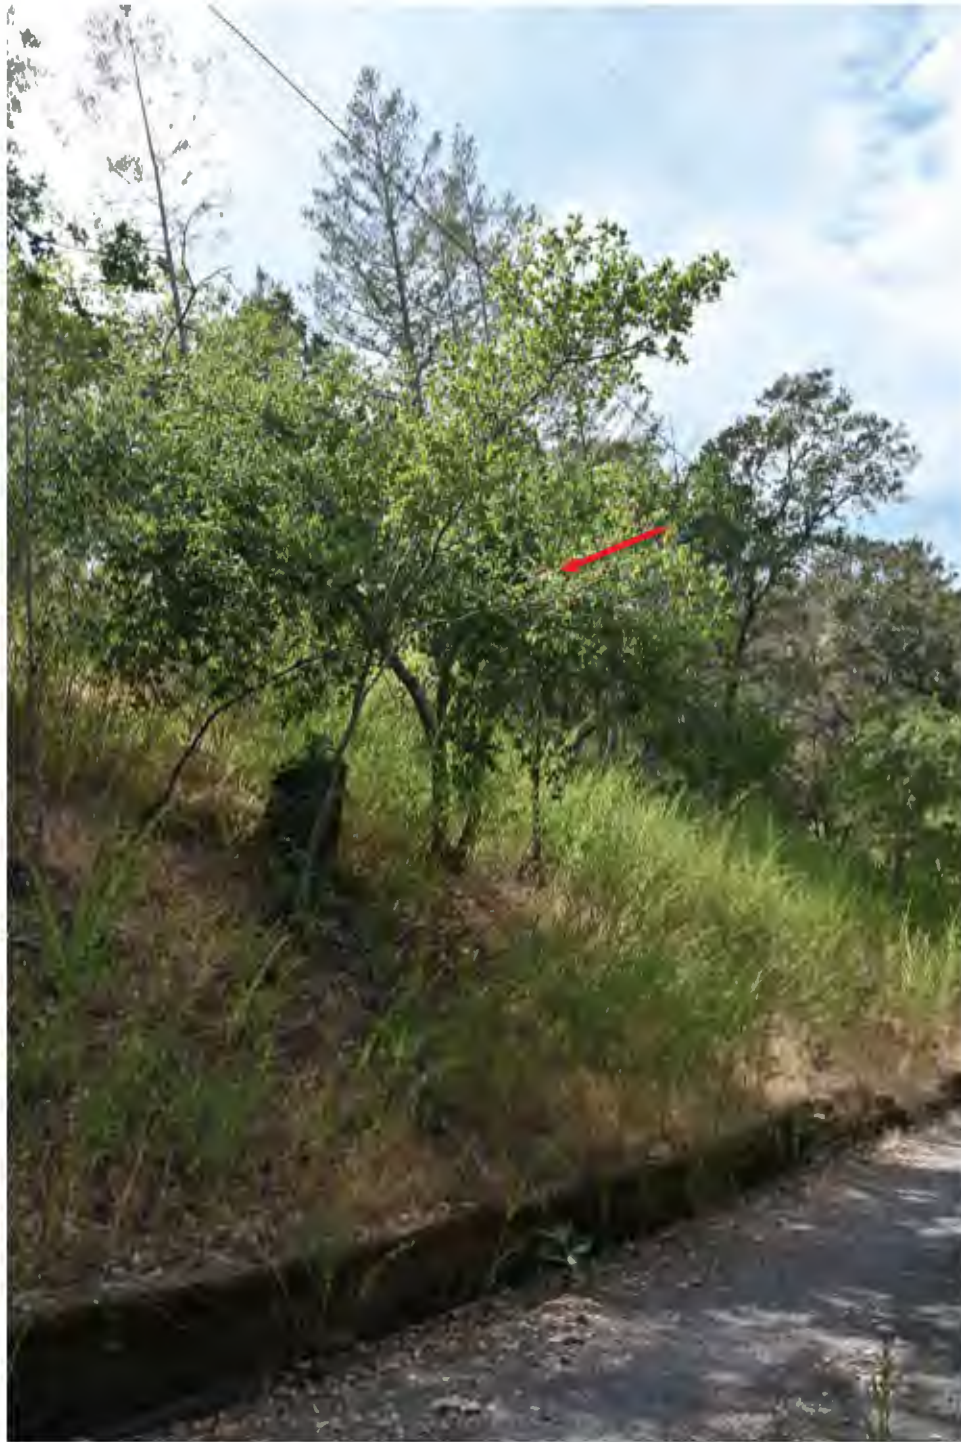
Tree #1, a coast live oak located in future road turnout. Located below electrical distribution lines and subject to clearance pruning.

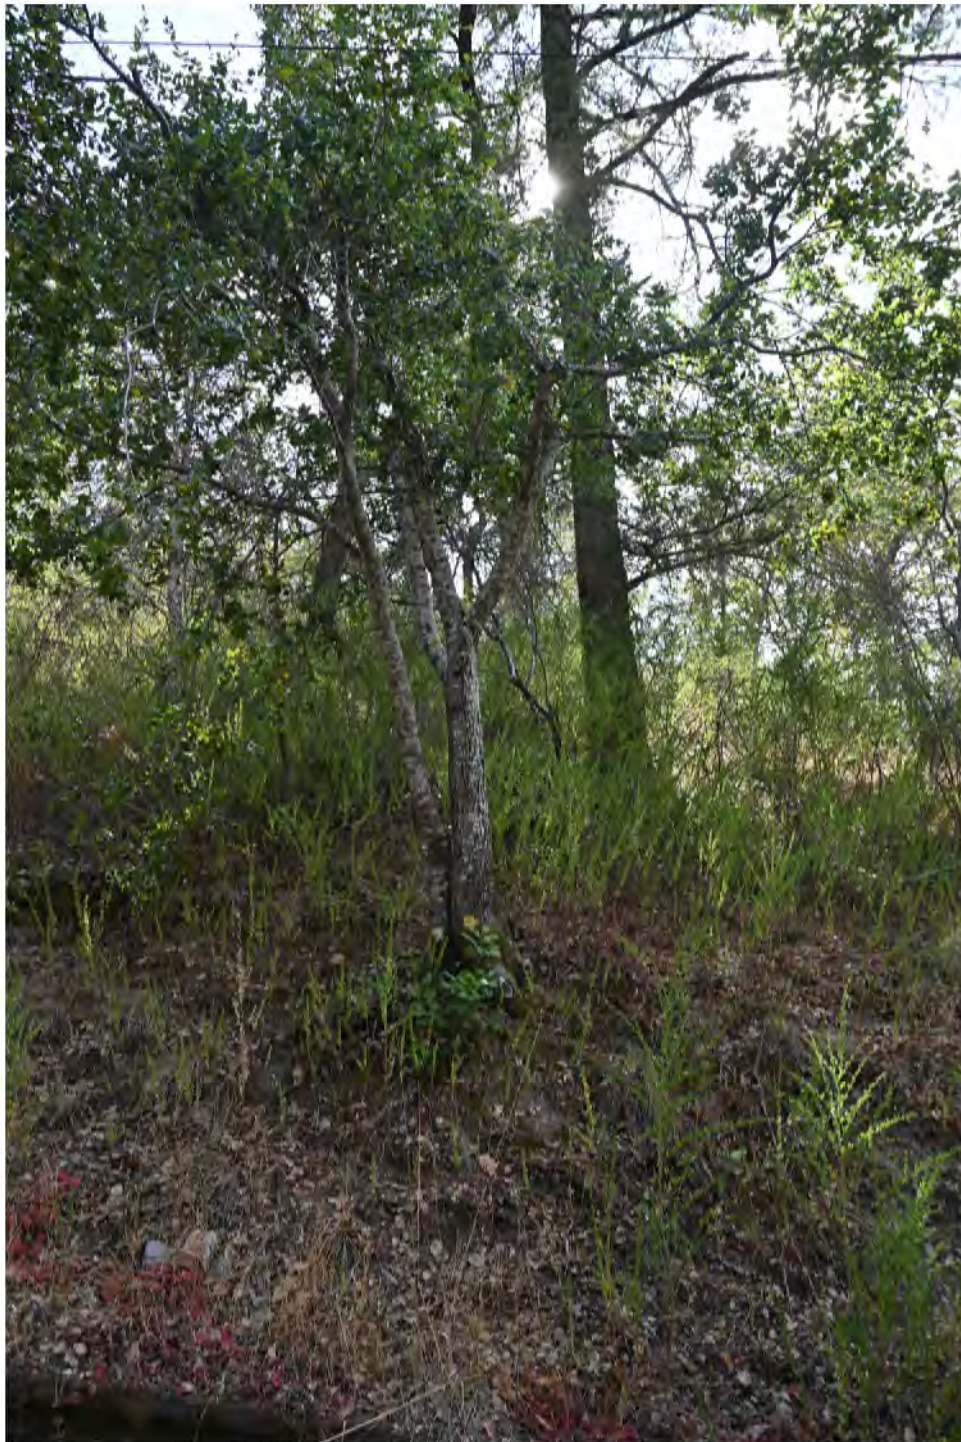
Tree #2, a coast live oak located in future road turnout. Located below electrical distribution lines and subject to clearance pruning.

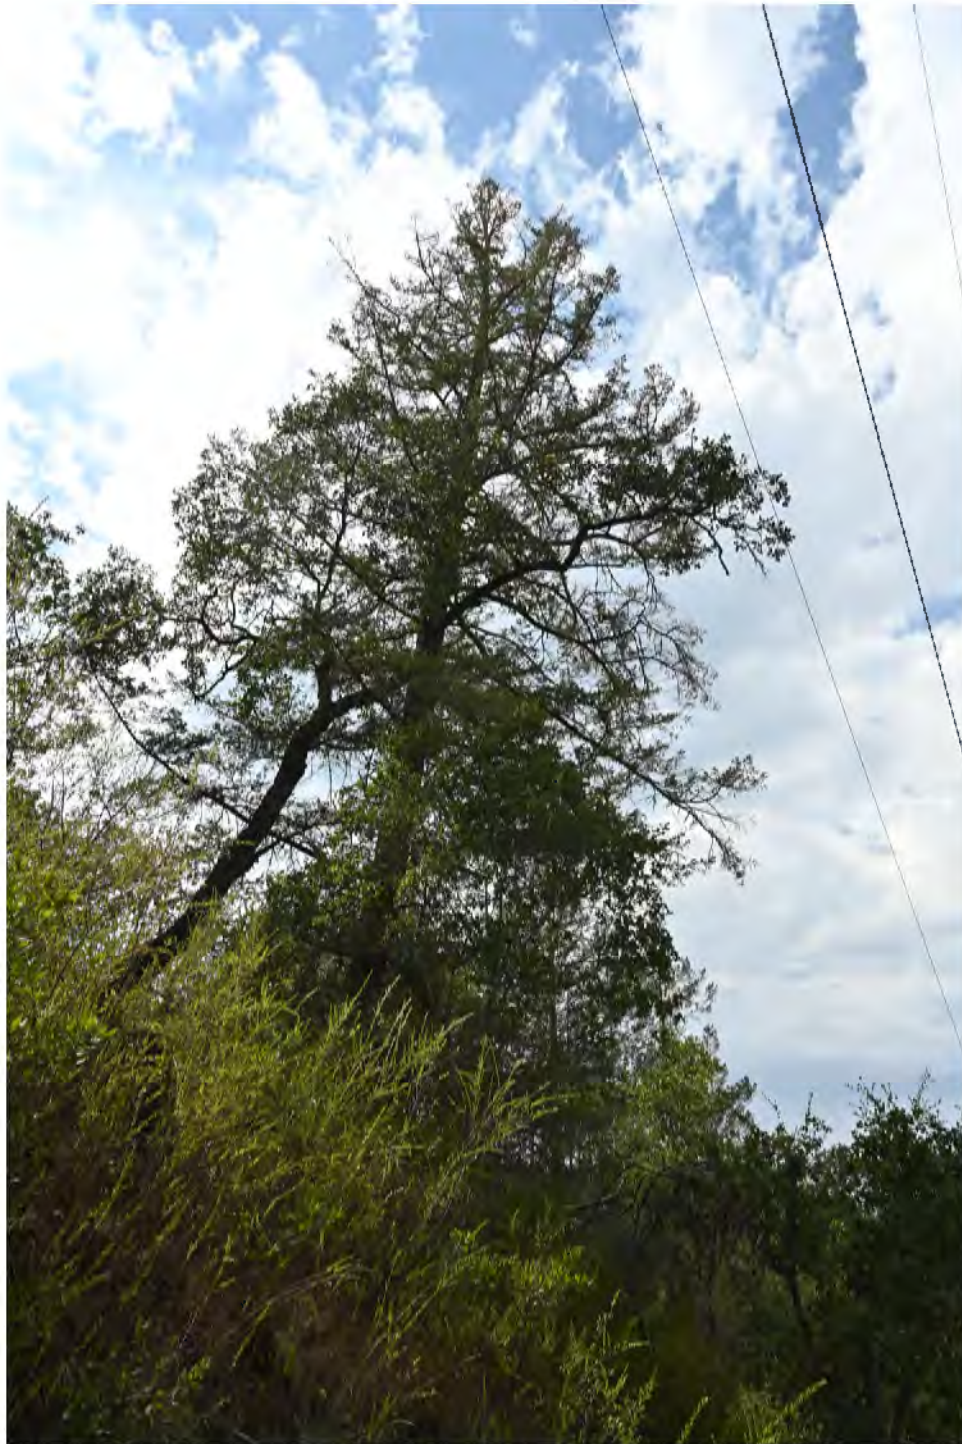
Tree #3, a Douglas fir, is in decline from boring insect attack. The tree is likely located in grading limits for road turnout.

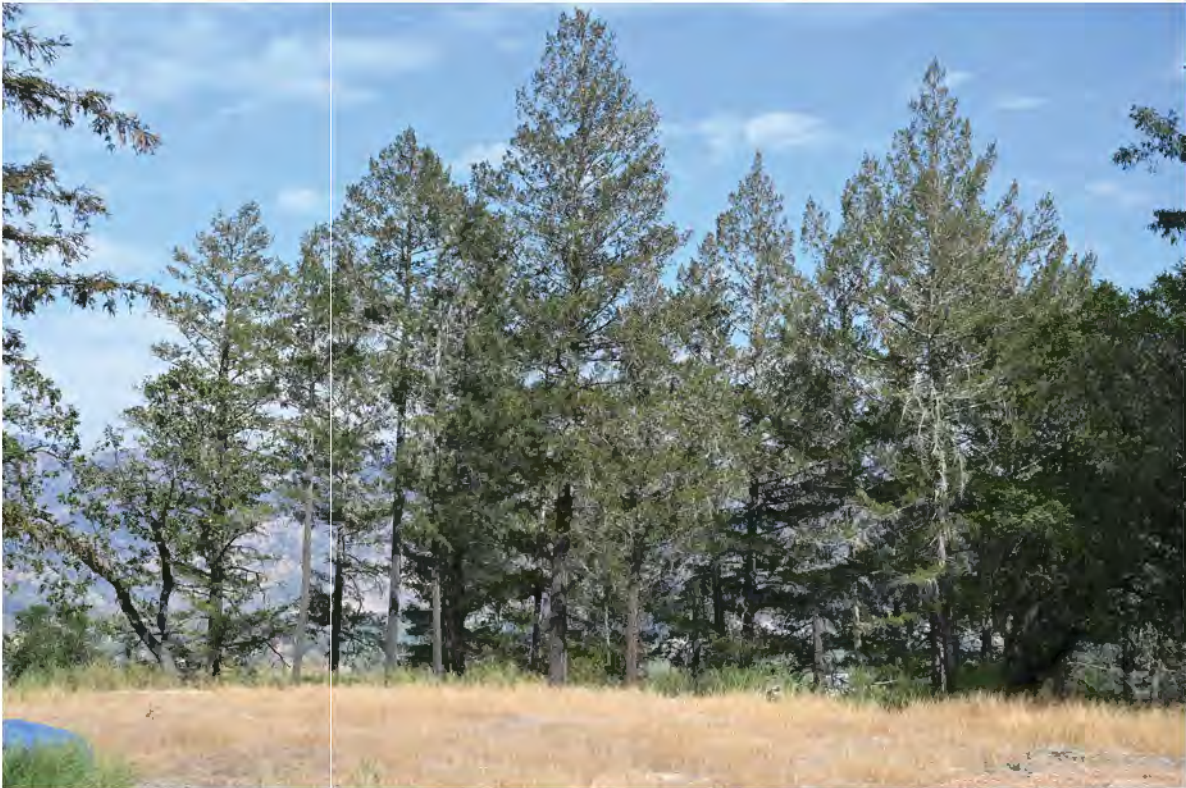
View of trees located in roadway realignment grading limits. Sixteen trees will require removal. The Douglas firs are in marginal health due to drought and boring insect attacks (flatheaded fir borer).

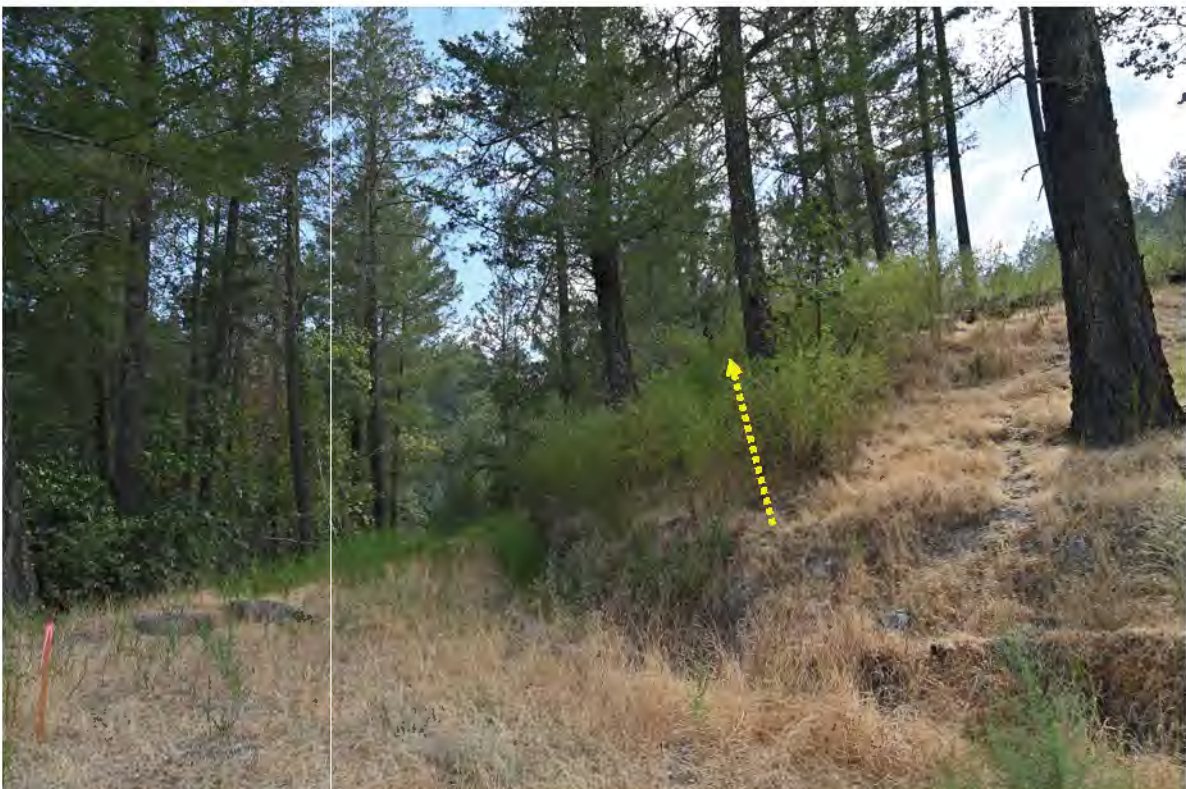
View to the south with the arrow indicating approximate roadway grading limits extending upslope and impacting 16 trees (3 oaks and 13 Douglas fir). (GPS waypoint 002.)

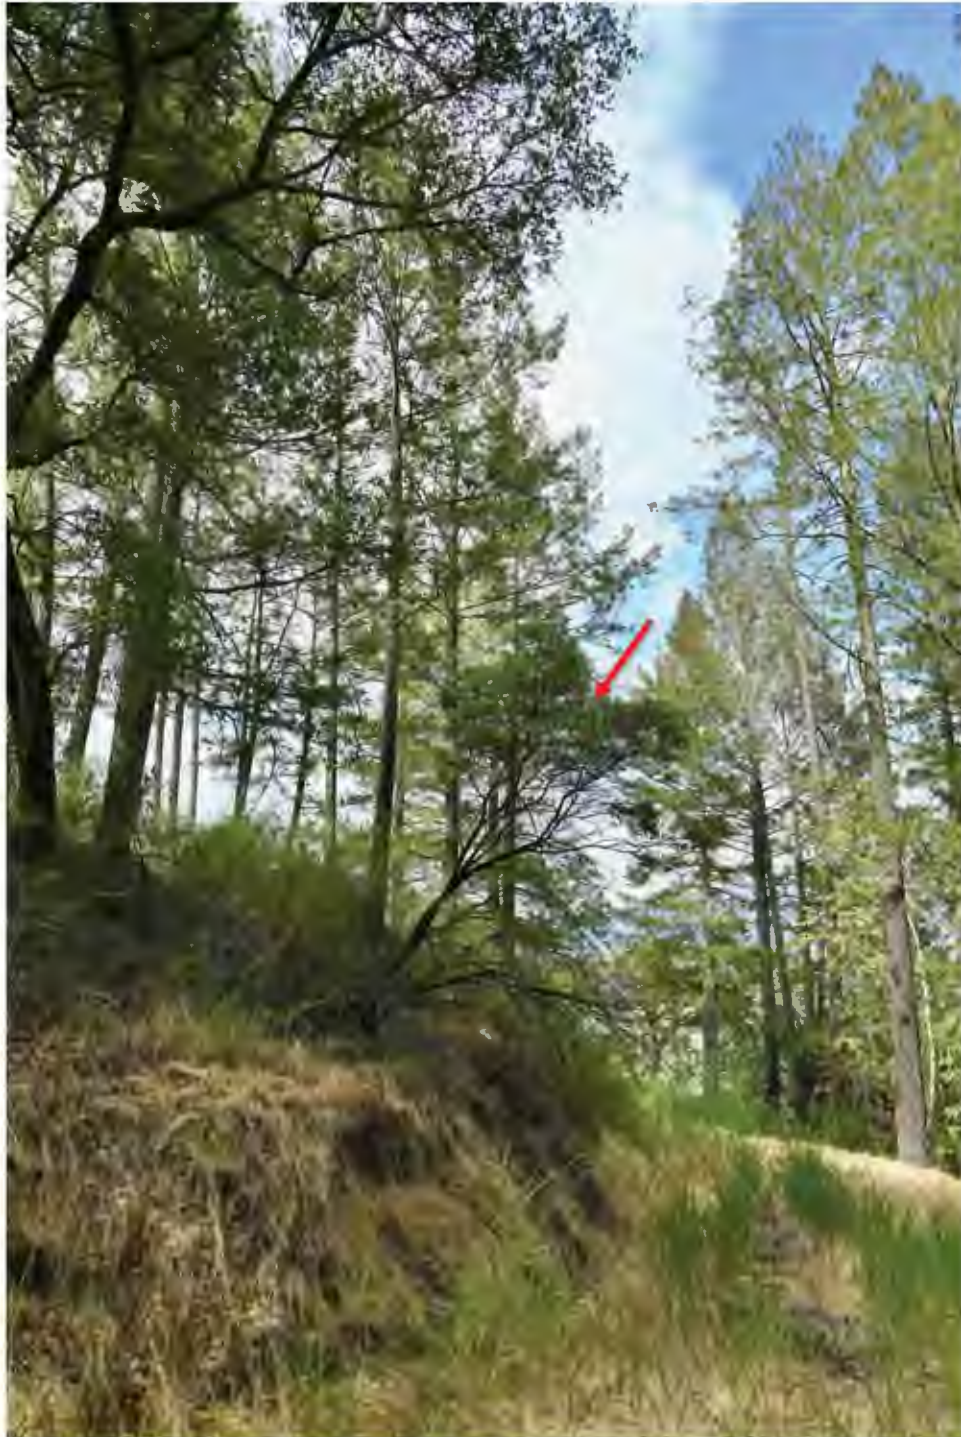
View from the north with the arrow indicating tree #9, a small coast live oak growing on the cut slope and within the grading limits. Also, the thinning crowns of the Douglas fir are evident.

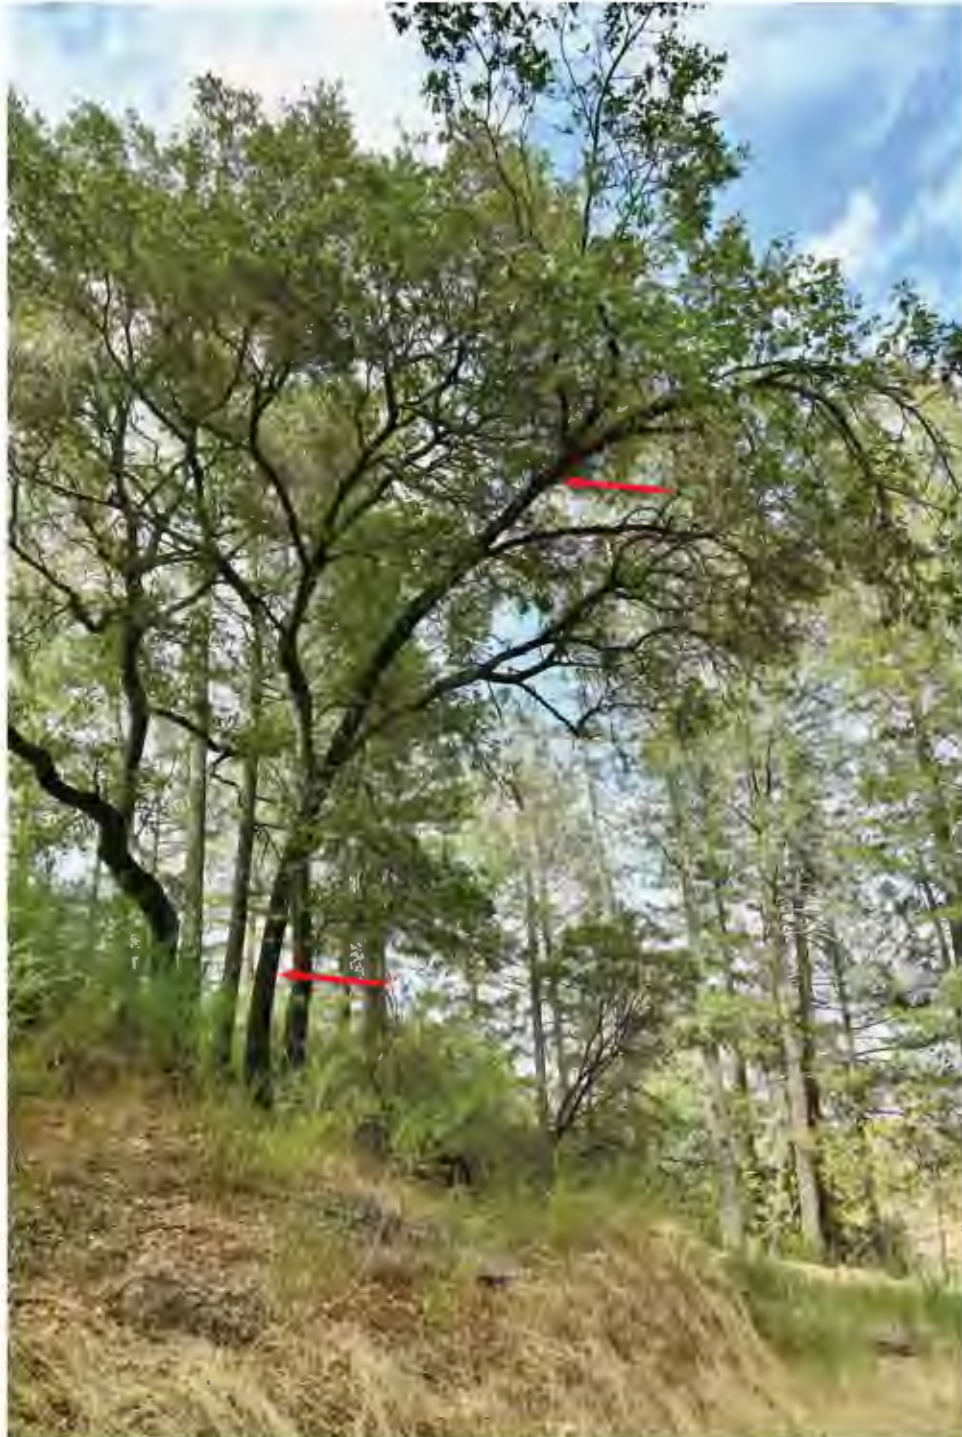
12 (002)	black oak ( <i>Quercus kelloggii</i> )	10"	1	35'±	30	2.5	2.5	Semi-mature tree with leaning, asymmetrical form. Growing in shaded conditions with moderately low vigor and foliage density.	Fair to Moderate	Yes	Yes	Located within grading limits. Removal required.
13 (002)	coast live oak	9.5"	1	35'±	20'±	2.5	2.5	Semi-mature tree with high-branched structure. Shaded with moderately low vigor and foliage density.	Fair to Moderate	Yes	Yes	Located within grading limits. Removal required.
14 (002)	Douglas fir	18"	1	65'±	30'±	1.5	2.0	Tree has low vigor with thinning crown. Likely under attack by the FFB. Lower trunk canker.	Poor	Yes	Yes	Located within grading limits. Removal required.
15 (002)	Douglas fir	16"	1	65'±	30'±	2.0	3.0	Tree has low vigor with thinning crown. Likely under attack by the FFB.	Poor	Yes	Yes	Located within grading limits. Removal required.
16 (002)	Douglas fir	16"	1	65'±	30'±	2.0	3.0	Tree has low vigor with thinning crown. Likely under attack by the FFB.	Poor	Yes	Yes	Located within grading limits. Removal required.

The red arrows indicate the bowed form of tree #12, a black oak. The tree is near the edge of the proposed grading limits and may require removal.

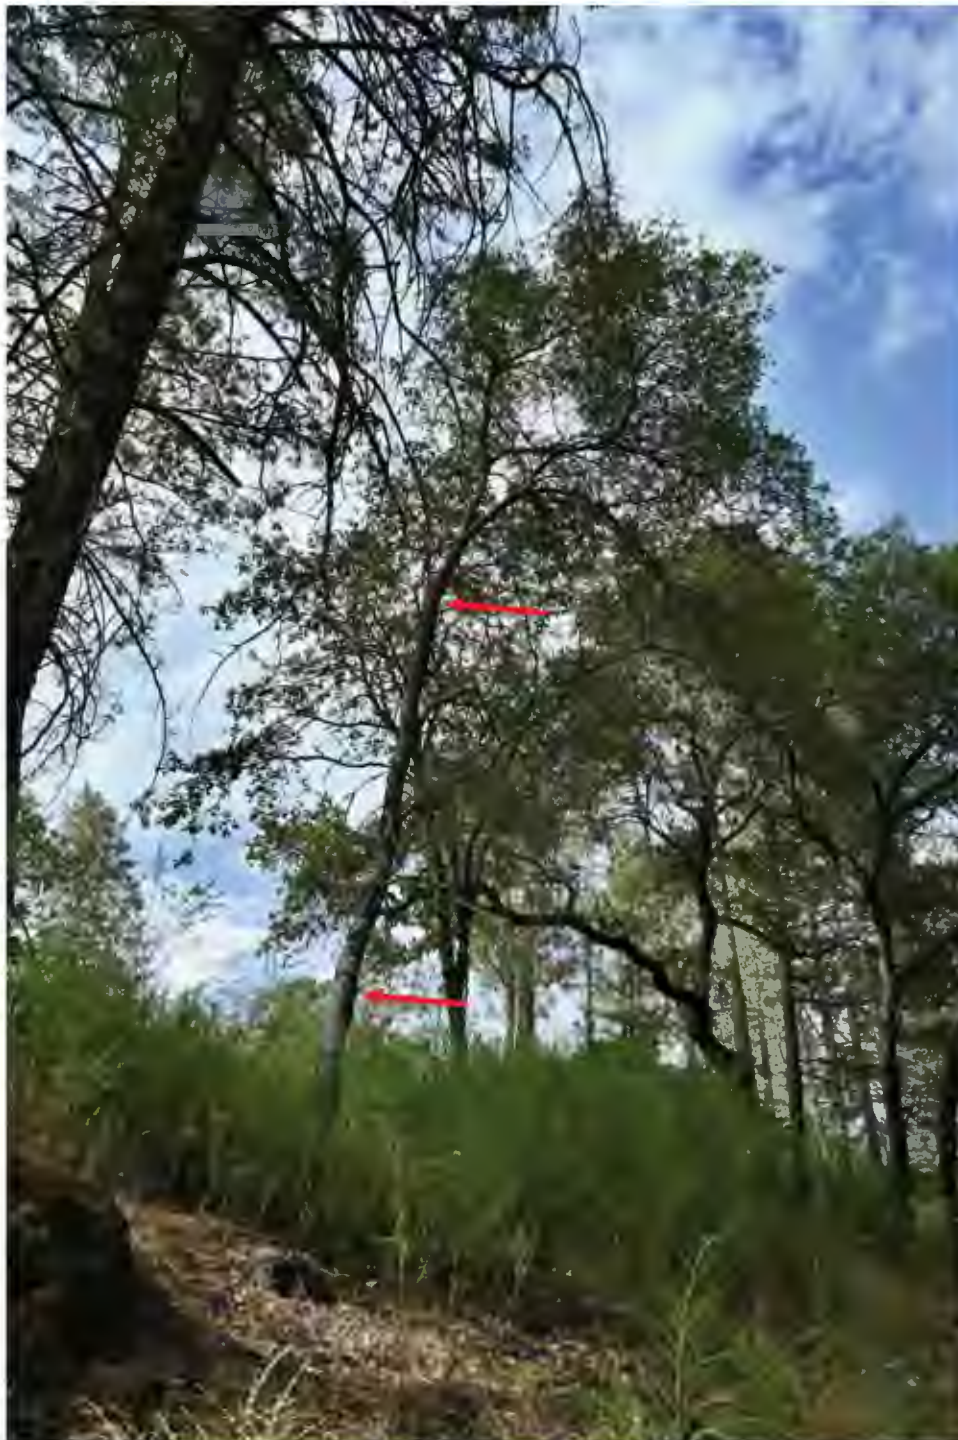
Tree #13, a coast live oak likely located in the road grading limits.

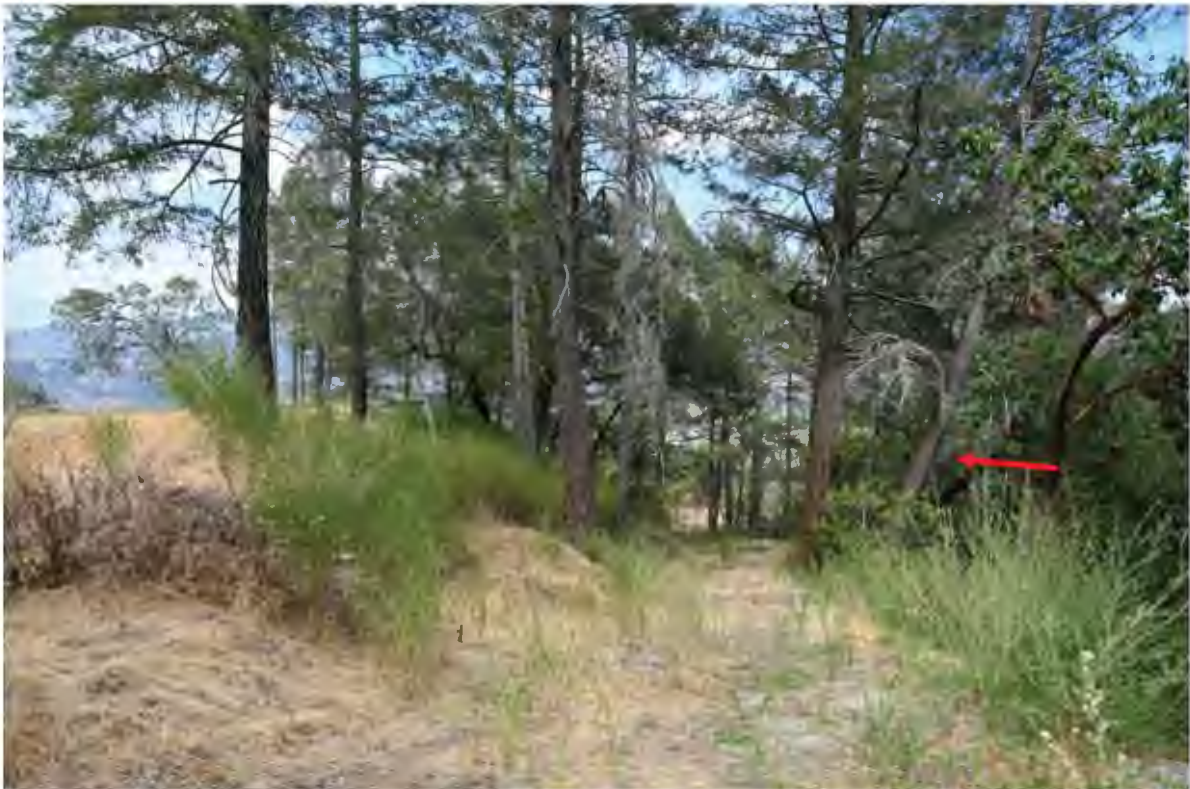
17 (002)	Douglas fir	24"	1	65'-70'±	30'±	2.0	3.0	Tree has low vigor with thinning crown. Likely under attack by the FFB.	Poor	Yes	Yes	Located within grading limits. Removal required.
18 (002)	Douglas fir	36"	1	65'-70'±	30'±	2.0	3.0	Tree has low vigor with thinning crown. Likely under attack by the FFB. Located at edge of roadway.	Poor	Yes	Yes	Located within grading limits. Removal required.
19 (002)	Douglas fir	24"	1	45'-50'±	20'±	1.0	2.0	Leaning structure with top of trunk broken. Tree is in advanced decline.	Poor	Yes	Yes	Located within grading limits. Removal required.

The south end of the roadway grading limits the area with trees #14 through #19. Trees #18 and #19 are on the left (arrow). Significant areas of the invasive French broom are present.

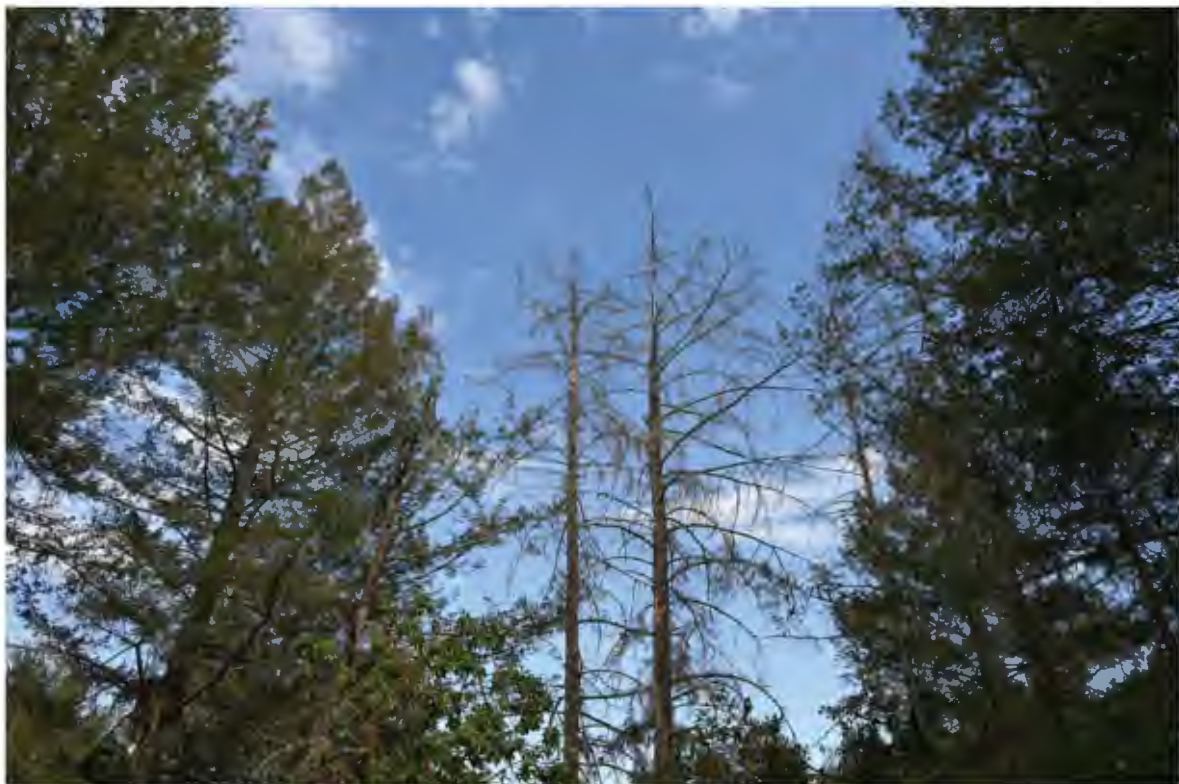
Numerous Douglas firs are either dead or in decline in this area from the FFB.

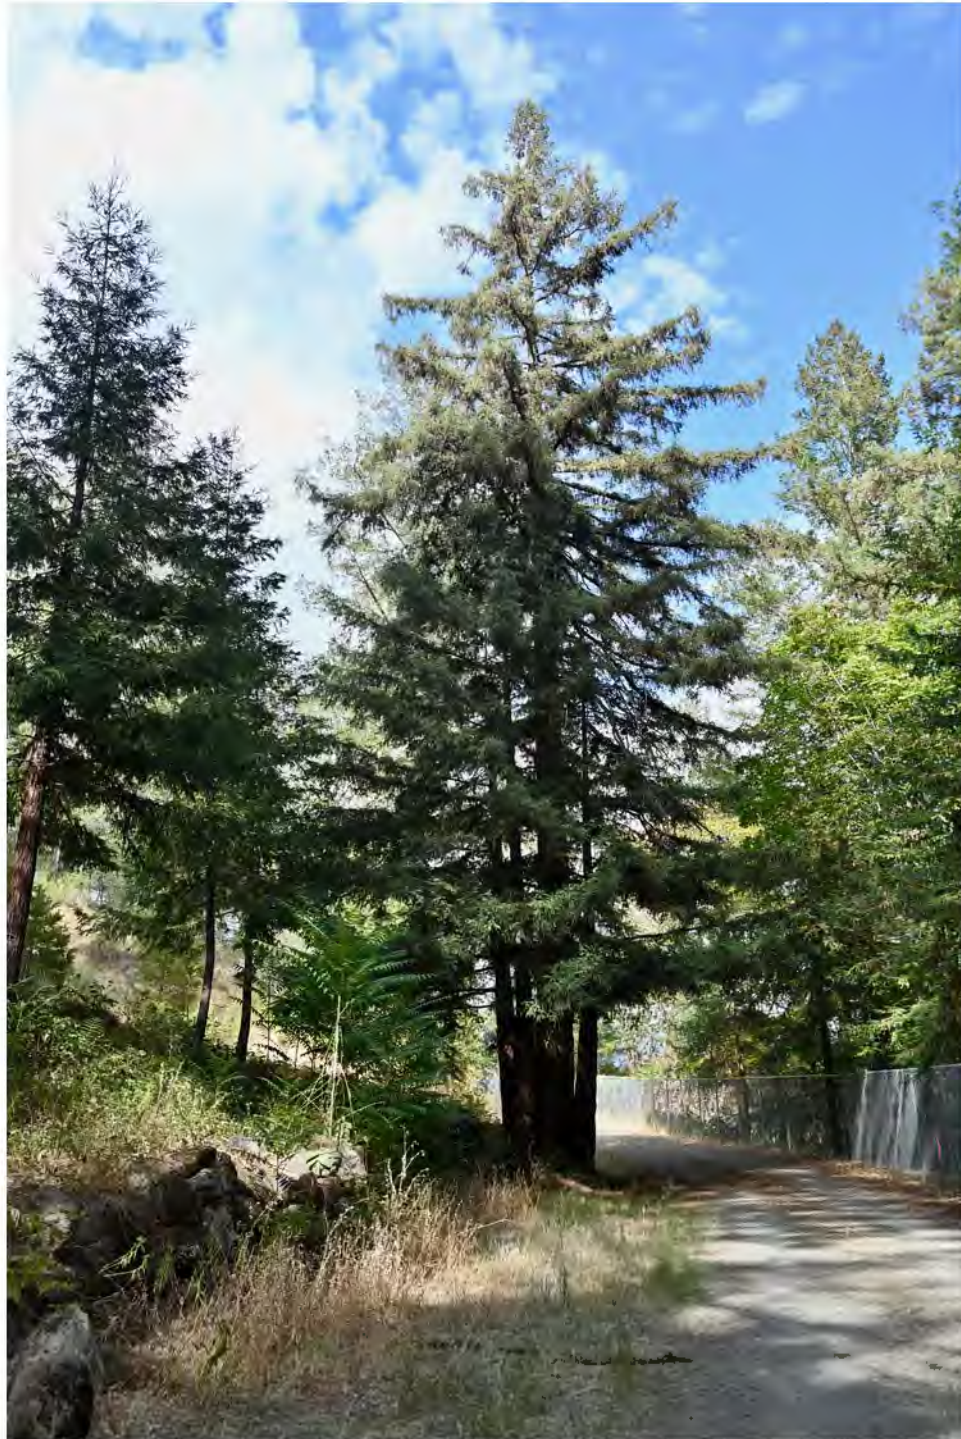
Tree # (GPS Waypoint)	Species	Trunk Diameter @ 54" (inches)	# of Trunks	Crown Height	Crown Diameter	Health Rating	Structural Rating	Comments/Observations	Suitability for Preservation (Based Upon Condition)	Native Tree	Protected Tree Status	Construction Impact Assessment
20 (003)	coast redwood ( <i>Sequoia sempervirens</i> )	15"; 17"; 18"; 32"±	4	70'±	35'±	3.0	2.5	Mature cluster with 18" and 32" trunks attached. Possible old trunk wound. Moderate vigor and foliage density. Located in grading limits.	Moderate	Yes	Yes	Located within grading limits. Removal required. May possibly be retained depending on roadway width requirement.

Tree #20, a coast redwood, is located in the road grading limits (GPS waypoint 003). Depending on the required minimum road width for fire equipment, efforts will be made to retain the tree.

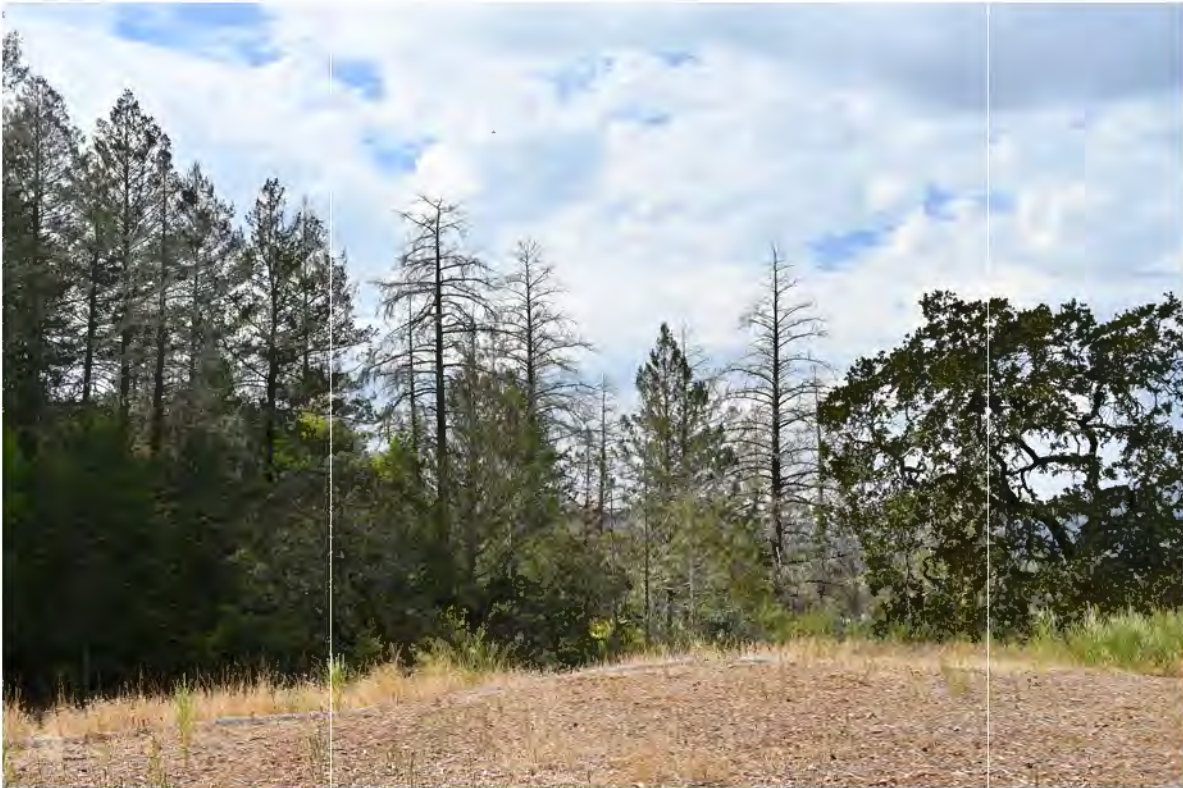
View to the northwest from the central portion of the property. The dead firs tend to be in clusters because of the method of infestation from FFB.

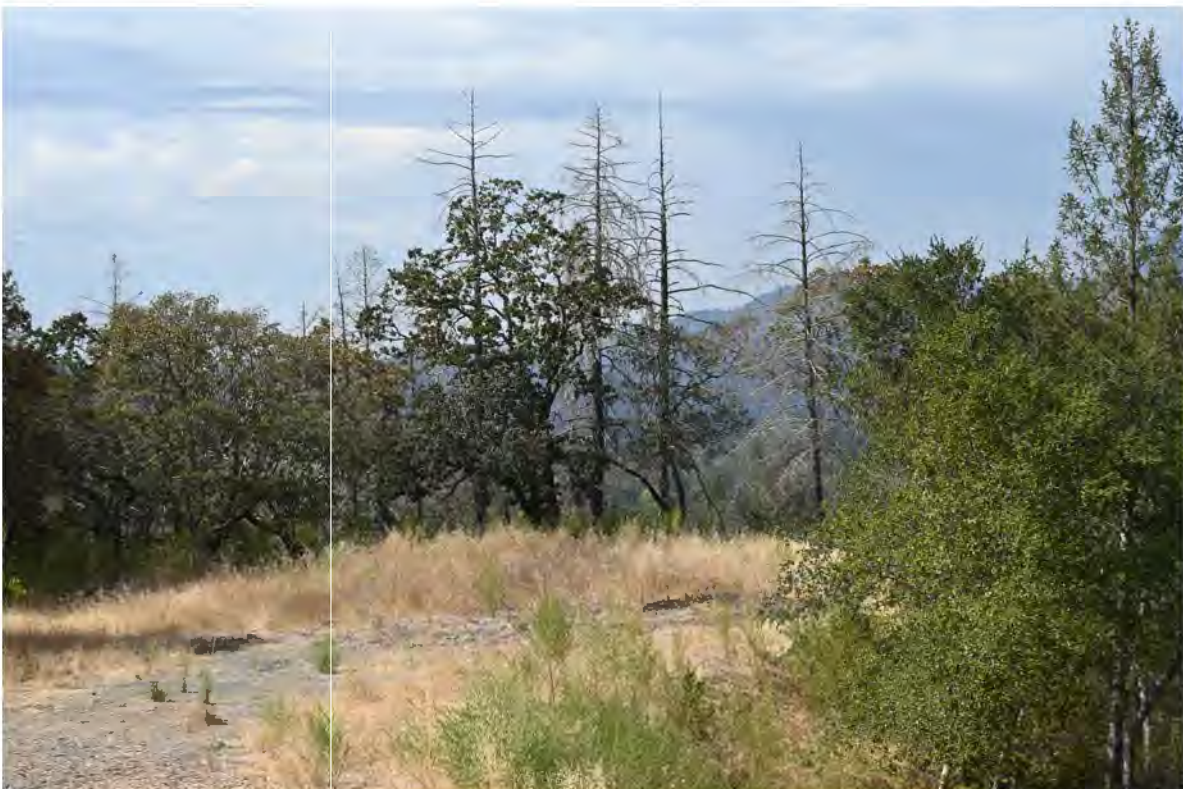
There are numerous dead firs on the north downslope side of the property. Many are on the neighboring property.

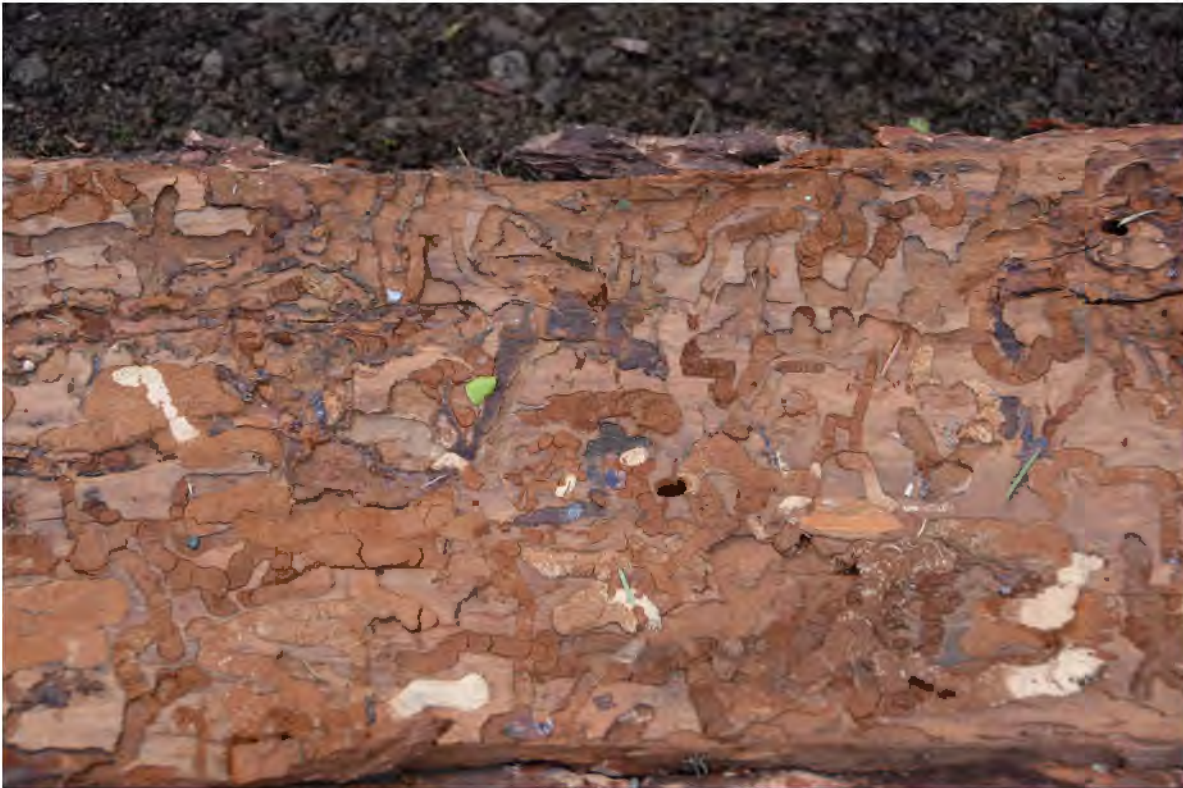
Larval galleries of the flatheaded fir borer (Kenwood, CA)

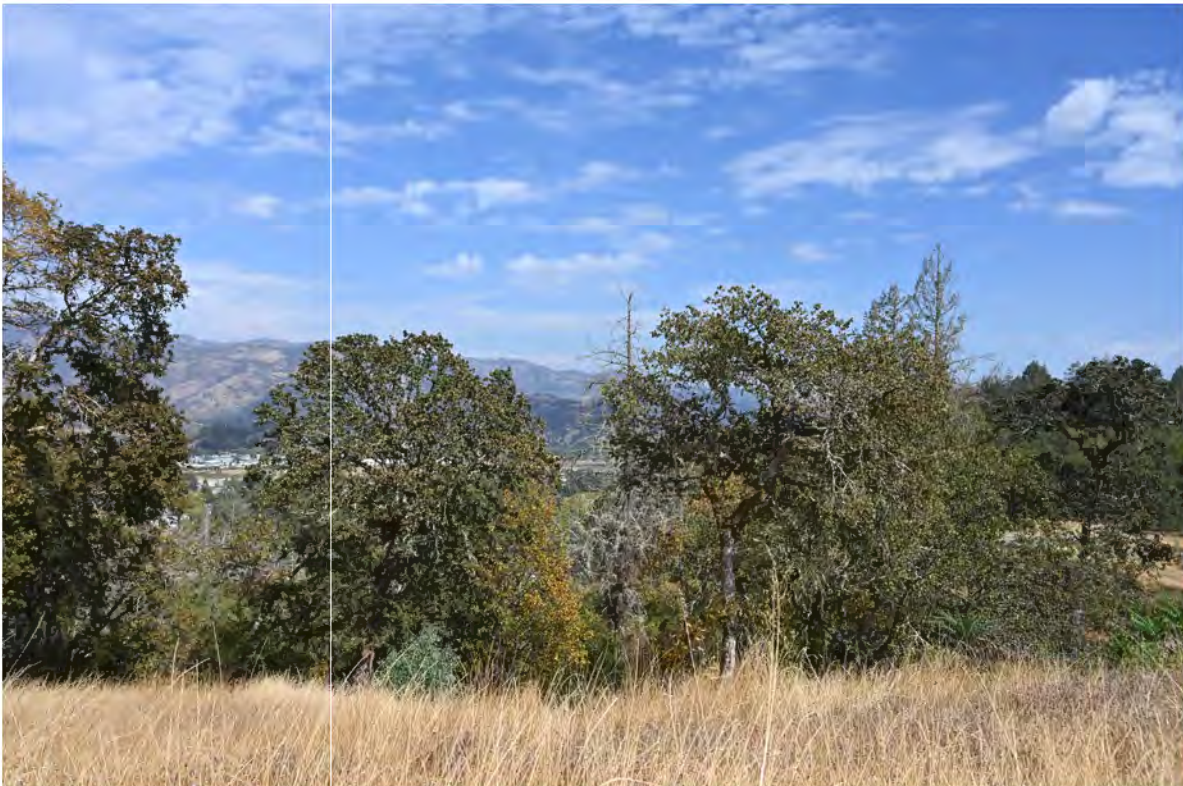
The various native oak species are generally in moderate condition despite the drought conditions.

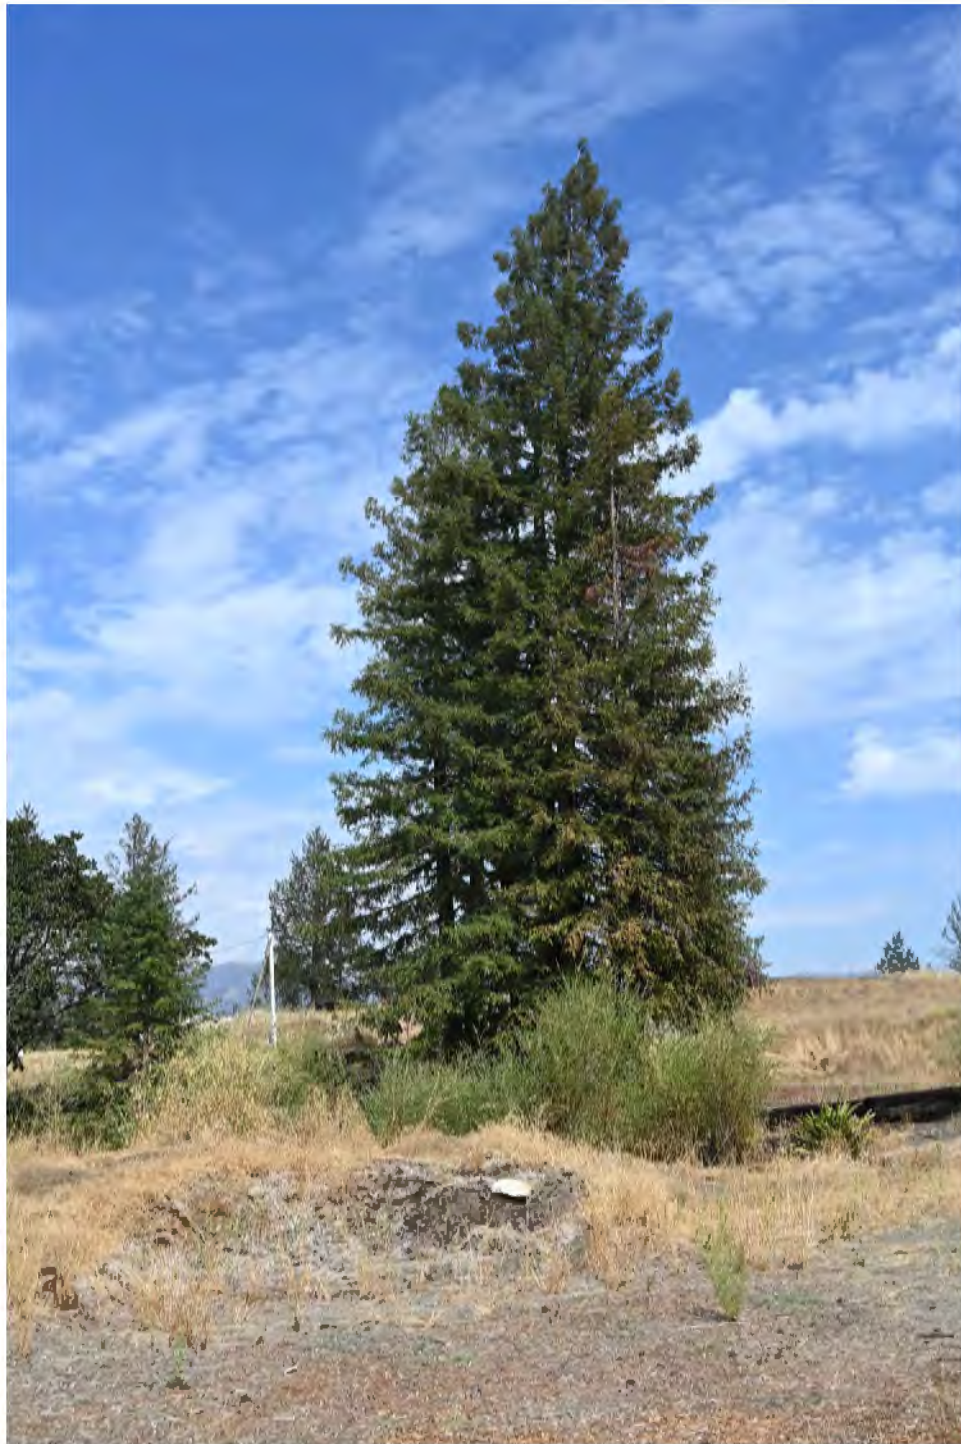
The coast redwoods on the site are also generally in moderate health.

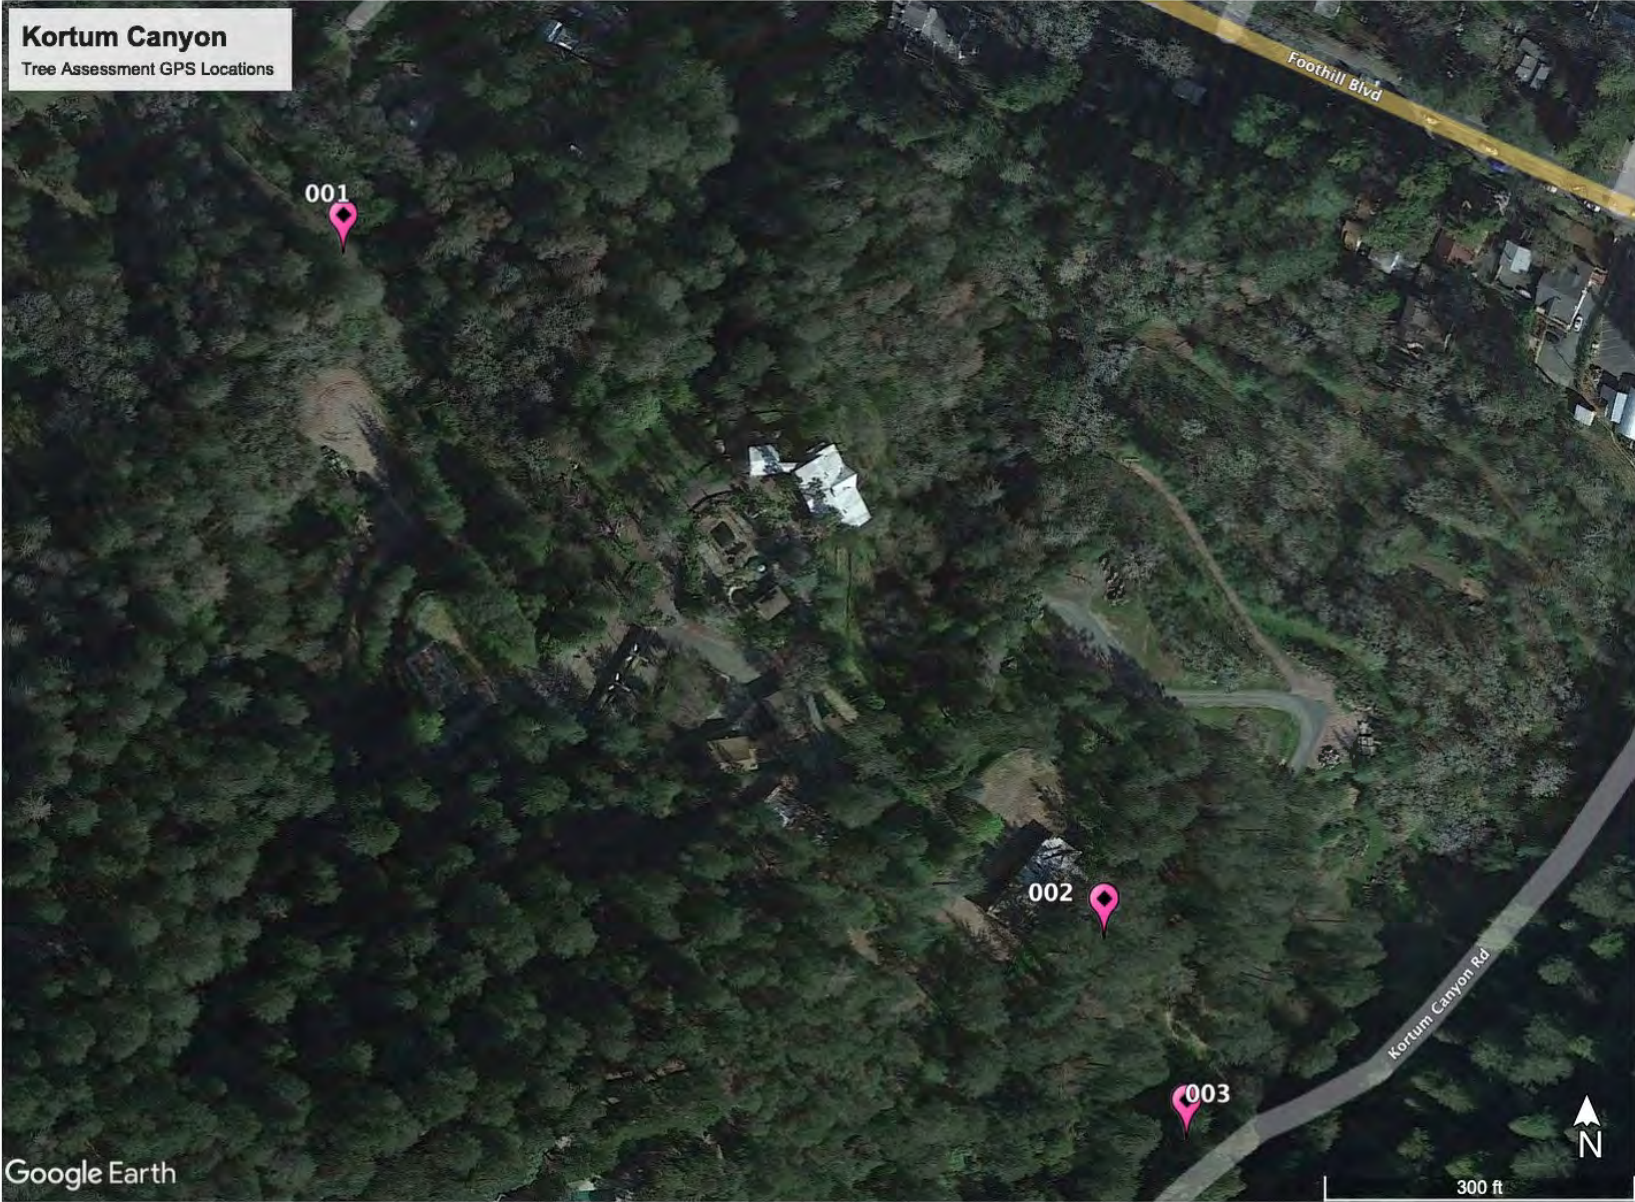
Aerial showing roadway tree impact areas.
