ARBORIST REPORT-
Tree Survey & Construction Impact Assessment

125 Kirk Avenue

APN: 601-07-066

12/7/2021

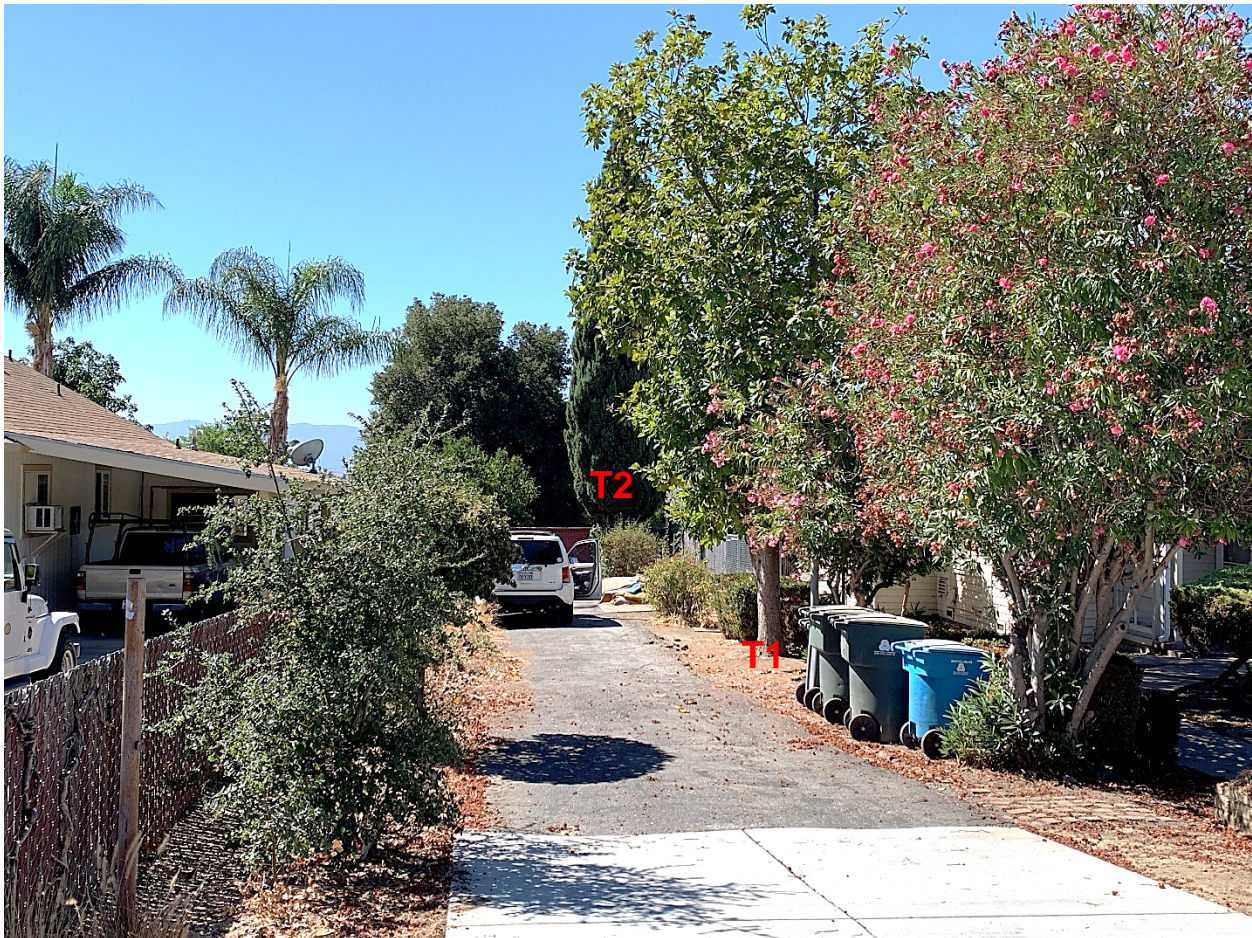
Image #1 – Trees T1, southern magnolia T2, Italian cypress, growing along access driveway, as seen from Kirk Avenue.

Both the magnolia and the Italian cypress are mature trees in good condition.

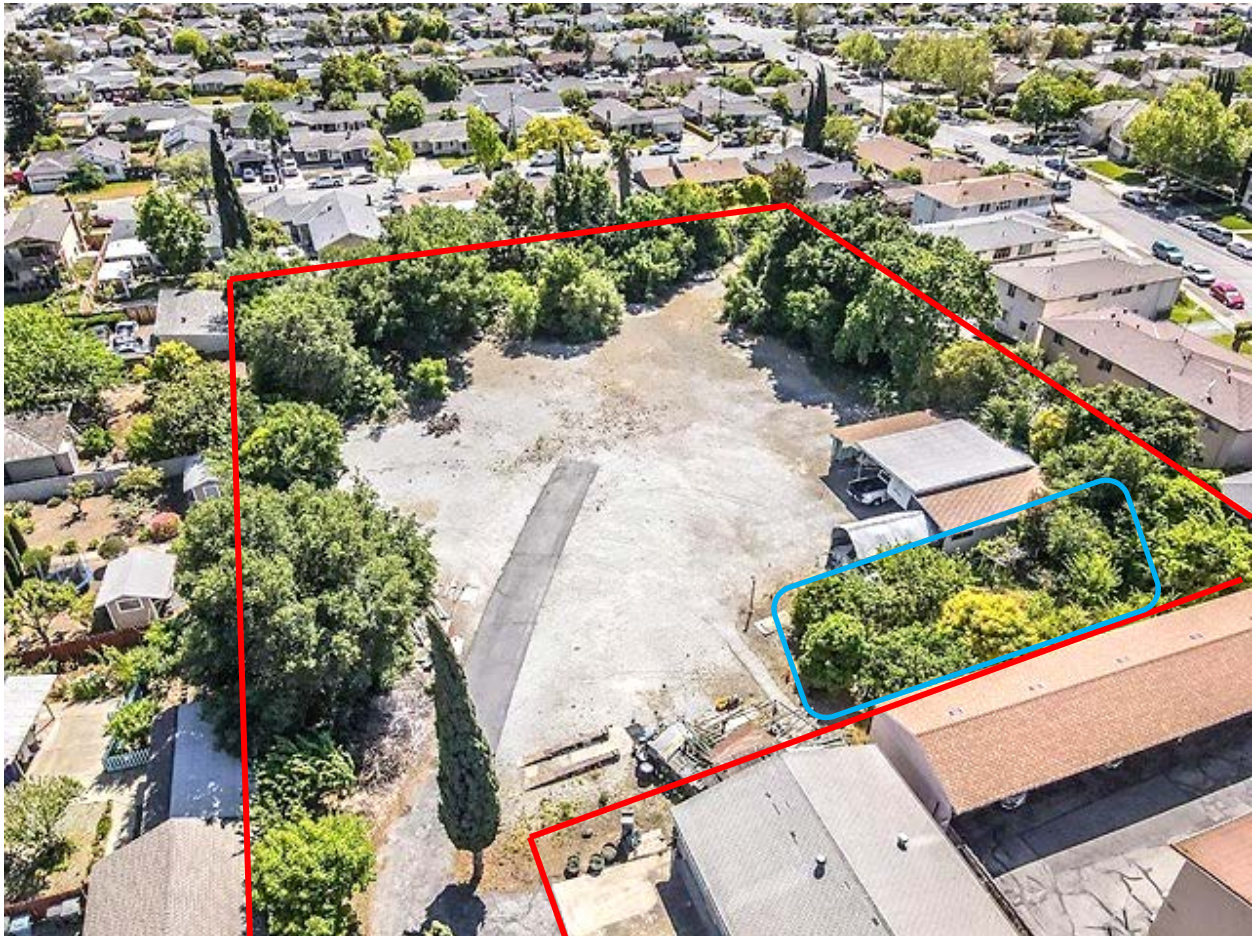
Image #2, overhead view of back lot where most trees are located. Property boundary in red is approximate. Most trees are oak species. The blue rectangle indicates the area planted as a fruit tree orchard.

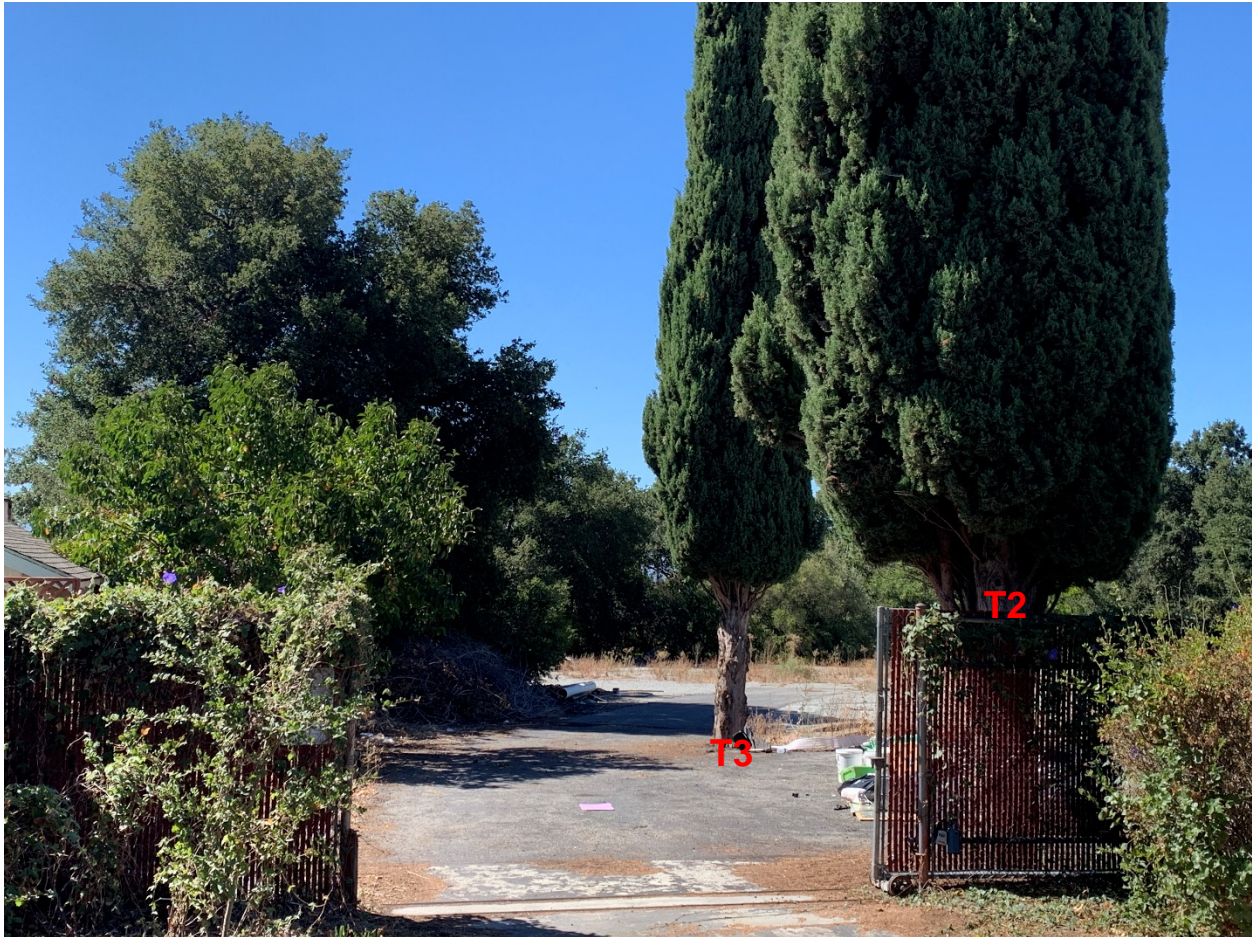
Image #3- Trees T2 & T3, Italian cypress.

The two cypress are in good condition.

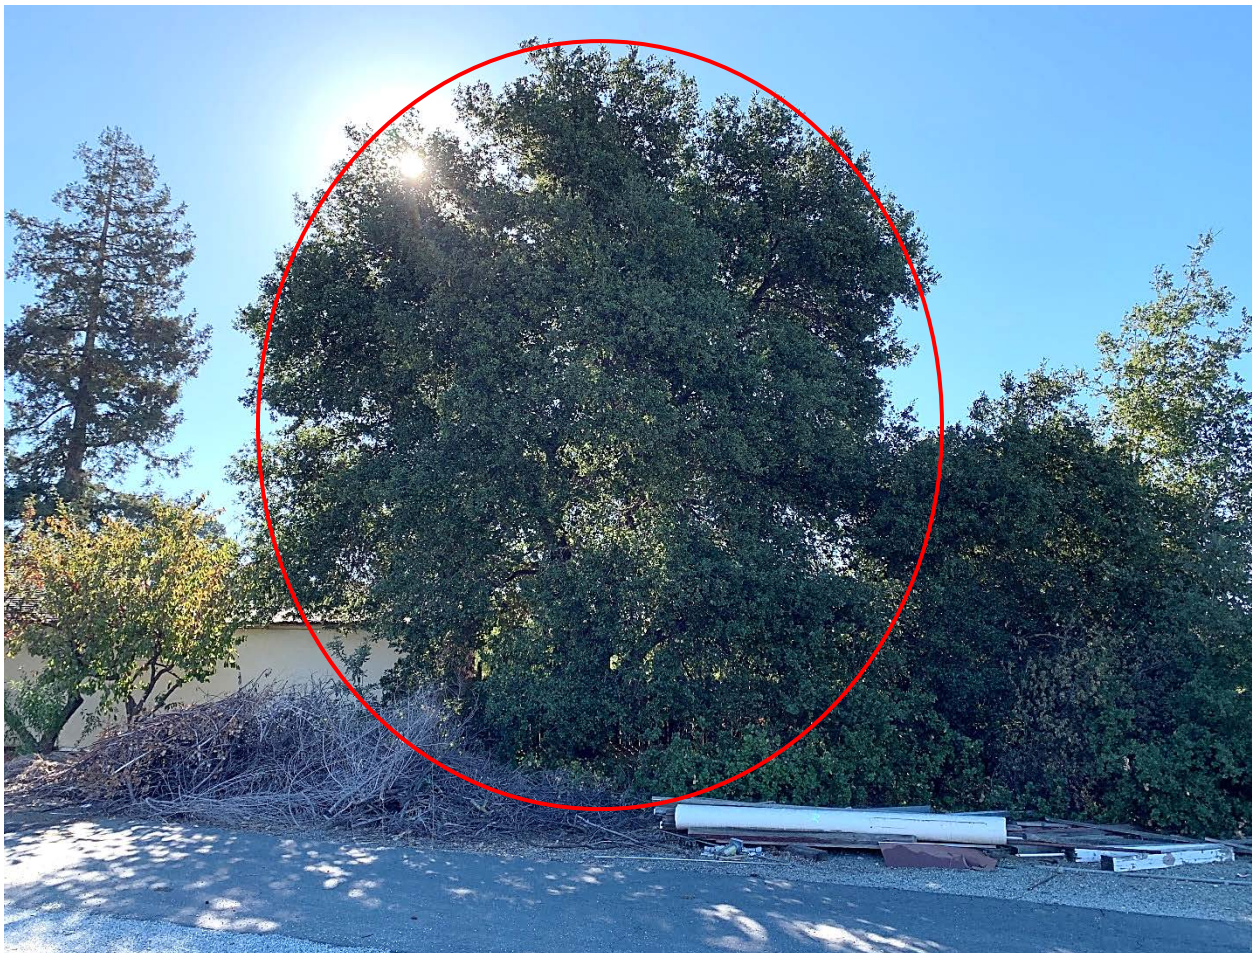
Image #4- Tree T107, coast live oak, (circled). Tree T106, plum is seen growing to the left of oak.

Coast live oak T107 was in good condition and had co-dominant trunks of 24-inches and 20-inches.

Most of the largest “ordinance size”, coast live oak trees in good or fair condition including T107, T112, T122, T135, & T137 are within or very near the building footprint, will be significantly impacted, and their removal will be necessary.

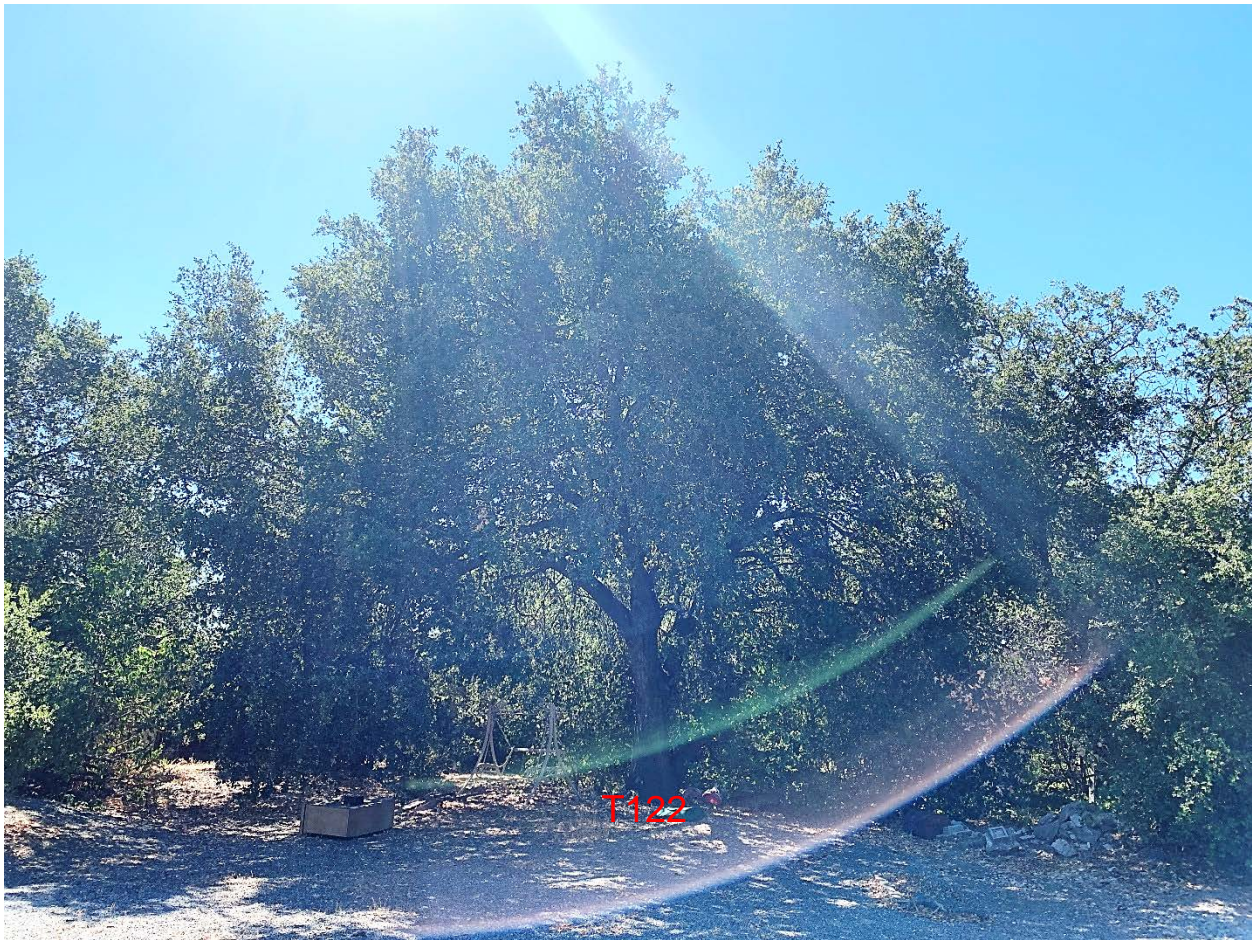
Image #5 Tree T122, coast live oak. Oak grows towards the (southern), rear end of property.

The large, mature coast live oak is in good condition.

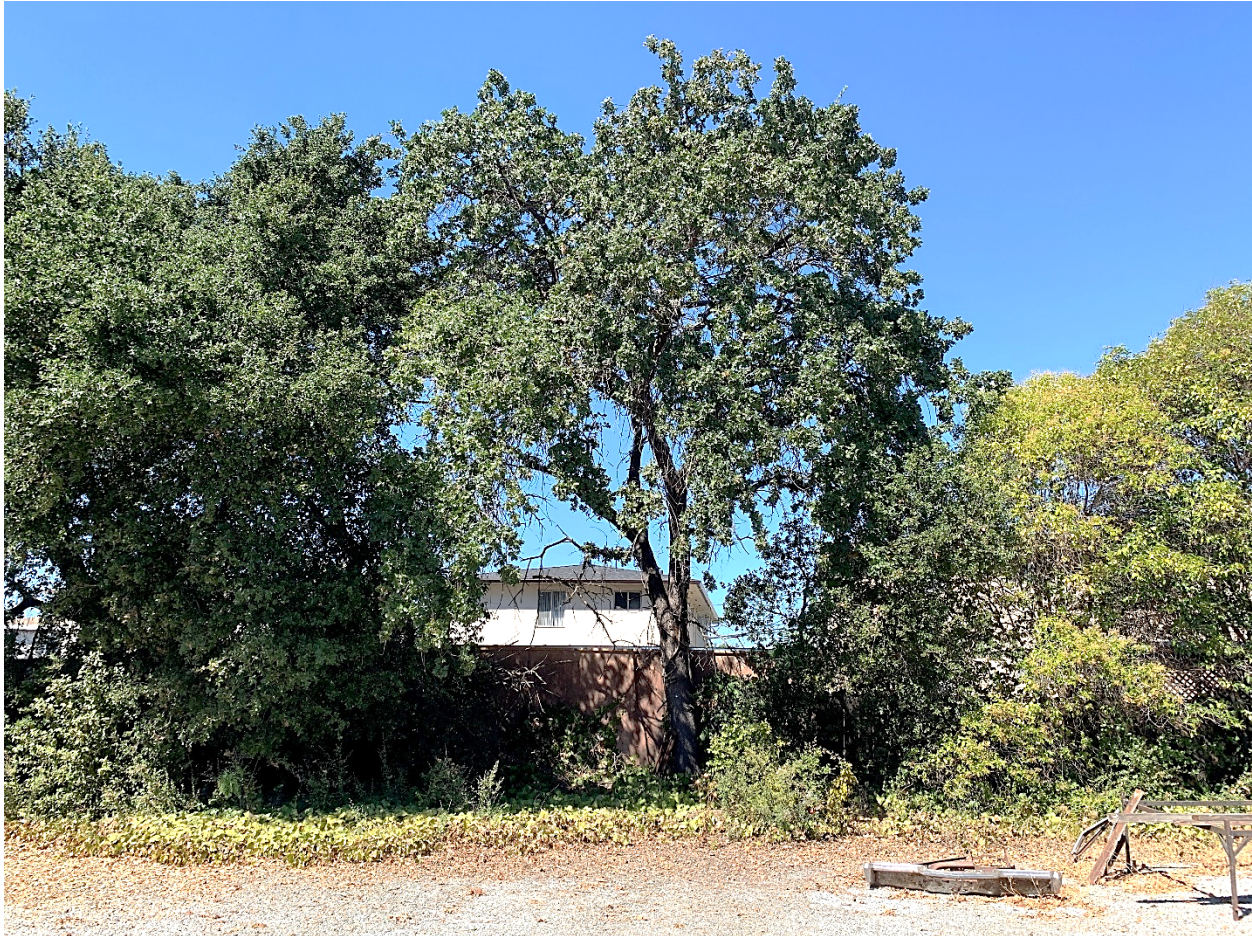
Image #6 – Tree T139, valley oak. This oak is in fair to poor health as evidenced by significant tip dieback that is not discernable in image.

Three of the valley oaks were in poor condition. All appear to be drought stressed as evidenced significant tip dieback. Some were in crowded growing conditions and had thin canopy densities as a result.

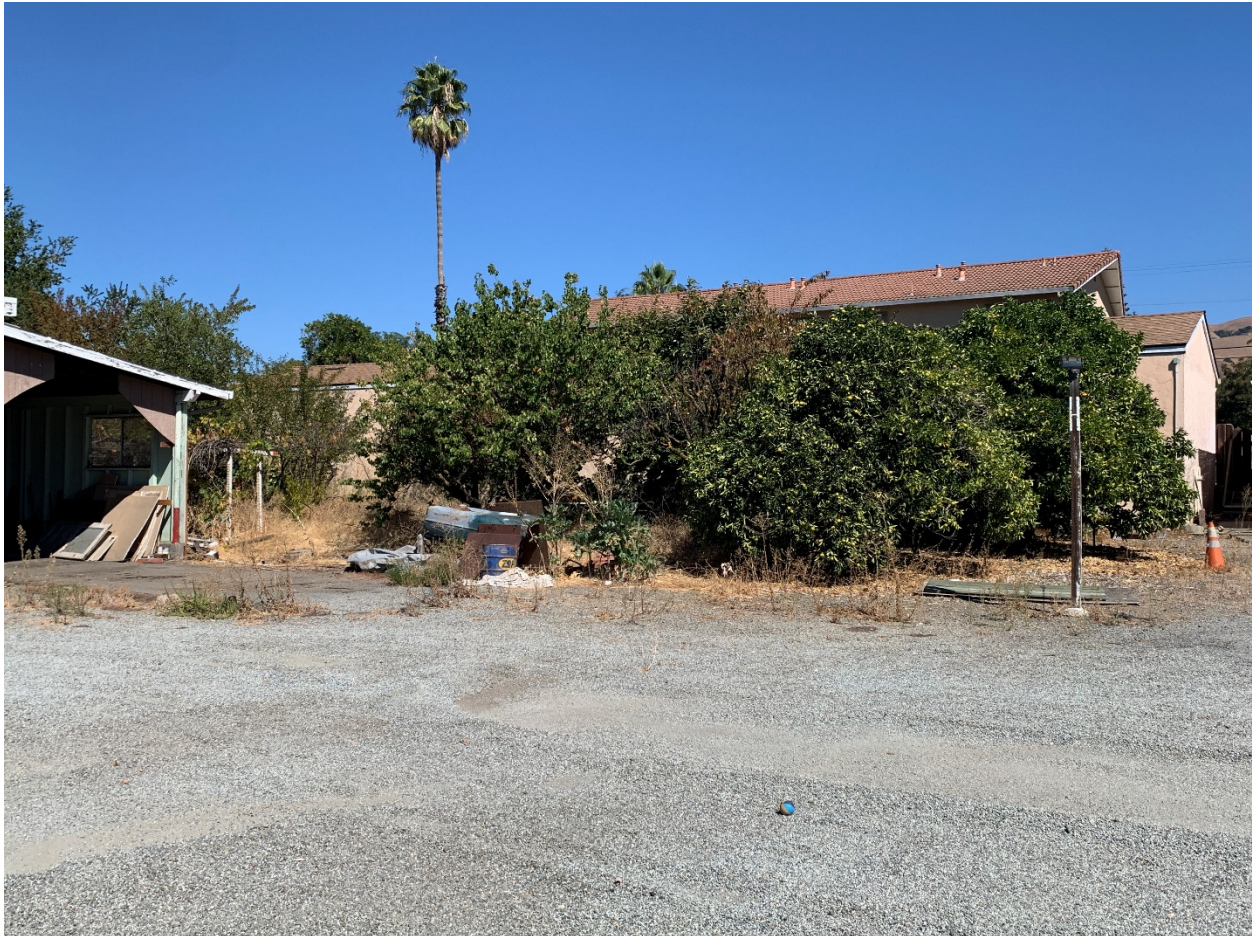
Image #7 – Trees T150 – T156, fruit trees.

Fruit trees in the orchard include plum , persimmon, apricot, fig and citrus. Some of the fruit trees are “ordinance size”. The fruit trees are in good or fair condition, except two plums (one “ordinance size”), are in poor condition.

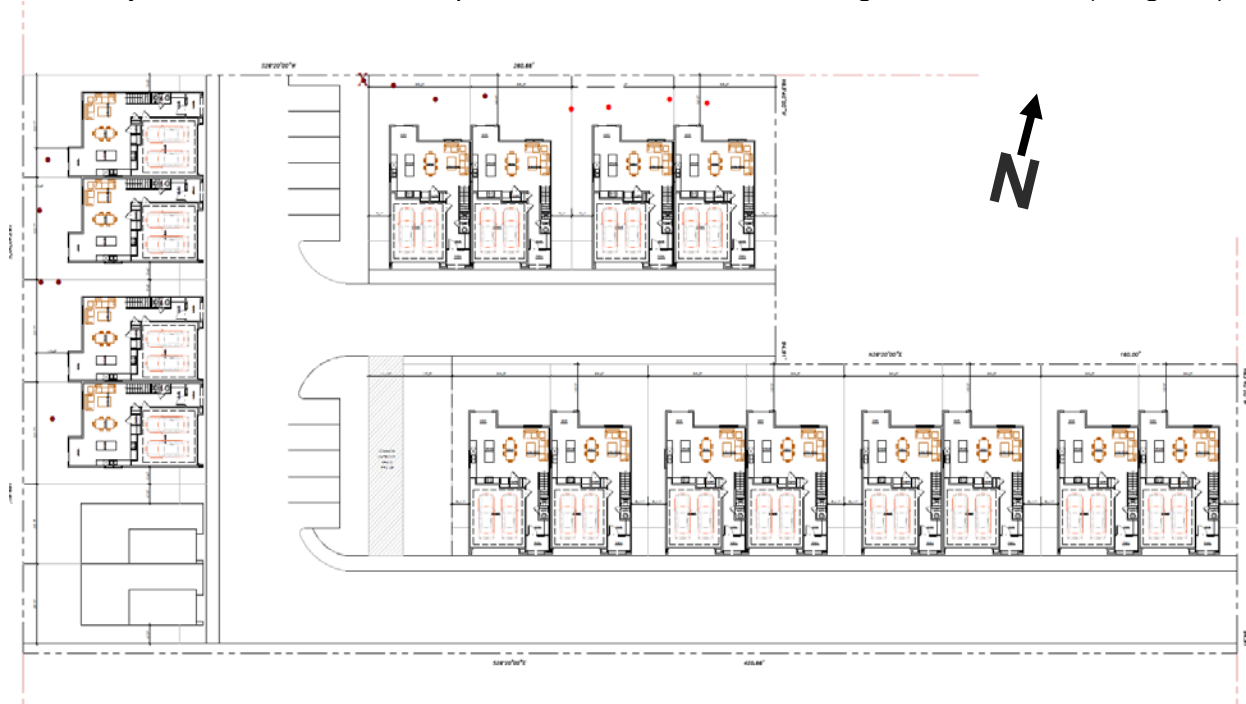
Image #8 – Conceptual site plan. Trees that may be retained (12 total), are shown as brown or red dots. An enlarged site plan can be found in Appendix E of this report.

Both root loss and canopy loss impacts will be high to most existing trees. Most trees will be within the building, or hardscape (roadway and parking) footprint, and their removal will be necessary.

Twelve trees not in the footprint, that may be retained, will have both root loss and canopy loss. These losses will be moderate to significant, depending on final staking location of foundations. If after staking is placed, the impacts are anticipated to be moderate, the trees can tolerate this loss and will require mitigation to reduce root loss impacts. Six of these trees are “ordinance size” oaks including T24, T25, T26, T39, T47 & T48.
